CONDITION SURVEY

LECTURE THEATRES 1 + 2 -  
EDUCATION NORTH

EXISTING GF LOADED LAYOUTS

2344-ELC-ZZ-ZZ-DR-A-70001

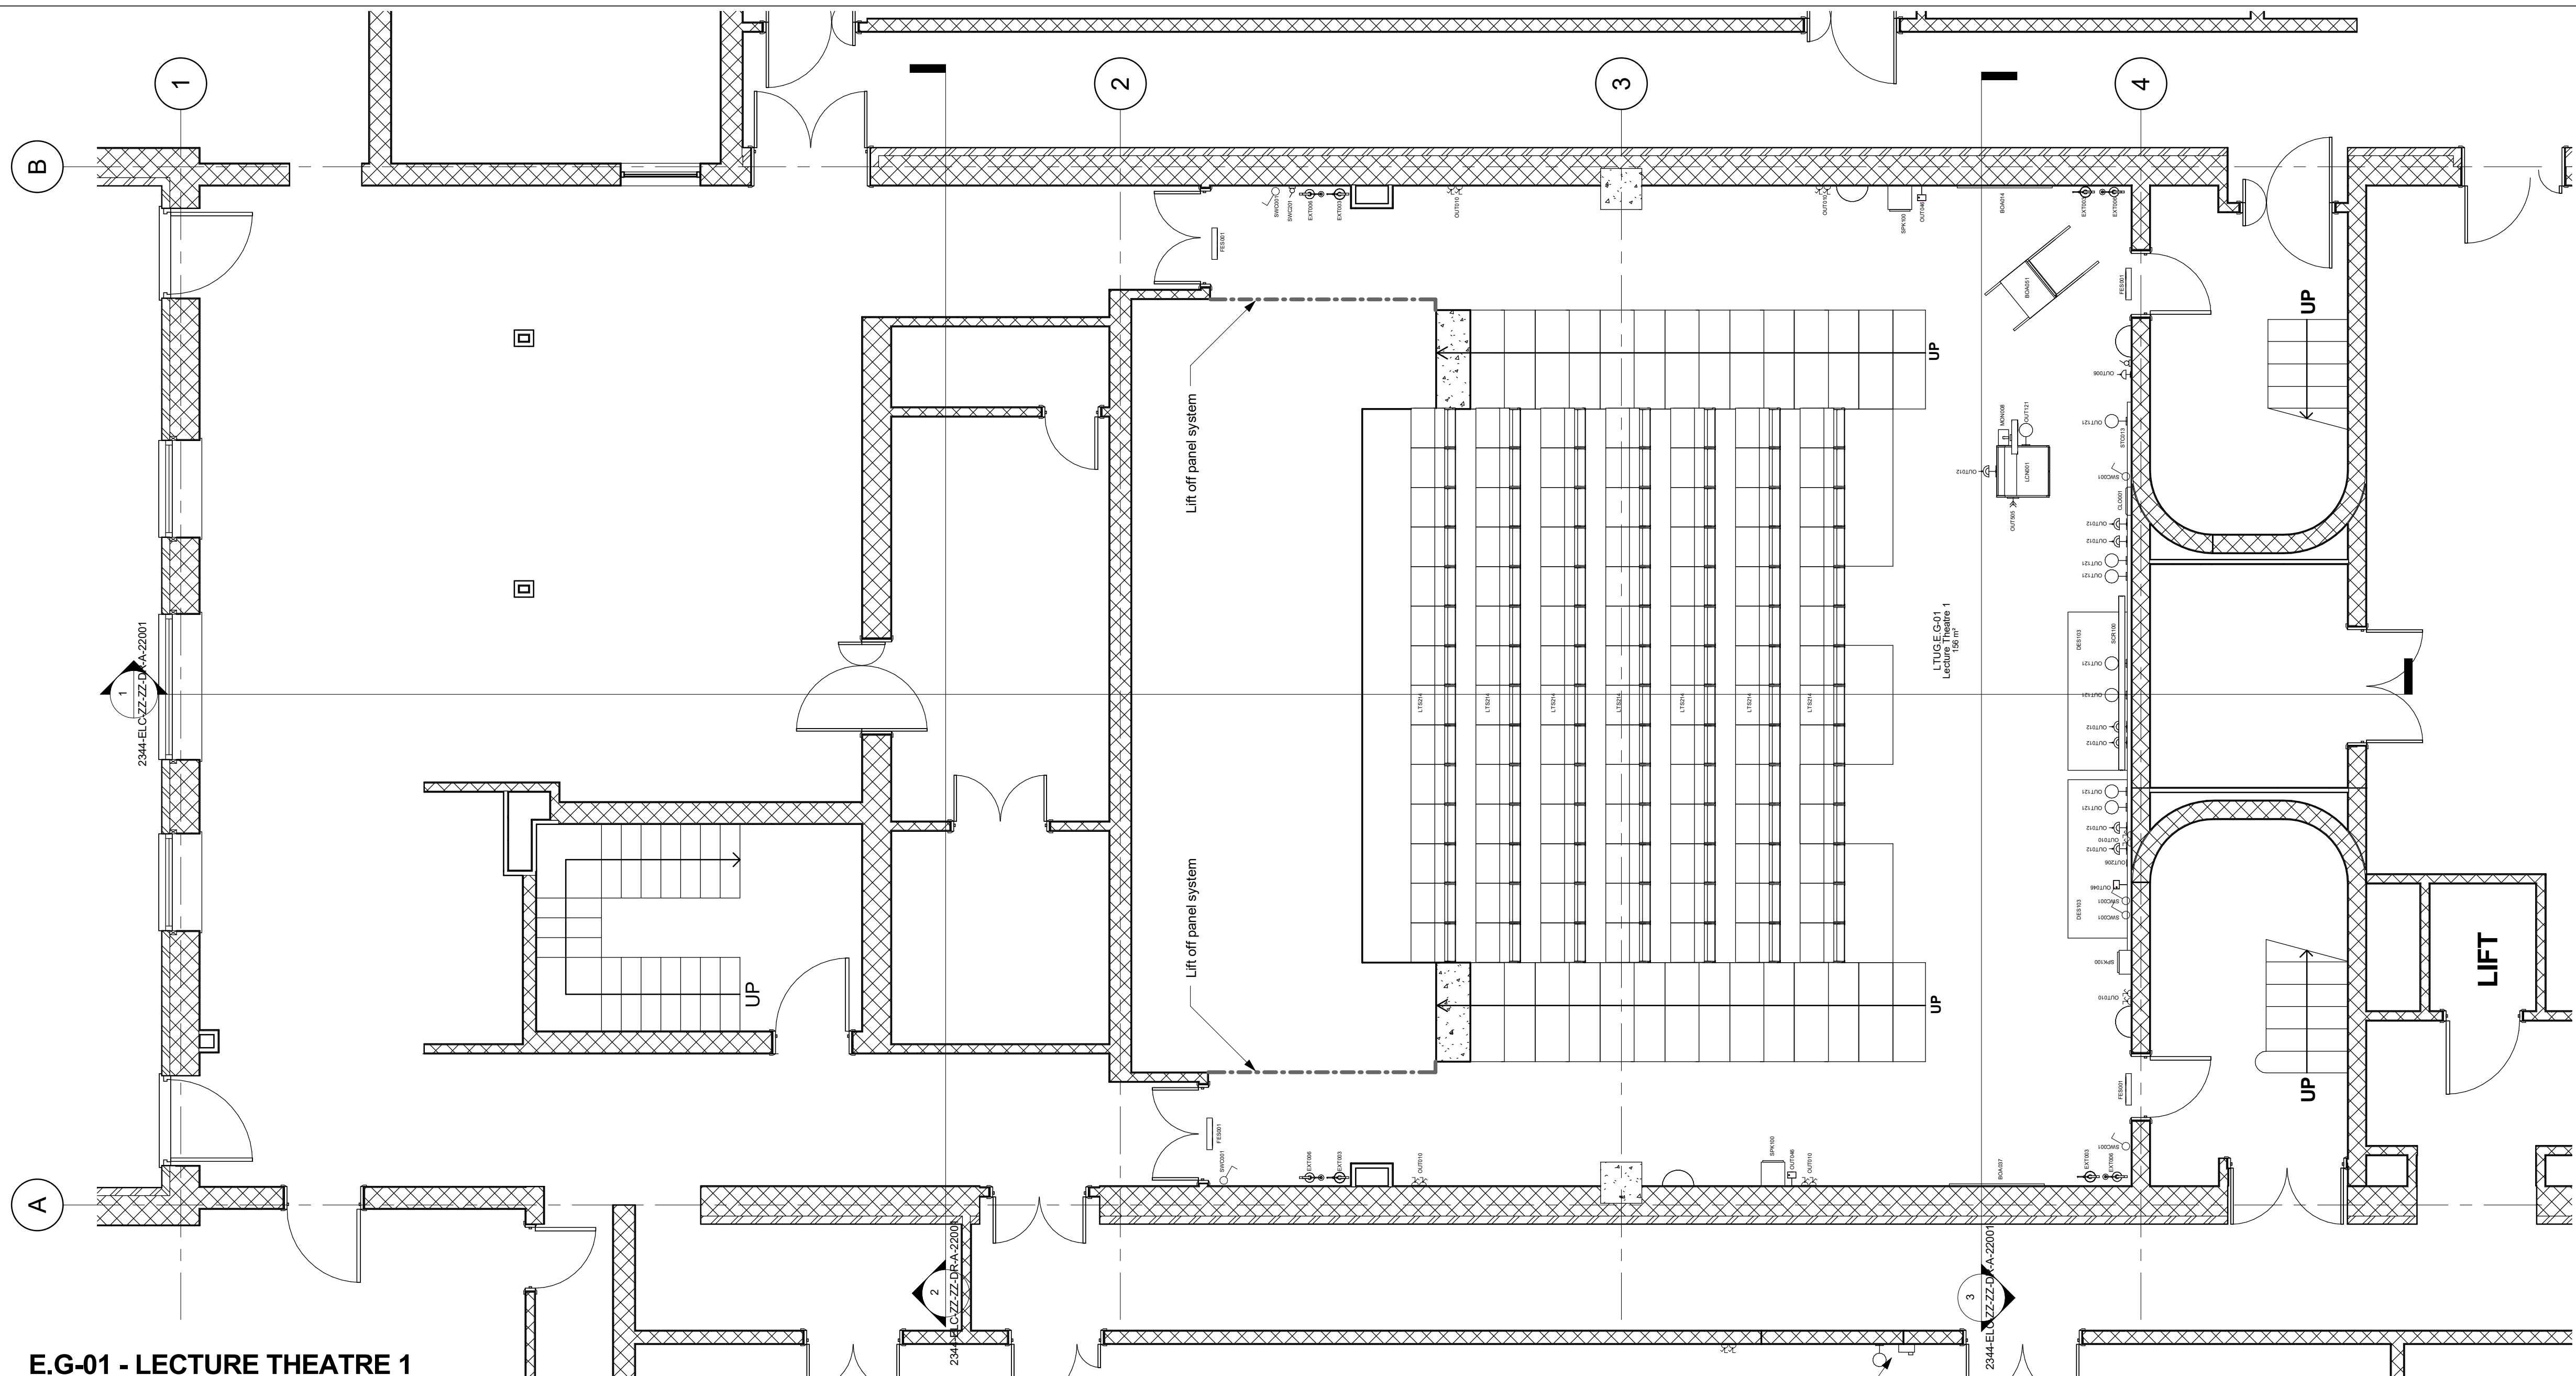
E.G-01 - LECTURE THEATRE 1

LECTURE THEATRE 1

- **Walls:** Areas of patching require making good, general marks, column edges damaged, wallpaper, evidence of damp/water penetration
- **Floor:** Carpet, heavily stained

- **Skirtings:** Good condition, timber, painted/varnished
- **Seating:** Fabric stained, damaged and missing seats (retractable portion performance not checked)

- **Balustrades:** Good condition
- **Acoustic Panelling:** Poor condition, heavily stained (acoustic performance unknown)
- **Vinyl Flooring:** (Control Room), Reasonable, joints not welded

- **Worktops:** (Control Room), Poor condition, holes in laminate, chipped laminate, stained
- **Blinds:** Poor condition, broken/damaged slats
- **Projection Screens:** Good condition

- **Ceilings:** Poor condition of plasterboard ceiling in control room, other (plasterboard ceilings in good condition, raked metal plank ceiling tiles require reseating)

- **Doors:** Painted doors, generally in good condition, existing double doors not DDA compliant, smoke/intumescent seals not continuous over lock/hinges, upper level doors no smoke seals to fire doors

- **Lecturn:** Good condition

- Suspended ceiling tiles marked and stained
- Vinyl flooring stained but generally intact

- Strip out existing lecture theatre seating (retractable structure remains)
- Strip out existing FF&E
- Remove existing carpet finish to retractable structure and floors
- Remove existing acoustic boards from rear wall and separating wall to Lecture Theatre 2
- Remove existing lecturn and AV equipment
- Remove existing data point and telephone from mess room and store telephoe for re-fixing

Remove existing data/telephone outlet.  
Remove wall mounted telephone and  
store for relocating onto new partition
