| Project Title | Boohoo Windows | | |
| Drawing Title | Lizard Street NW, SW, NE Elevations - Fabric Repairs and Window Replacement Works | | |
| | 8965 | (05) 007 | B |

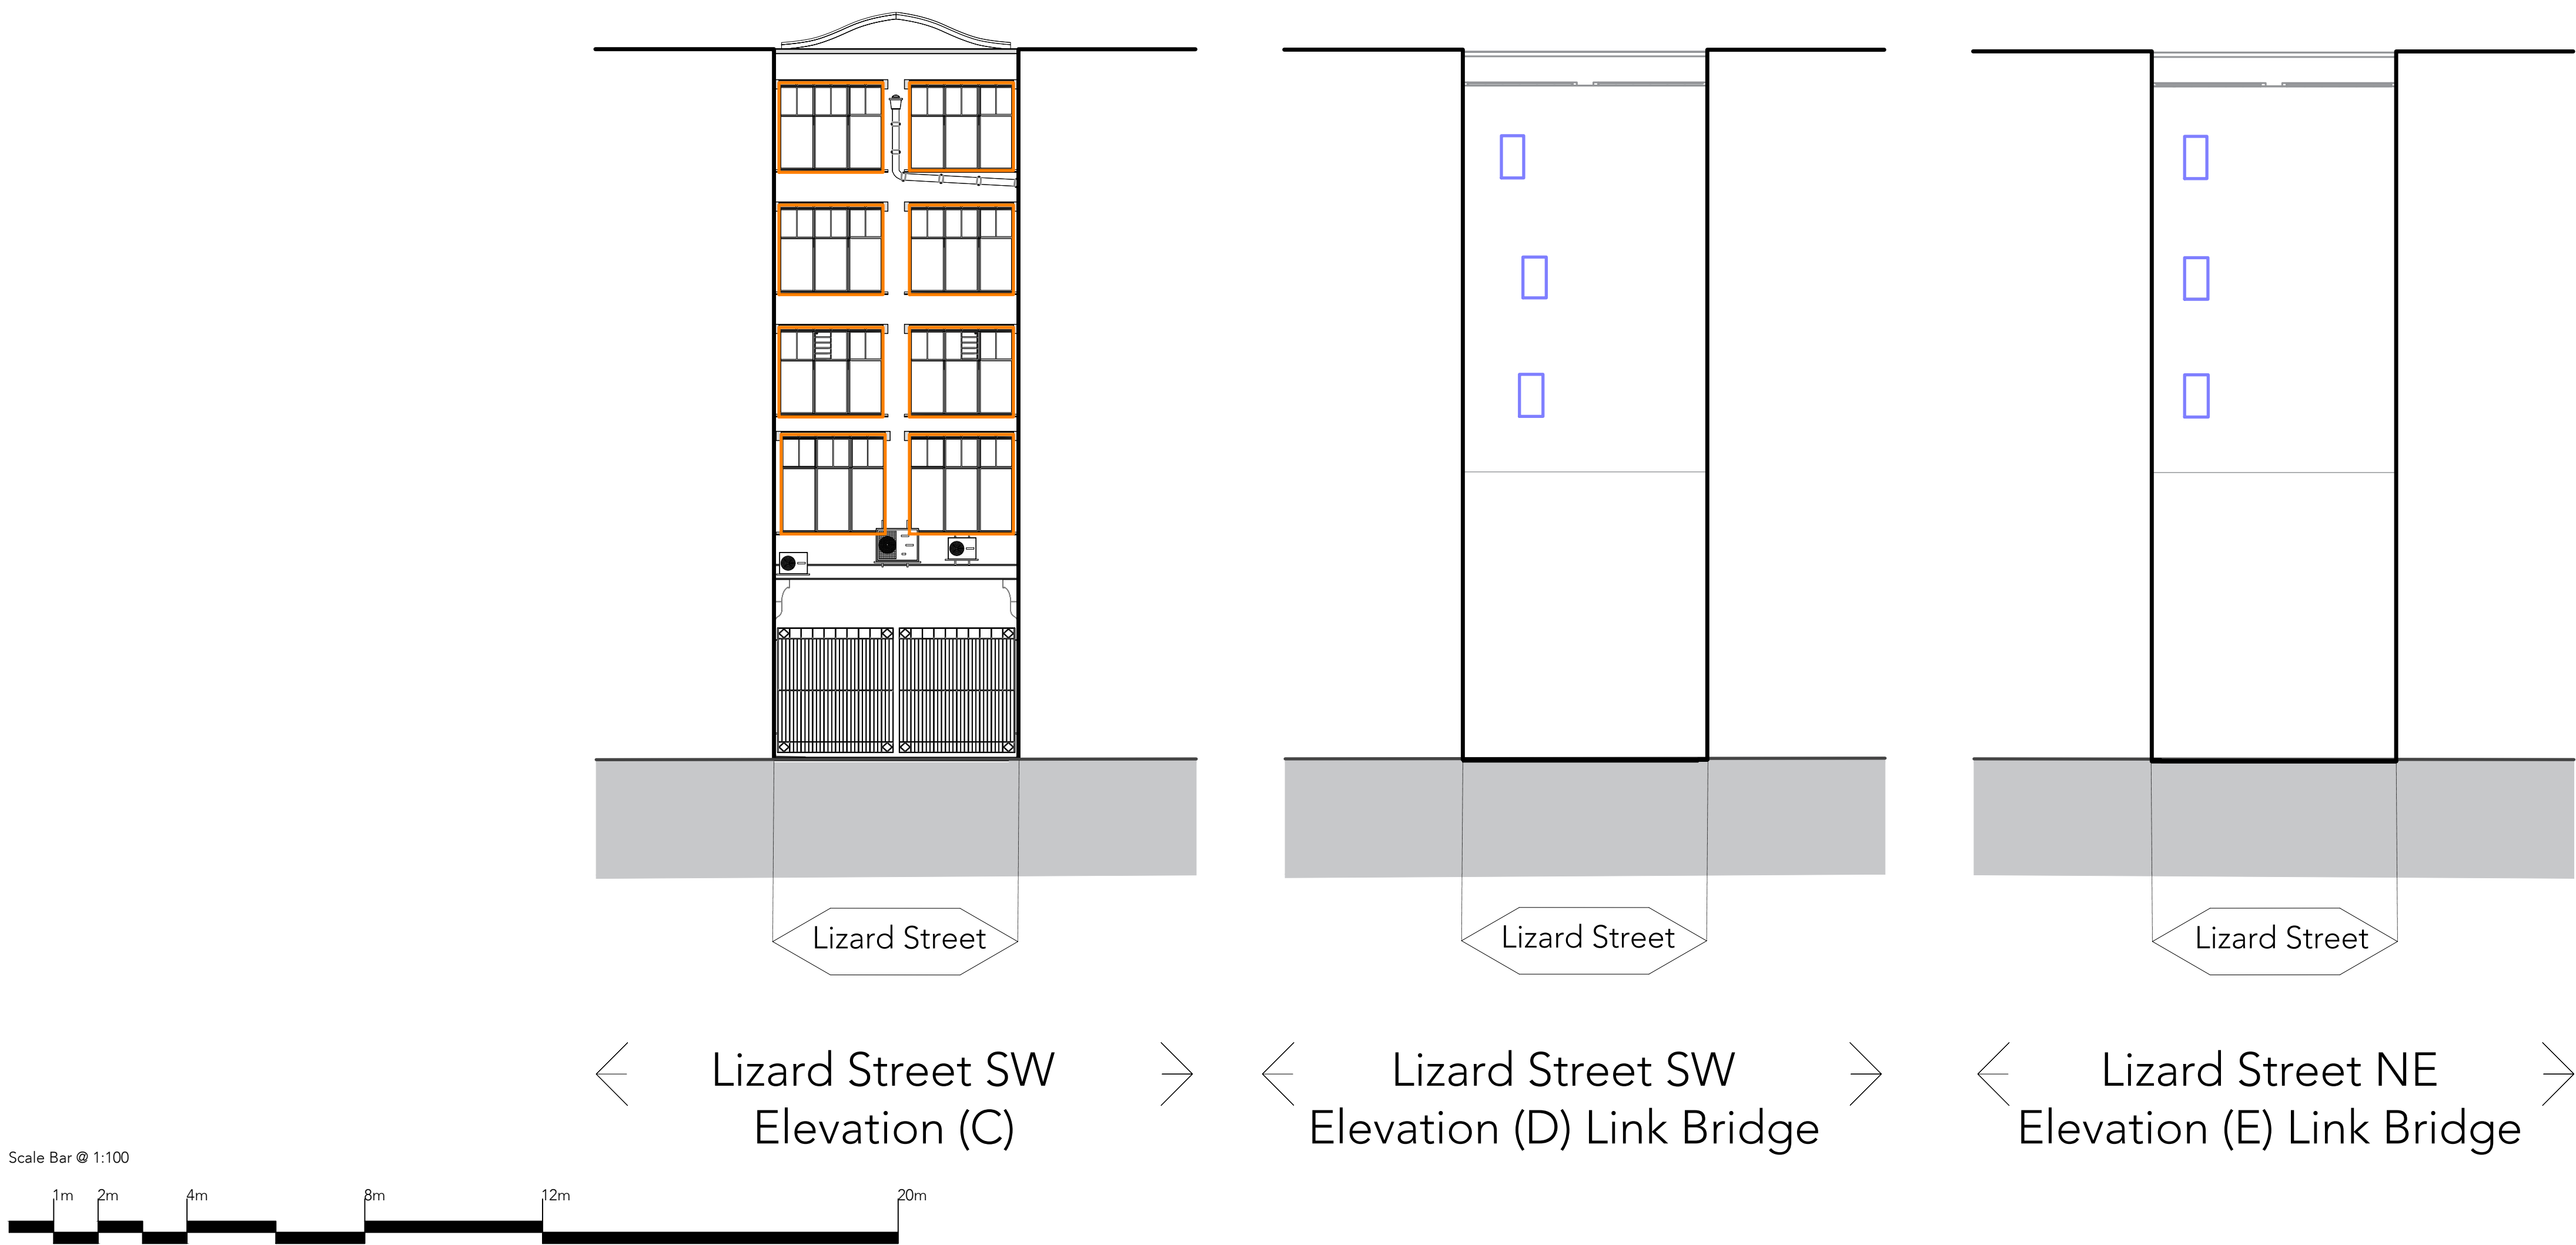
<br>Window overboarded.<br>

<br>Typically a 3 bay metal framed window with mullions and transom. 1/1 light window with central pivoted window.<br>Vegetation growth.<br>

<br>2nr. metal framed windows have previously been removed for investigation and trial restoration works. Openings are currently temporarily blocked with plywood.<br>

<br>Previous metal framed window has been replaced with a timber alternative.<br>

<br>Allow for stonework repairs and/or repointing works to be undertaken.<br>

<br>Allow for masonry repairs and/or repointing works to be undertaken. |

<br>Existing timber doors are to be redecorated.<br>

<br>Existing timber sash windows are to be redecorated. | <b>Restoration Specification Definitions</b> <ul style="list-style-type: none"><li>• RS1 Protection of Historic Fabric / Features</li><li>• RS2 Access Scaffolding</li><li>• RS3 Hydraulic Lime Mortar</li><li>• RS4 Masonry Repairs</li><li>• RS5 Pointing of Ashlar</li><li>• RS6 Brick Repair</li><li>• RS7 Pointing of Brickwork</li><li>• RS8 Masonry Cleaning: General Requirements</li><li>• RS9 Masonry Cleaning: Removal of Organic Growth</li><li>• RS10 Paint and Clear Finishing</li></ul> | <b>Repairs To Stonework Legend</b><br><br>Refer to restoration specification for further details; (X no. indicated on elevations)<br><br>
