Existing Ground Floor Plan

| Project | 56 Faulkner Street Signage Application | Scale | 1:100 @A3 |
| Title | Existing Ground Floor Plan | Drawn | TL |

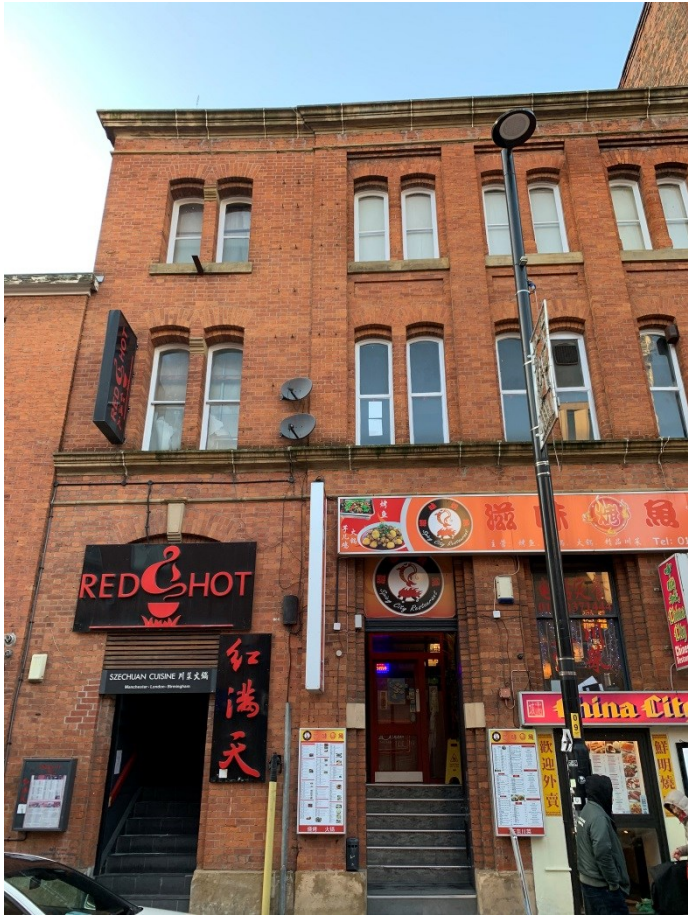
Photo 001

**Signage (See Photo 001)**

All existing signage was installed in 2006 to replace the previous signage. The proposed signage will be dealt with in a separate signage application

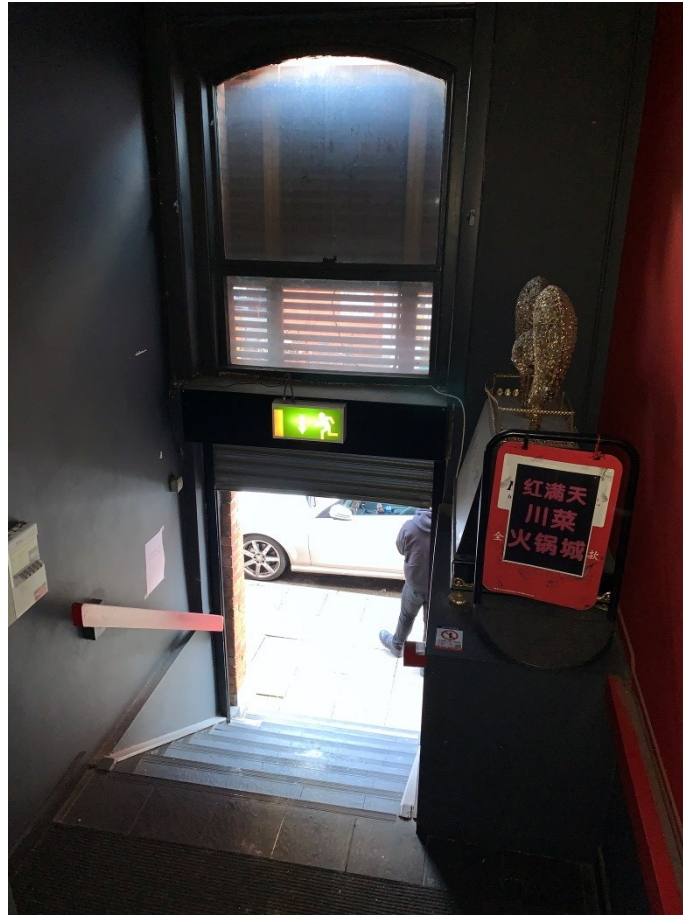
Photo 002

**Entrance Door (See Photo 002)**

The staircase was installed in or before the 1980's when the building floors was separated into different tenants and access was formed for the 1st floor. The first step start immediately from the pavement level. On the entrance opening within the masonry brickwork the entrance door was not installed as this would clash with the steps leading up and prevented the door swing being operational. Without a door, the 1st floor space would be a vulnerable space to intruders. A Vertical roller shutter was installed to mitigate this issue and will be deployed during out of opening hours. The shutter was installed in the 1980's. The roller shutter blades were removed and refurbished in 2006

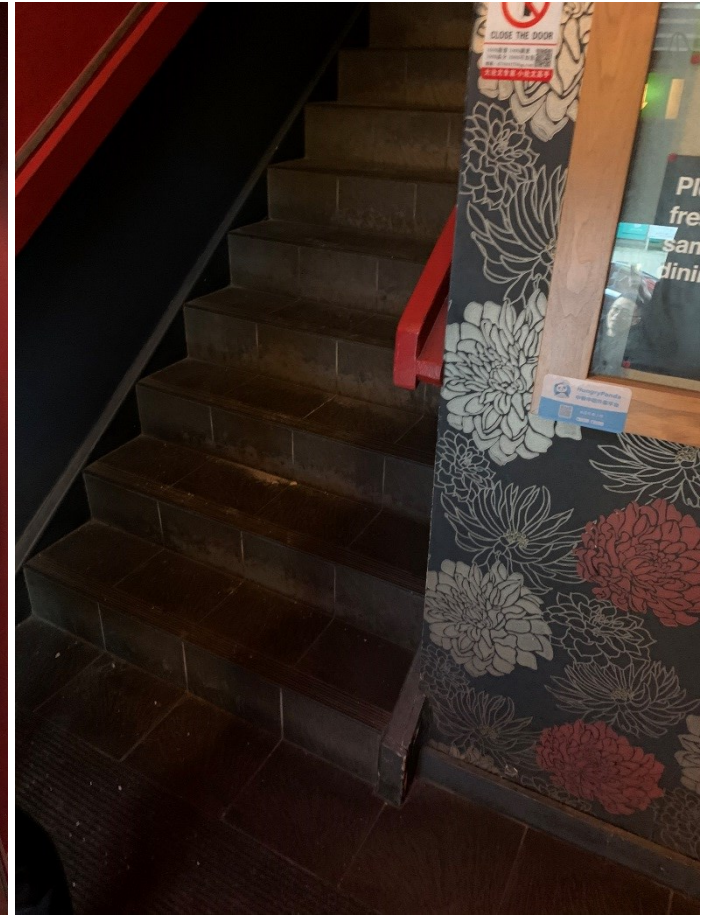
Photo 003

**Entrance Staircase (See Photo 003)**

Staircase is the principle entrance up to the 1st floor. This staircase is original and was installed when the build was subdivided into separate tenanted floors. This was installed in or before 1980's.

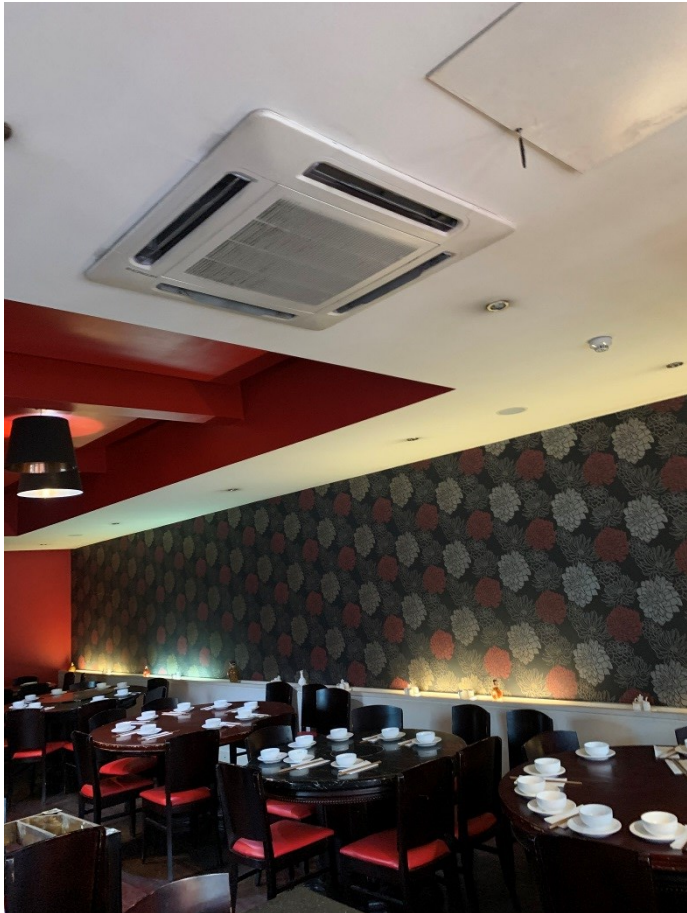
Photo 101

R1/ Existing Walls (See photo 101)

Wall paper applied onto original painted walls  
The wallpaper was applied 2006 to replace the old wallpaper

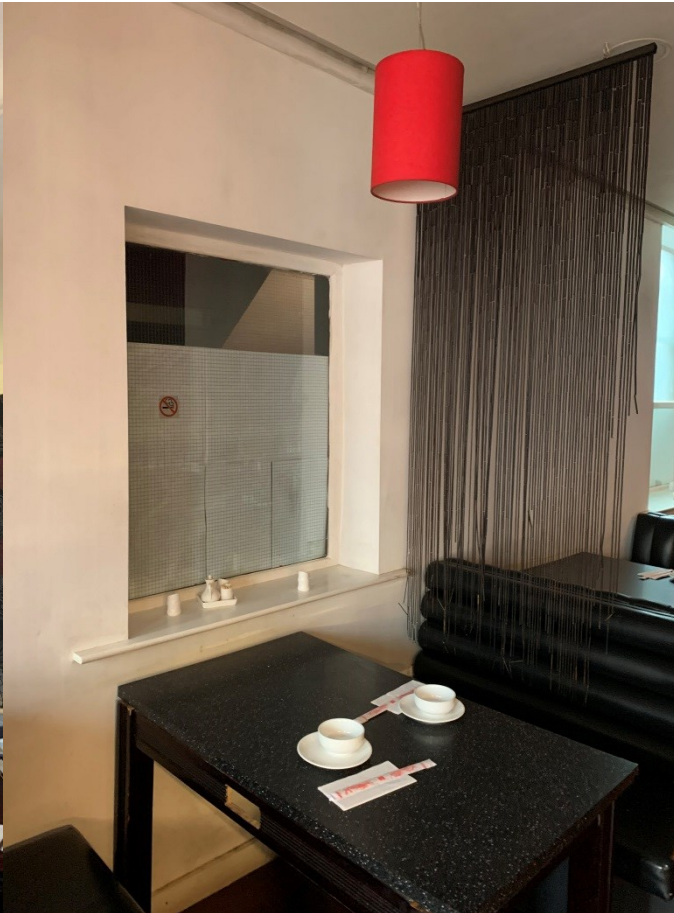
Photo 102

R2/ Existing Walls (See photo 102)

Original plastered walls in painted finish

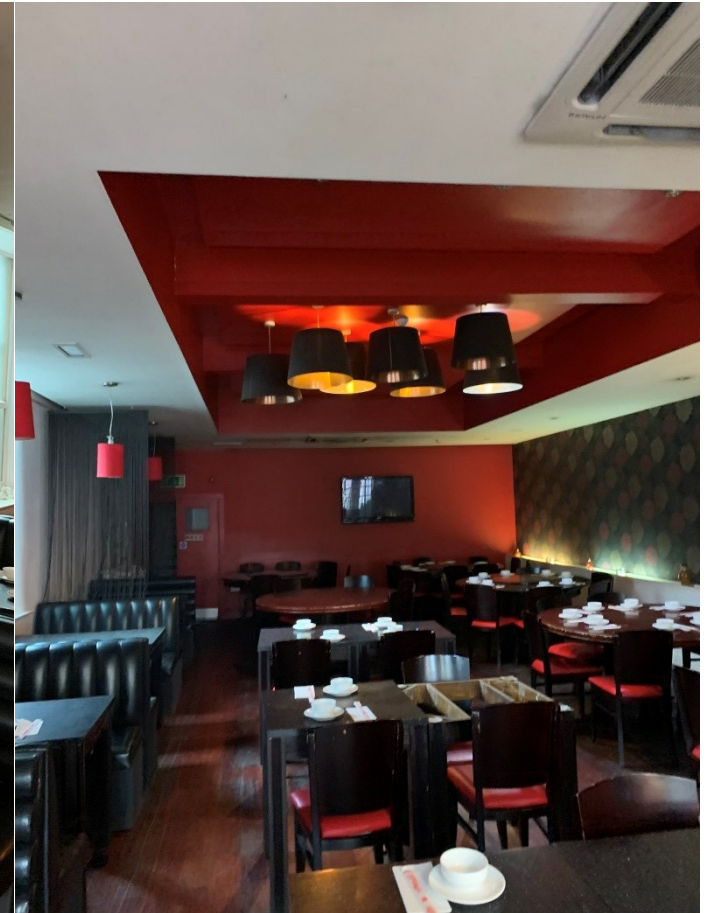
Photo 103

R3/ Restaurant Ceiling (See photo 103)

Plasterboard suspended ceiling to the restaurant area was installed in 2006 to replace the grid suspended ceiling. Please refer to existing ceiling plan for more information on the ceiling

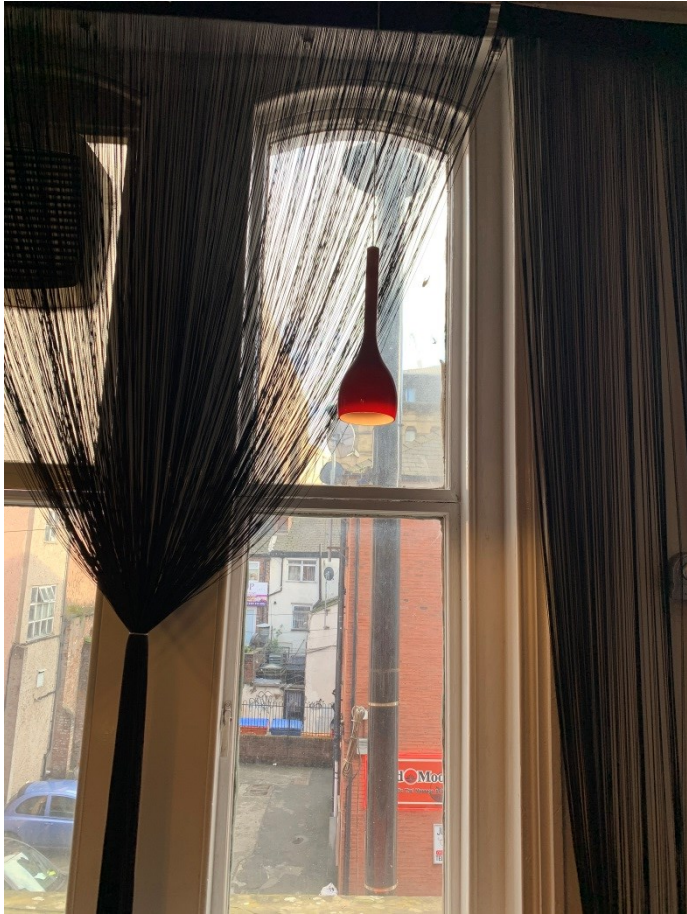
Photo 104

\* R5/ Existing Windows (See photo 104)

Painted timber Side hung opening windows  
Windows are original windows with painted timber internal cills, jamb reveals and head

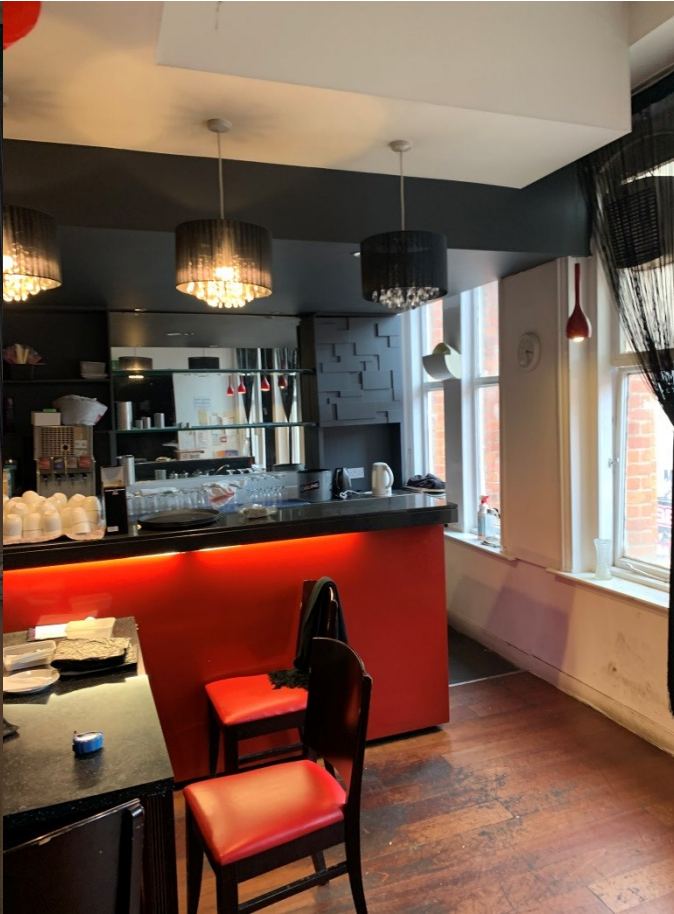
Photo 105

R6/ Bar Area (See photo 105)

The bar area is in the same arrangement as the original bar area when the space was converted into a restaurant in or before 1980's  
The existing bar (counter tap, rear wine rack, sink etc) were replaced with new in 2006 whilst maintaining the main frame of the previous bar. the back wall of the bar is a independent wall not fixed to the original masonry wall of the building  
The floor finish to the bar area is antislip sheet vinyl. this was installed in 2006 to replace the previous square vinyl tile which was installed in the 1980's

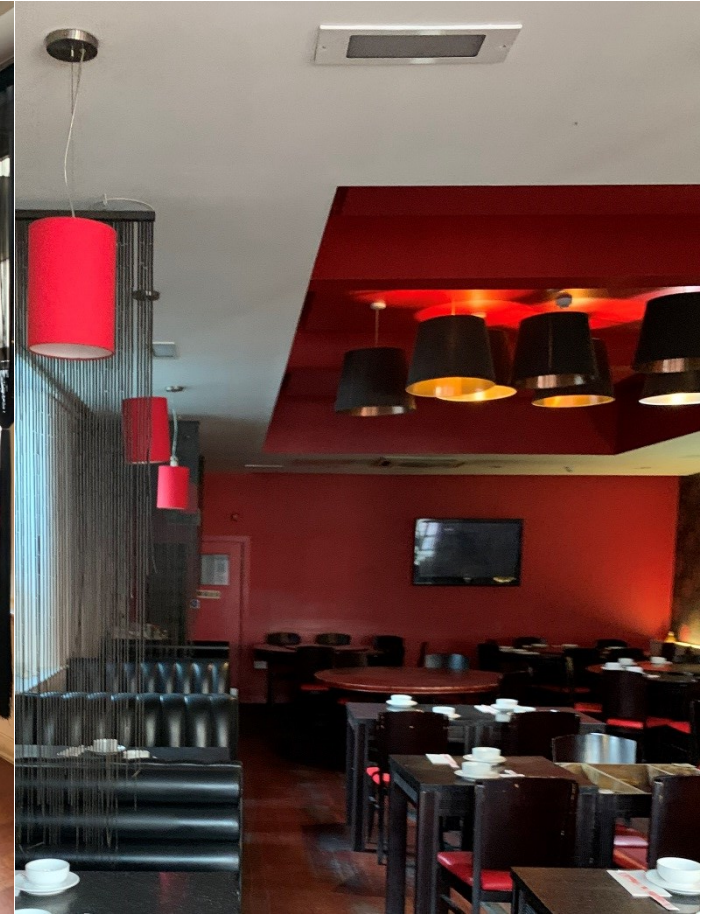
Photo 106

R7/ Light Fittings (See photo 106)

Light Fitting was replaced with new fittings in 2006 by previous owner. The electric supply and switching arrangement was based upon the existing

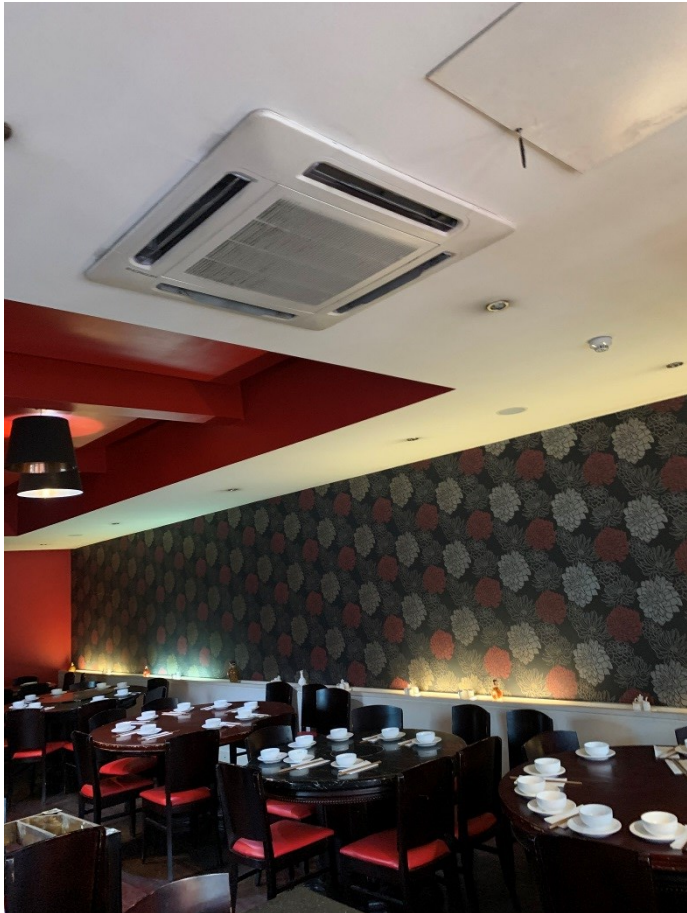
Photo 107

R8/ Air Conditioning Units (See photo 107)

Air conditioning unit was replaced in 2006 with New ceiling mounted cassettes to replace the old units where were from the 1980's

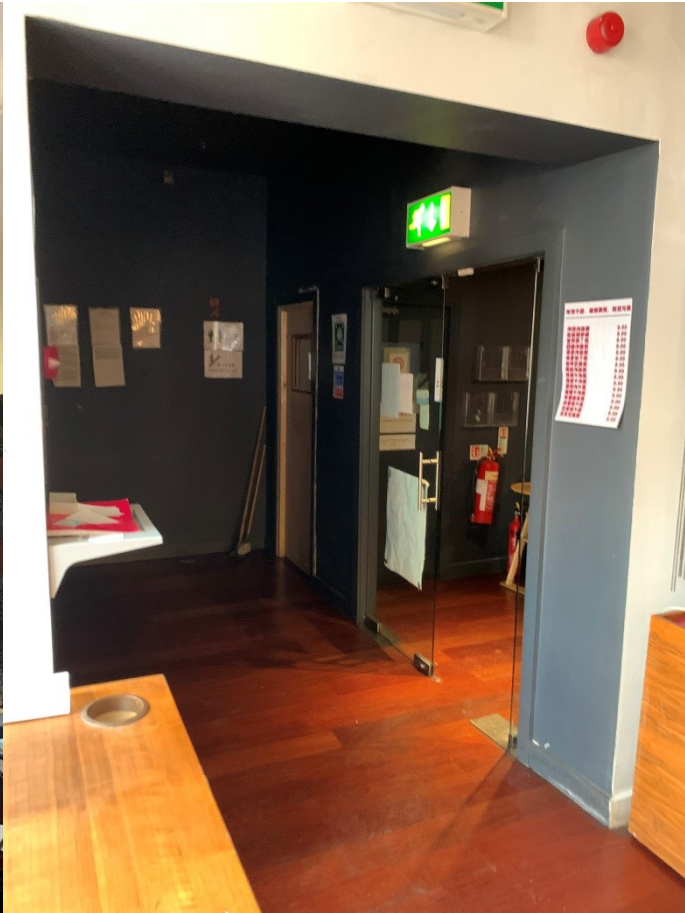
Photo 108

R9/ Existing Floor (See photo 108)

Solid timber plank floor finish on underlay. timber plank interlock and glued.  
Timber floor finished scribed up to skirting perimeter and floor to skirting junction sealed with silicon joint.  
Floor finish installed in 2006.  
Original timber floor is under the floor finish

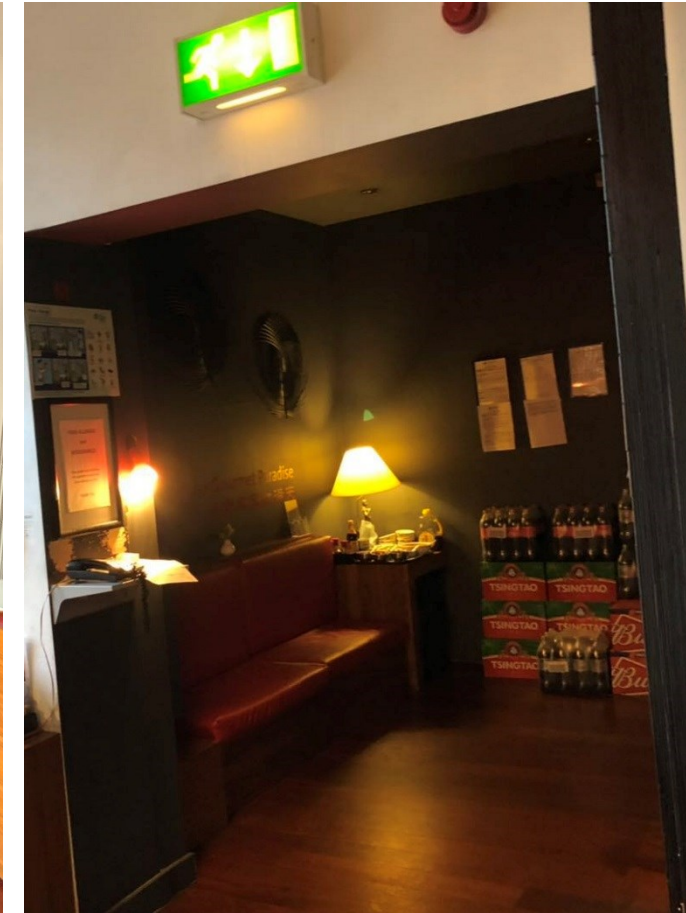
Photo 109

R10/ Blanking Wall (See photo 109)

Partition independent from main original wall was build in 2006 to conceal the window when the waiting area was formed.  
Timber stud with plasterboard fixed to one side and painted finish.

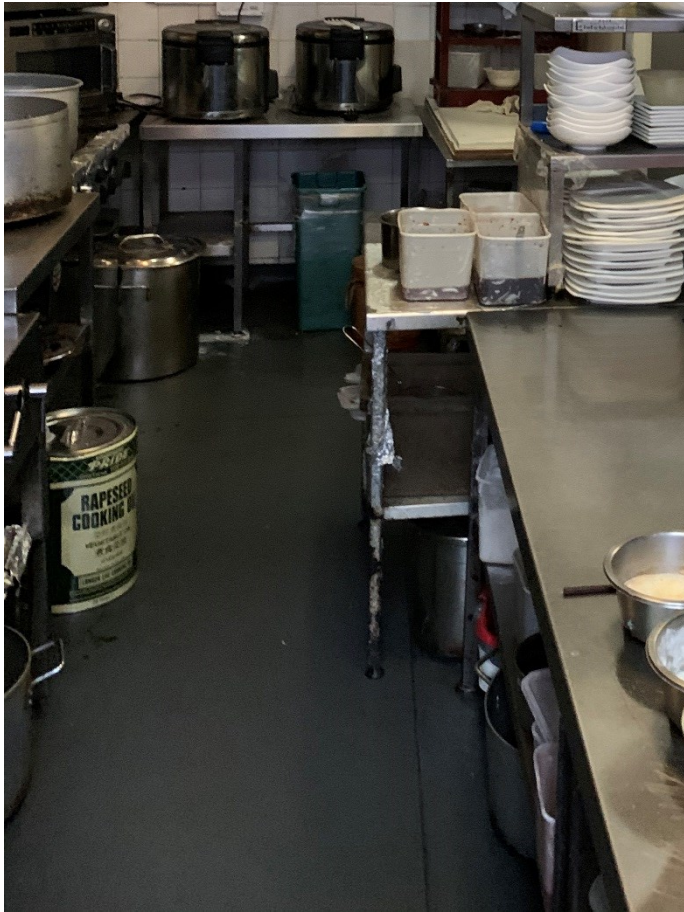
Photo 201

K2/ Kitchen Floor (See photo 201)

Antislip vinyl floor on timber board. Original floor under timber board.  
A Vinyl tile floor was installed in the 1980's when this was already a working restaurant kitchen. The latest replacement to a new sheet vinyl to replace the previous (due to wear) was changed in 2006

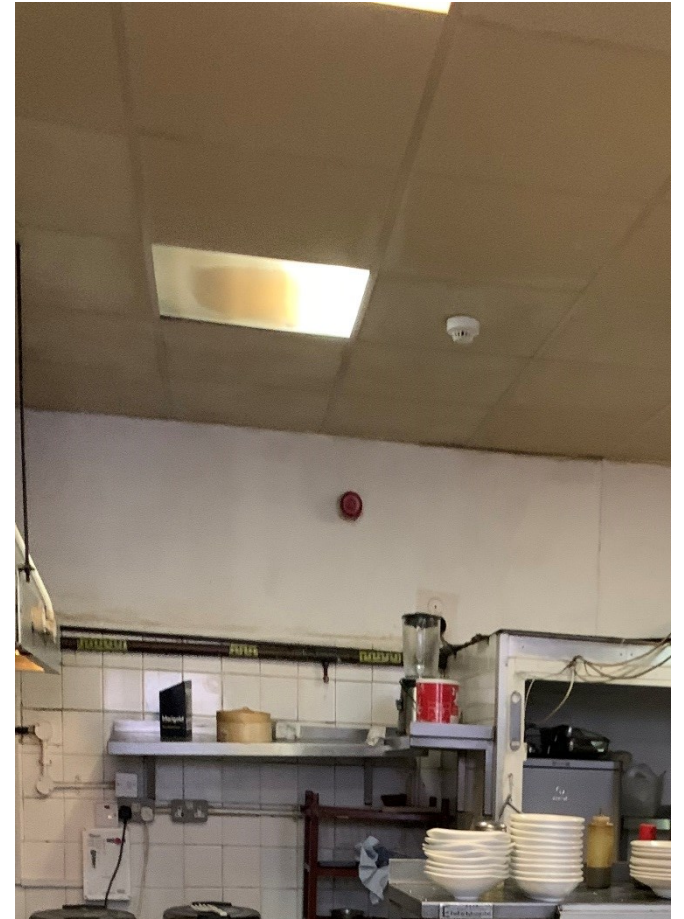
Photo 203

K4/ Kitchen Walls (See photo 203)

Walls are combination of white square ceramic tiles and stainless steel / aluminium sheet cladding finish for kitchen hygienic use. The tiles and metal sheets were installed since the 1980's when the space was operating as restaurant kitchen
