## **Interim Summary for the North View, Dantzic Street Archaeological Evaluation Trenches**

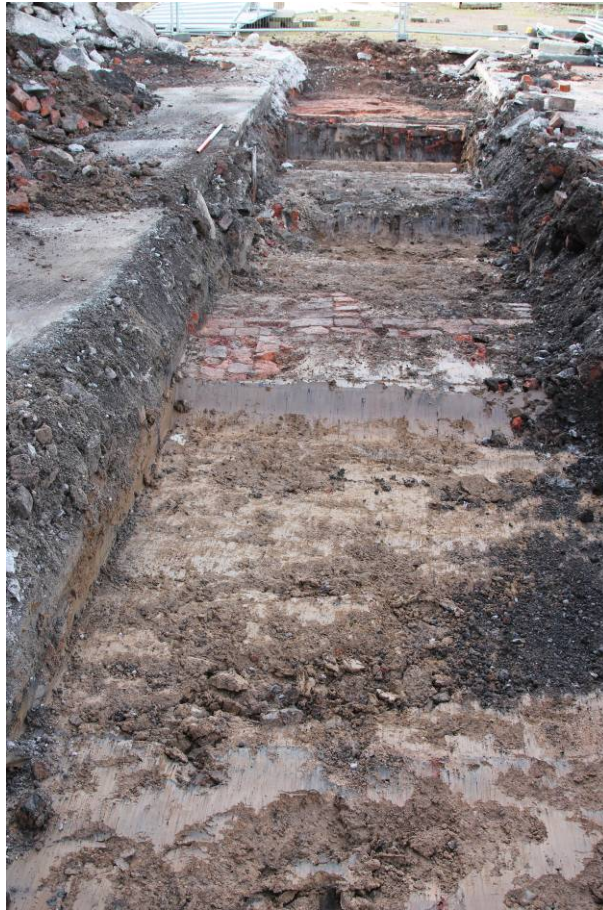
At the eastern end of the trench were the bases of some hand made brick walls with lime mortar *112*, *113*, *114* and *115*, running the entire width of the trench, which were possibly hearths associated with the workers cottages. All these walls were built using full and half bricks which were 220mm x 120mm in size. To the north of these walls was a modern concrete plinth *110* extending beneath the southern edge of the trench which had a concrete filled metal post set into it.

At the western end of the Trench 1 was a section of hand made brick floor *107* at a depth of approximately 0.4m, which was abutted to the north by a short section of east west aligned brick wall *108* and to the east by brick wall *109* which ran in a north south direction across the entire width of the trench. Both these walls and floor were made of 230mm x 120mm sized hand made brick with a sandy mortar.

To the east of wall *109* was a modern brick wall *106* which ran in a north south direction across the entire width of the trench and was also observed at ground level.

Plate 1: Trench 1 looking southwest

The workers housing along Flag Row within the northwest pay and display car park (trench 1) were not cellared and only very fragmentary remains were observed. It was felt that this area did not merit further investigation.

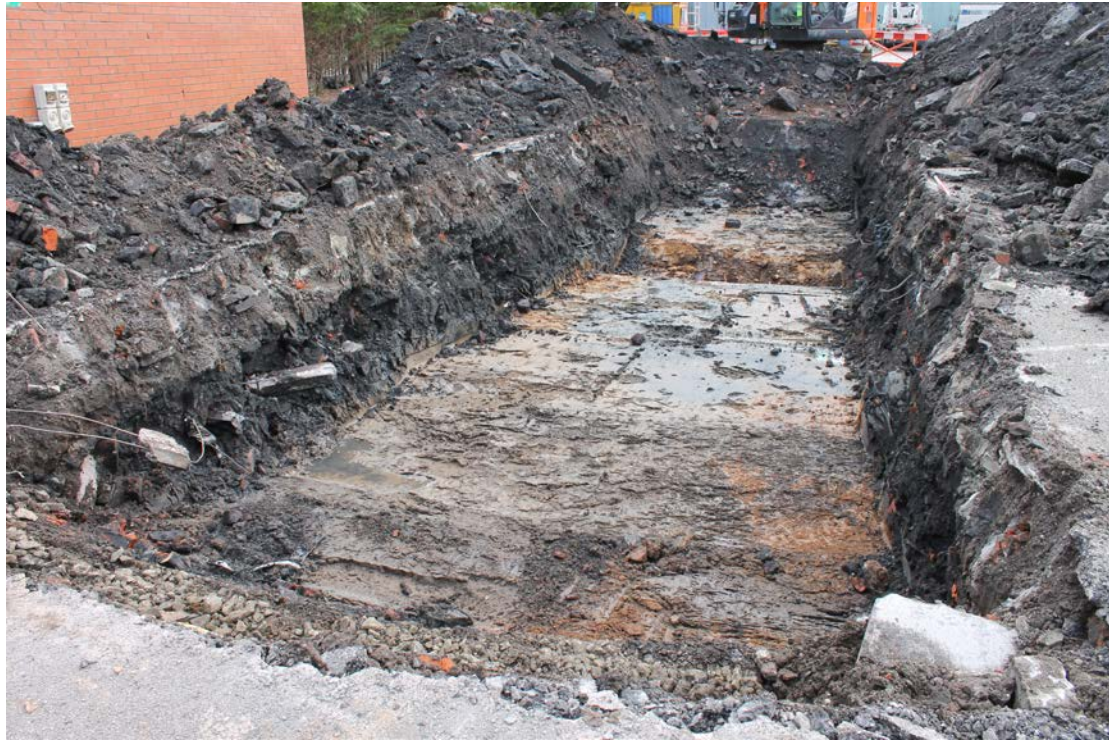
Trench 2 was located in the Astra Signs car park. It measured 16.2m x 4.4m in a north/south direction and was excavated to a maximum depth of 1.6m at which natural clay 104 was observed. The trench was overlain by a 0.06m layer of hard tarmac 166 beneath which was a 0.66m layer of very compact mixed infill 167 which contained tarmac, stone, brick, clay, concrete, reinforced concrete beams, plastic bags and rubber hoses, and appeared to have been compacted with a roller. Below 167 was a 0.53m layer of very oily mixed compact infill 168 containing brick, stone, concrete, tarmac, tyres and other plastic materials (Plate 2).

At the southern end of the trench was ceramic drain 165 at 1.6m below ground level set into the natural clay 104. Drain 165 ran in an east/west direction across the entire width of the trench. At the northern end of the trench was a yellow plastic duct 169 within a stone infill, 169 was 0.6m below current ground level and was uncovered by hand and left intact *in situ*.

Plate 2: Trench 2 looking south

No remains of the workers housing were present within trench 2. This trench suggested that in this area the whole car park had been cleared and levelled during the 20th century and therefore no further investigation was required.

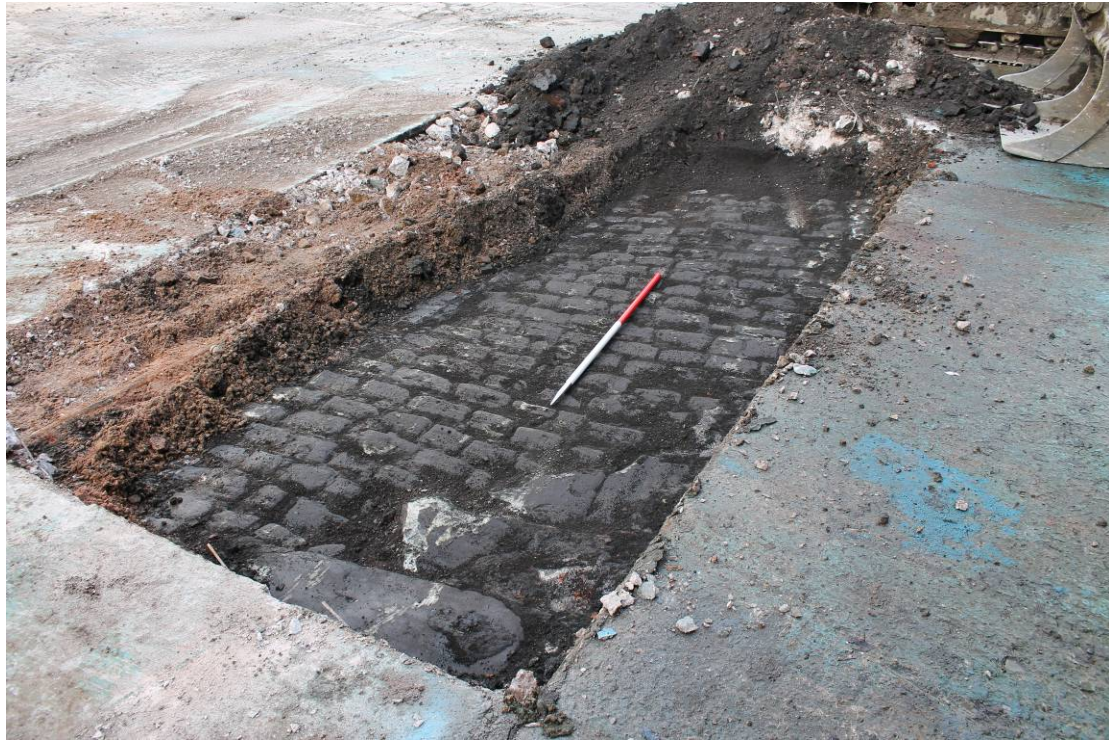
Trench 4 was located in the waste depot rear yard to the immediate north of the open fronted shed and measured 4.5m by 3m running in an east west direction and was excavated to maximum depth of 1.5m (Fig 4). The test pit was overlain by a 200mm thick layer of concrete *100*, below this was 60mm layer of bedding sand *160* which overlaid a compact mixed ash layer *161* 100mm thick. Below this was a very compact 20mm layer of ash *137* which overlaid a stone sett surface *153*. These setts measured approximately 180mm x180mm and were set into a clay bedding layer *162* (Plate 3).

In the south west corner of Trench 4 was the remains of some stone slabs *154* associated with the stone setts *153*. These appeared to be running at an angle from northwest to southeast and were respected by the setts surrounding them, indicating a possible working surface.

Plate 3: Sett surface in trench 4, looking north

Substantial remains associated with the glassworks were uncovered within trenches 4 and 6. Trench 6 was at the lowest point in this area and the fact that the ground level rises slightly to the south of that trench would suggest that significant remains of the glassworks will survive beneath the concrete surfaces within the rear yard and open fronted shed in the waste depot. Both the flag surface and the drain below it in trench 4 appeared to respect the curvature expected for the nearby kiln (appearing on the mapping and located beneath the north wall of the open fronted shed). The flues and refractory brick along with the brick, stone sett and stone flag surfaces suggest that substantial remains survive associated with the annealing hearths and other working areas of the glassworks. Although it is known that a gas main runs across the position of the kiln this type of main should be at a maximum depth of 1.3m and would not have removed such a substantial structure as a glass kiln. It was felt that as the remains of the glassworks were sufficiently significant and have been shown to have a good level of survival these would likely require further investigation.

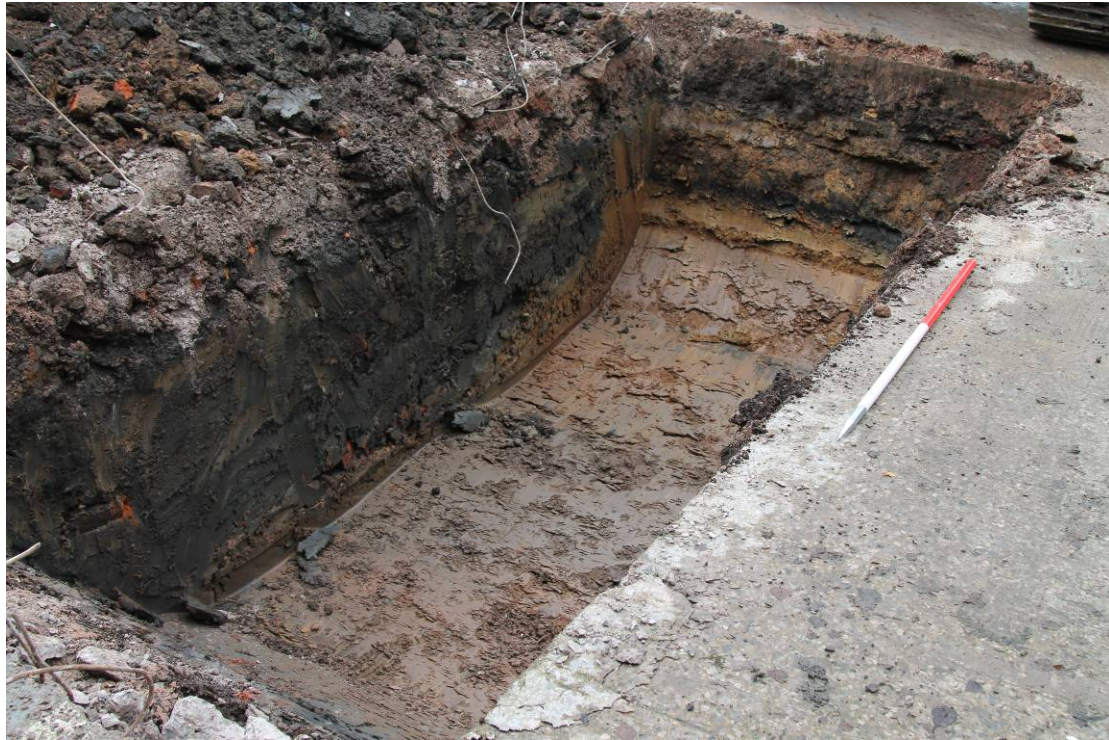
Trench 5 was located within the waste depot rear yard, towards the east side and in front of the offices. It measured 5.2m by 2.24m, was excavated to a maximum depth of 1.7m and was aligned northwest/southeast (Plate 4, Fig 5). It was overlain by 0.22m of reinforced concrete *100* with 40mm of fine sand bedding *146* below it. Below this was a 120mm levelling layer of mixed clay *147* with brick, stone and ash. Beneath this levelling layer was a clean clay capping layer *148*, which was 120mm in depth.

Below these modern layers, associated with the laying of the depot surface, was a 1.2m deep deposit of mixed dark grey/brown clay *149* with brick, mortar, plaster, slate and stone. This overlay natural brown clay *104* at a depth of 1.7m. At the northwestern end of the trench deposit *149* had been cut by a northeast/southwest feature *150*. This was cut from the top of *149* and was not bottomed where it descended through into the natural clay. The cut was 0.63m wide and filled with a yellow mixed clay *151*.

Plate 4: Trench 5, looking west

Although no remains were uncovered within trench 5 the cut feature at the northern edge of the trench is intriguing. The origin of the cut and its fill suggest a 19th century date rather than a modern service. The glass kiln would have required an air intake flue which must have entered from either the east or north and would be a substantial brick structure at depth. It is possible that the cut uncovered within this trench may be the edge of the construction cut for such a feature. The possible presence of such a structure would merit further investigation in this area as part of the further investigation of the glassworks.

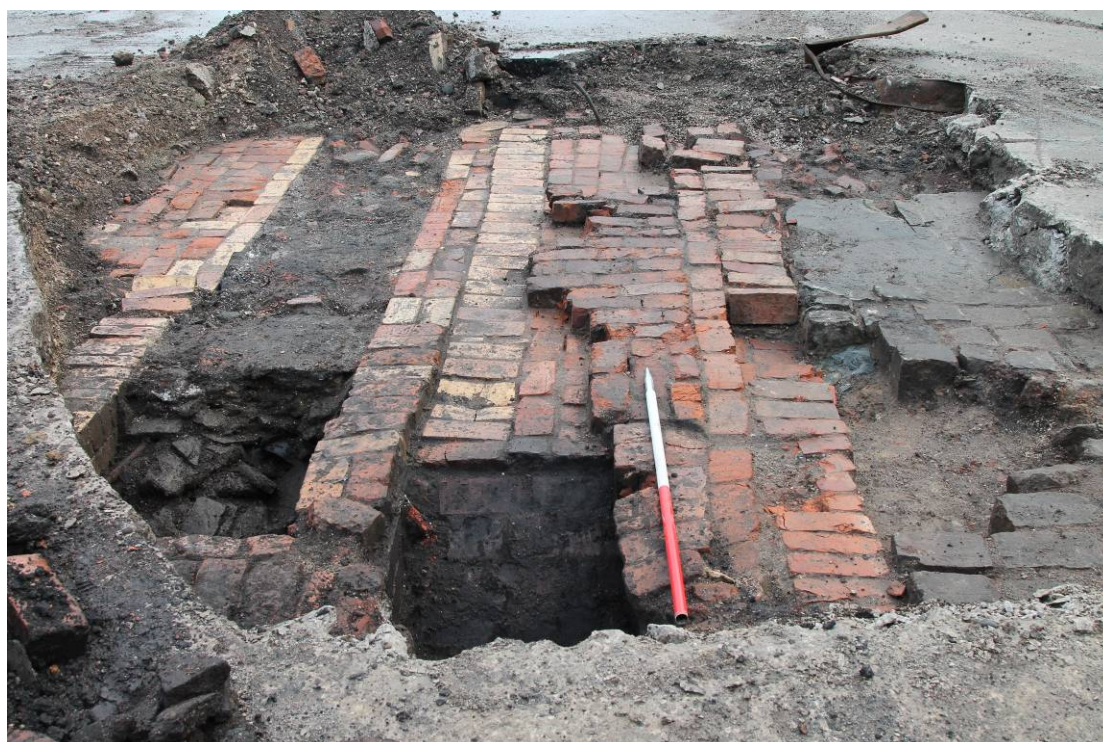
Running parallel southwest/northeast across the northwest and central parts of the trench were two hand made brick walls *125* and *122* forming the two sides of a 0.67m wide flue. Wall *125* had its inner side lined with refractory brick and both walls showed numerous signs of repair in both hand made and machine made brick. The flue had been later blocked with brick *124* at its southwest end. It was filled with a mixed burnt deposit *127* of ash and cinder which contained glass fragments and a large amount of broken dark grey conglomerate material. This was hardened ash and very small stones and may have been a lining built up on the inside of a furnace which would have been chipped off as regular maintenance. A 0.68m deep sondage was excavated at the southwest end of the flue, which did not bottom it, and a sample of the lining was taken. All these wall were bonded with lime mortar and had a slightly later sandy mortar visible in the areas of repair. At the northwest side of wall *125* was a machine made brick surface *128* with a concrete block *129* partially truncating its southwest end.

At the southeast side of wall *122* a refractory brick wall *121* ran parallel, abutting *122*. This was of early machine made refractory brick with a mid 19th century type sandy

mortar and appeared to be a later addition, possibly dating to the 1860's. At the southeast side of this wall was a hand made brick surface *120*. At the southwest end of wall *121* and surface *120* was a 0.69m wide sloping surface of hand made brick *123* with sandy mortar which sloped downwards to the southwest and was covered with burnt ash and cinder *126* and contained glass fragments.

To the southeast of surface *120* was a hand made brick wall *119* with lime mortar. This ran parallel to wall *121* and also formed the southeast side of sloping surface *123*. To the southeast of this were what appeared to be internal working surfaces. At the southwest corner were the remains of stone setts *117* with the remains of stone flagging *116* to the immediate northeast. Beyond this the northeast ends of wall *119* brick surface *120* and stone flag surface *116* had been truncated by a modern cut containing ash and concrete *118*, possibly a base for a column.

Plate 5: Remains of glassworks flues and working areas, looking northeast

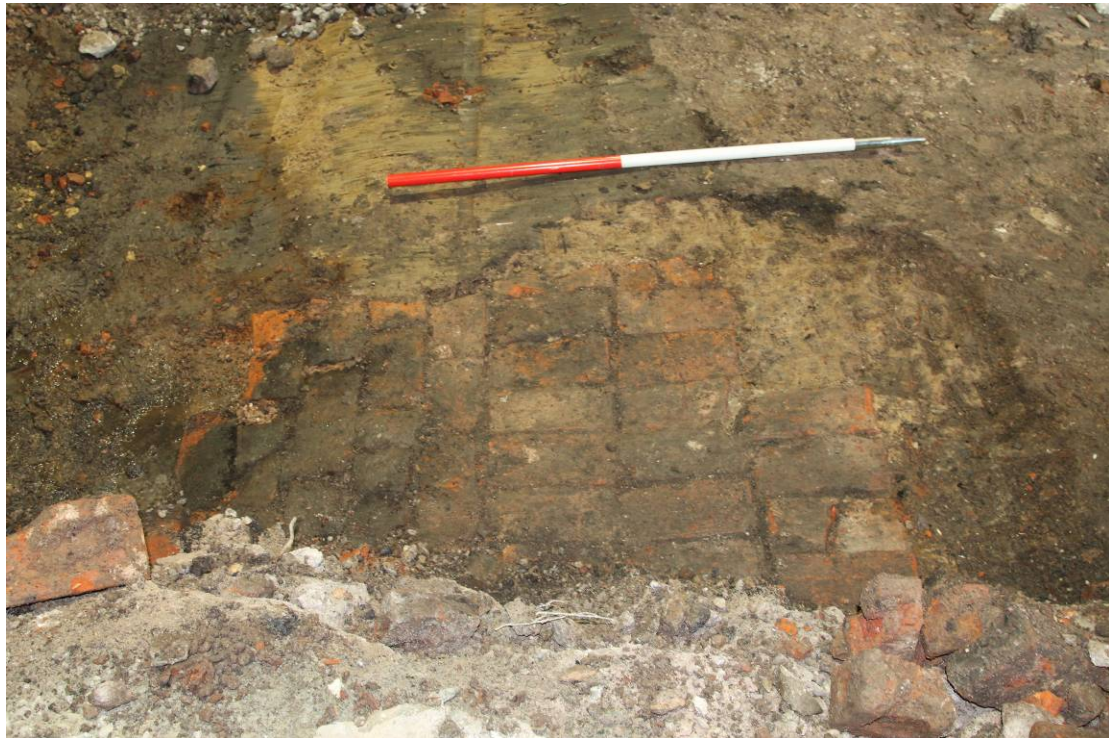
At 4.3m from the northwest end of the trench was a 1.3m by 0.82m hand made brick surface (Plate 6). This comprised two different sections of brickwork, *135* had the stretchers running northeast/southwest and *136*, to the immediate northwest, had the stretchers running northwest/southeast. This had been truncated on three sides with the fourth running in to the trench edge.

Plate 6: Remains of brick floor surface in trench 7, looking southwest

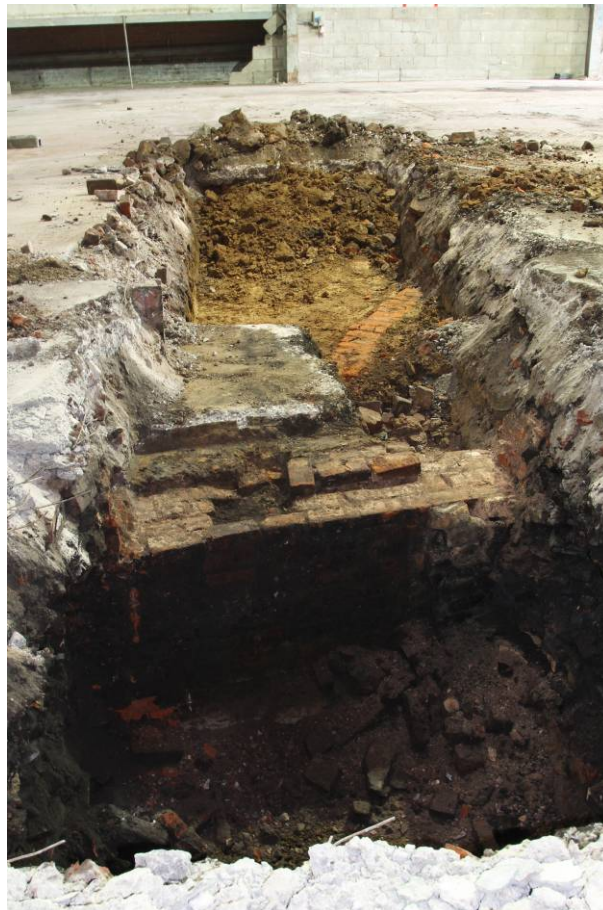
At 2.5m from the southeast end of the trench it was crossed by a 0.5m wide wall *141* of machine made brick with sandy mortar (Plate 7). The wall comprised 5 stretcher

courses wide of bricks with a 340mm by 250mm gap in the upper surface, possibly a socket for industrial fixtures. The inner, southeast, face of the wall had been lined with refractory brick 140. The southeast side of the wall was excavated and found to contain a large amount of black burnt material 139 including cinders, ash and burnt wood. The structure was excavated to a depth of 1.7m at which burnt and blackened clay was observed. Due to the unstable nature of the infill material it was not possible to excavate further but it appeared that the stepped out base of the wall had been reached and that the burnt clay may have been the heat affected top of the natural clay.

Plate 7: Substantial brick wall in trench 8, looking northwest

Some fragmentary remains survive from the nut and bolt works but these are mostly patchy and highly truncated. The only substantial find was the large wall and associated burnt material at the southeast end of trench 8. The nut and bolt works is unlikely to have been smelting or forging and would probably have received blanks made elsewhere and used lathes to thread them. This kind of work would have required a small engine, probably powered by gas. This would have been placed in a small basement engine room and would have become sufficiently hot as to require the walls to be lined with refractory brick. It is felt that due to its late date the remains of the nut and bolt works would not require further investigation.
