111 Ivygreen RD, Chorlton

Proposed Roof Plans

SCALE: | MM\_2 | A  
DRAWING NUMBER: | REV: (A2)

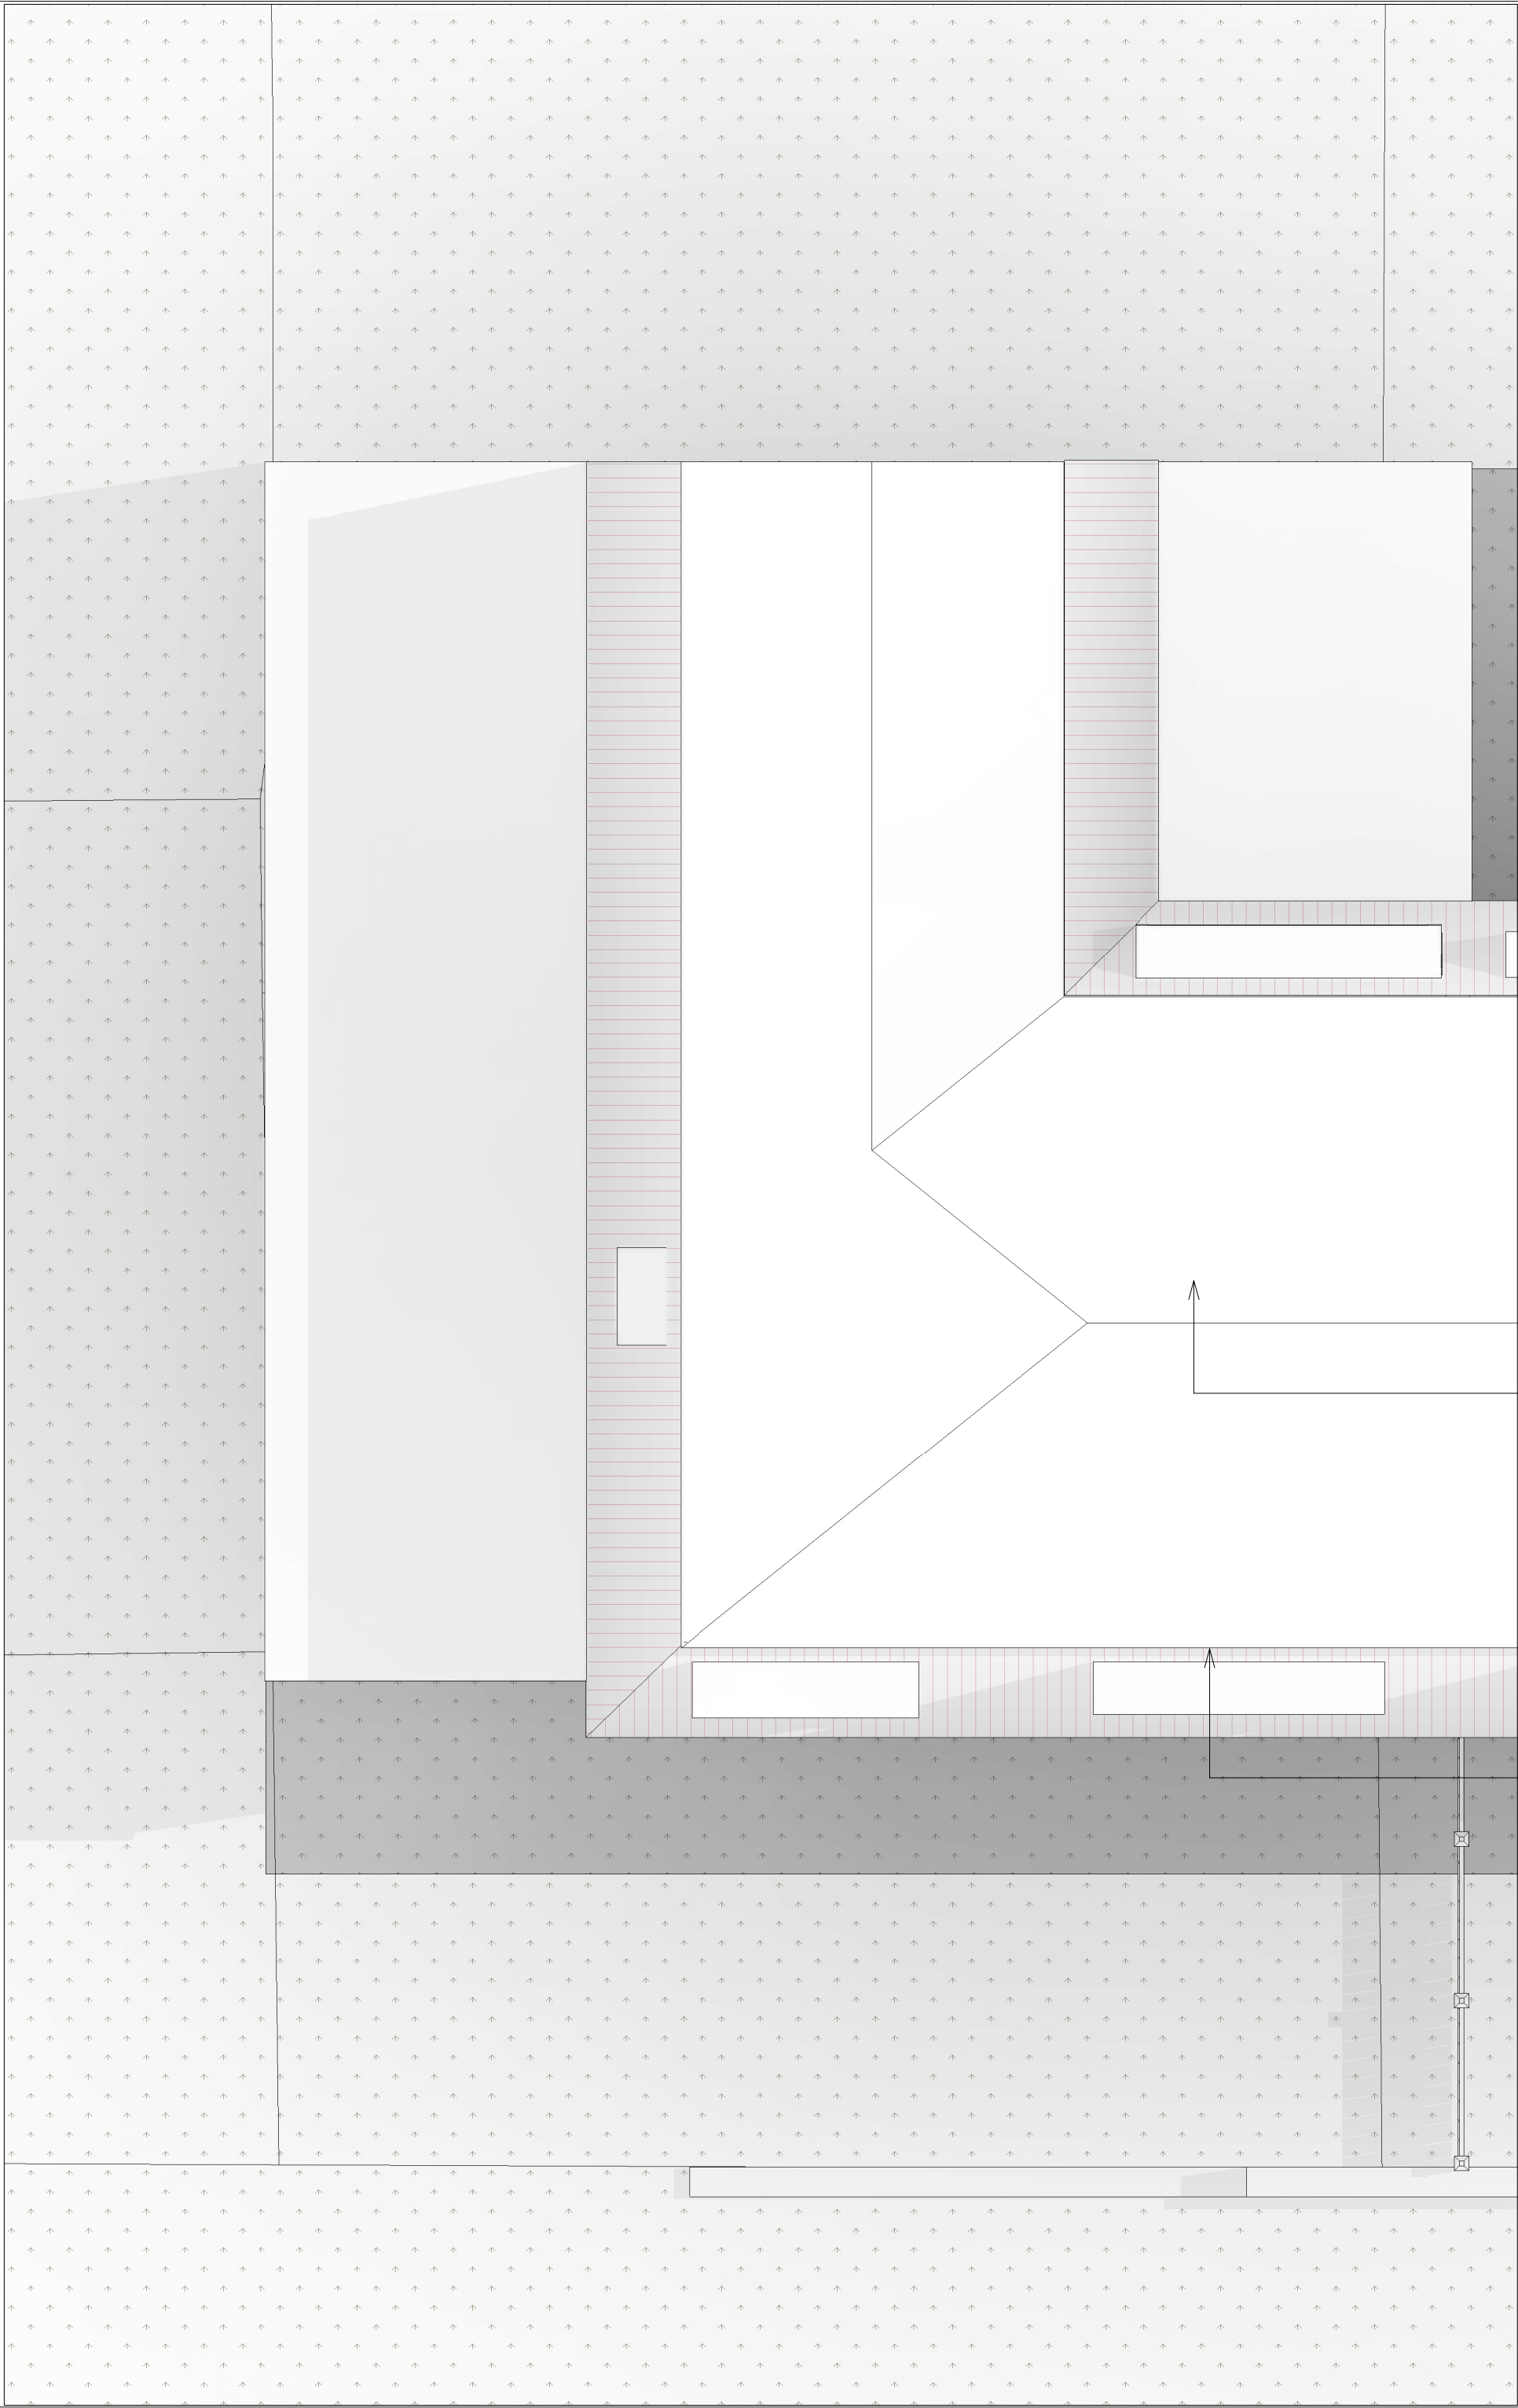
IT IS A MANSARD ROOF WITH DORMERS, WHICH HAS AGED, WEATHERED AND SOME TILES MAY BE STARTING TO WRAP OF SHIFT. ITS LIKELY THAT THERE IS ALSO A MOSS/DIRT BUILDUP WHICH SHOULD TO BE ADDRESSED.

THE DORMER CHEEKS (THE SIDE CLADDING OF THE DORMER WINDOWS) ALSO LOOK DATED AND MAY NEED ATTENTION, AS WATER INGRESS OFTEN HAPPENS AROUND DORMER JUNCTIONS.
