# LAND AT WHITE MOSS ROAD, BLACKLEY

## Remediation & Enabling Works Strategy

| Report No | BEK-24070-1 (Rev D) |
| Date | June 2025 |

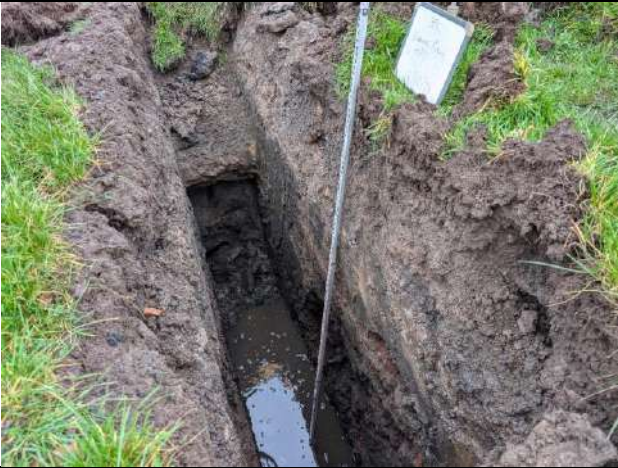
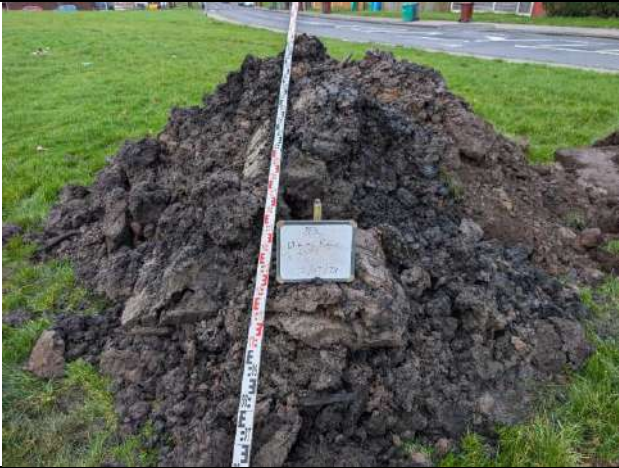
| Location | Evidence for Contamination |
|---|---|
| TP1 | <b>Moderate</b> hydrocarbon odour (towards base, ~2.5 m)<br>Lenses of black stained clay with moderate hydrocarbon odour<br>Slight oily sheen on standing water in pit |

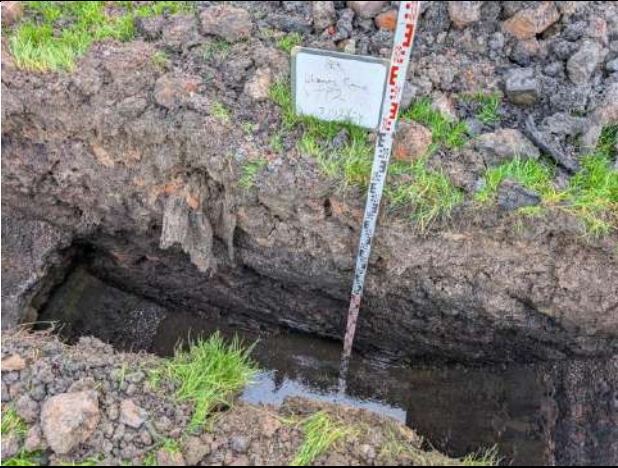
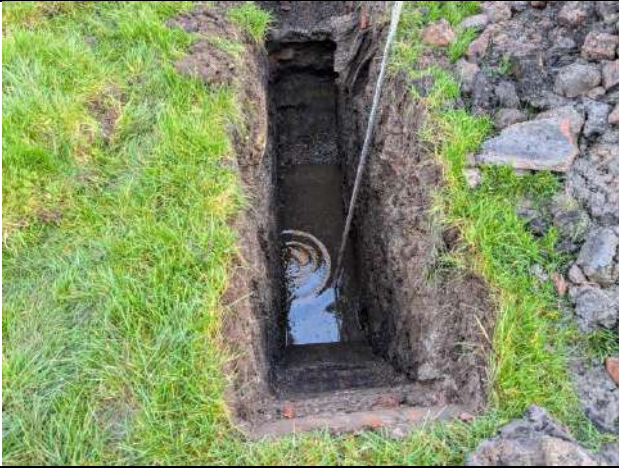
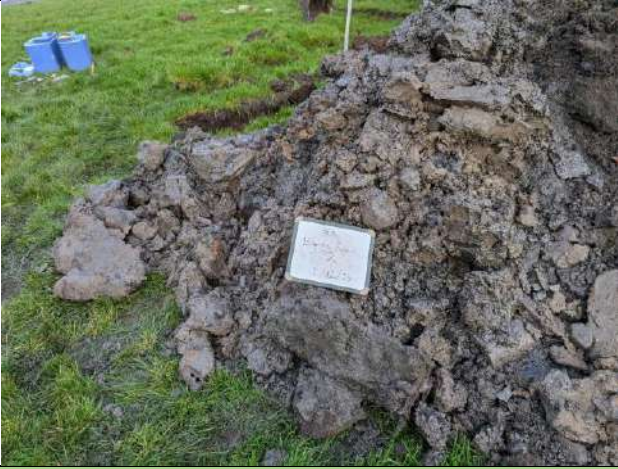
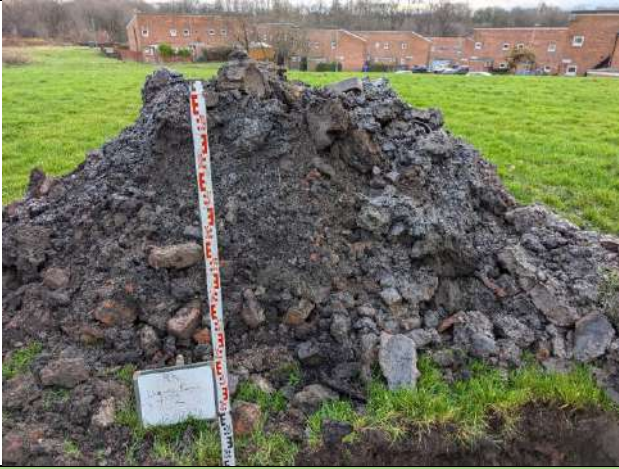
| Location | Evidence for Contamination |
|---|---|
| TP2 | <b>Slight to Strong</b> hydrocarbon odour (increasing in intensity from slight at ~0.8 m to strong at ~2.5 m)<br>Moderate oily sheen on standing water in pit<br>Oily sheen/staining on arisings |

- 3.9.5 Oily sheens were noted to be present on standing water within several of the trial pits. An oily sheen was also noted on arisings excavated from Trial Pit TP2. This indicates free product may be present within the confines of the infilled pond and shows the contents of the made ground may have the potential to leach contaminants/hydrocarbons.
