Bat Survey Report - 2025 Surveys

**Fallowfield Campus Redevelopment  
Project**

**John Graham Construction Ltd**

Report Reference: GRA001-013-004/001/002

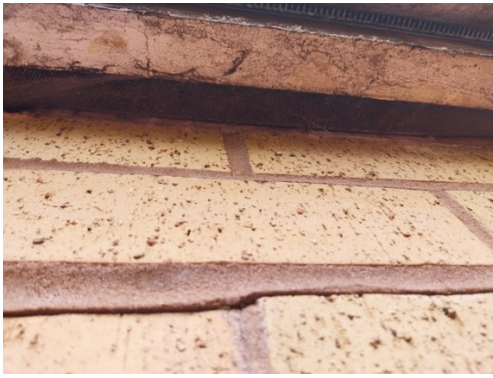
Photograph 1: Metal mesh present on all buildings surveyed

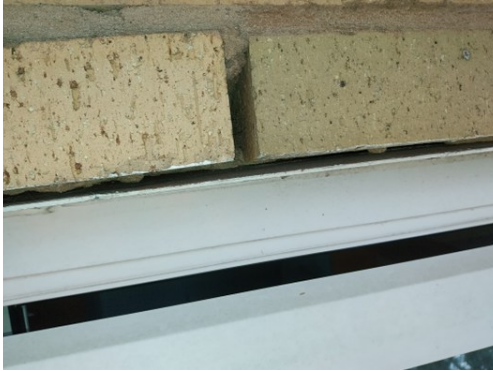
Photograph 3: Missing mortar and weep holes above windows

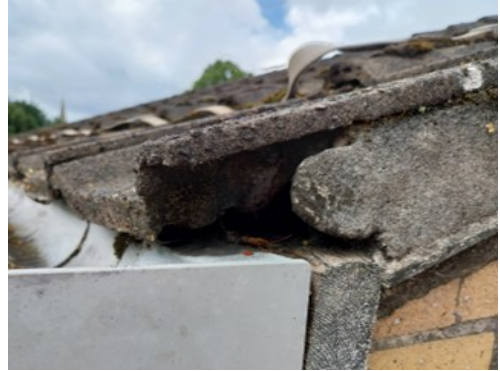
Photograph 4: Gap in slate tile roofing

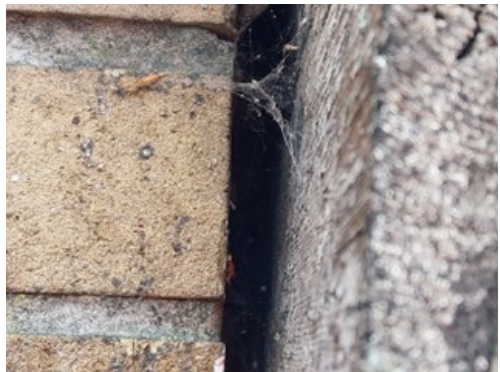
Photograph 6: Gap behind fascia board

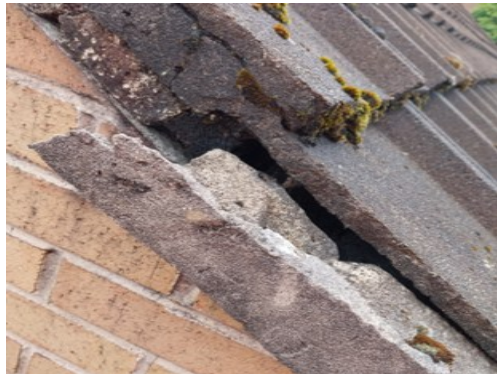
Photograph 10:  
Gap in slate tile roofing

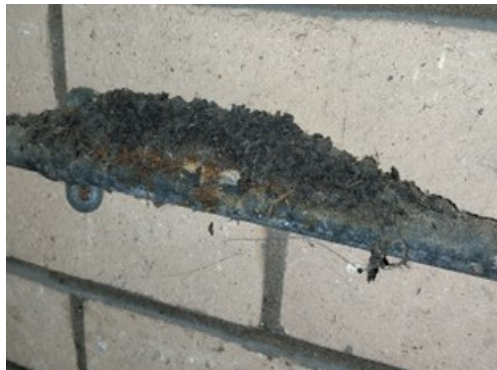
Photograph 14: Bat droppings present at B18

- 1.3.2 Samples of the bat droppings collected from B18-Maple Court will need to be sent for DNA analysis to determine the species of roosting bats.
- 1.3.3 If more than 12 months pass before works are undertaken that could impact bat roosts, follow up surveys are recommended to determine if the suitability of the buildings has changed.

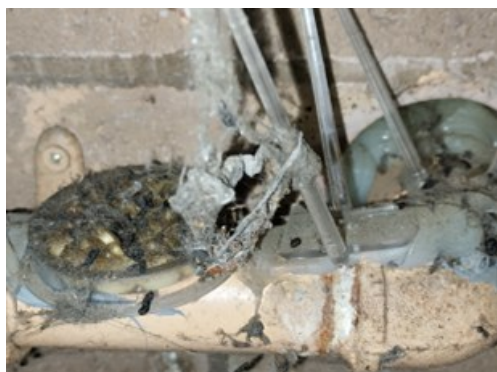
Photograph 16:  
Bat droppings present at B18

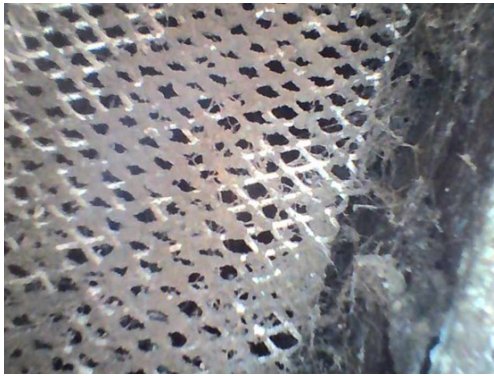
Photograph 17: Endoscope view of metal meshing present on B15, 16, 17, 20 and B21.

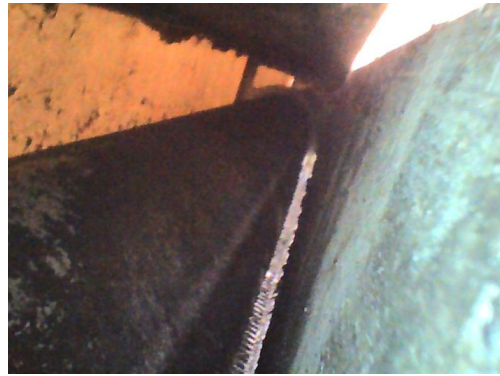
Photograph 18: Endoscopic view of behind fascia board

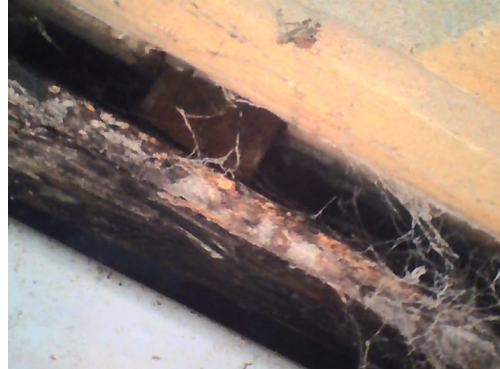
Photograph 20: Endoscopic view of behind fascia board

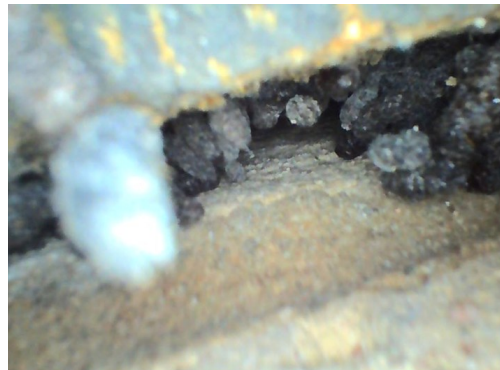
- 1.2.4 At B19, the roost location from the previous survey (2023) was observed. No bats were found. Some bat droppings were observed but were unable to be collected due to being located inside the fascia board.

Photograph 22: Endoscope inspection of B19. Bat droppings present

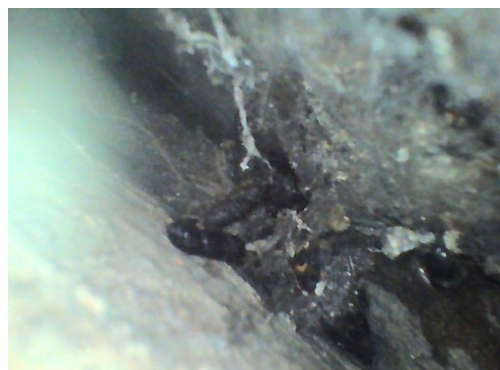
Photograph 24: Endoscope inspection of B18. Bat droppings present

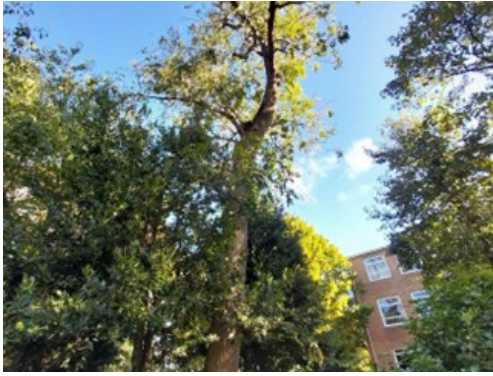
Photograph 1:  
Tree 177

- 1.2.2 A single tree required further assessment (FAR), Tree T177 was deemed not safe to climb due to suspected ash dieback.
- 1.2.3 Two new roost features were found during the MEWP inspection, both of which were located within the known roost building B18. Roost one is located at the south inner corner of the building located behind the fascia boards. It is deemed to be most likely a large pipistrelle day roost. Roost two is located at the north inner corner of the building, located behind the fascia boards. It is deemed to be most likely a pipistrelle day roost.

- 1.3.4 As tree T177 was not safe to climb, it is recommended that three emergence surveys are carried out, two of which should be undertaken between May and August as per BCT best practice guidelines (4th Edition) (Collins, J. (ed) 2023). This will allow for: re-assessment of the suitability of PRFs; determination of the likely presence/absence of roosting bats, and the need for further survey and/or mitigation.

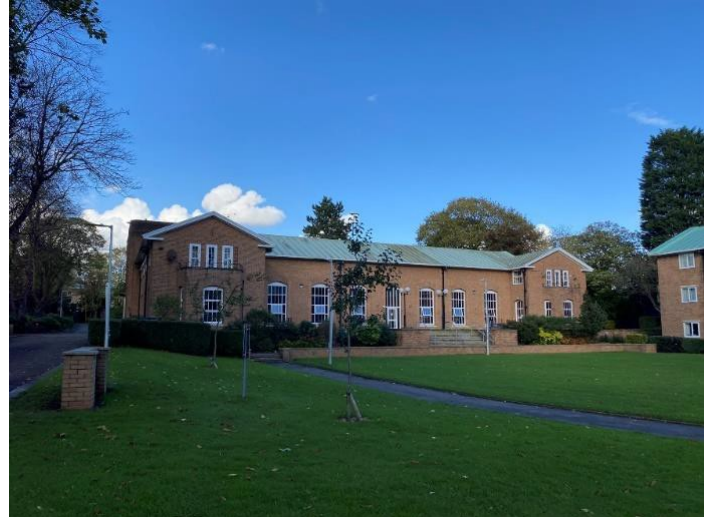
| Description of property | | | | | |
|---|---|---|---|---|---|
| <b>Description of PRFs</b> | Large two storey brick-built building with a multi-pitched metal roof. Large timber soffits, which appeared well sealed through. Lead flashing at join between sections and elevations. Main ornate entrance to Woolton Hall on western elevation. | <b>Bat roost potential</b><br><br><b>Low/Moderate/High</b> | <b>Low</b> | <b>Confirmed Roost</b><br><br><b>YES/NO</b> | <b>NO</b> |

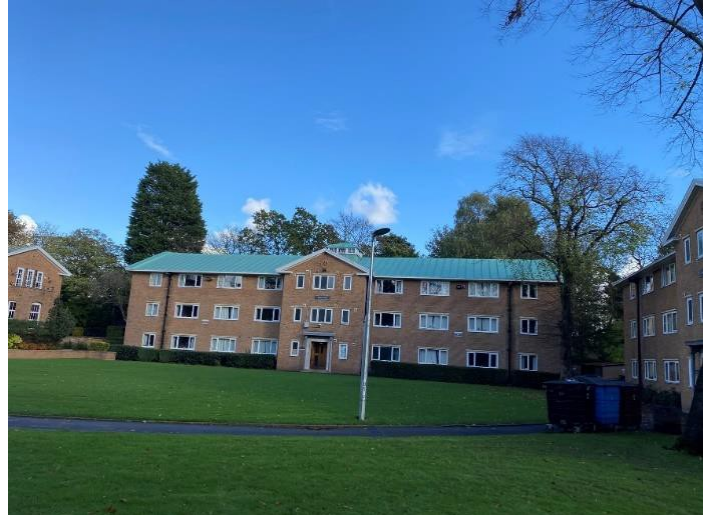
| Description of property | | | | | |
|---|---|---|---|---|---|
| <b>Description of PRFs</b> | <p>Large three storey brick-built building with a metal roof. Large timber soffits. Gaps noted along base of soffits. Ornate ventilation slits on the gable ends that could provide access into roof voids.</p> | <p>Bat roost potential</p> <p><b>Low/Moderate/High</b></p> | <p><b>High</b></p> | <p>Confirmed Roost</p> <p><b>YES/NO</b></p> | <p><b>NO</b></p> |

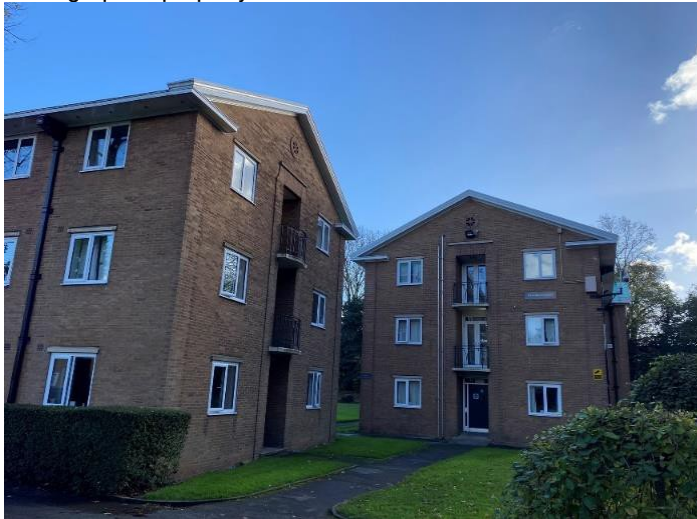
| Description of property | | Large three storey brick-built building with a metal roof. | | | | | | |
| Description of PRFs | | Large timber soffits. Gaps noted along base of soffits. Ornate ventilation slits on the gable ends that could provide access into roof voids.<br><br>Confirmed as a roost location in 2023 dusk surveys. | | Bat roost potential<br><br>Low/Moderate/High | | High<br><br>Confirmed Roost<br><br>YES/NO<br><br>YES | | |

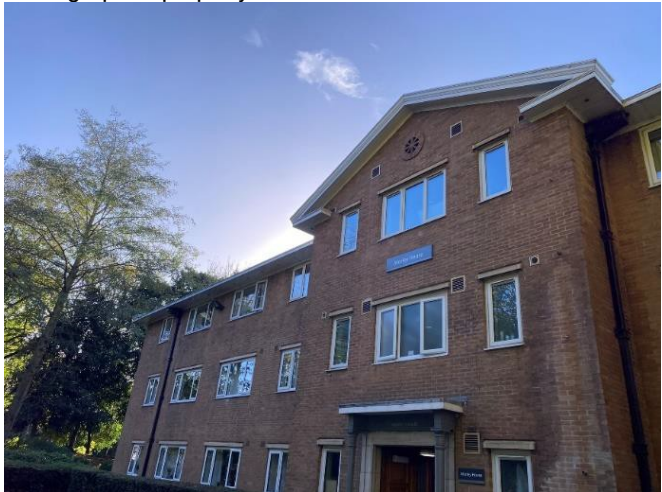
| Description of property | | Large three storey brick-built building with a metal roof. | | | | | | | |
| Description of PRFs | | Large timber soffits. Gaps noted along base of soffits. Ornate ventilation slits on the gable ends that could provide access into roof voids | | Bat roost potential<br>Low/Moderate/High | | High | Confirmed Roost<br>YES/NO | NO | |

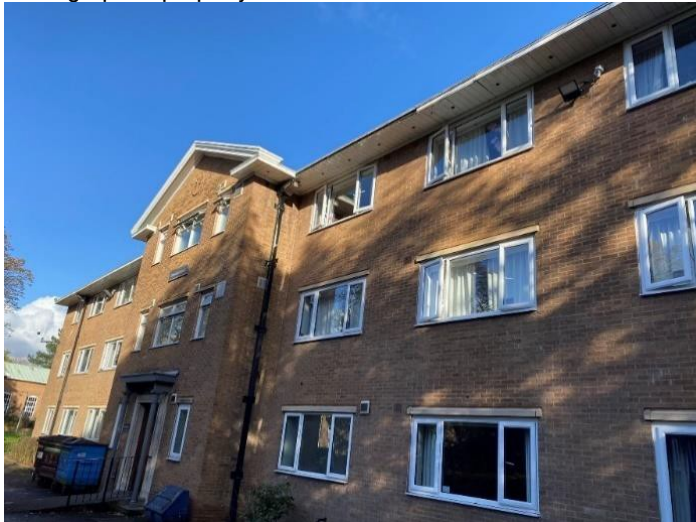
| Description of property | | Large three storey brick-built building with a metal roof. | | | | | | |
| Description of PRFs | | Large timber soffits. Gaps noted along base of soffits. Ornate ventilation slits on the gable ends that could provide access into roof voids. | | Bat roost potential<br><br>Low/Moderate/High | | High | Confirmed Roost<br><br>YES/NO | NO |

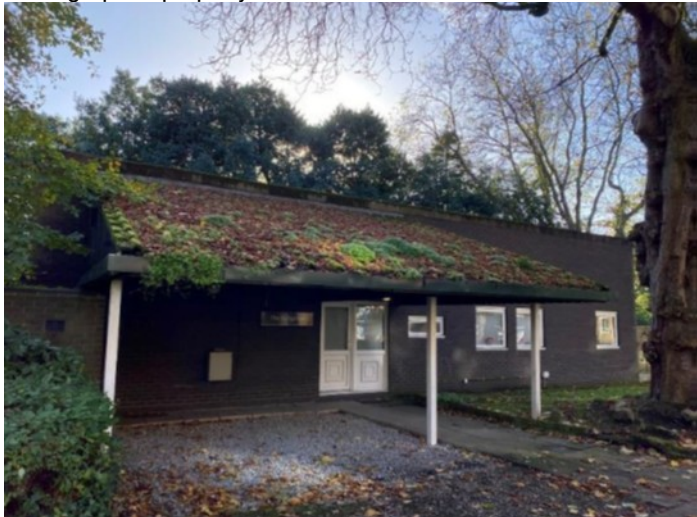
| Description of property | | Brick built with a multi sloping tile roof. Open porch to front (northern elevation) with a sloping tiled roof. | | | | | |
| Description of PRFs | | There is an extensive covering of moss across the roof line. Shaded by surrounding trees. Gaps noted between tiles, weep holes and gaps between fasciae. | | Bat roost potential<br><br>Low/Moderate/High | | High<br><br>Confirmed Roost<br><br>YES/NO<br><br>NO | |
