# Preliminary Roost Assessment

17-19 Slade Lane  
Longsight  
Manchester  
M13 0QJ

For  
Khalid Din

# Gritstone Ecology

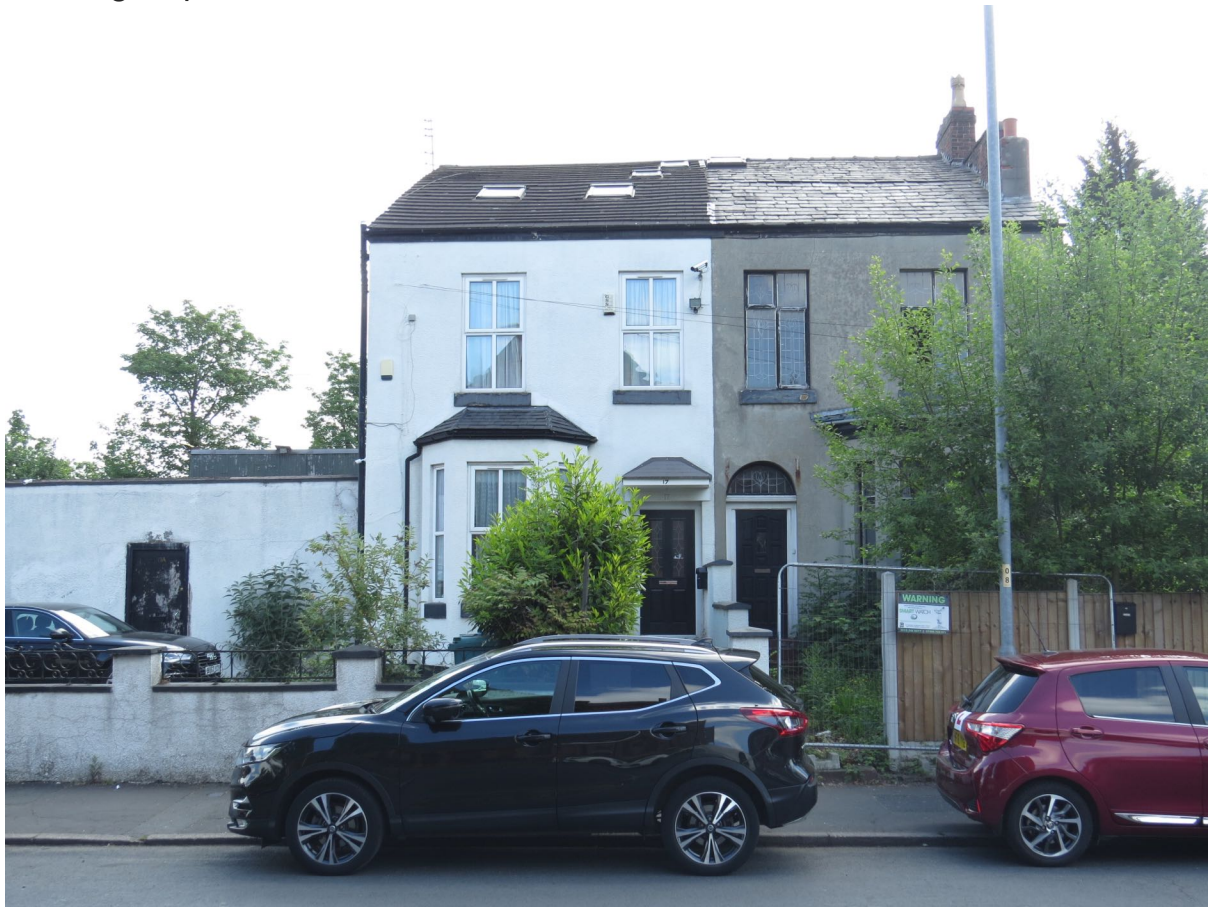
3.1a – The front of N° 17 & 19 Slade Lane.

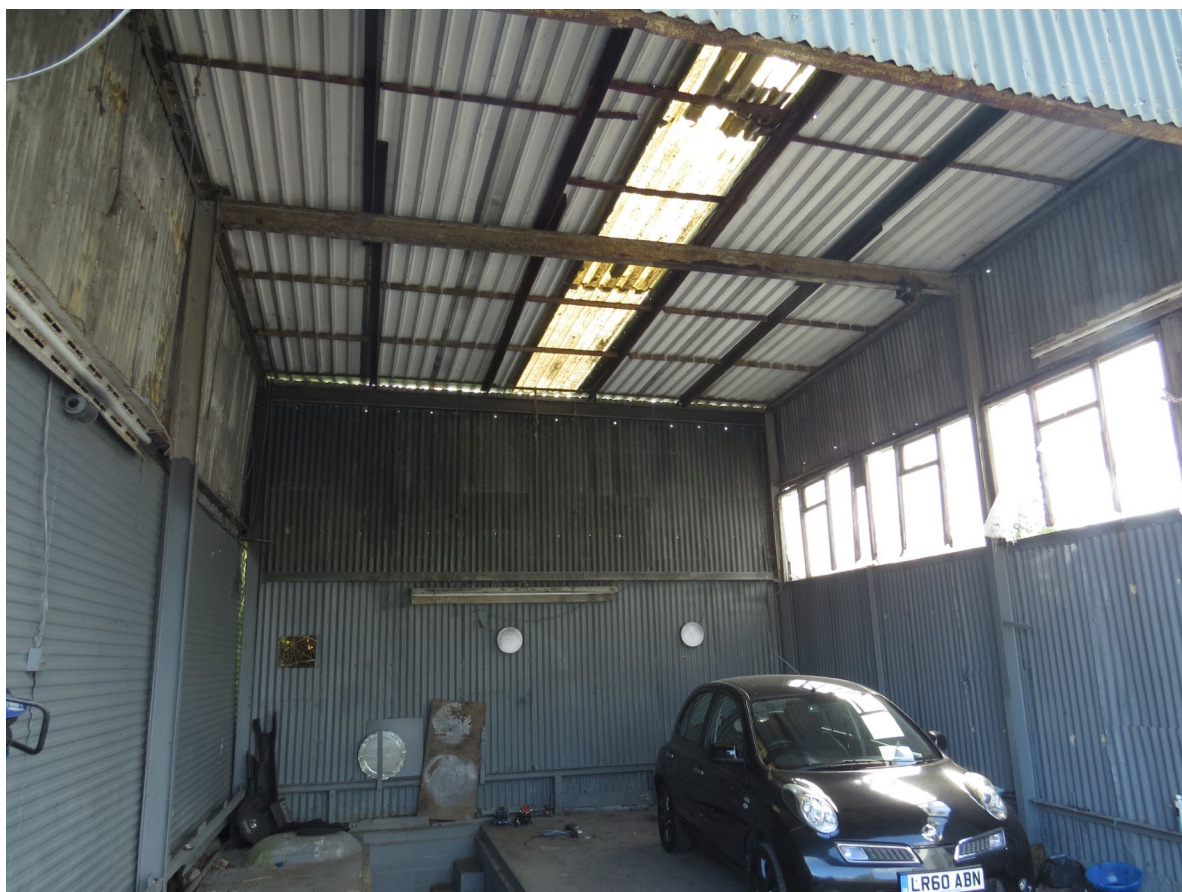
3.1a – The open sided steel shed to the rear of N°17.

There is an open sided steel shed to the rear of N°17, which was formerly used to service commercial vehicles, and is currently used as a car park. The shed has a steel frame, covered with corrugated steel panels. The building is open to the elements, and has no suitable crevices, or enclosed areas, which could be used by roosting bats.

The open-sided shed has negligible potential for use by roosting bats. This is as the materials, and type of building are unsuitable, and as no suitable roosting opportunities were noted during the building inspection.

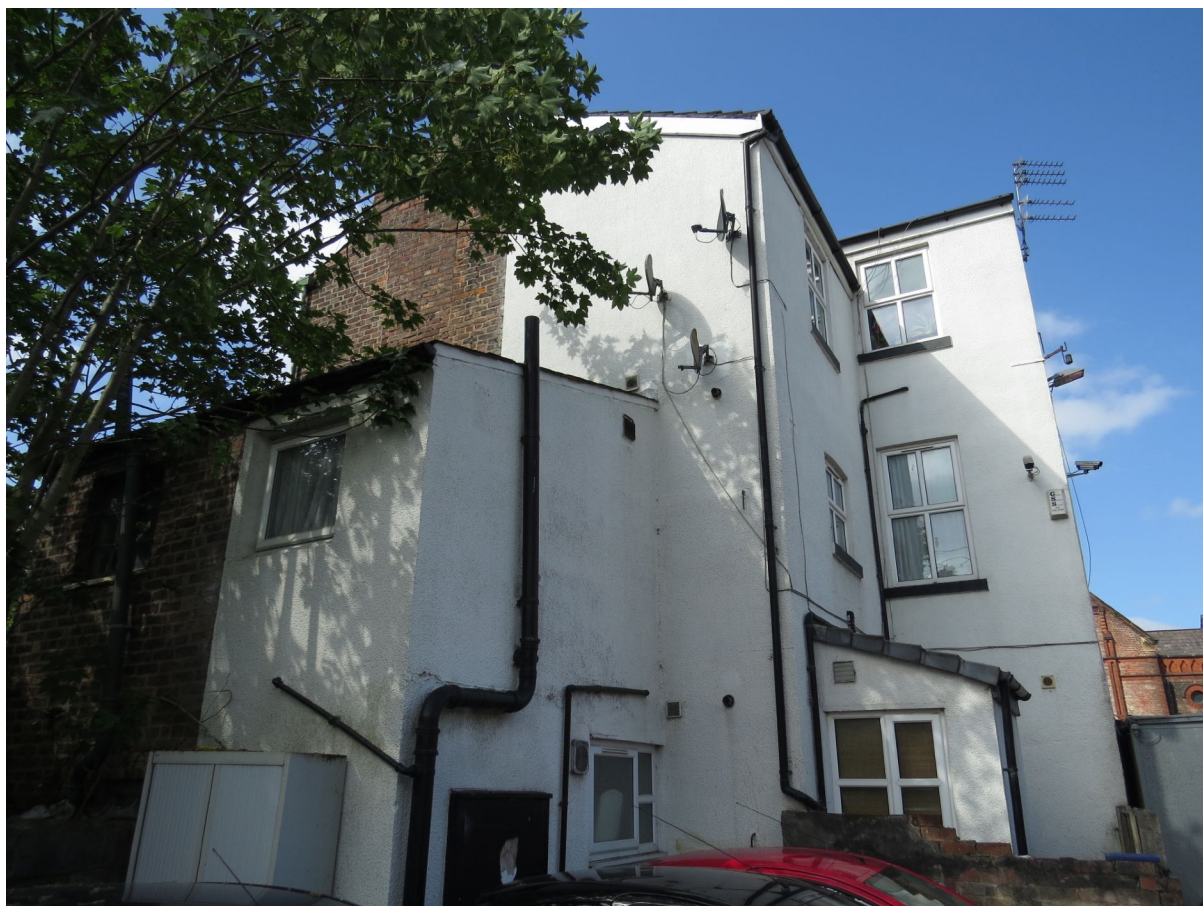
4 – The rear of N°19.

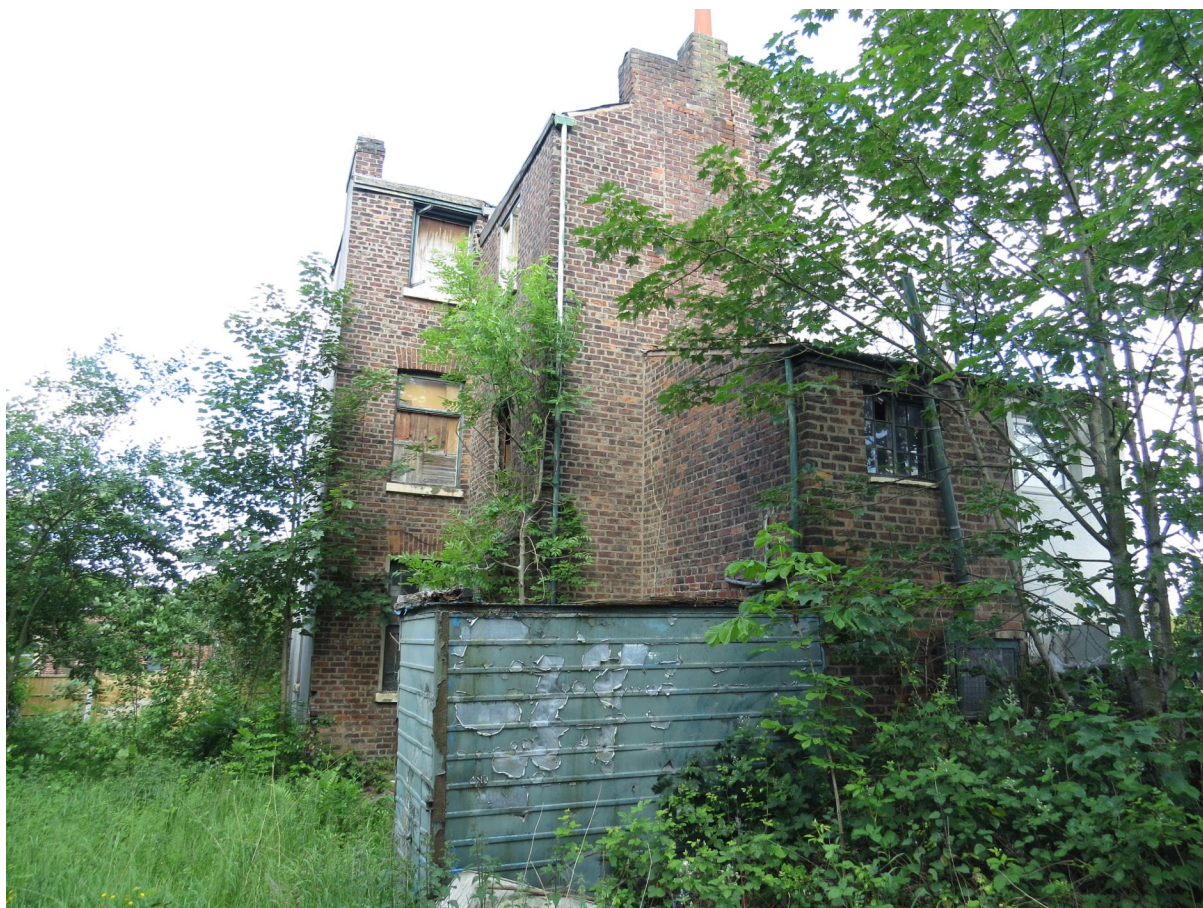
There are gaps around window boarding to the rear which could allow access into the building.

5 – The rear of Nº19.

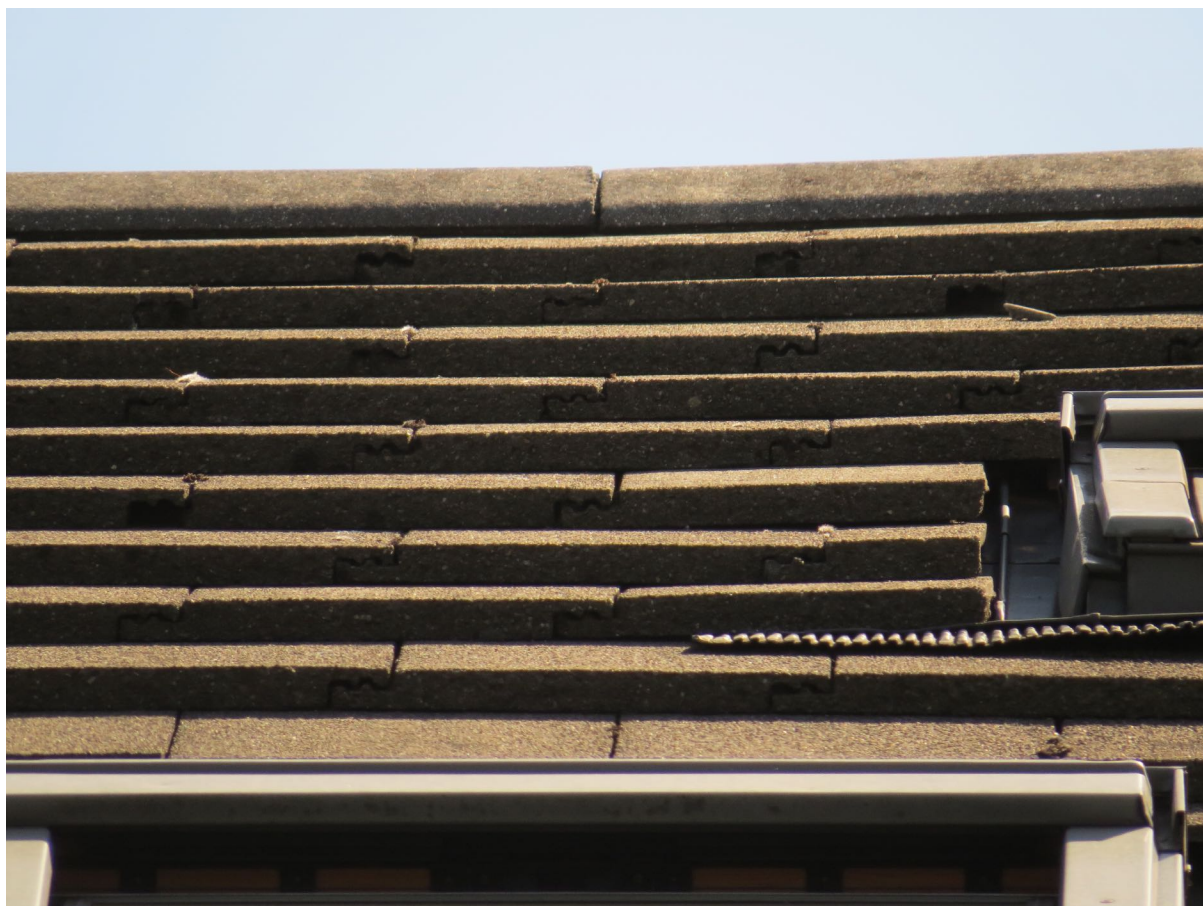
6 – The roof and ridge tiles of Nº17 are tightly fitted with no suitable gaps.

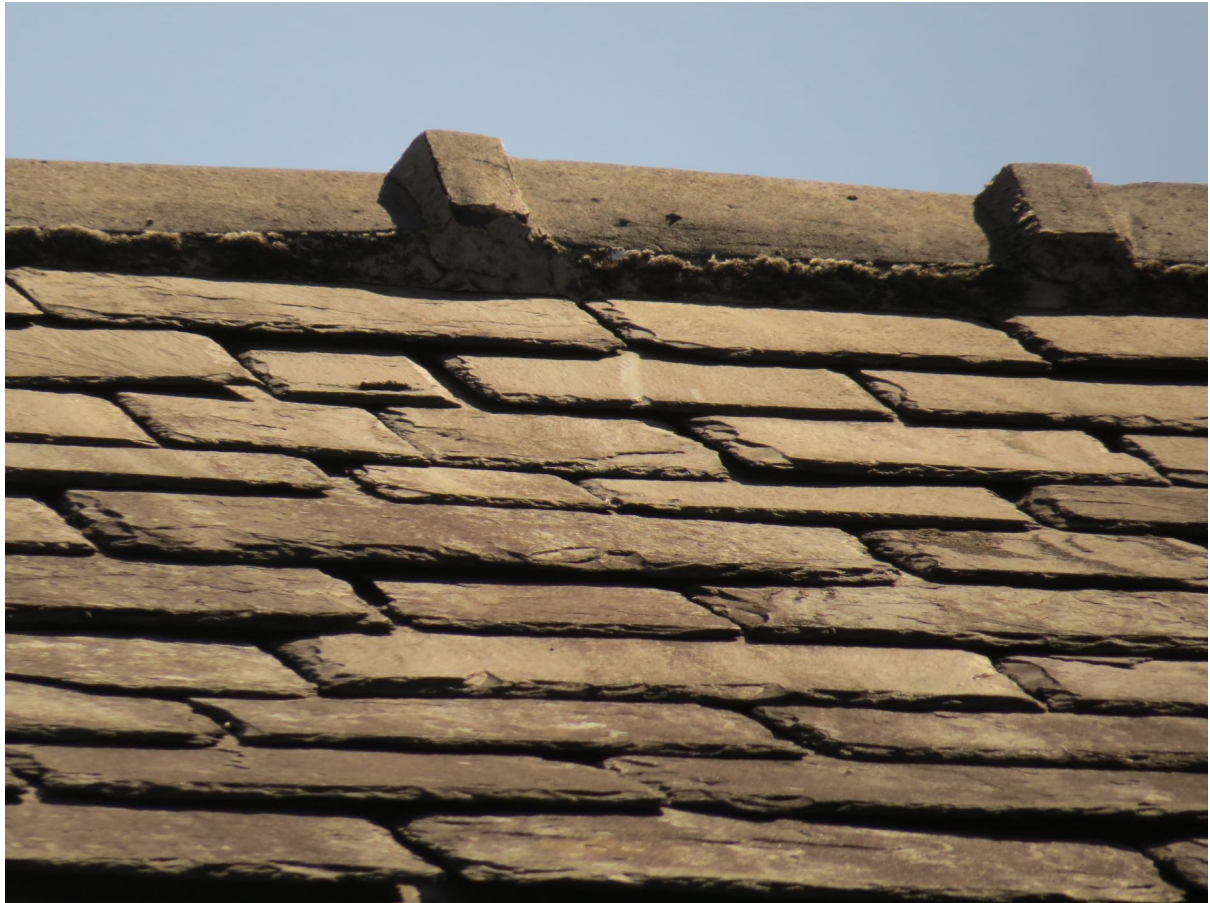
7 – The roof and ridge tiles of N°19 are tightly fitted with few gaps..

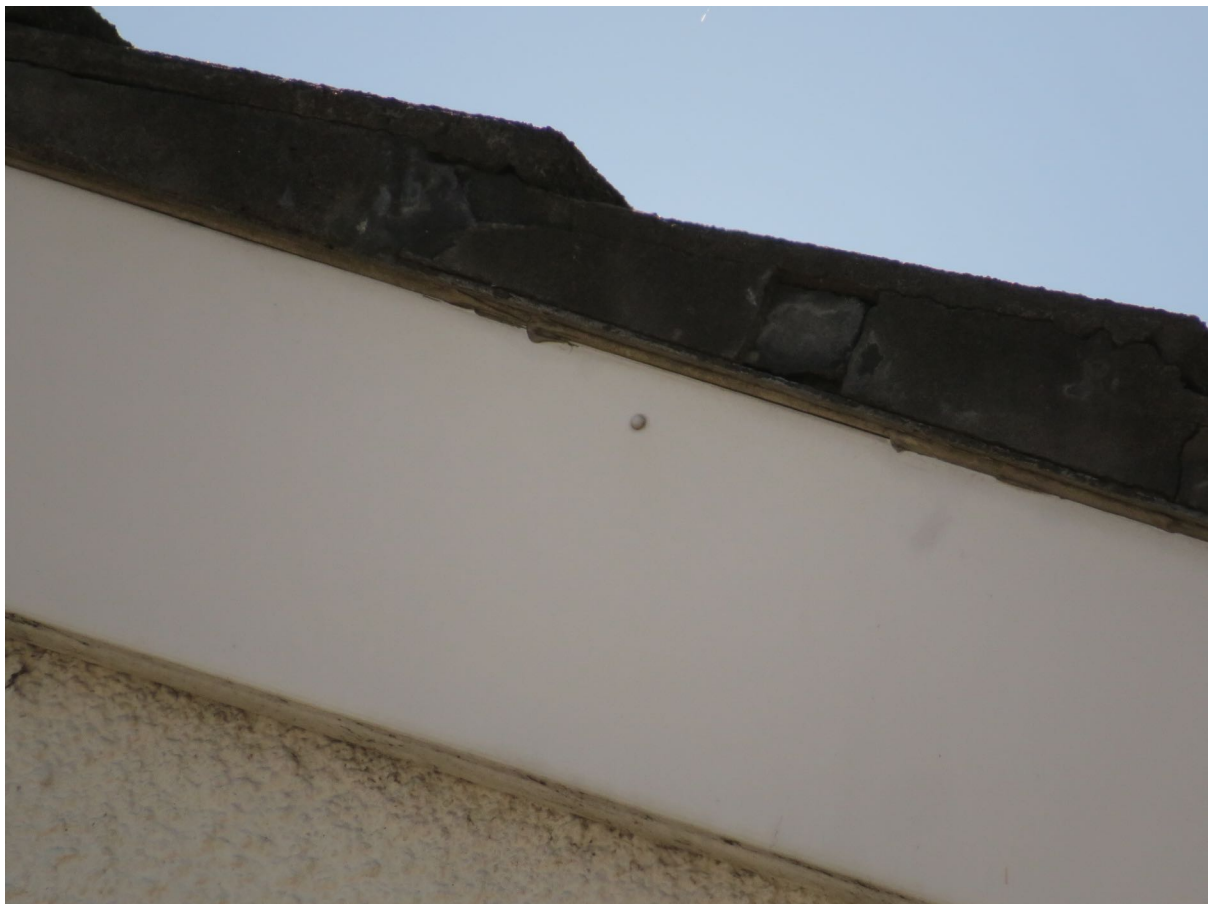
8 – End tiles at the verges are sealed with cement fascias are fitted tightly.

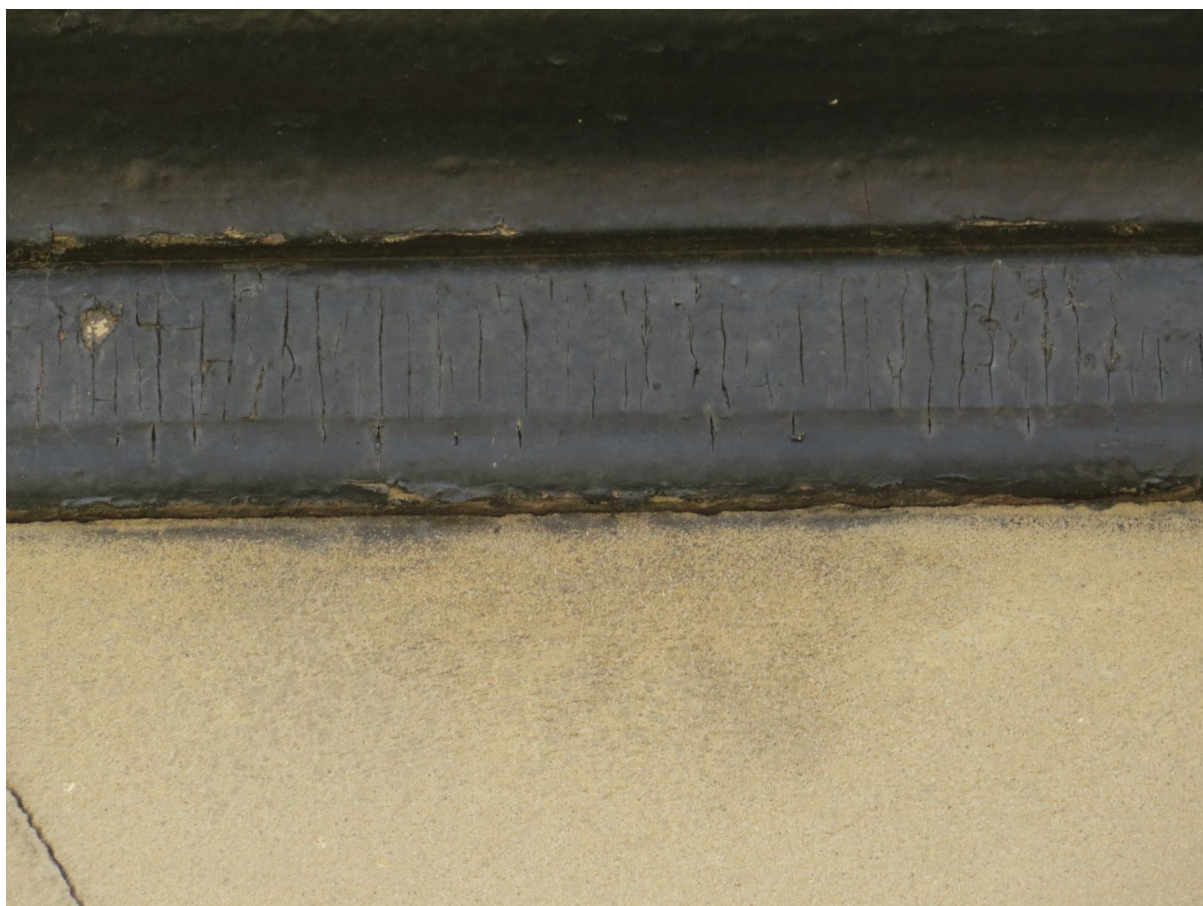
9 – Timber fascias are tightly fitted.

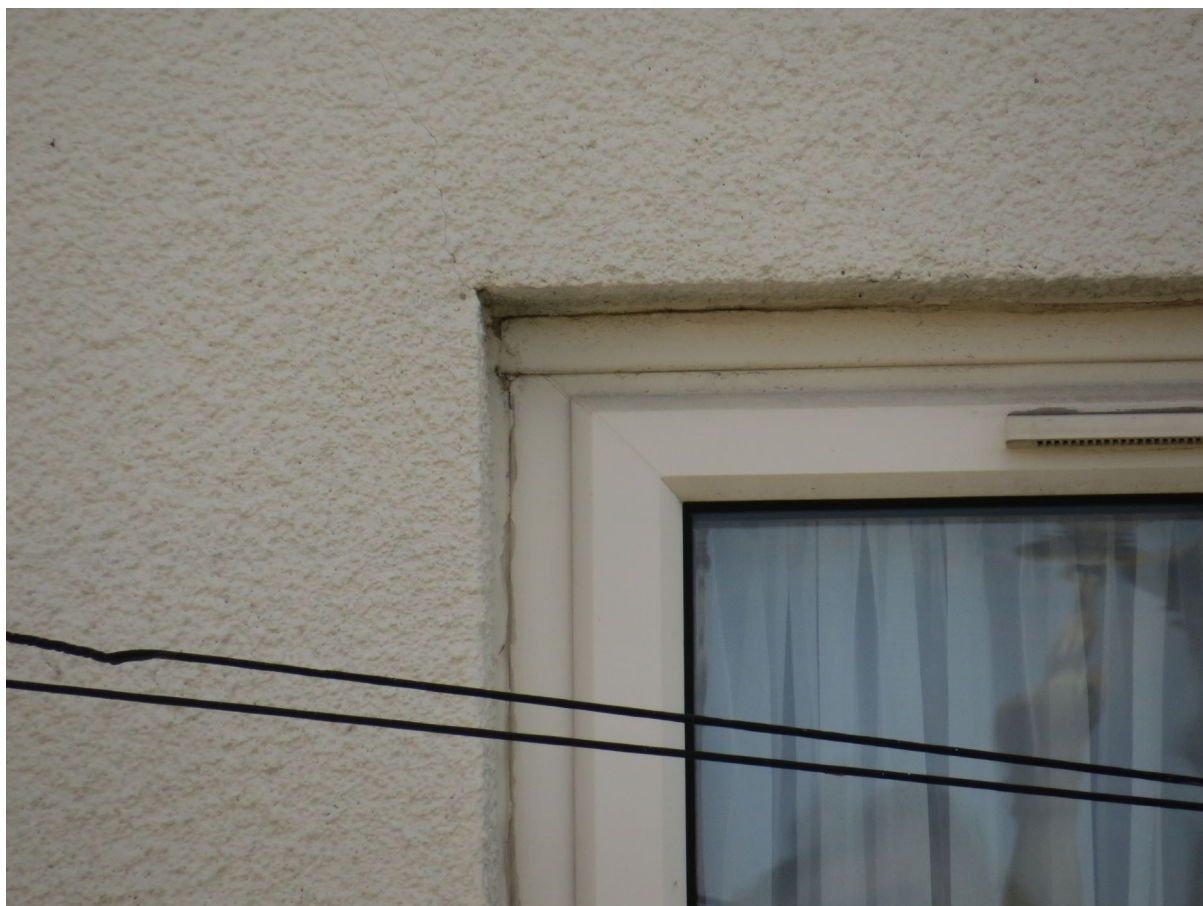
10 – UPVC window frames are tightly fitted.

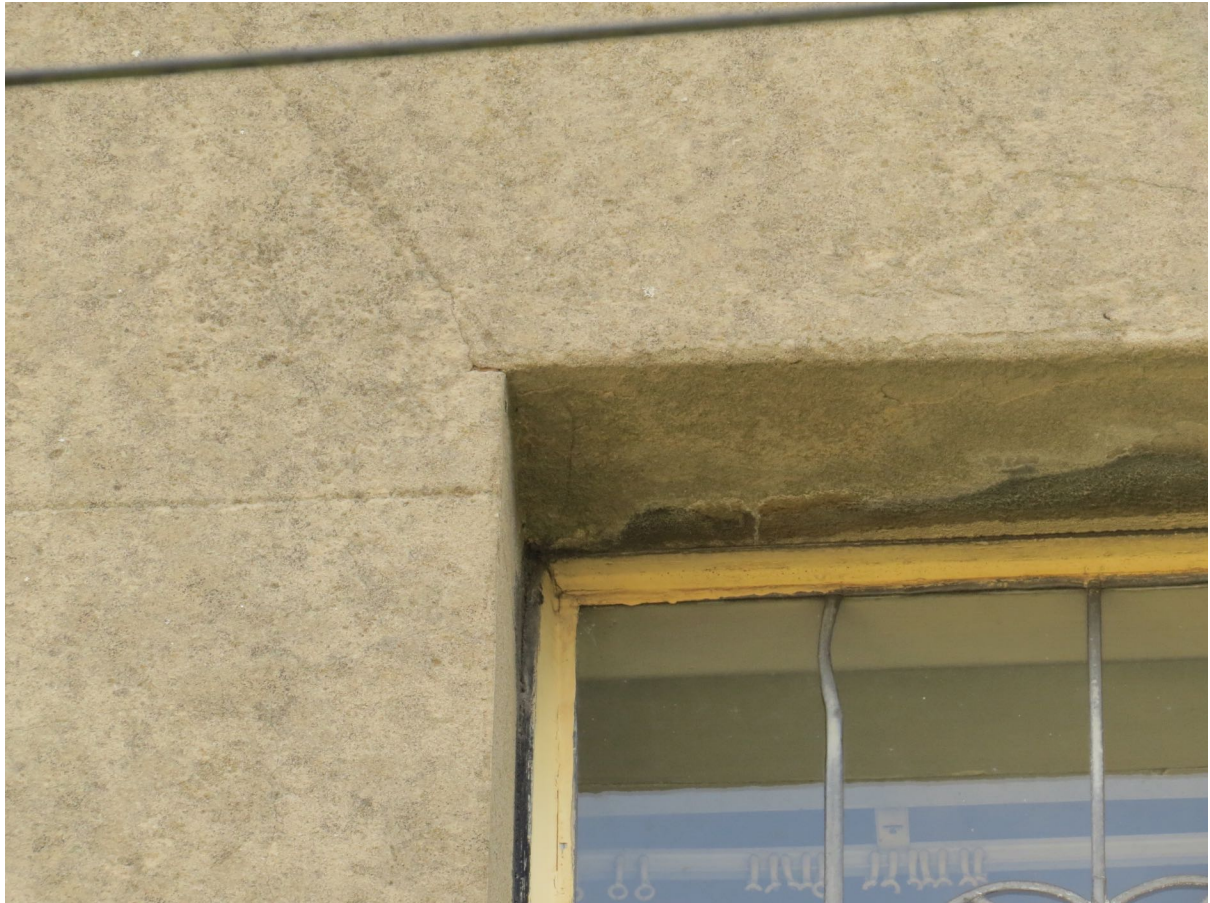
11 – Timber window frames are tightly fitted with no gaps between frames and brickwork.

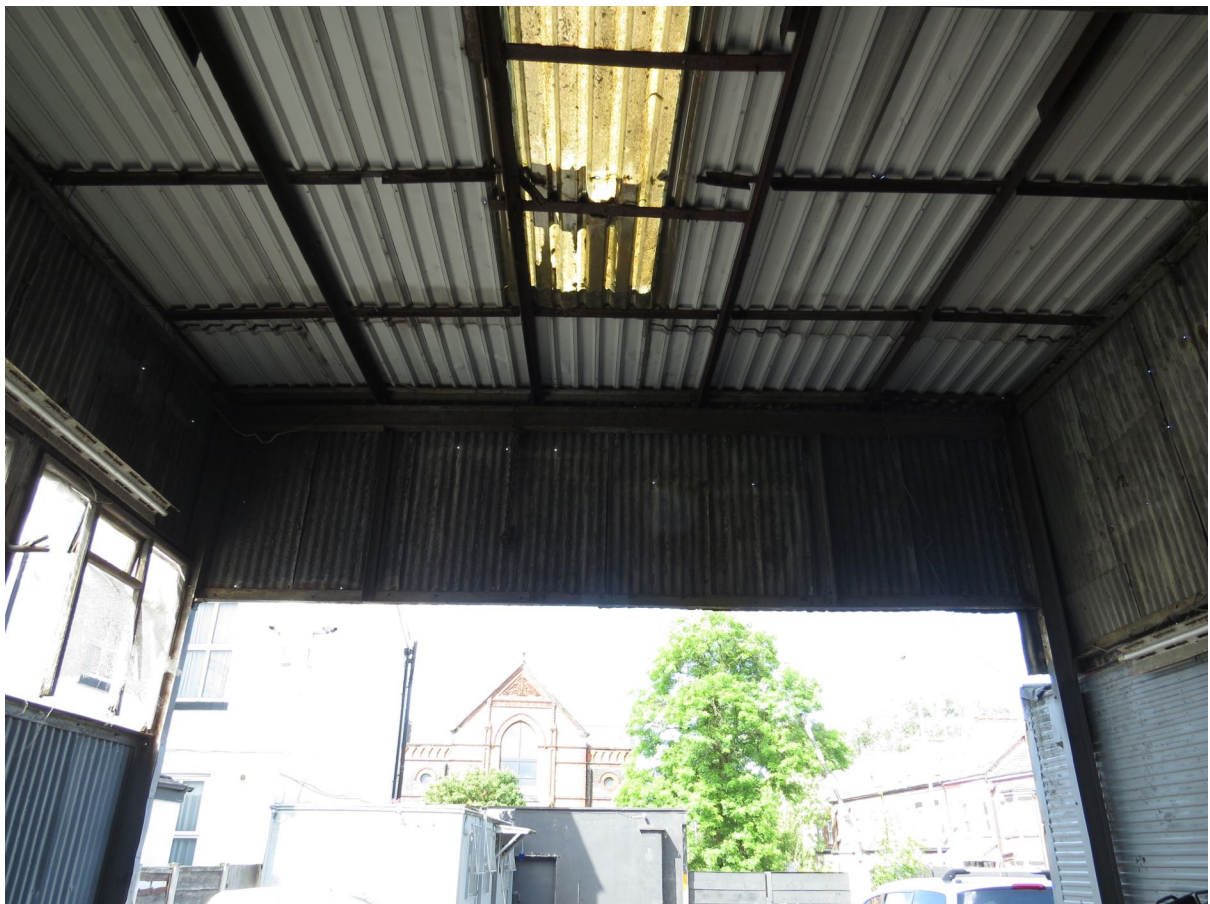
12 – The steel framed shed has no features suitable for roosting bats.

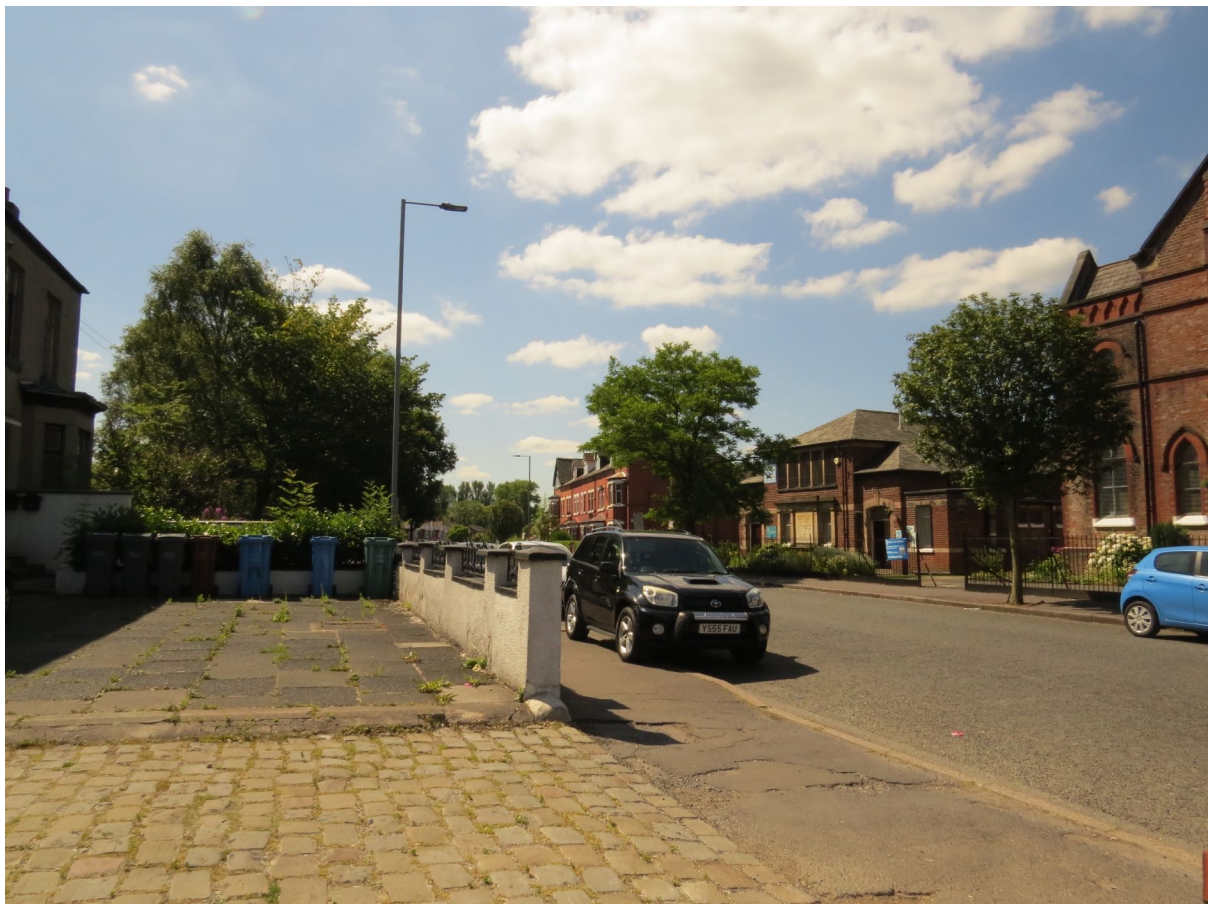
14 – The surrounding habitat is subject to disturbance from light, noise and human activity.
