# Arboricultural Impact Assessment

17 Didsbury Park  
Didsbury  
Manchester  
M20 5LH

July 2025

| <b>Job no.</b> | LTC303 |

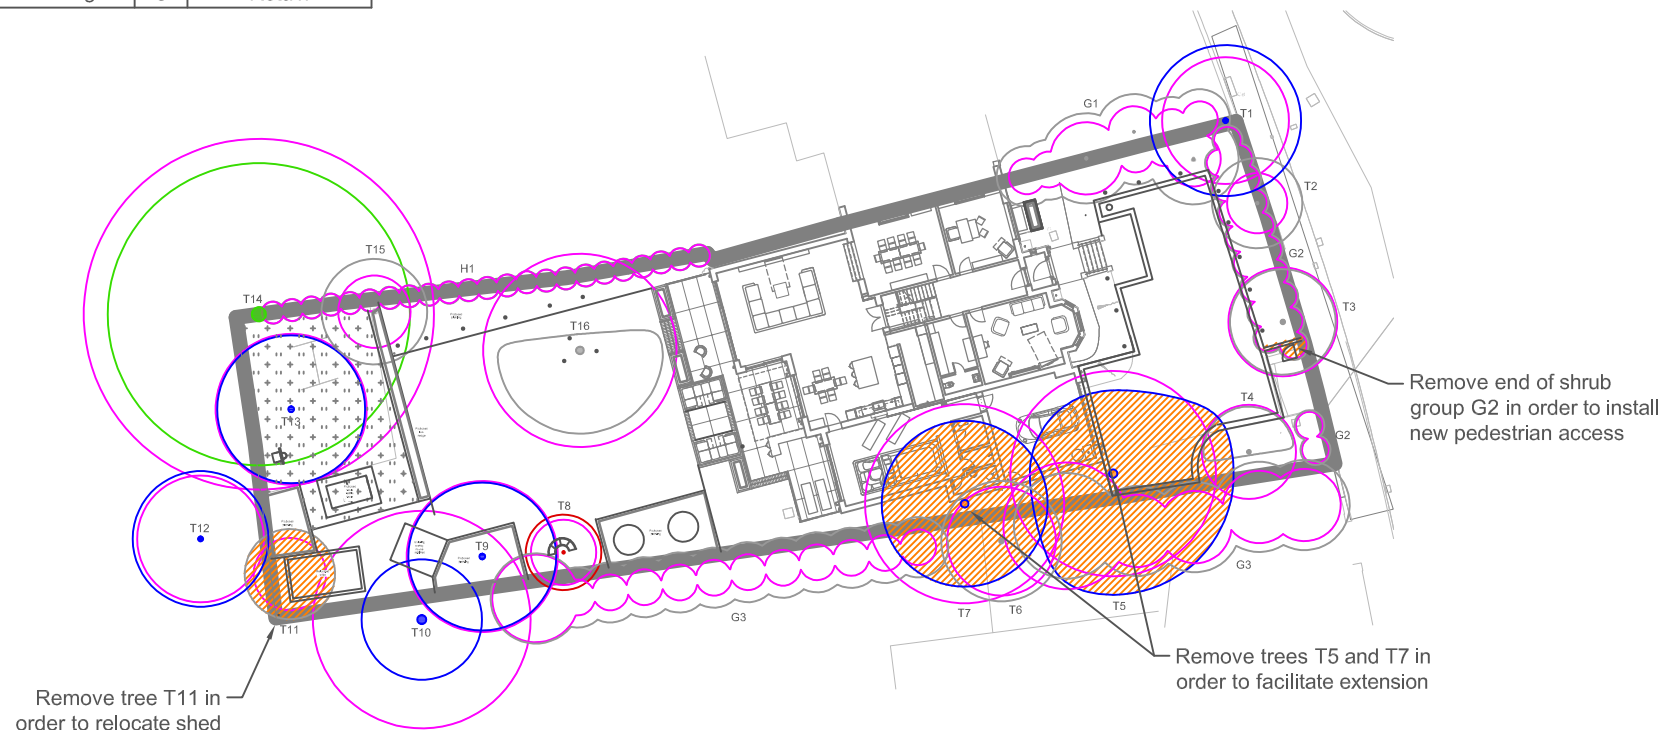
# Tree Removal Plan

4.3 As shown on the appended Tree Removal Plan and in Table 1, below, construction of the development as proposed will require the removal of two moderate quality trees, one low quality tree and a small section of a low quality shrub group.

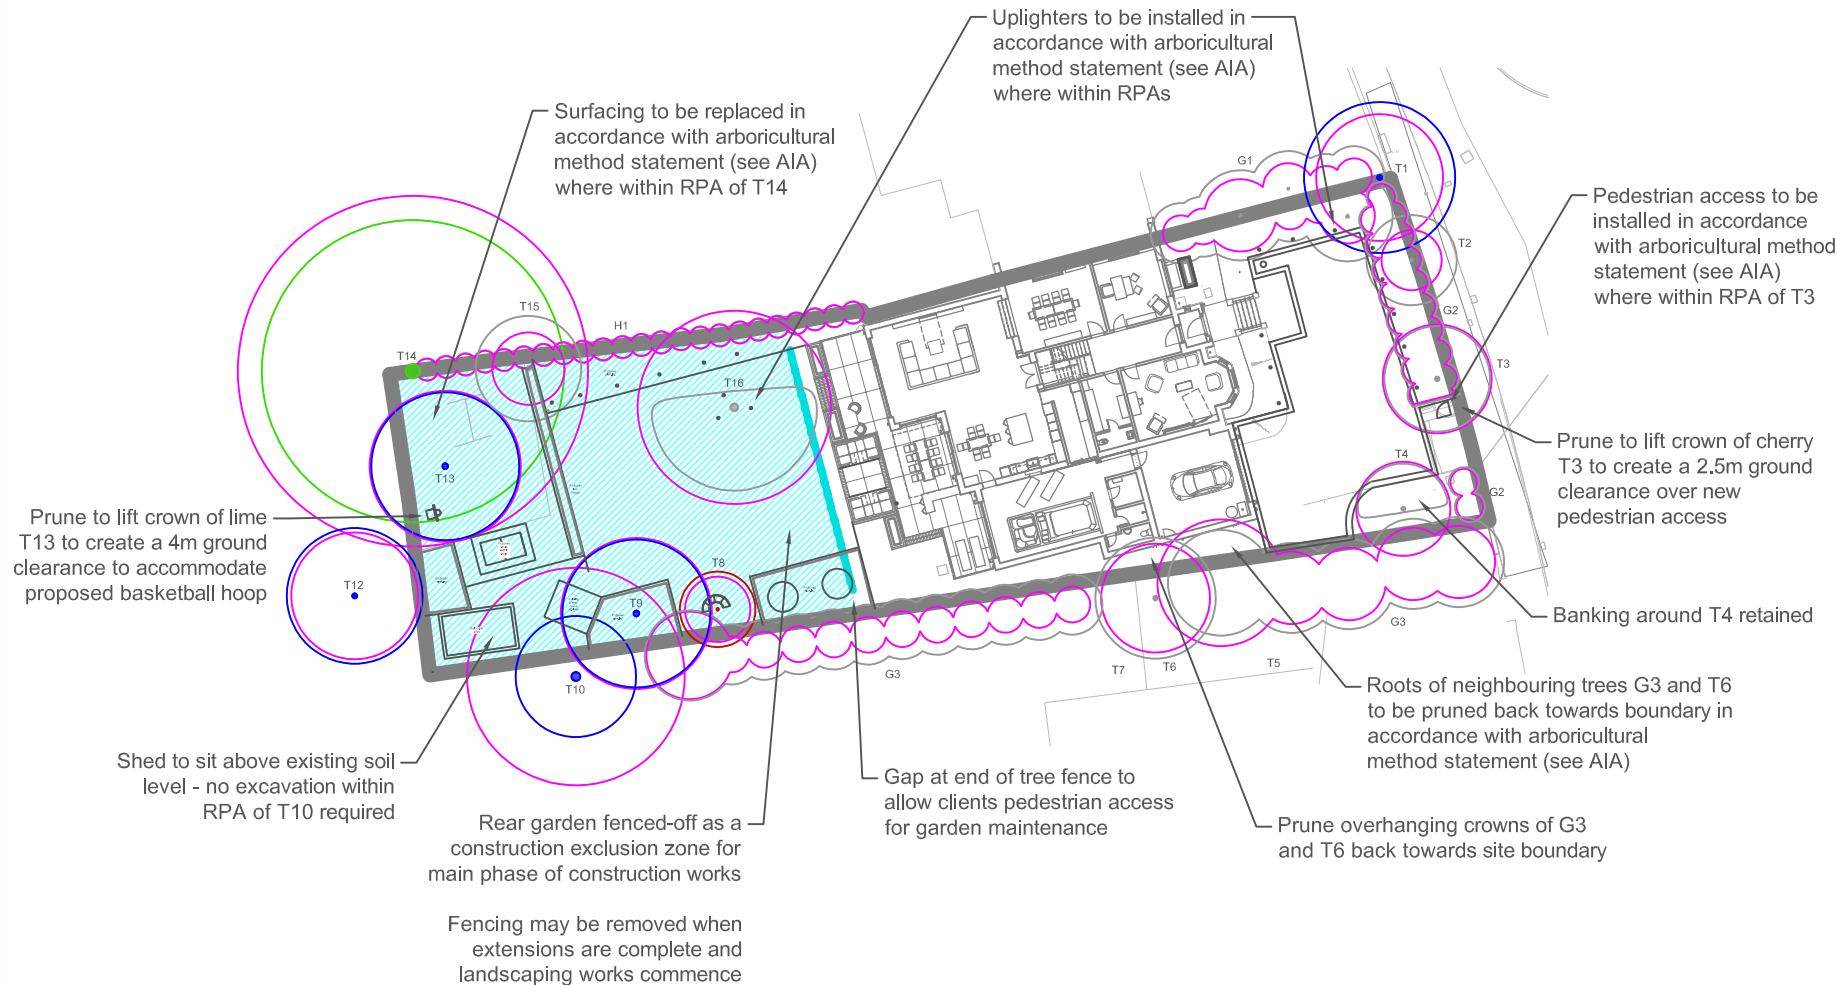
# Tree Protection Plan

4.7 As shown on the appended Tree Protection Plan, proposed works within or close to the RPAs of retained trees include: -

- Installation of pedestrian access within RPA of T3
- Installation of uplighters within RPAs of G1, G2, T3, T14 and T16
- Erection of side extension within RPAs of G3 and T6
- Shed relocated to within RPA of T10
- Existing bark mulch replaced with rubber bark mulch within RPAs of T13, T14 and T15
- Installation of garden furniture and planters within RPAs of T8, T9, T10, T13, T14, T15 and T16

- 5.3 The fencing is to be laid-out as indicated on the appended Tree Protection Plan prior to any works on site, including site preparation and deliveries, and shall remain in place until the extensions are complete and the landscaping phase is ready to commence. Once erected, the tree protection fencing shall be labelled with an all-weather notice stating 'TREE PROTECTION AREA - KEEP OUT!'. The tree protection fencing must be kept well-maintained and functional for the duration of the construction works.
