| PROJECT | SMITHFIELD BUILDINGS<br>MANCHESTER |
| TITLE | EXISTING AND PROPOSED<br>ROOF SECTION A-A |
| DWG NO. | TRI01-V-AX1.01 |

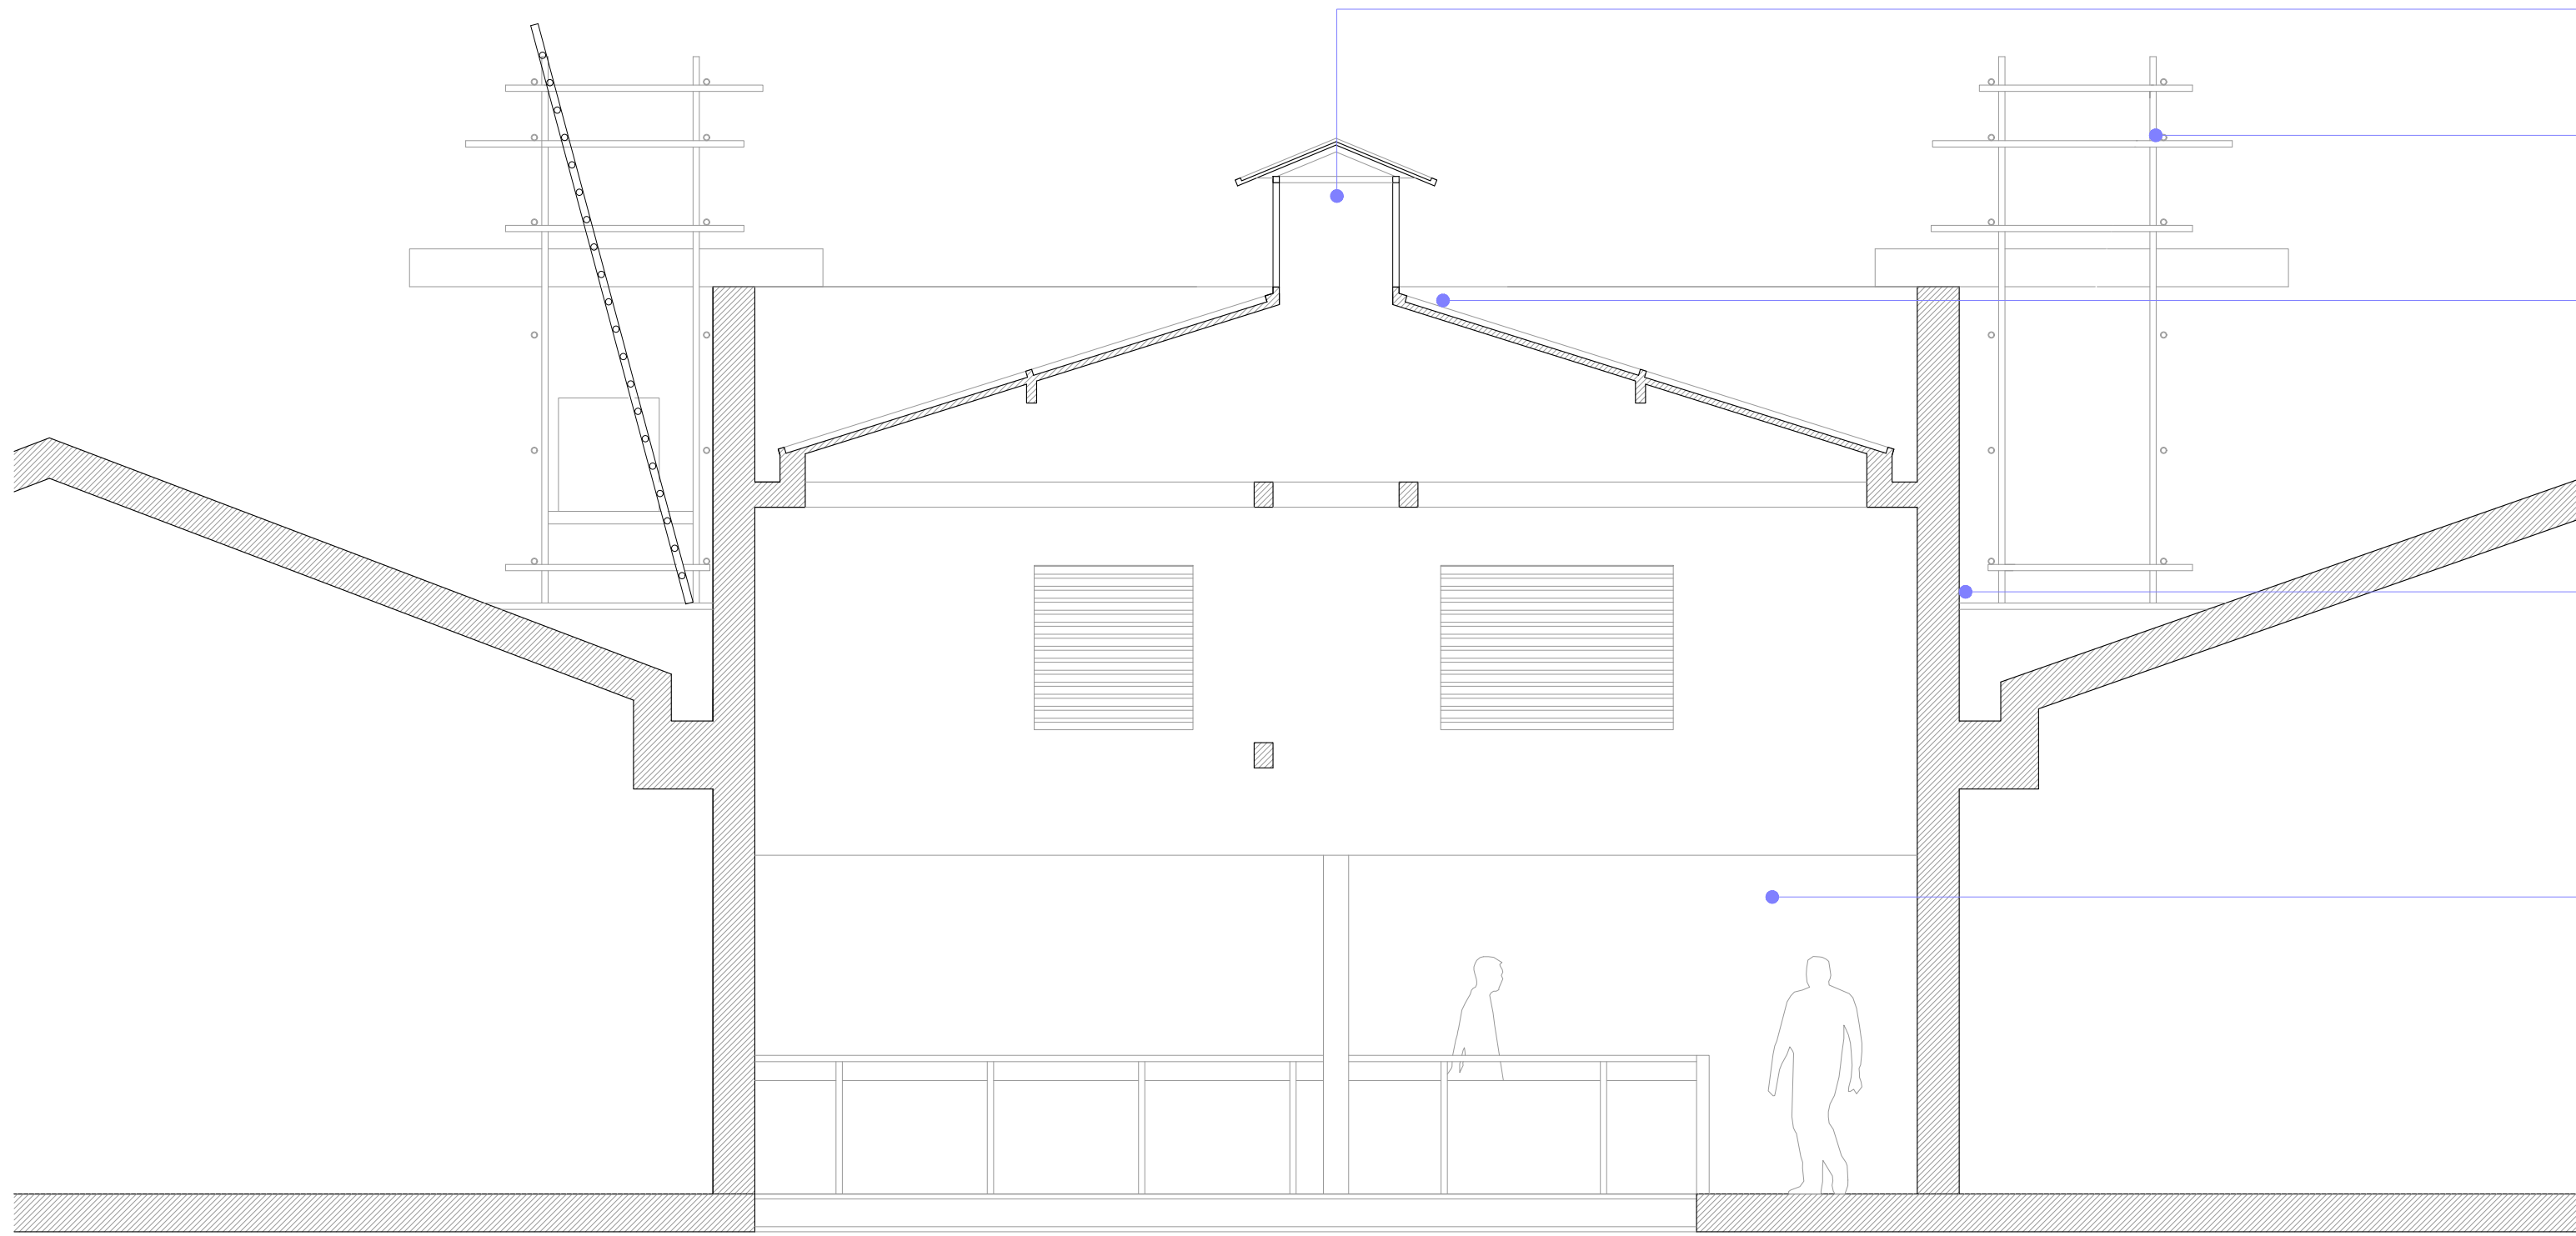
Existing Section A-A  
Scale - 1:50

Existing ventilation lantern is currently in poor condition, showing signs of age and deterioration. These issues not only diminish the lantern's aesthetic appeal but also pose safety concerns.

Existing glazing panels are damaged, with cracks and broken sections that compromise both the appearance and functionality of the structure.

Existing parapet render is in poor condition and upon inspection by S.engineer to be removed from host masonry wall,
