| <div><div><div>Lally</div><div>Arboricultural Impact Assessment.</div><div>515 to 521 Barlow Moor Rd</div></div><div><div>Arboricultural Data Sheet: Barlow Moor Road</div><div>Date of Survey: 19/05/2020</div><div>Surveyor: Matthew Lally</div></div></div> | | | | | | | | | | | | | |

| PROJECT | | | 515 to 521 Barlow Moor rd.<br>Chorlton | | |
| DWG No. | | | 149-PL- GTS1 | | |
| DRAWING TITLE | | | Existing Tree plan together with survey notes | | |

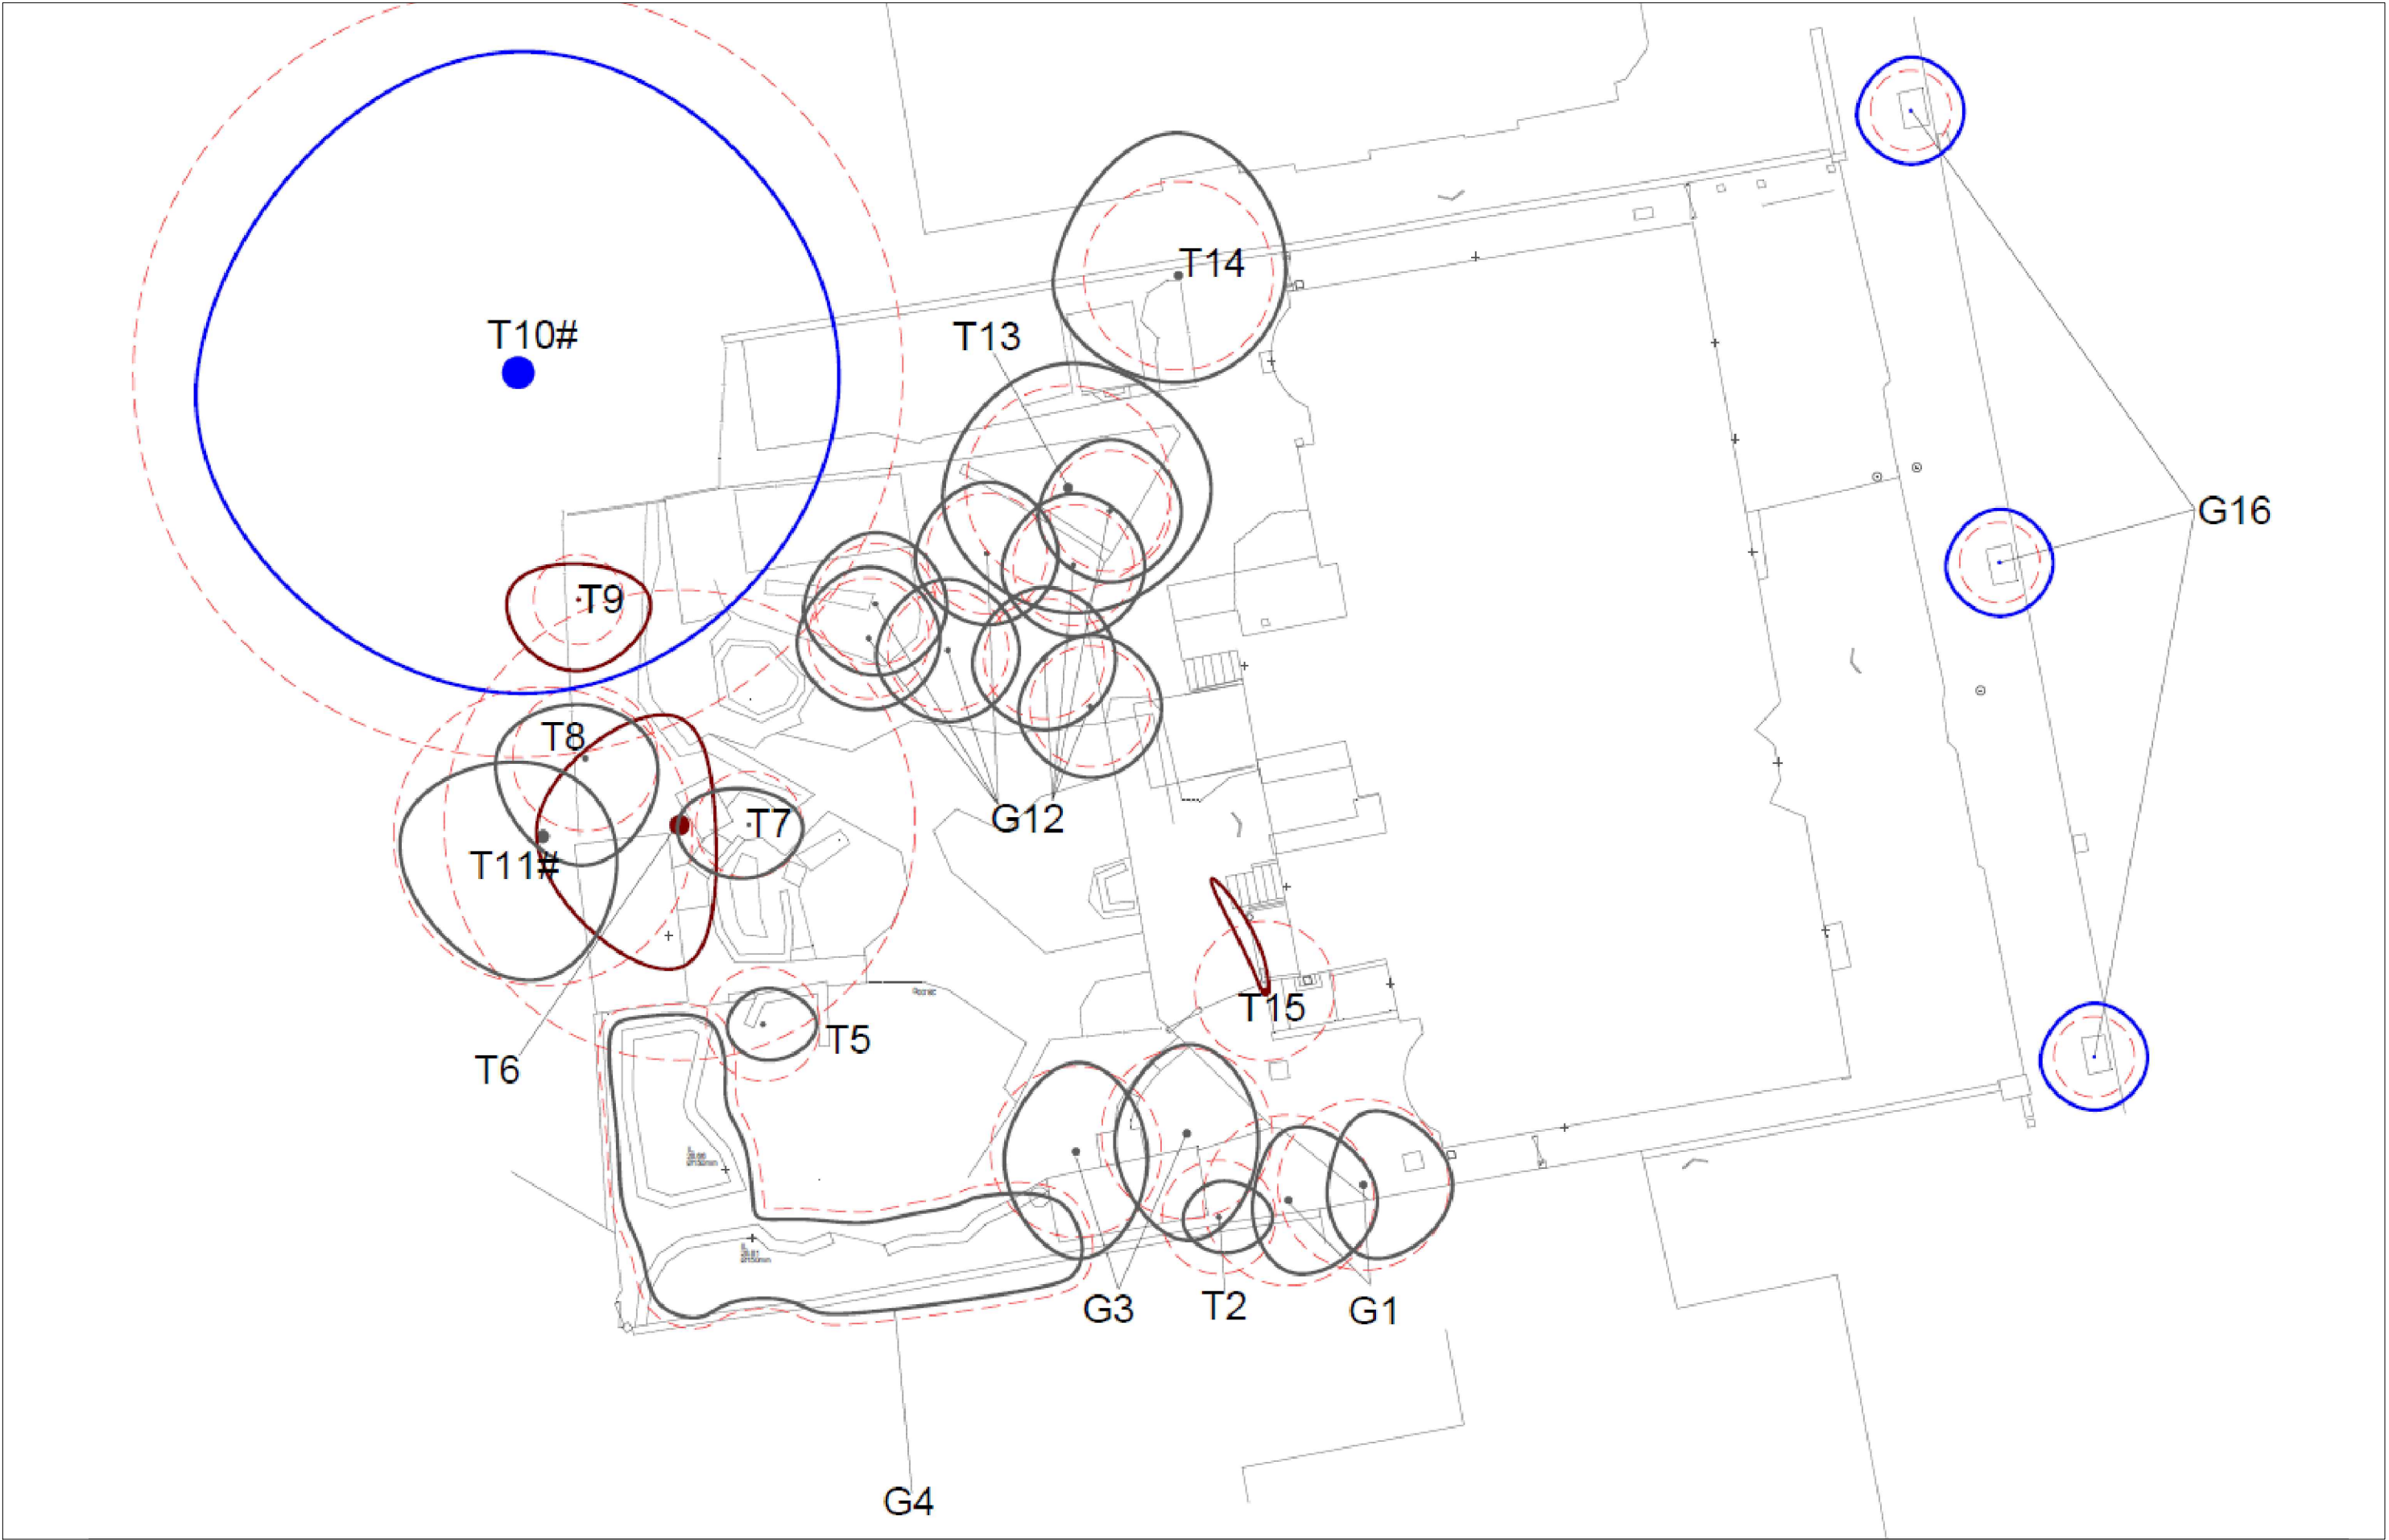
| <div><div><div>Lally</div><div>Arboricultural Impact Assessment.</div><div>515 to 521 Barlow Moor Rd</div></div><div><div>Arboricultural Data Sheet: Barlow Moor Road</div><div>Date of Survey: 19/05/2020</div><div>Surveyor: Matthew Lally</div></div></div> | | | | | | | | | | | | | |
|---|---|---|---|---|---|---|---|---|---|---|---|---|---|
| G1 | Sycamore x 2 | Avg. 200 | 12 | SM | 2 | 2.5 | 2 | 1 | 3N | B | A group of two sycamores growing in close proximity to a wall, touching buildings. If the trees are retained, they may cause damage to the building in the future.<br><b>Fell</b> | 20+ | C1 |
| T2 | Ash | 130 | 8 | SM | 1 | 1.5 | 1 | 1 | 3N | B | A tree growing out of the wall, which will cause damage if retained.<br><b>Fell</b> | 10+ | C1 |
| G3 | Sycamore x 2 | Avg. 200 | 8 | SM | 2.5 | 2 | 3 | 2 | 3N | B | A group of two Sycamore that have been topped previously. The trees are in acceptable condition but are of low value.<br><b>No action</b> | 10+ | C1 |
| G4 | Privet x 8 (approx.) | 150 | 6 | EM | - | - | - | - | 1N | B | A lapsed privet hedge of low value.<br><b>No action</b> | 10+ | C1 |
| T5 | Sycamore | 130 | 4 | SM | 1 | 1.5 | 1.5 | 0.5 | 2N | C | A tree of average vigour that has been previously topped. A semi-mature self-set tree of low value.<br><b>No action</b> | 20+ | C1 |
| T6 | Sycamore | 550 | 8 | EM | 3 | 1 | 4 | 4 | 2N | C-D | A multi-stemmed tree located by the out-house. The tree has multiple topped stems and the roots have been severed at the base. Some fungal colonisation observed. No long-term future.<br><b>Fell</b> | 10+ | U |

| <div><div><div>Lally</div><div>Arboricultural Data Sheet: Barlow Moor Road</div><div>Date of Survey: 19/05/2020</div><div>Surveyor: Matthew Lally</div></div></div> | | | | | | | | | | | | | |
|---|---|---|---|---|---|---|---|---|---|---|---|---|---|
| T7 | Cherry | 120 | 4 | SM | 1 | 1.5 | 1.5 | 2 | 2N | B | A self-set tree of good vigour which has been previously topped and is of low value.<br><b>No action</b> | 20+ | C1 |
| T8 | Laburnum | 170 | 10 | M | 1.5 | 2 | 3 | 2.5 | 2N | B | A tree of average form and vigour with included unions and basal decay observed. Acceptable condition.<br><b>No action</b> | 10+ | C1 |
| T9 | Midland Thorn | 110 | 4 | SM | 1 | 2 | 2 | 2 | 1S | C | A leaning tree located at the rear boundary of low value. Evidence of stem decay.<br><b>No Action</b> | Less than 10 | U |
| T10# | Horse Chestnut | 900 | 17 | M | 9 | 9 | 9 | 9 | 4N | B | A third-party tree of good form and vigour which was not fully inspected. A bleeding canker was observed.<br><b>No action</b> | 20+ | B1 |
| T11# | Willow | 350 | 11 | EM | 2 | 2 | 4 | 4 | 5W | B | A third-party willow tree which was not fully inspected.<br><b>No action</b> | 20+ | C1 |
| G12 | Holly, Ash, Rowan, Elm & Apple | Avg. 140 | 6 | SM | 2 | 2 | 2 | 2 | 1N | B | A mixed group of semi-mature trees of average form and vigour and low value. Low visibility from public viewpoints.<br><b>No action</b> | 20+ | C1 |

| <div><div><div>Lally</div><div>Arboricultural Data Sheet: Barlow Moor Road</div><div>Date of Survey: 19/05/2020</div><div>Surveyor: Matthew Lally</div></div></div> | | | | | | | | | | | | | |
|---|---|---|---|---|---|---|---|---|---|---|---|---|---|
| T13 | Apple | 240 | 7 | EM | 3.5 | 4 | 3.5 | 3.5 | 2N | B | A tree of good form and vigour which has been pruned for fruit and has old pruning wounds that are partially occluded. No significant defects observed.<br><b>No Action</b> | 20+ | C1 |
| T14 | Sycamore | 220 | 14 | EM | 4 | 3 | 3 | 3.5 | 1S | B | A tree growing in close proximity to a wall, towering the building. Future retention may cause damage to the wall.<br><b>Fell</b> | 20+ | C1 |
| T15 | Ash | 160 | 3 | SM | 3.5 | 0.1 | 0.1 | 0.1 | 2N | D | A previously topped tree of low value which is putting pressure on the wall.<br><b>Fell</b> | 10+ | U |
| G16 | Maple x 2 & Pear x 1 | Avg. 90 | 4 | SM | 1.5 | 1.5 | 1.5 | 1.5 | 3N | B | A group of three street trees of good form and vigour. Acceptable condition.<br><b>No action</b> | 20+ | B1 |
