# CONDITIONS TO BE DISCHARGED:

## SITE INSPECTION REPORT – 29<sup>th</sup> April 2025

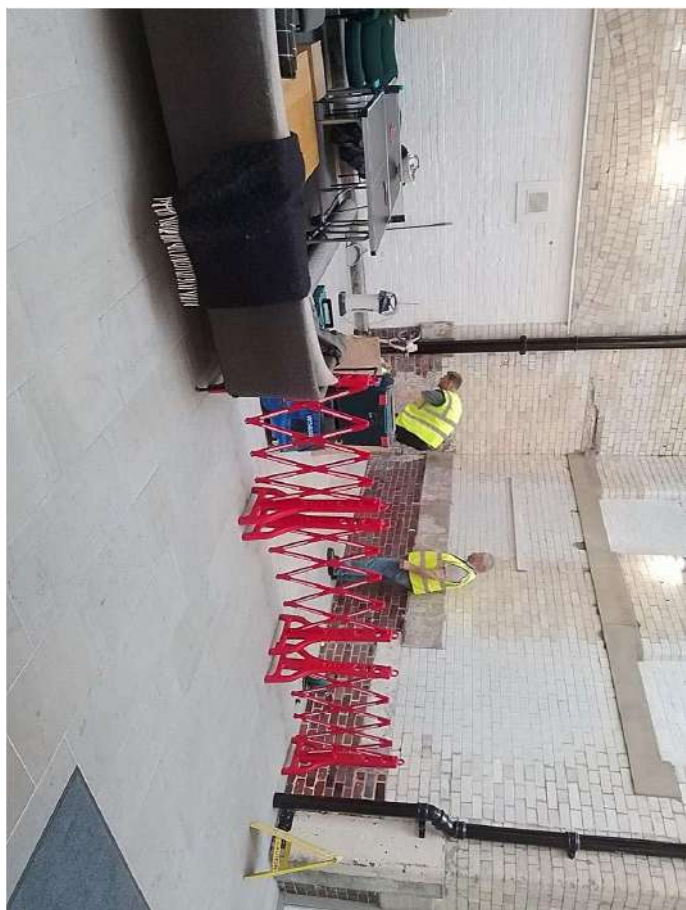
Photo 3

- 2.4 The area off works was cordoned off and furniture cleared. (Photo No. 3)
- 2.5 The slab was cat-scanned to check for buried services within the suspended floor structure. Areas where electrical cables were sensed by the equipment were marked with orange tape to define zones not to be cored due to risk. (Photo Nos. 4 & 5) Note, the cables may be a false reading or maybe below the slab, but as this could not be proven, the marked area was avoided for penetrative work. A safe zone was identified against the north wall as Appendix C and an 'X' marked as per Photo Nos. 6, 7 & 8.

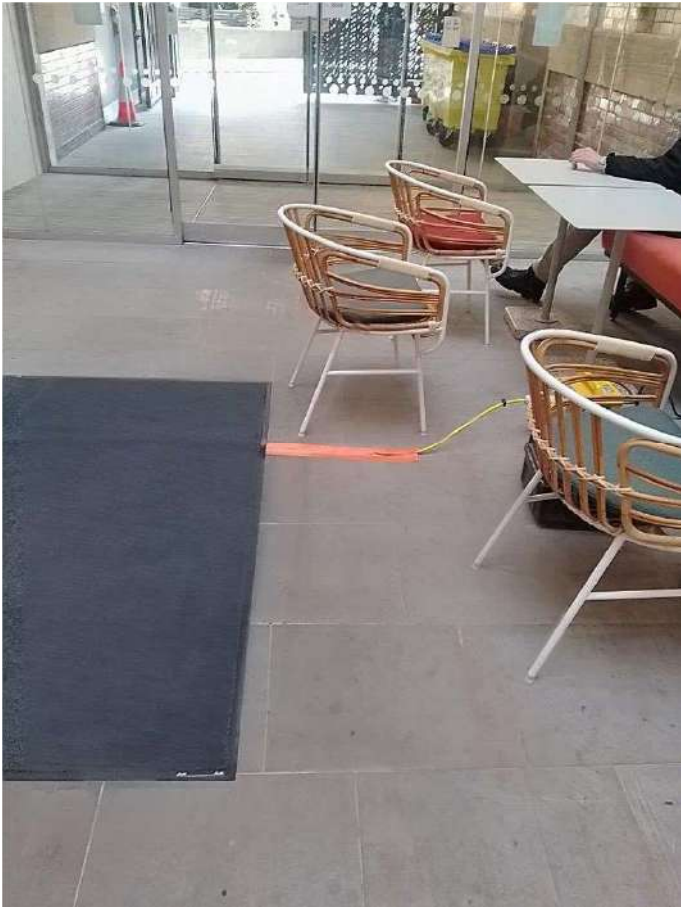
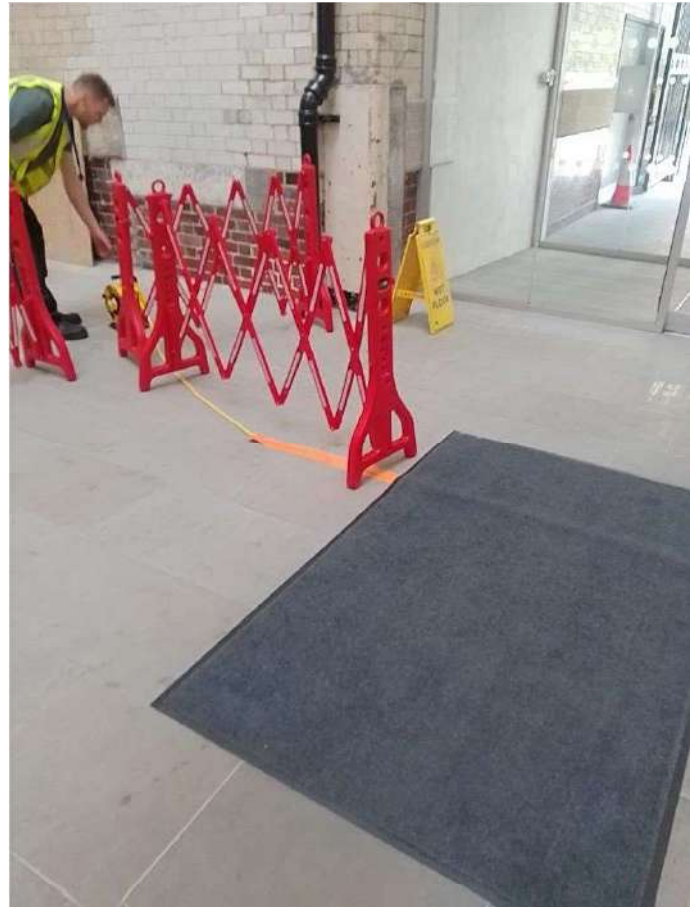
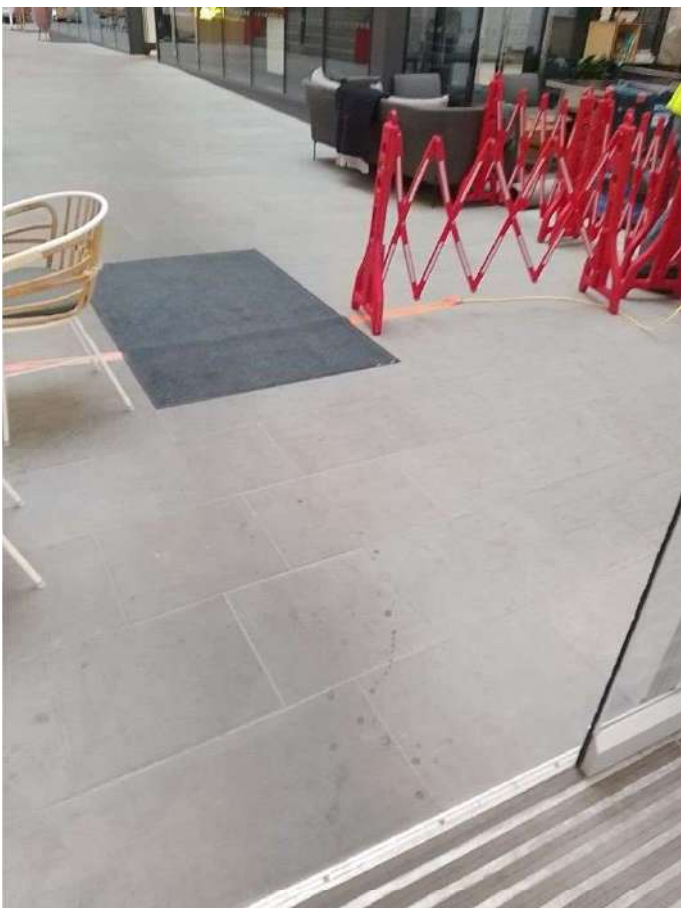
- 2.6 The power supply required for the tool used to survey was on the opposite side of the working area. A cable was run from the socket to the working area, taped to the floor and covered with a mat to maintain access to the Hanover Street access. The power supply was connected to a 110v transformer. (Photo Nos. 9, 10 & 11)

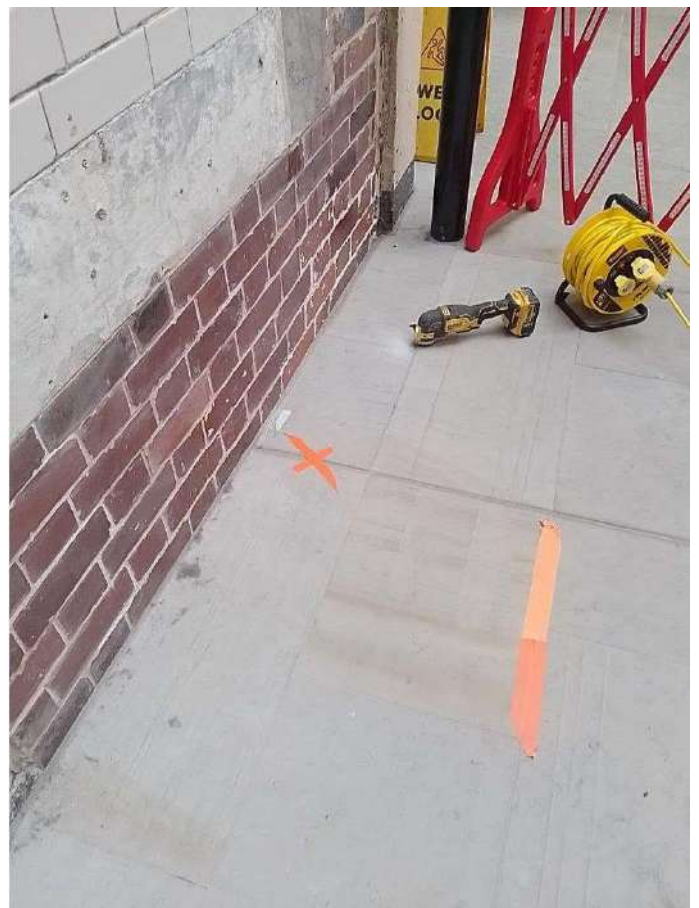
Photo 12

- 2.7 The stone tile that was selected for removal was also chosen as it was next to an expansion joint and adjacent to the wall which had a mastic seal. Both locations were presumed to provide unbonded edges that could be cut out with a sharp blade. The last two edges were grouted and were to be cleaned out using a multitool. (Photo No. 12)

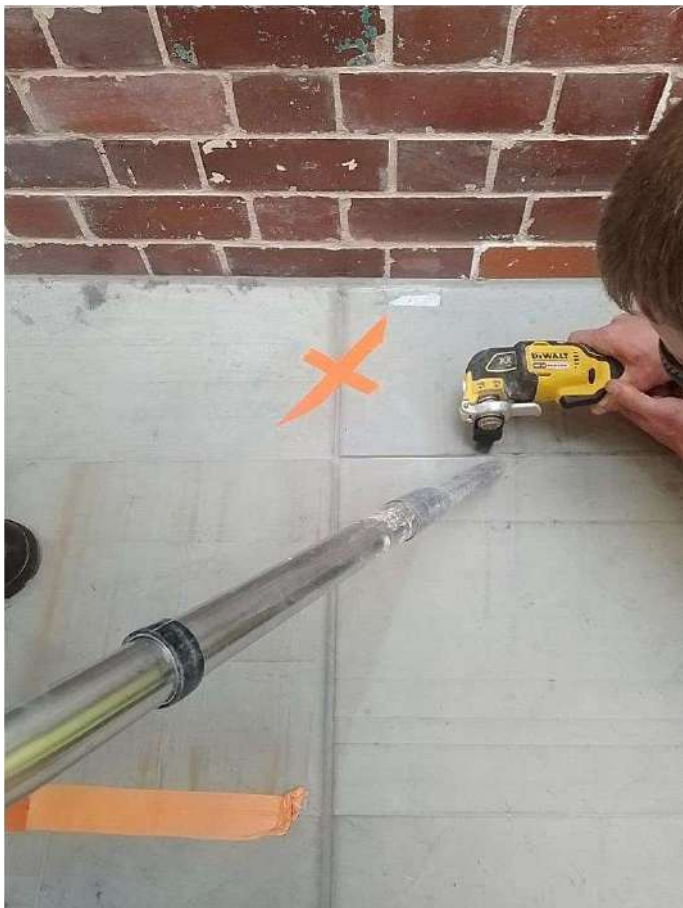
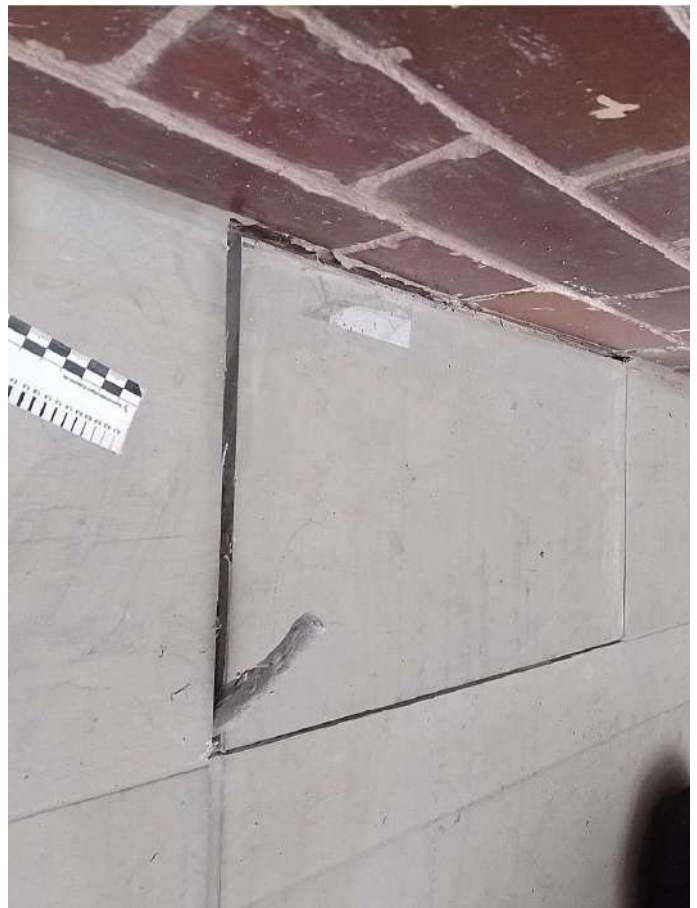
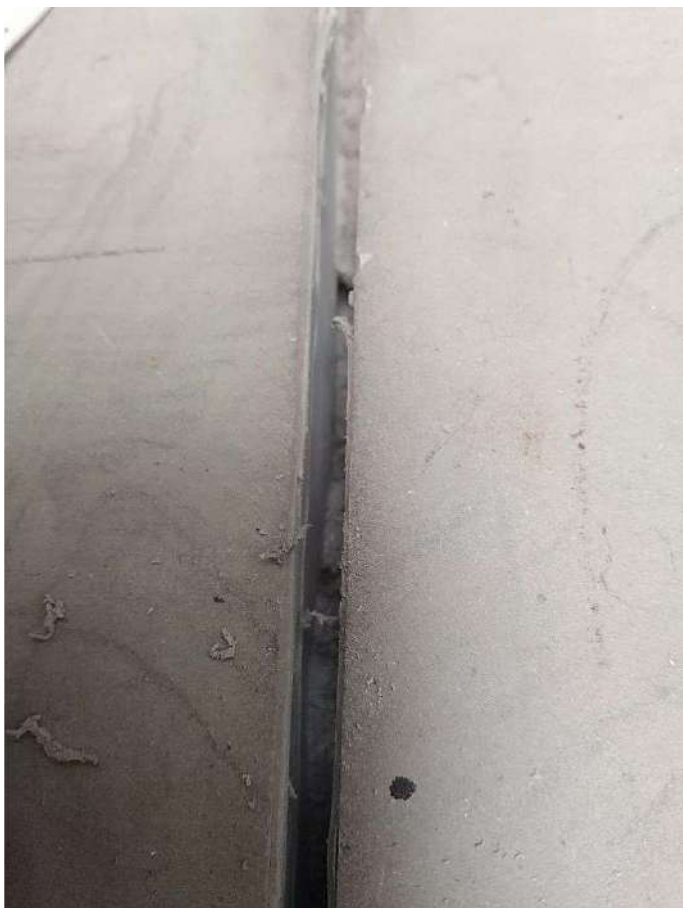
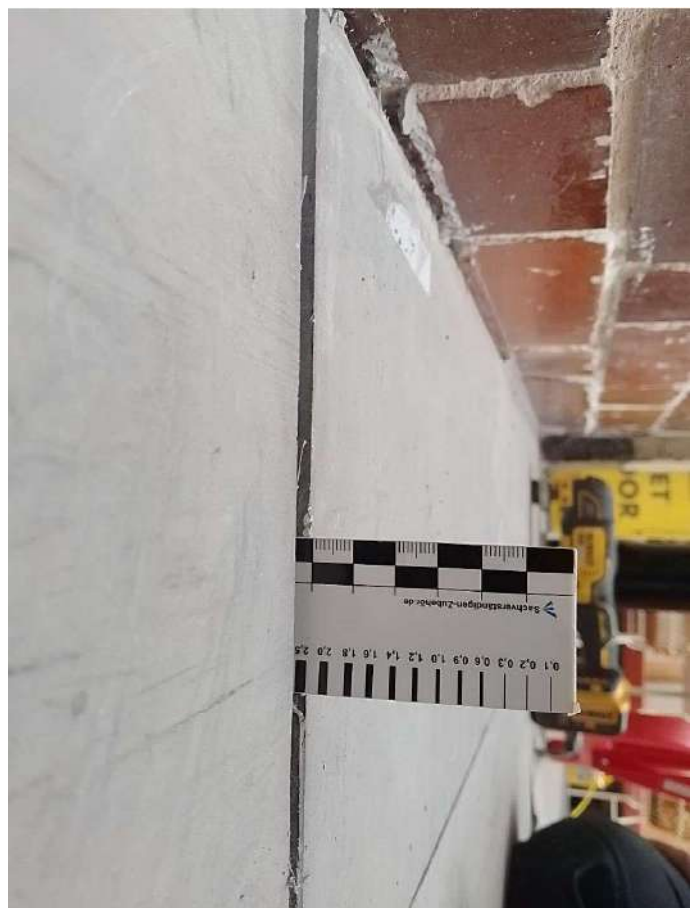
- 2.8 The two grouted edges were cut out using a multitool (with a vacuum cleaner nozzle catching any dust) and found to be approximately 15-20mm deep with a void below. The two soft edges were cut out using a blade which allowed a compressible strip to be removed from the expansion joint which was approximately 20mm deep with 10mm of mastic seal.

Cleaning out the wider slot of the expansion joint allowed the depth of stone tile to be confirmed as 40mm. Probing the exposed slot around the tile revealed bedding compound had protruded upwards, which is common. The multitool was used to clean out the perimeter around the stone tile to more than 40mm deep. A vacuum cleaner was used to capture dust arising during this stage of the work. (Photo Nos. 13,14, 15 & 16)

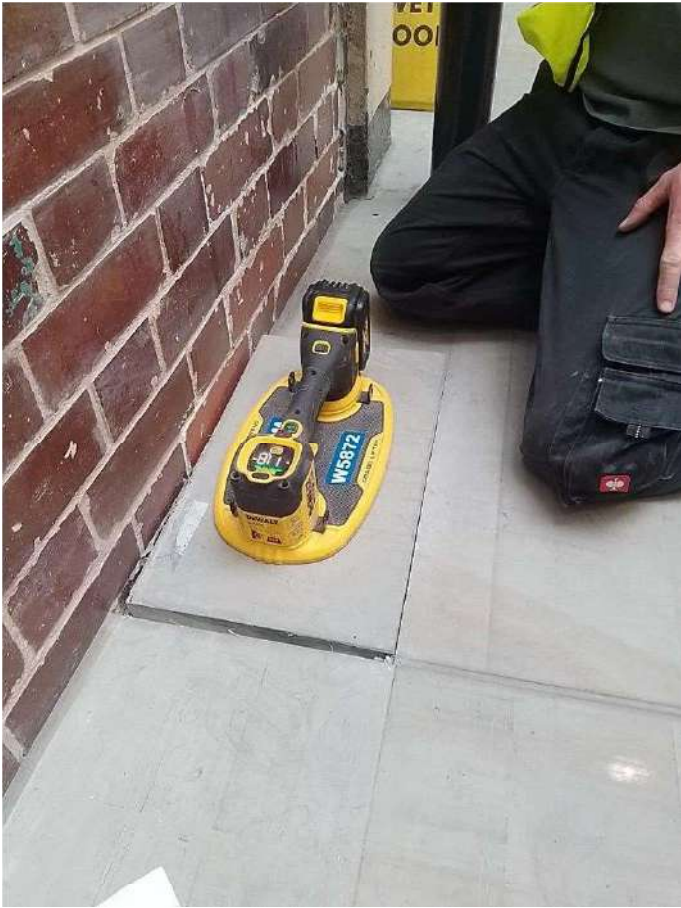
Photo 17

2.9 The first attempt to remove the stone tile, without damage, was successful. This method utilised applying a Dewalt Grabo Lifter (Photo No. 17) which is a powerful handheld battery-operated vacuum lifter. The grip exerted on the surface of the stone tile transferred the hand-applied side-to-side shaking motion which was sufficient to break the adhesion bond between the stone tile and the grout bedding compound, allowing the stone tile to be lifted free and undamaged, leaving the grout bedding compound in place and intact. (Photo Nos. 18 & 19)

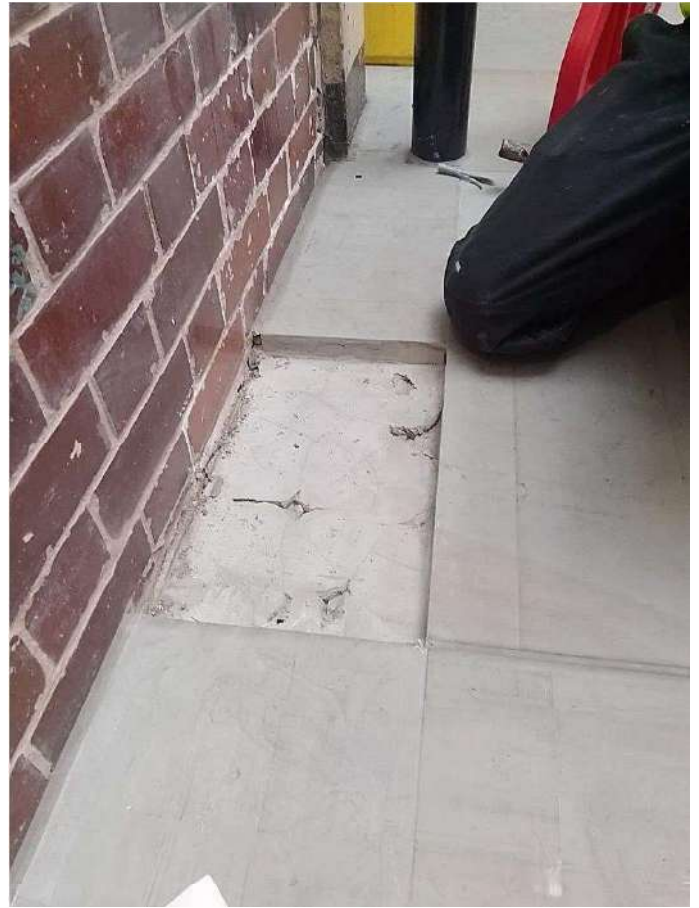
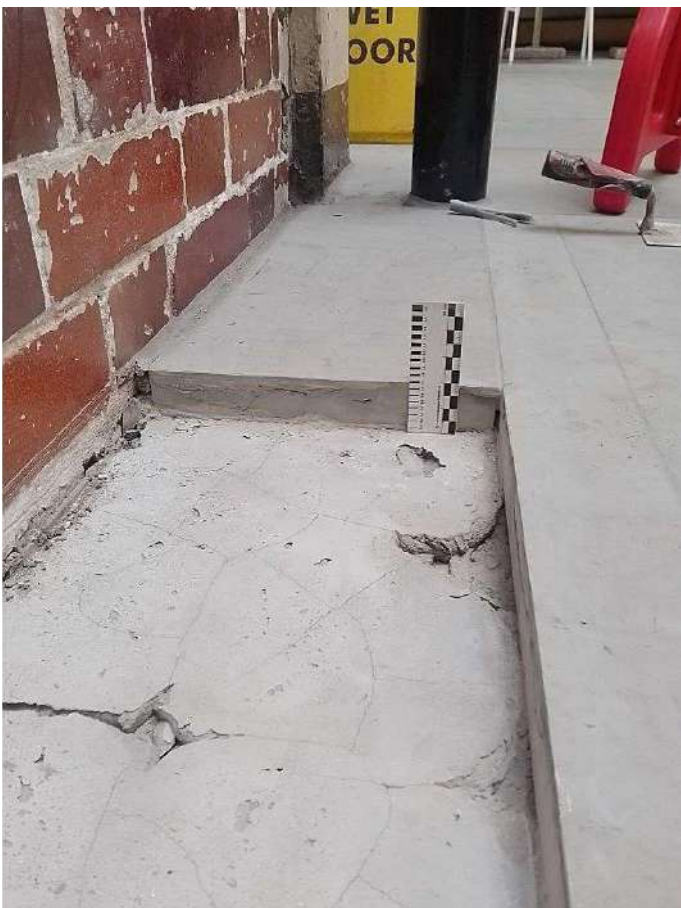
- 4.2 Removal of a stone tile without damage was successfully achieved. The proposed removal of approximately 80m<sup>2</sup> of stone tile will require care to be exercised and is expected to follow a similar approach taken during this trial removal. It is anticipated once one stone tile is removed, clearing the edge grout and using the suction grip to pull upwards, combined with careful application of a wide bolster placed at the junction of the stone tile and grout bed and struck with a hammer, should induce separation of the two materials. Before removal consideration is to be given to marking each tile in a logical sequence of numbered rows which are recorded on a drawing including dimensions of each row to prevent either over or under joint gapping resulting in an unsatisfactory placement of the last row of stone tiles.

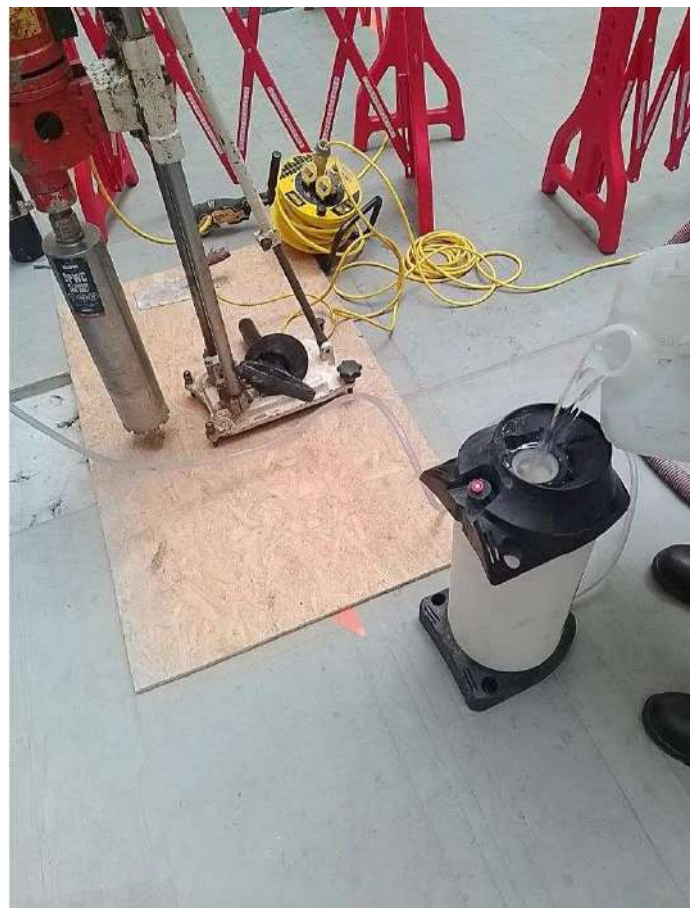
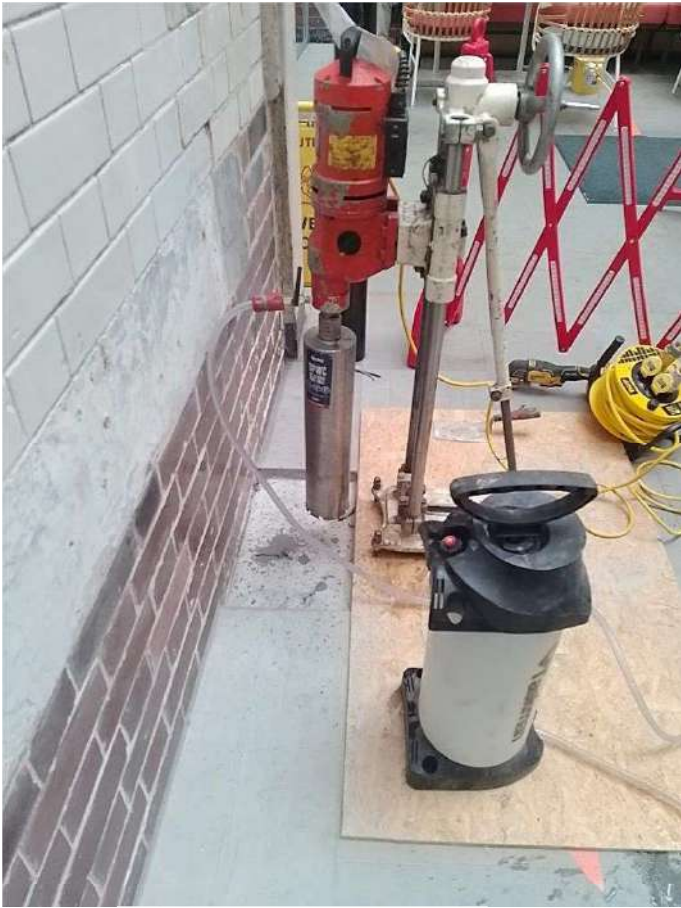
2.10 The next task was to core the substrate to prove the construction below the slab. The corer was a water-fed Weko 22 on a Braun stand. (Photo Nos. 20 & 21)

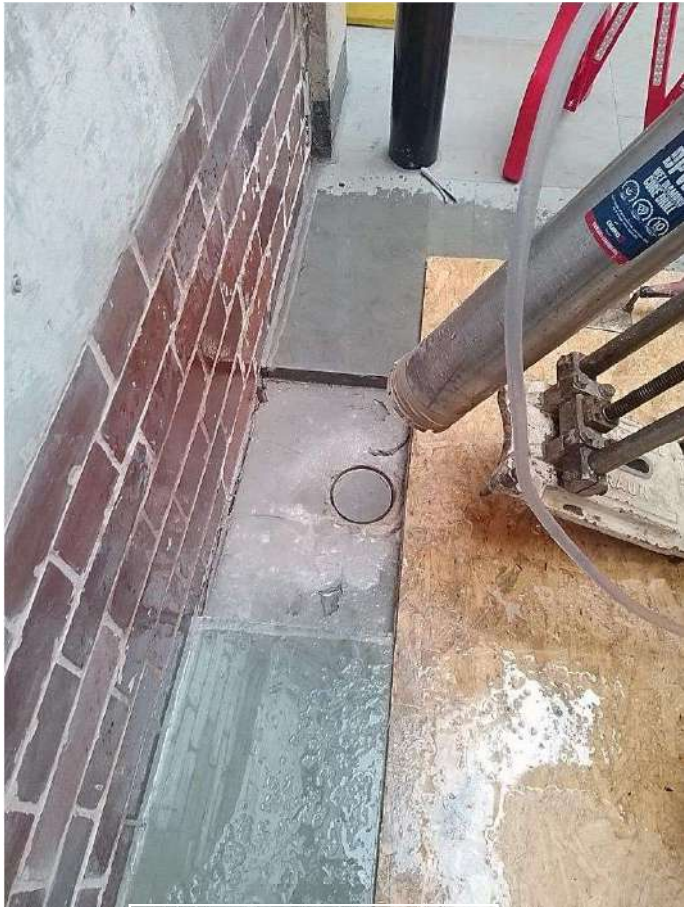
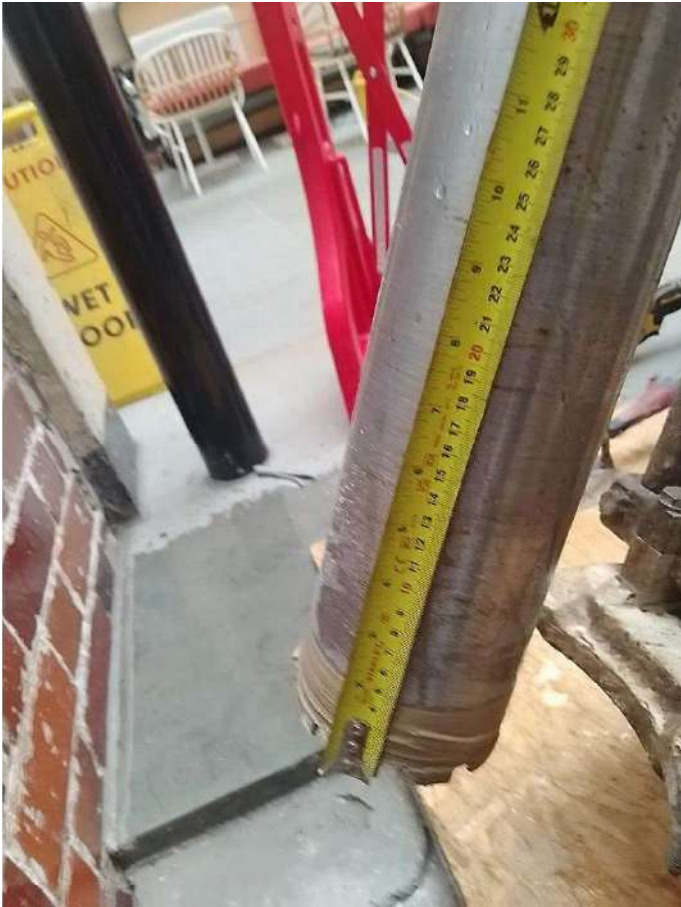
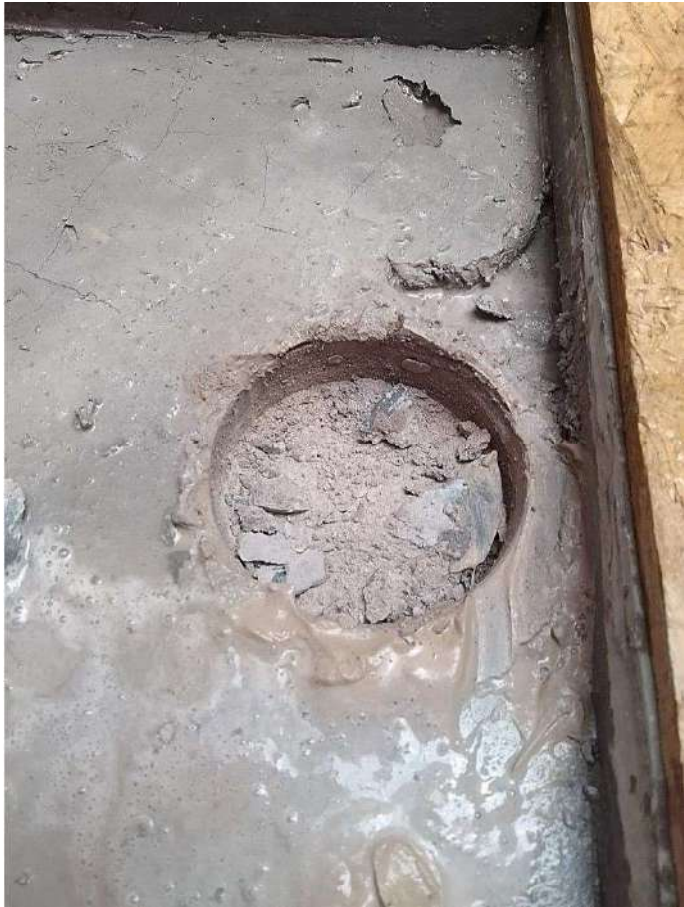
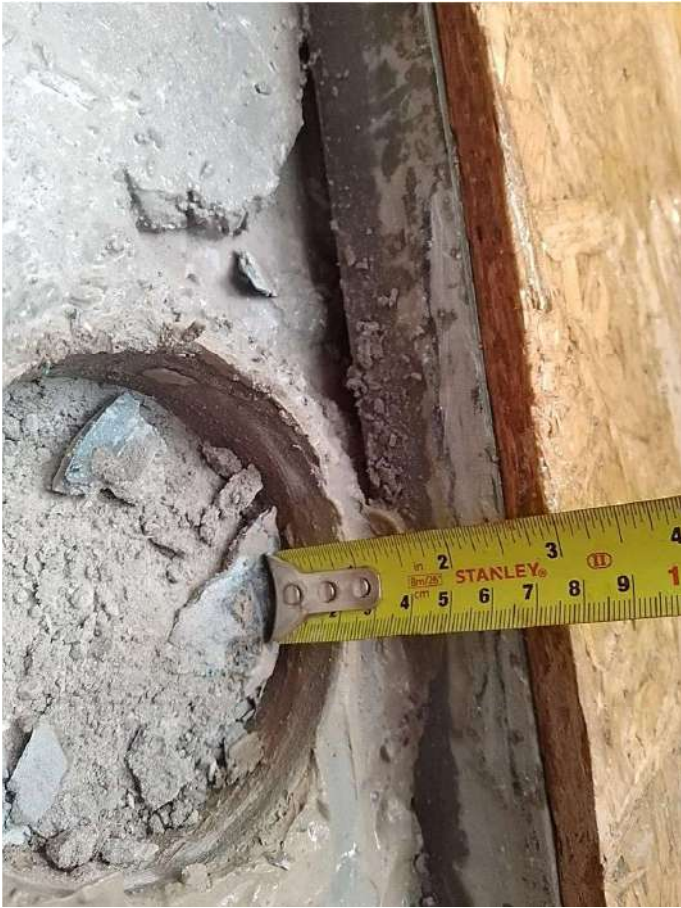
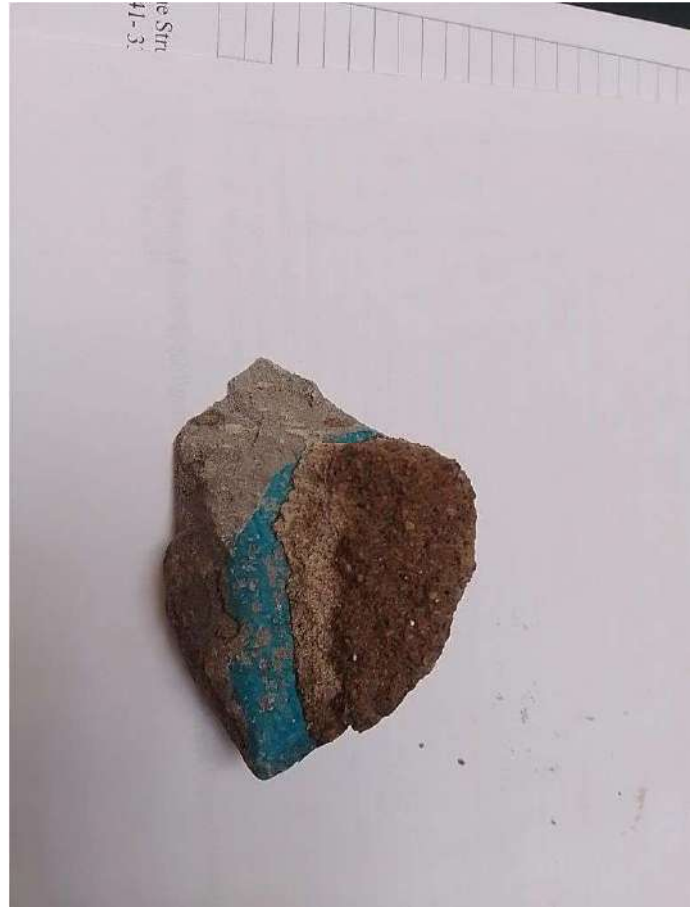
2.11 The core revealed the bedding was a cementitious compound layer 210mm thick. The compound appeared to be bonded to the concrete surface (60mm below FFL) underneath by a blue coloured adhesive. (Photo Nos. 22-26). The core depth was increased and verified that the concrete layer was a 60mm thick aerated sand cement screed. Close inspection of the aerated screed revealed synthetic fibre reinforcement to be present (Photo Nos. 26,33 & 34). Below the aerated screed is 50mm insulation. (Photo Nos. 28-32). Underneath the insulation a concrete surface was revealed and this was cored to a depth of 65mm and halted as this is considered to be the structural slab. The partial core was broken out and confirmed to be a non-aerated normal concrete with aggregate present. (Photo No. 31)

2.12 The overall construction above the structural slab was confirmed as: 170mm thick comprising:

- 40mm stone tile
- 20mm bedding compound
- 60mm aerated screed
- 50mm insulation

- 4.1 The anticipated floor build up was not as expected. The planned fixing of the new speed gates will require a suitable substrate. The presence of the insulated layer is not conducive to providing adequate restraint as long-term flexing can be induced by daily lateral loadings. Therefore, recommendation is given to locally cutting out the floor below the speed gate bases to allow the insulated layer to be replaced with fibre reinforced rapid set concrete up to the top of aerated screed layer and stone tiles re-bedded. Fixings can then be drilled and resin anchor fixed into the structural slab. Embedment depth of fixings is dependent on the design loading exerted by the speed gate bolts.
