# **Site Tree Appraisal**

## ***27 – 29 Middleton Road, Crumpsall M8 5DT***

**“BS 5837 2012: Trees in Relation to Design, Demolition and Construction – Recommendations”**

Ref: RTS/27112024 02

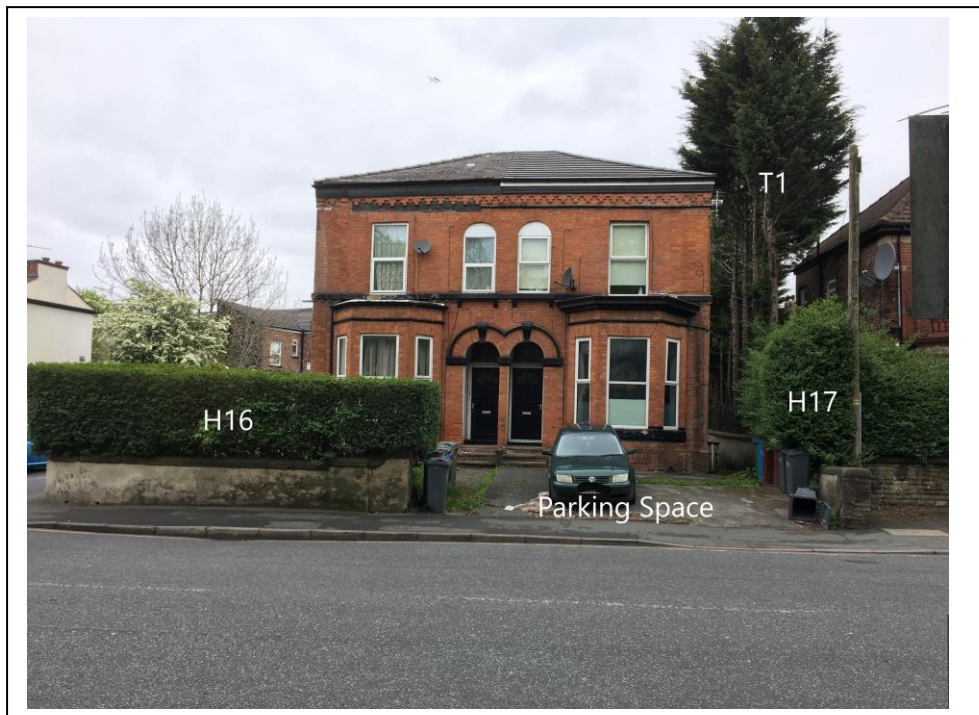
**Photo 01:**

**2.2 Brief site description:** 27 and 29 Middleton Road is a pair of semi-detached, two storey Victorian properties. The building is sited on a corner plot of land measuring some 490 square metres, at the junctions of Middleton Road and Moxley Road. The building is divided into individual apartments and the grounds are all hardstanding tarmacadam or gravel surface. The main parking area for the property is at the rear and accessed from Moxley Road, there is also parking space at the front of the property for approximately 3 motorcars (photo 01).

**3.5** None of the significant trees adjacent to the build site will need to be removed to facilitate the proposed building extensions. Only the small privet hedgerow (H16) will require removal, see photo 01. All of the adjacent significant trees (and hedgerow H17) will need their branch overhang to be prune back to facilitate the proposed building works. The tree works require to facilitate the building construction are noted in Table 1 at the recommendations, section 5 of the report.

| Tree | Tree Work | Priority |
|---|---|---|
| H16 | Dig out the hedgerow | Prior to any other site works |

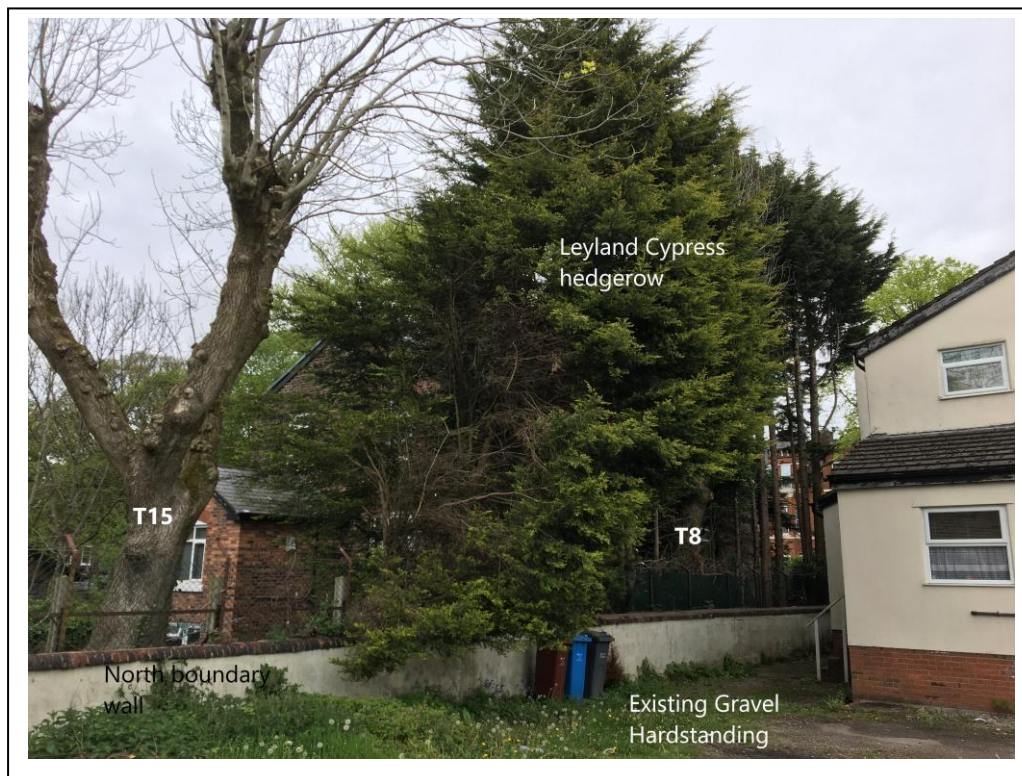
**Photo 02:**

**3.3** The significant trees, adjacent to the site, are all located in the neighbouring garden just beyond the north boundary wall. The majority of these trees are Leyland Cypress, which are planted linearly to form a hedgerow. Two mature ash trees (T8 and T15) are located within the Leyland Cypress hedge. The hedgerow is overgrown and has been poorly maintained (photo 02).

| Tree | Tree Work | Priority |
|---|---|---|
| T1, T2, T3, T4, T6, T7, T9, T10, T11, T12, T13, T14 and H17 | Trim back their southern branch and foliage overhang of the boundary wall | Prior to any other site works |
