# **ARBORICULTURAL REPORT & Impact Assessment to BS 5837:2012 at:**

***440 Hollinwood Avenue,  
Moston,  
Manchester,  
M40 0AE***

Date: February 2025

Reference: AWA6229

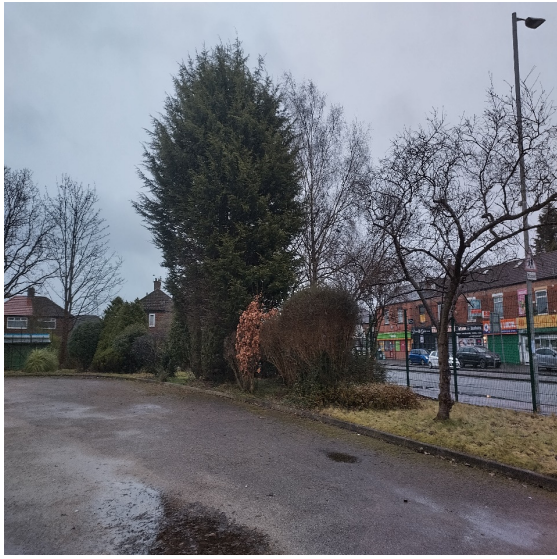
- 3.2.9 The row of trees situated along and close to the southern site boundary (T1 - T15) are individually of low amenity value. T2 Goat Willow is located within this group and is in poor structural condition and overhangs the south site boundary. This tree has been recommended for removal regardless of the development.

Photo 1: T1 – T17, looking southeast

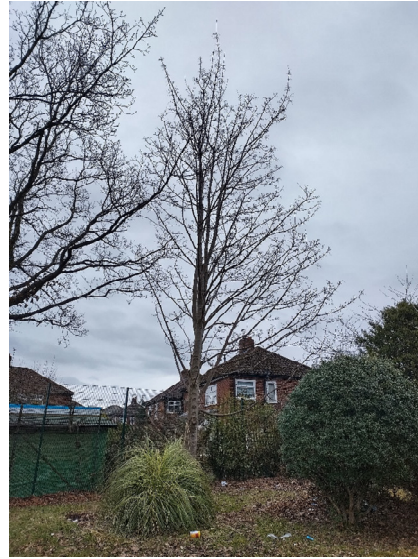
Photo 2: T17, looking east

| Tree Species | | | | Measurements | | | Crown (m) | | | | Tree Condition | | | | | | | Value | | Management | | |
|---|---|---|---|---|---|---|---|---|---|---|---|---|---|---|---|---|---|---|---|---|---|---|
| T17 | Sycamore | Acer pseudoplatanus | Semi-mature | 12 | 1 | 390 | No | 3.5 | 3 | 5 | 4 | 4 | No visual defects | Single stemmed. Vertical. Old pruning wounds. Co-dominant stems at 2m | Minor deadwood | Historic crown lift works to west | Good | Good | 20 to 40 yrs | Low | C | Removal required to facilitate development |

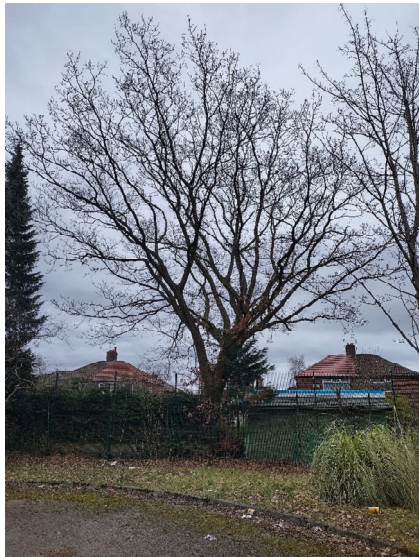
- 3.2.7 Most of the trees are semi-mature with only the occasional early-mature tree.
- 3.2.8 The sites most significant tree is T18, an early-mature Oak. Situated to the east of the site on adjacent land. This tree is prominent in its location and appears in good condition, although access and restricted visibility prevented detailed inspection. This tree provides moderate amenity value and is retention category 'B'.

Photo 3: T18, looking east

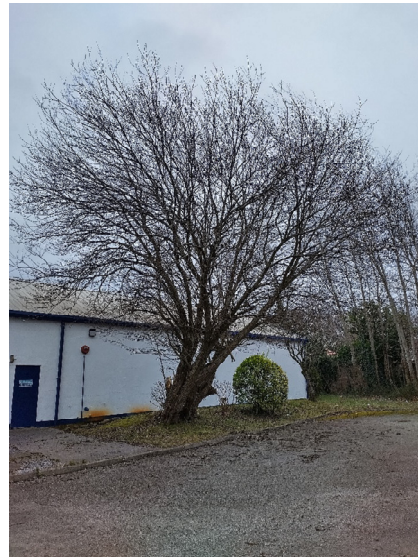
Photo 4: T19, looking northeast

| Tree Species | | | | Measurements | | | Crown (m) | | | | Tree Condition | | | | | | | Value | | Management | | |
|---|---|---|---|---|---|---|---|---|---|---|---|---|---|---|---|---|---|---|---|---|---|---|
| T19 | Goat Willow | Salix caprea | Semi-mature | 11 | 6 | 290 avg | Yes | 3 | 3 | 7.5 | 7.5 | 7.8 | No visual defects | Multiple stemmed at base. Significant lean. Tight union. Minor cavity. Decay. Partially included bark. Old pruning wounds | Old pruning wounds. Unbalanced. Minor deadwood | Minor cavities and signs of decay at base of stems. Likely limited prospects and structural weakness. X4 additional stems have died back and have decay presence. Asymmetric crown. Historic pruning works to south. Decayed fungal fruit bodies present in grass within rooting zone to south west. Unable to confirm species identification | Fair | Poor | <10 yrs | Low | U | Removal recommended regardless of development |

- 3.2.14 Some trees were found to have defects and require felling regardless of any new development at the site, this includes T2, T19 and T38 (as detailed in Appendix 4).

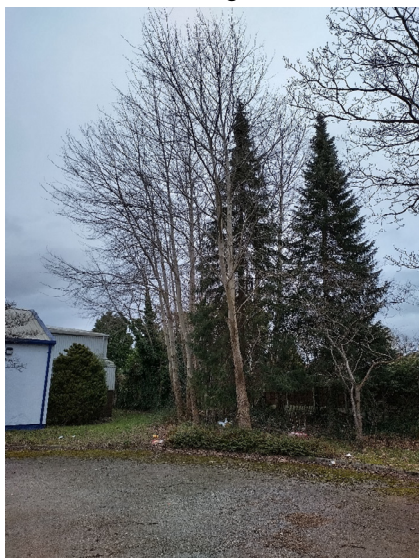
Photo 5: T21 – T47, looking northeast

| | Tree Species | | | Measurements | | | | Crown (m) | | | | | Tree Condition | | | | | | | Value | | Management |
|---|---|---|---|---|---|---|---|---|---|---|---|---|---|---|---|---|---|---|---|---|---|---|
| T47 | Grey Poplar | Populus canescens | Semi-mature | 17 | 1 | 430 | No | 5 | 6 | 3 | 4 | 6.5 | Exposed roots. Root damage /loss | Single stemmed. Slight lean. Old pruning wounds. Ivy covered | Slightly unbalanced | Impact wounds to exposed roots to southwest. Slight lean to west. Crown overhangs building and is in direct contact. Dense Ivy prevents detailed inspection | Good | Good | 10 to 20 yrs | Low | C | Removal required to facilitate development |

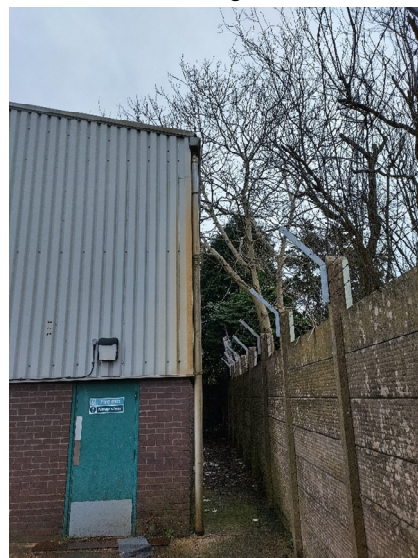
Photo 6: T63 – T67, looking west

- 4.2.5 T64, T65, T66, T67 and T68 require pruning works to facilitate the development. T64 – T67 require reducing and crown lifting to the south as required to prevent damage during the demolition works. T68 requires reducing by up to 3m and crown lifting by up to 1 to 2m to the east to prevent damage during the demolition works and to provide adequate clearance from a proposed building. These trees are located on adjacent land and should not be pruned beyond the boundary.
