## CRIME IMPACT STATEMENT

The Shamrock Public House, 17 Bengal Street

Refurbishment of Existing Public House

REFERENCE: 2024/0344/CIS/01

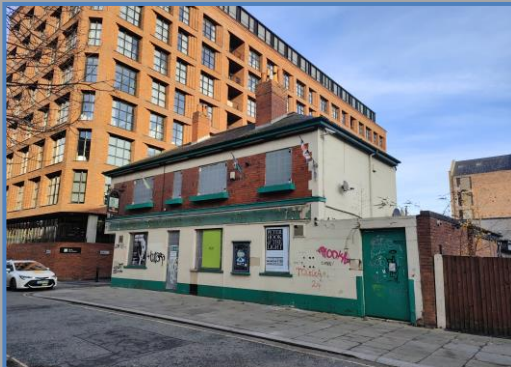
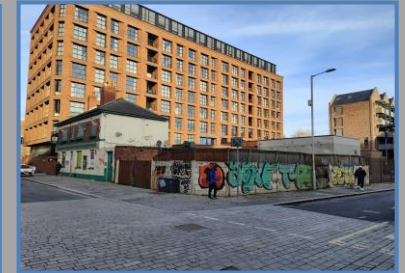
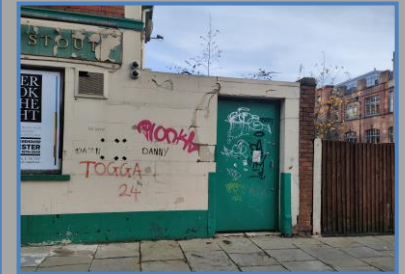
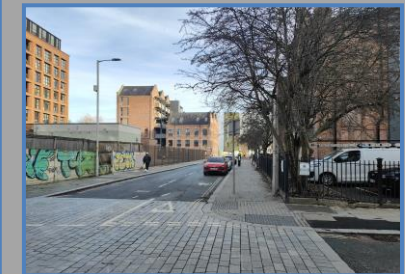
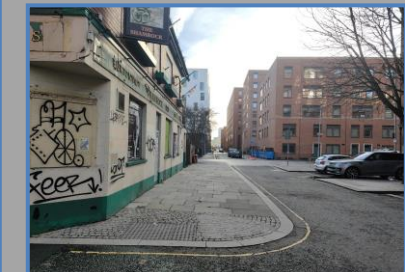
The site is currently developed as a public house which is currently vacant. The building is to be refurbished and brought back into use as a public house. The building fronts onto Silk Street and Bengal Street, which is the main entrance to the building, to the rear of the building is a gated yard defined with timber gates and concrete panel fencing. There is extensive graffiti to the fencing and the building which is likely due to it being vacant.

- 3.3.5 Graffiti is prevalent in the local area and the building has been defaced in multiple places. Bringing the building back into use will reduce the potential for it to be targeted, as buildings are regularly targeted because they are vacant. It would be prudent to consider an anti-graffiti coating to the external walls to a height of 2000mm so that graffiti can be easily removed.
