# Queen's Park Conservation Studio

Planning Condition 3  
November 2024

Project name: Queen’s Park Conservation Studio  
Project number: 9450  
Client: Manchester City Council

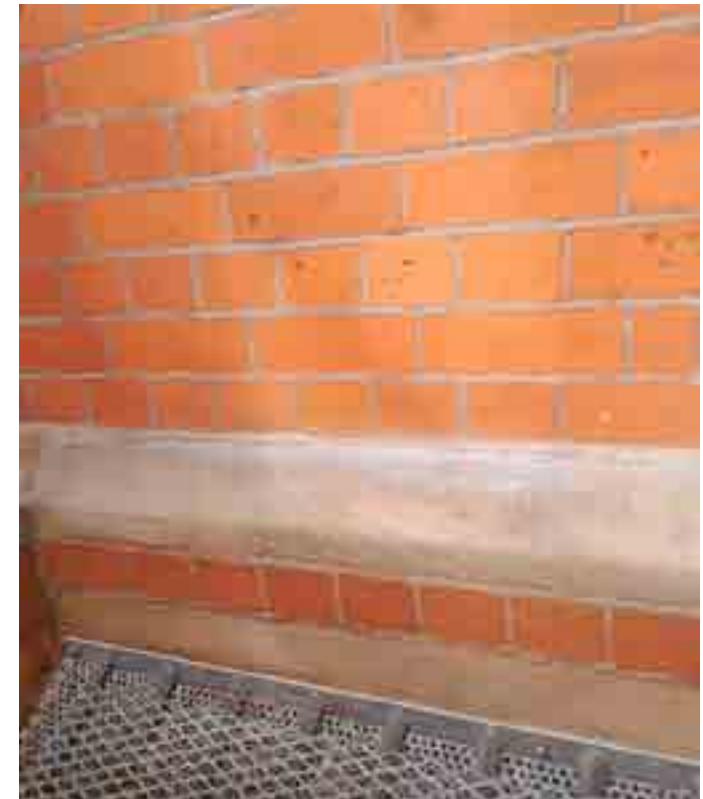
The new lime mortar pointing shown in the photos is to the bed and top of the sandstone stringer. Any brickwork mortar repointing is minimal and at high level as shown on the elevation drawings previously issued. The brickwork mortar is the same product as the sandstone mortar.

repointing stone string

The pointing mix is 1-part St Astier NHL 3.5, 1-part Nosterfield Washed Sand and 2-parts Leighton Buzzard washed river sand all as per Section RS7 of the Restoration Spec.

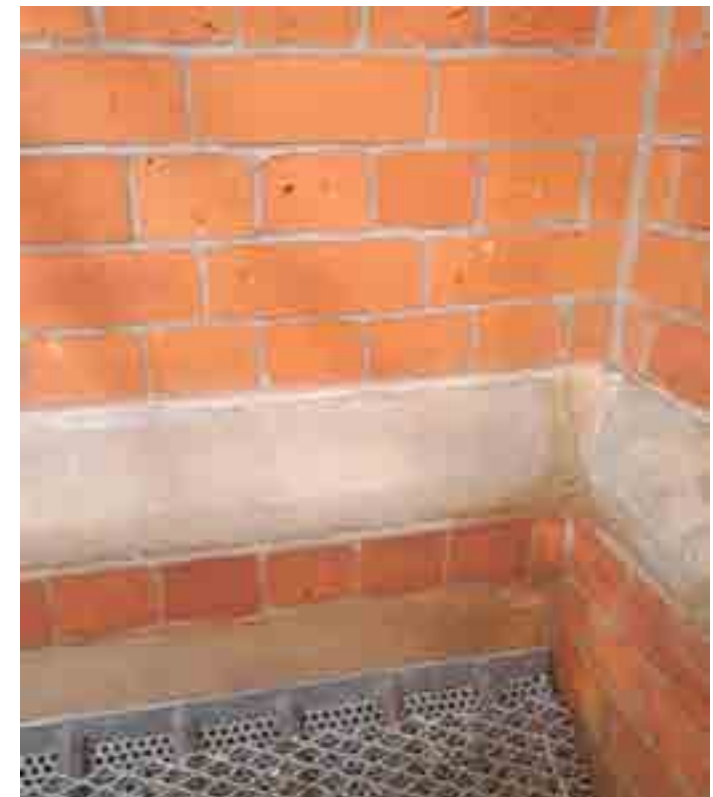
repointing of stone string internal corner

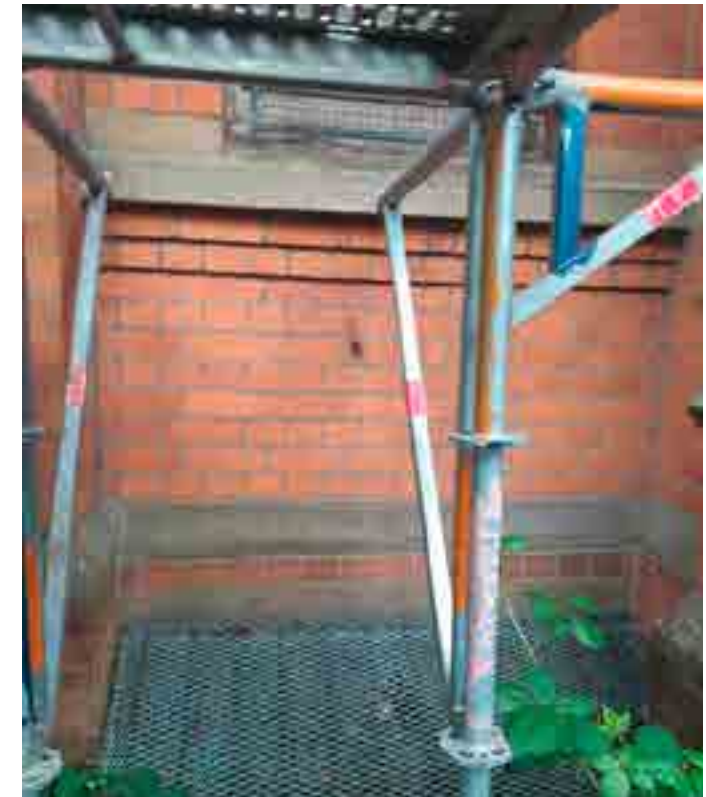
Images opposite illustrates the DOFF cleaning to the brickwork. The top image illustrates the 'before' condition and bottom image 'after' condition.

image illustrates the 'before' condition

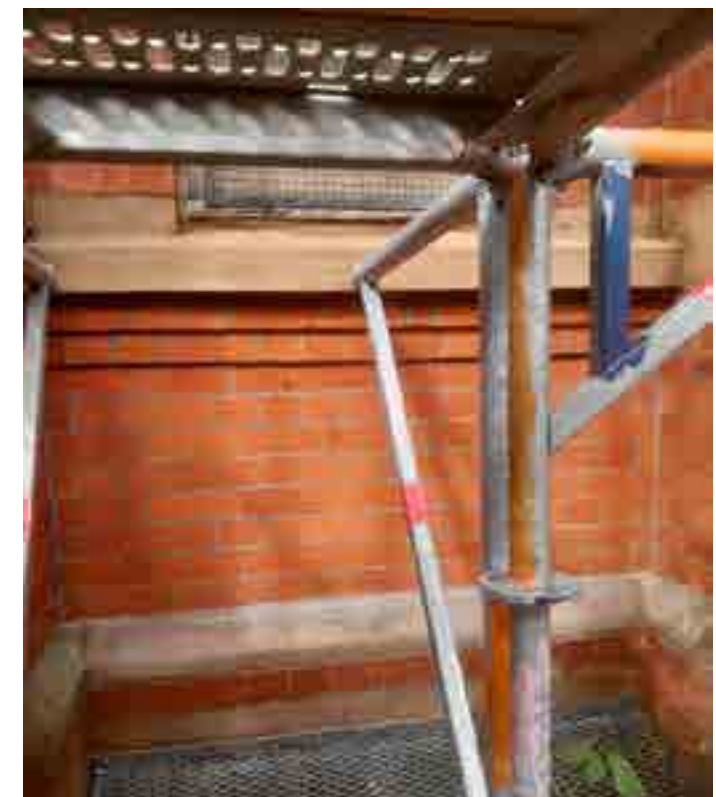
images illustrates the 'after' condition

Equipment Type:  
Stonehealth DOFF with DRS steam / water vacuum recovery unit.
