EXTERNAL WORKS  
SUNLIGHT HOUSE  
OCTOBER 2024

SUNLIGHT HOUSE

# DETAIL SCOPE OF WORKS

WORKS REQUIRED BASED ON  
CONDITION SURVEY FROM PAYE  
QUAY STREET ELEVATION (SOUTH)

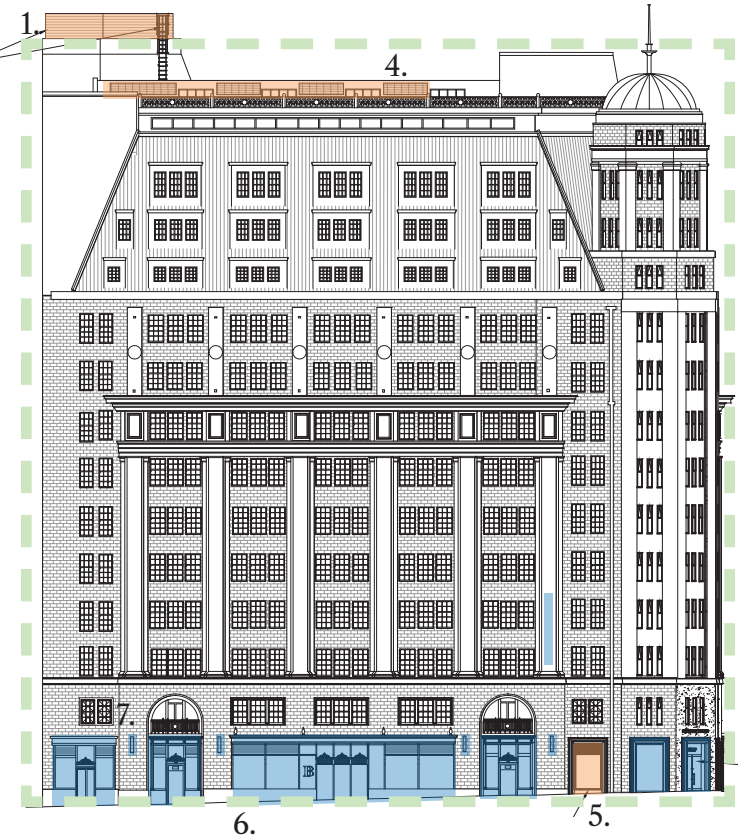
QUAY STREET (SOUTH)

There is evidence of extensive historic repairs (possibly to steel frame treatment to all vertical pilasters and to the 2nd floor cornice). It appears;

1. The masonry between the 2nd floor windows and cornice has been replaced (with the exemption of the arched keystones which appear original).

2. All pilasters have been replaced with new 'cladding' built off corbel brackets at every floor level. A silicone movement joint has been included at the new-old stone vertical reveal joint and horizontally at every floor level.

At ground floor it is suspected that a cementitious pointing has been used to re-point the facade. The type of pointing to the upper levels is unknown. Cementitious pointing is impervious to water and will cause degradation to the facing Portland stone. Recommend to make an allowance to rake out all joints to the ground and first floor and re-point with a lime-base mortar

It is strongly recommended to consult with a structural engineer and obtain the as-built drawings and photographs for the extensive repairs to confirm that the works was undertaken to a high standard and align with modern building codes.

The as-built information should confirm; specification for steel frame treatment, thickness of "new" stone, fixing details including corbel brackets and restraints (including materiality), cavity trays and barriers.

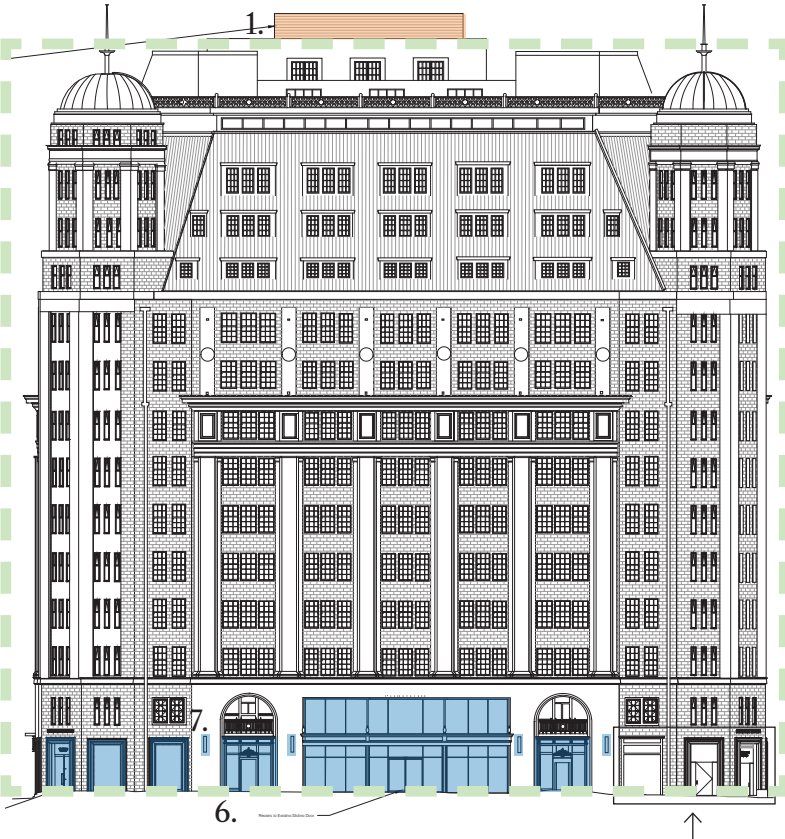
LITTLE QUAY STREET (EAST)

Previous fracture dog-cramp in repair. No further fracturing observed.

A continuous vertical hairline fracture was observed to the NE turret. The cause of the fractures may be settlement or steel frame corrosion. Recommend consultation with a structural engineer

There is a failed repair to the grand cornice on Little Quay Street. It is covered with lead flashing so is protected but is a risk of falling. Recommend removing the loose section of masonry as soon as possible. To expediate this, it could be undertaken via abseil. Once scaffold is available recommend an indent repair

The sky surface gully was clear; however, vegetation growth and debris was observed to the outlet

Fractures (category 0 to 2) and displacement to the ground floor stone were observed. The cause for the fractures is likely steel frame corrosion – with the ground floor not included in the widespread historic repairs.

It appears the hoppers are blocked causing rainwater to cascade down the face of the stone, resulting in organic staining.

Decay observed to timber windowsills. Recommend undertaking a full condition survey of the timber windows and spandrels

Recommend clearing out the debris and rodding the downpipes. Consideration should be given to how the downpipes are to be maintained in the future. Installing a lead flashing with a positive gradient away from the façade will minimize the need for periodic maintenance.

It is strongly recommended to consult with a structural engineer and obtain the as-built drawings and photographs for the extensive repairs to confirm that the works was undertaken to a high standard and align with modern building codes.

The as-built information should confirm; specification for steel frame treatment, thickness of 'new' stone, fixing details including corbel brackets and restraints (including materiality), cavity trays and barriers.

Recommend consultation with a structural engineer. Repairs could include cutting out the masonry to inspect and treat the steel frame or thumb pointing over the fractures to maintain the buildings weathertightness and continue to monitor for further defects as part of the Pre-Planned Maintenance.

Recommend refurbishing all rainwater downpipes and undertaking maintenance of the hoppers. Consideration should be given to how the downpipes are to be maintained in the future.

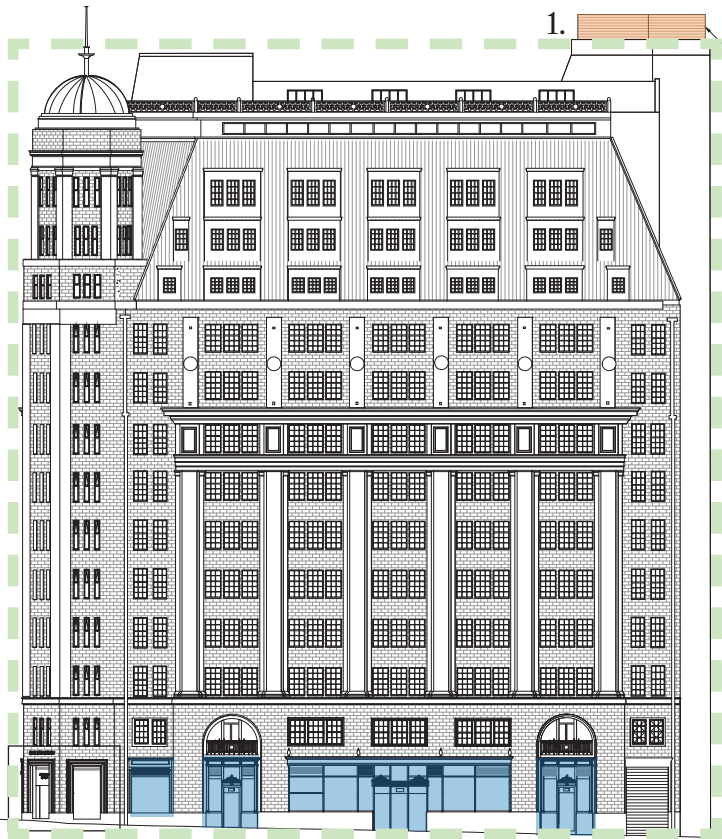
ATKINSON STREET (NORTH)

Horizontal hairline fractures were observed to a ninth-floor window lintel on Atkinson Street. The stone joint arrangement suggests the likelihood of a steel beam behind. The cause for the fractures may be steel frame corrosion. Although in its infancy, there is a risk that if left untreated it could deteriorate (especially due to the proximity the parapet hidden gutter). Historic mortar repairs were observed to the same bed joint three bays over (see (D)A-23, 02, which suggest there may have been a historic issue

Significant vegetation growth and water pooling was observed to the grand cornice

it appears the hoppers are blocked causing rainwater to cascade down the face of the stone, resulting in organic staining.

Decay observed to timber windowsills. Recommend undertaking a full condition survey of the timber windows and spandrels

Fractures (category 0 to 2) and displacement to the ground floor stone were observed. The cause for the fractures is likely steel frame corrosion – with the ground floor not included in the widespread historic repairs.

Hairline fractures (category 0-1) was observed to the decorative frieze band below the cornice. The cause for the fractures may be steel frame corrosion. Strongly recommend consultation with a structural engineer with further investigations undertaken.

Recommend clearing out the debris and rodding the downpipes. Consideration should be given to how the downpipes are to be maintained in the future. Installing a lead flashing with a positive gradient away from the façade will minimize the need for periodic maintenance.

Recommend refurbishing all rainwater downpipes and undertaking maintenance of the hoppers. Consideration should be given to how the downpipes are to be maintained in the future.

Recommend consultation with a structural engineer. Repairs could include cutting out the masonry to inspect and treat the steel frame or thumb pointing over the fractures to maintain the buildings weathertightness and continue to monitor for further defects as part of the Pre-Planned Maintenance.

It is strongly recommended to consult with a structural engineer and obtain the as-built drawings and photographs for the extensive repairs to confirm that the works was undertaken to a high standard and align with modern building codes.

The as-built information should confirm; specification for steel frame treatment, thickness of 'new' stone, fixing details including corbel brackets and restraints (including materiality), cavity trays and barriers.

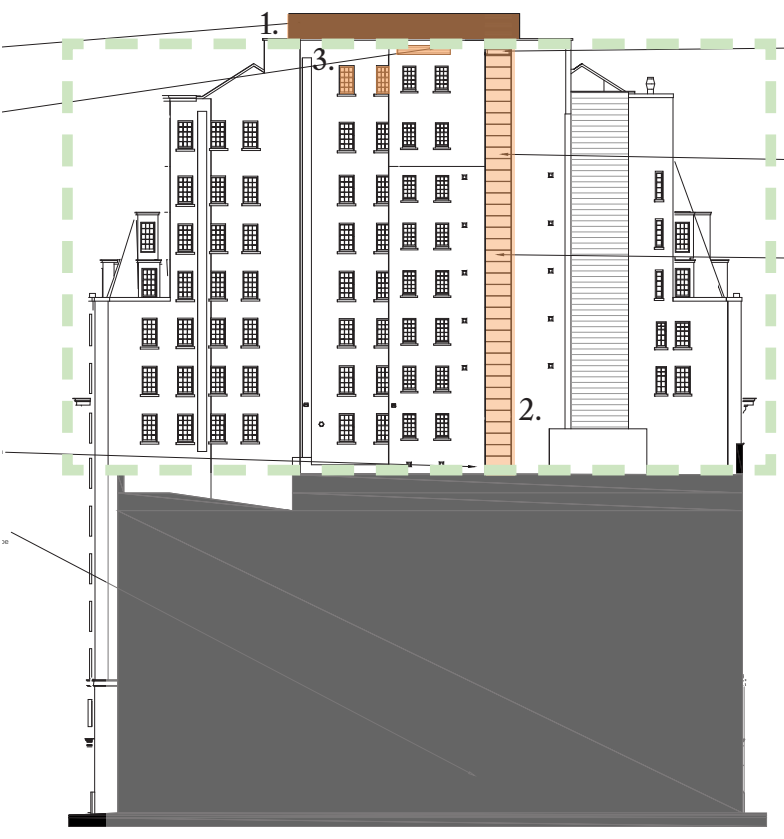
REAR ELEVATION (WEST)

- Structural Annotations:** Various symbols and text indicating structural issues and required work, such as "Hairline fractures - originating from the windowsill - were observed to localised areas. The cause for the fractures is possibly settlement of the facades. Recommend consultation with a structural engineer and continued monitoring as part of the Pre-Planned Maintenance.", "Rust staining was observed to several lintel and windowsills at L13. The cause for the rust staining is likely corrosion of the steel lintels which has washed down the window to the windowsill. Recommend consultation with a structural engineer and up-close inspection once access scaffold is available.", "VEGETATION GROWTH OBSERVED TO THE BED JOINTS. RECOMMEND 100% RAKING OUT AND REPOINTING", and "RECOMMEND 100% RAKING OUT AND REPOINTING".
