**Site Tree Appraisal**  
***60A Wood Road, Manchester M16 8BL***

**“BS 5837 2012: Trees in Relation to Design, Demolition and Construction – Recommendations”**

Ref: RTS/25102024

**60A Wood Road, Manchester M16 8BL:**

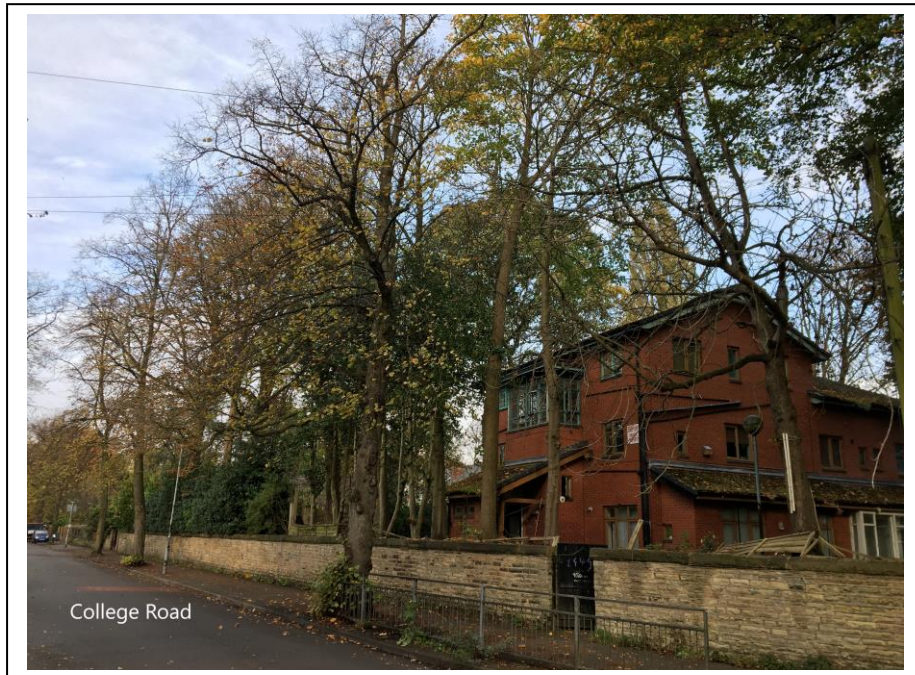
Photo 01:

**2.2 Brief site description:** 60A Wood Road is a large detached former HMO building which is set back from the Wood Road frontage (photo 01). The large derelict building is located centrally towards the west side of the garden plot. The gardens are unmaintained and overgrown with general ground scrub and weed. There are 14 significant trees and one linear group of trees on the plot of land.

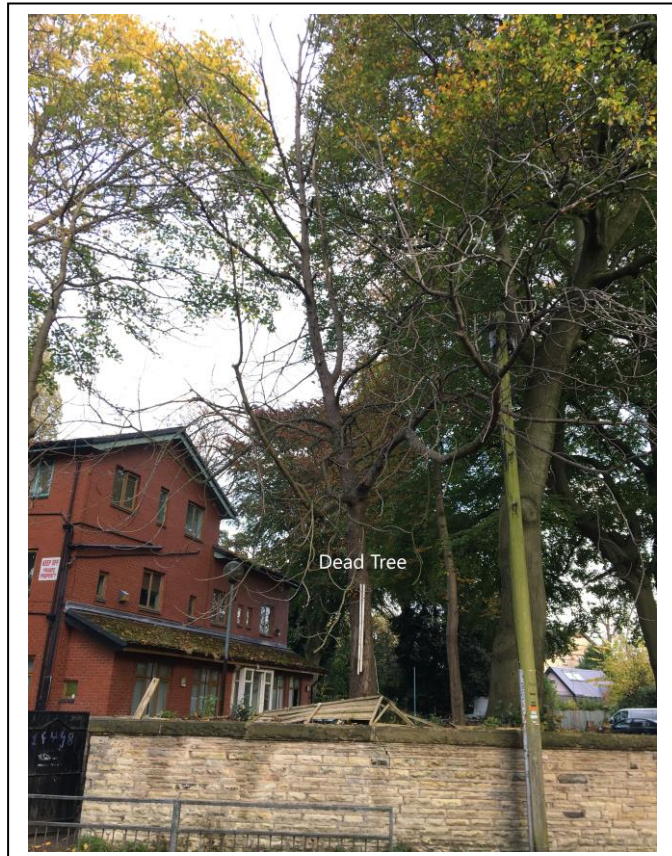
Photo 02:

**3.4** To allow space for one of the house units, crown spread reduction to T10 will be required. Also, general tree management pruning to the linear row of trees (G1) is recommended and removal of one dead tree within the group (photo 02). The tree pruning specifications are noted in the Recommendations, section 5 of the report.

| Tree | Tree Work | Priority |
|---|---|---|
| G1 | Crown clean the linear row of trees by pruning out dead branches that are greater than 50mm diameter. Also fell to ground level the one dead tree in the group (photo 02). | Prior to any other site works |
