MURRAY  
TREE CONSULTANCY

PRELIMINARY TREE REPORT  
(BS 5837:2012)

THE BANDSTAND  
1077 HYDE ROAD  
GORTON  
MANCHESTER  
M18 7LJ

April 2024

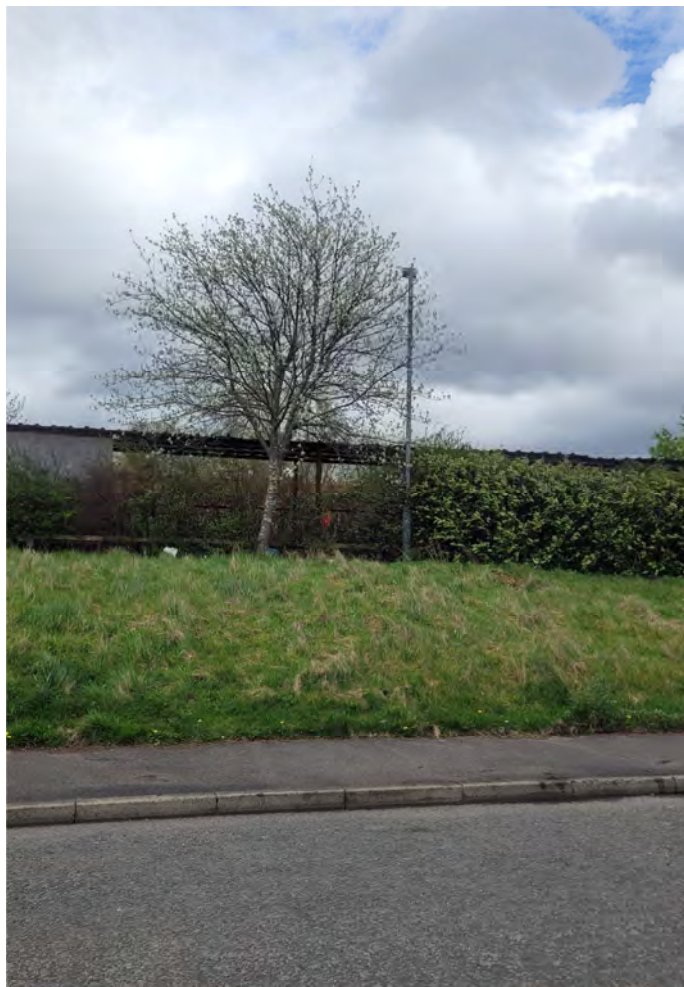
| Arboricultural Data Sheet: The Bandstand, 1077 Hyde Rd, Gorton, Manchester, M18 7LJ    Date of Survey: 07/04/24    Weather: Windy    Surveyor: PM | | | | | | | | | | | | | | | | |
|---|---|---|---|---|---|---|---|---|---|---|---|---|---|---|---|---|
| T1 | Whitebeam | 160 | 5 | SM | 4 | 4 | 3 | 4 | 1.8 | A | A young tree located within shrub area top of grass bank exhibiting good form and vigour. | n/a | 10+ | C1 | 11.58 | 1.92 |

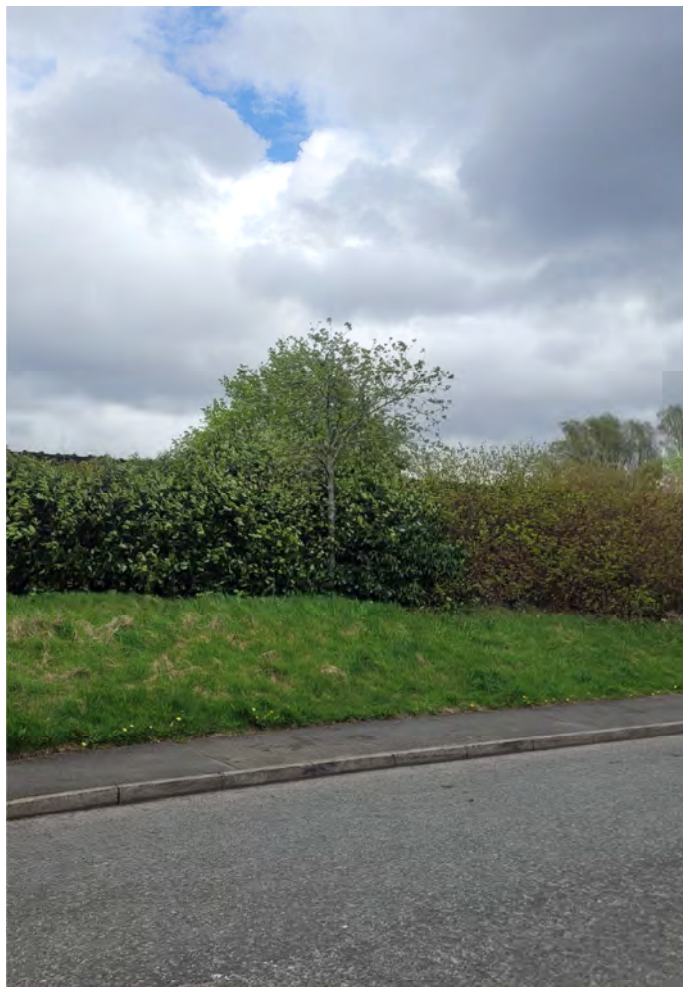
| Arboricultural Data Sheet: The Bandstand, 1077 Hyde Rd, Gorton, Manchester, M18 7LJ    Date of Survey: 07/04/24    Weather: Windy    Surveyor: PM | | | | | | | | | | | | | | | | |
|---|---|---|---|---|---|---|---|---|---|---|---|---|---|---|---|---|
| T2 | Rowan | 120 | 4.5 | SM | 2.5 | 2.5 | 2.5 | 2.5 | 1.8 | A | A young tree located within shrub area top of grass bank exhibiting good form and vigour. | n/a | 10+ | C1 | 6.51 | 1.44 |

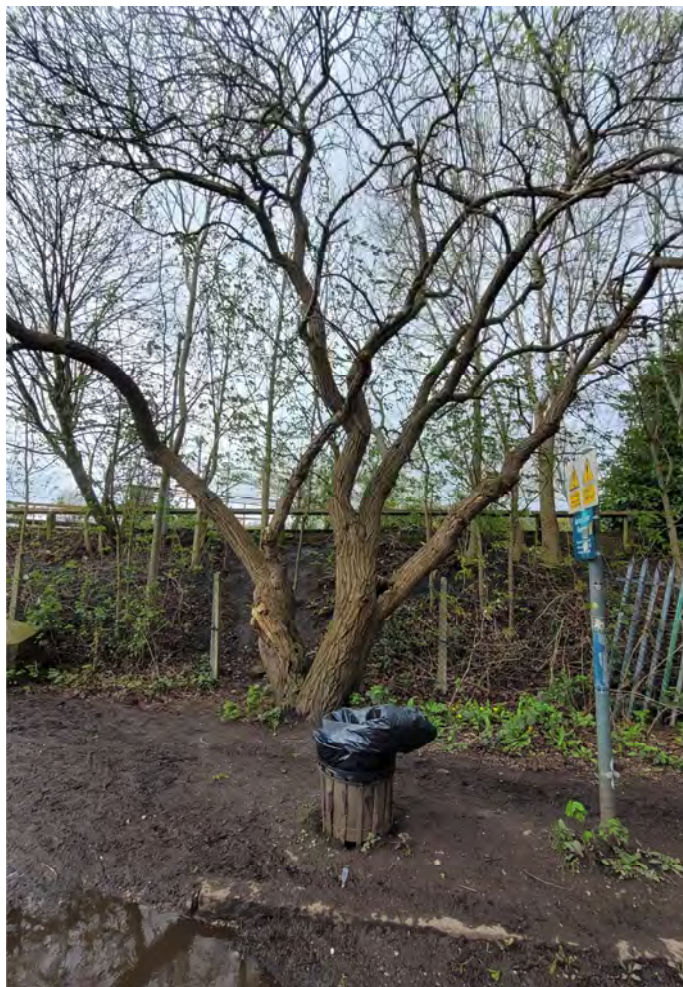
| Tree No. | Species | Dbh (mm) | Height (m) | Age | Crown Spread | | | | Crown C | Cond R | Observations and Comments | Preliminary Recommendations | ERC (Yrs) | TQC R | RPA (m <sup>2</sup> ) | RPA Circle Radius (m) |
|---|---|---|---|---|---|---|---|---|---|---|---|---|---|---|---|---|
| T19 | Goat Willow | 650 | 10 | M | 7 | 6 | 8 | 6 | 2 | C/D | A very poor specimen within adjacent site. Forked at base. Severe stem decay and cavities present. Very low vigour and deadwood. | <b>Fell to ground level.</b> | 0-5 | U | 191.13 | 7.80 |

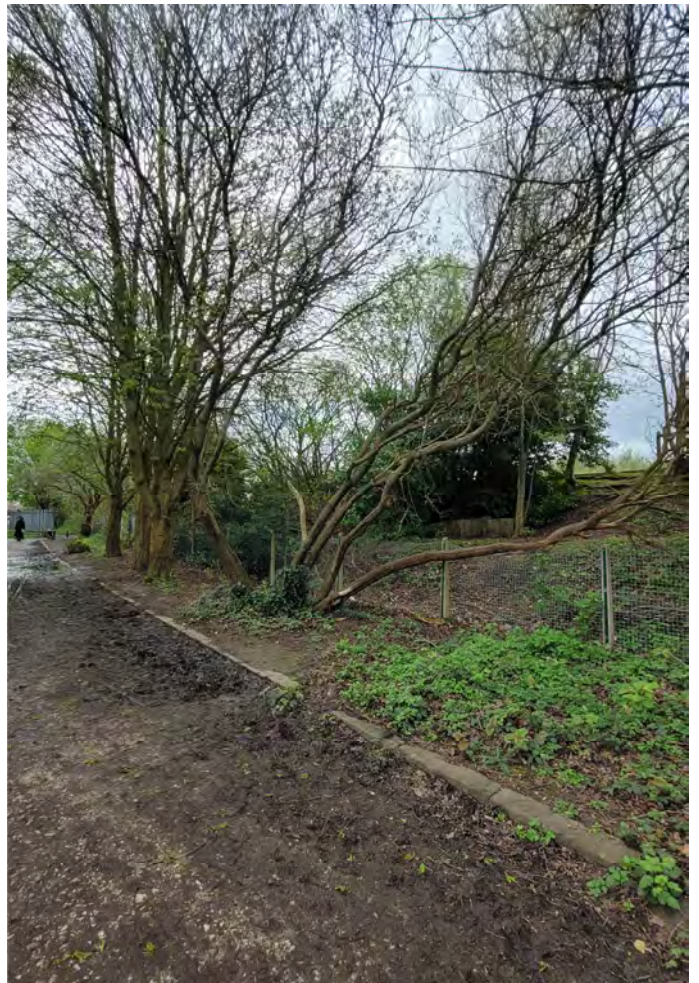
| Tree No. | Species | Dbh (mm) | Height (m) | Age | Crown Spread | | | | Crown C | Cond R | Observations and Comments | Preliminary Recommendations | ERC (Yrs) | TQC R | RPA (m <sup>2</sup> ) | RPA Circle Radius (m) |
|---|---|---|---|---|---|---|---|---|---|---|---|---|---|---|---|---|
| T20 | Goat Willow | 400 | 9 | M | 8 | 6 | 2 | 7 | 2 | C/D | A very poor specimen within adjacent site. Multi-stemmed at base. Severe stem decay and broken limbs. Very low vigour and deadwood. | <b>Fell to ground level.</b> | 0-5 | U | 72.38 | 4.80 |

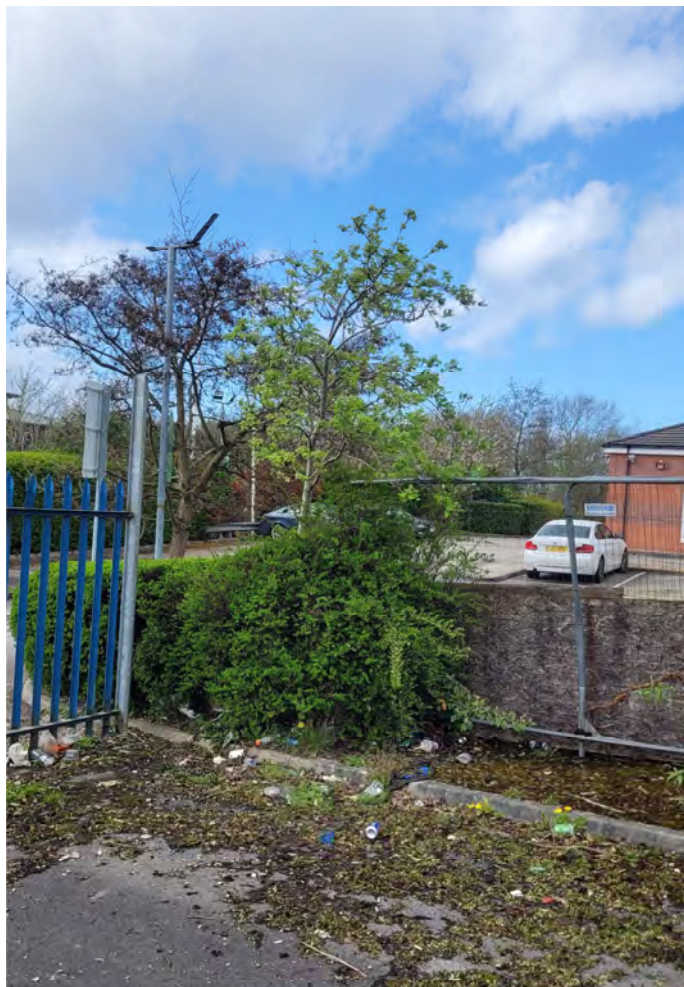
| Arboricultural Data Sheet: The Bandstand, 1077 Hyde Rd, Gorton, Manchester, M18 7LJ    Date of Survey: 07/04/24    Weather: Windy    Surveyor: PM | | | | | | | | | | | | | | | | |
|---|---|---|---|---|---|---|---|---|---|---|---|---|---|---|---|---|
| T3 | Rowan | 110 | 4 | SM | 2 | 1.5 | 1 | 1.5 | 1.8 | B | Located within the adjacent site in shrub area. One sided form. | n/a | 10+ | C2 | 5.47 | 1.32 |

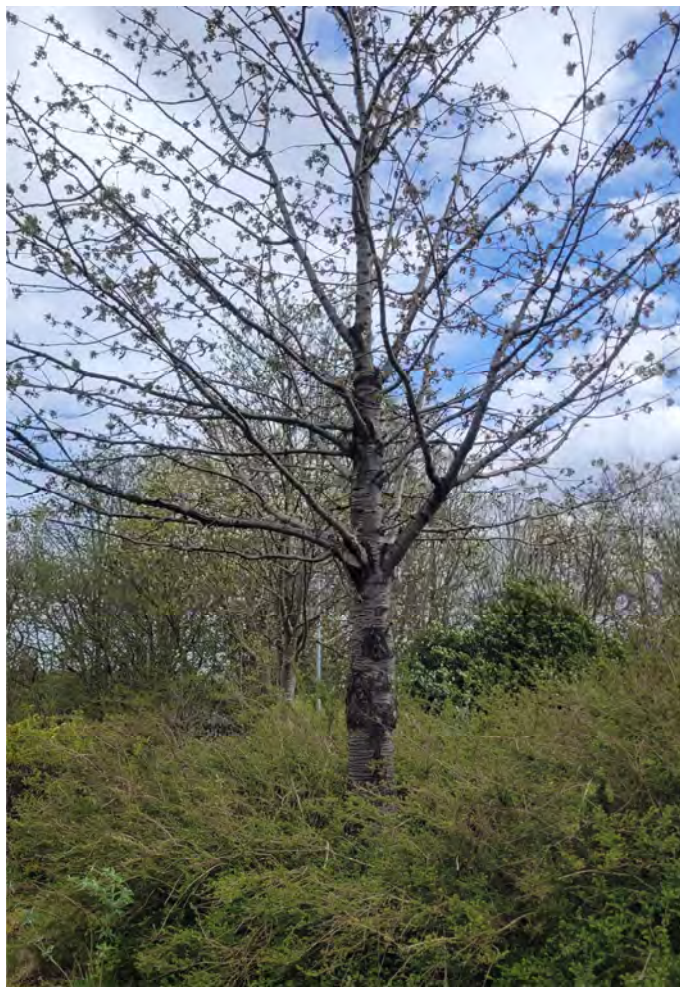
| Arboricultural Data Sheet: The Bandstand, 1077 Hyde Rd, Gorton, Manchester, M18 7LJ    Date of Survey: 07/04/24    Weather: Windy    Surveyor: PM | | | | | | | | | | | | | | | | |
|---|---|---|---|---|---|---|---|---|---|---|---|---|---|---|---|---|
| T11 | Cherry | 300 | 8 | EM | 5 | 5 | 4 | 4 | 1.8 | B | Located within shrub area exhibiting reasonable form and vigour. Split lower branch. Previous pruning wounds. | Remove damaged lower branch. | 20+ | B2 | 40.72 | 3.60 |

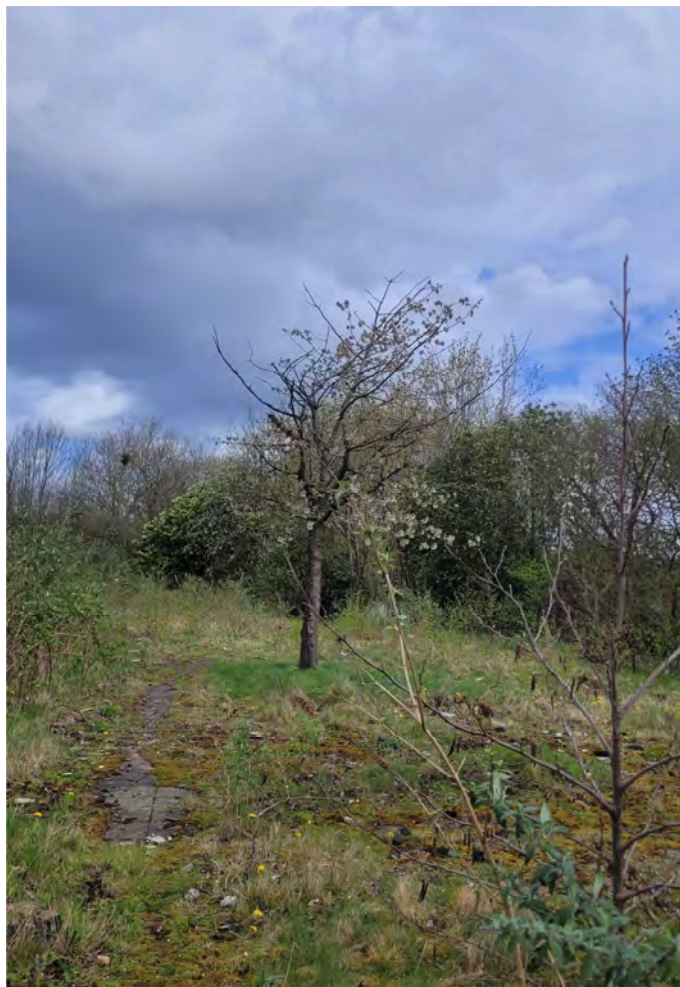
| Arboricultural Data Sheet: The Bandstand, 1077 Hyde Rd, Gorton, Manchester, M18 7LJ    Date of Survey: 07/04/24    Weather: Windy    Surveyor: PM | | | | | | | | | | | | | | | | |
|---|---|---|---|---|---|---|---|---|---|---|---|---|---|---|---|---|
| T13 | Cherry | 220 | 7 | EM | 2.5 | 4 | 4.5 | 3 | 1.8 | C | A poor specimen with major stem damage and dieback within the crown. | n/a | 5-10 | U | 21.90 | 2.64 |

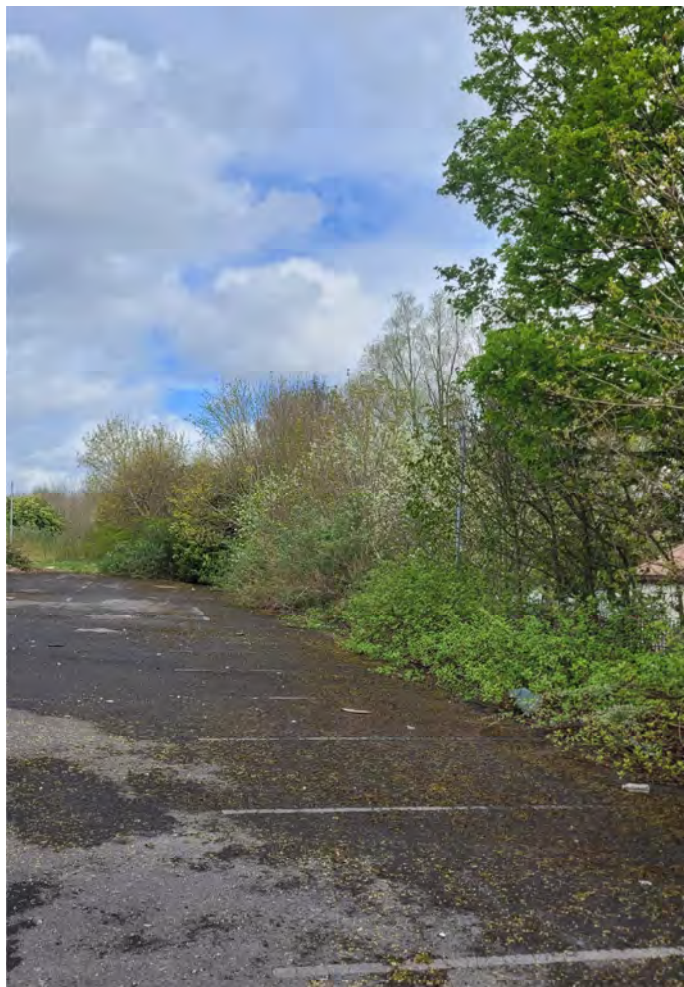
| Arboricultural Data Sheet: The Bandstand, 1077 Hyde Rd, Gorton, Manchester, M18 7LJ    Date of Survey: 07/04/24    Weather: Windy    Surveyor: PM | | | | | | | | | | | | | | | | |
|---|---|---|---|---|---|---|---|---|---|---|---|---|---|---|---|---|
| T12 | Whitebeam | 190 | 6 | EM | 3 | 3 | 3 | 3 | 1.8 | B | Exhibits good form with reasonable vigour. Stem damage present. | n/a | 10+ | C1 | 16.33 | 2.28 |

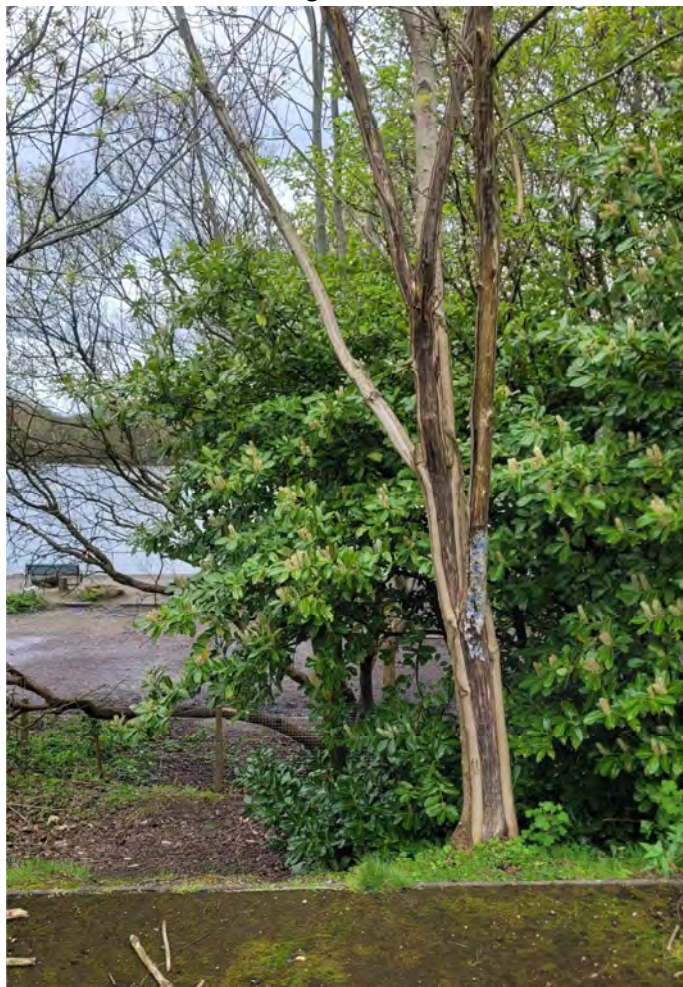
| Tree No. | Species | Dbh (mm) | Height (m) | Age | Crown Spread | | | | Crown C | Cond R | Observations and Comments | Preliminary Recommendations | ERC (Yrs) | TQC R | RPA (m²) | RPA Circle Radius (m) |
|---|---|---|---|---|---|---|---|---|---|---|---|---|---|---|---|---|
| G4 | Group - Norway Maple, Whitebeam, Ash & Laurel | 400 | <14 | Y-EM | 4 | 4 | 4 | 4 | 1 | B/C | A scattered group on bank area. Several of the Norway Maple have suffered stem damage most likely due to fire. The Ash present show some signs of Ash Dieback. | n/a | 10+ | C2 | 72.38 | 4.80 |

Stem damage within G4

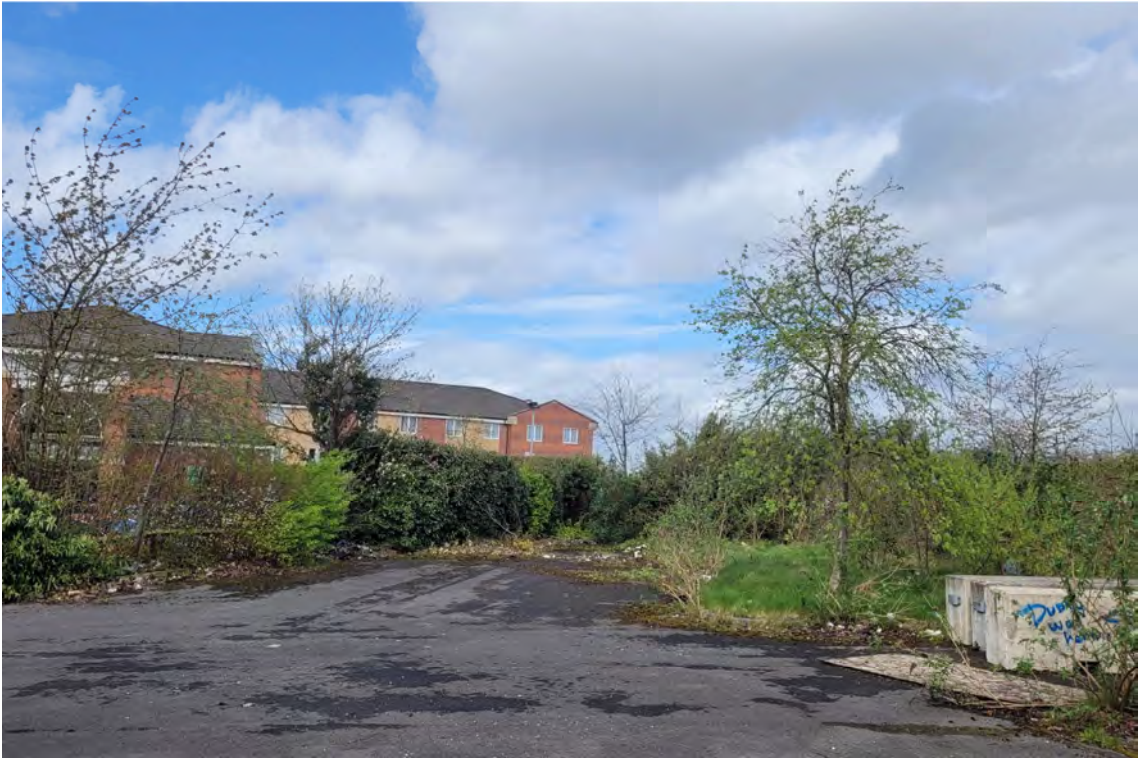
| Arboricultural Data Sheet: The Bandstand, 1077 Hyde Rd, Gorton, Manchester, M18 7LJ    Date of Survey: 07/04/24    Weather: Windy    Surveyor: PM | | | | | | | | | | | | | | | | |
|---|---|---|---|---|---|---|---|---|---|---|---|---|---|---|---|---|
| T7 | Whitebeam | 160 | 6 | SM | 4 | 4 | 4 | 4 | 1.8 | B | Located within shrub area swamped in Ivy. No view of base or stem. | Sever Ivy at base to 1m. | 10+ | C2 | 11.58 | 1.92 |
| T8 | Rowan | 150 | 6 | SM | 3.5 | 2.5 | 2.5 | 2.5 | 1.5 | B | Located within grass area with reasonable vigour. Minor stem damage. | n/a | 10+ | C1 | 10.18 | 1.80 |
