# Trees and Construction

## BS5837:2012 Tree Survey, Arboricultural Impact Assessment & Method Statement

**Site:** Dalton Ellis Hall External Lighting  
(University of Manchester)

**Ref:** 13986.23 / A2\_AIA\_Rev.B

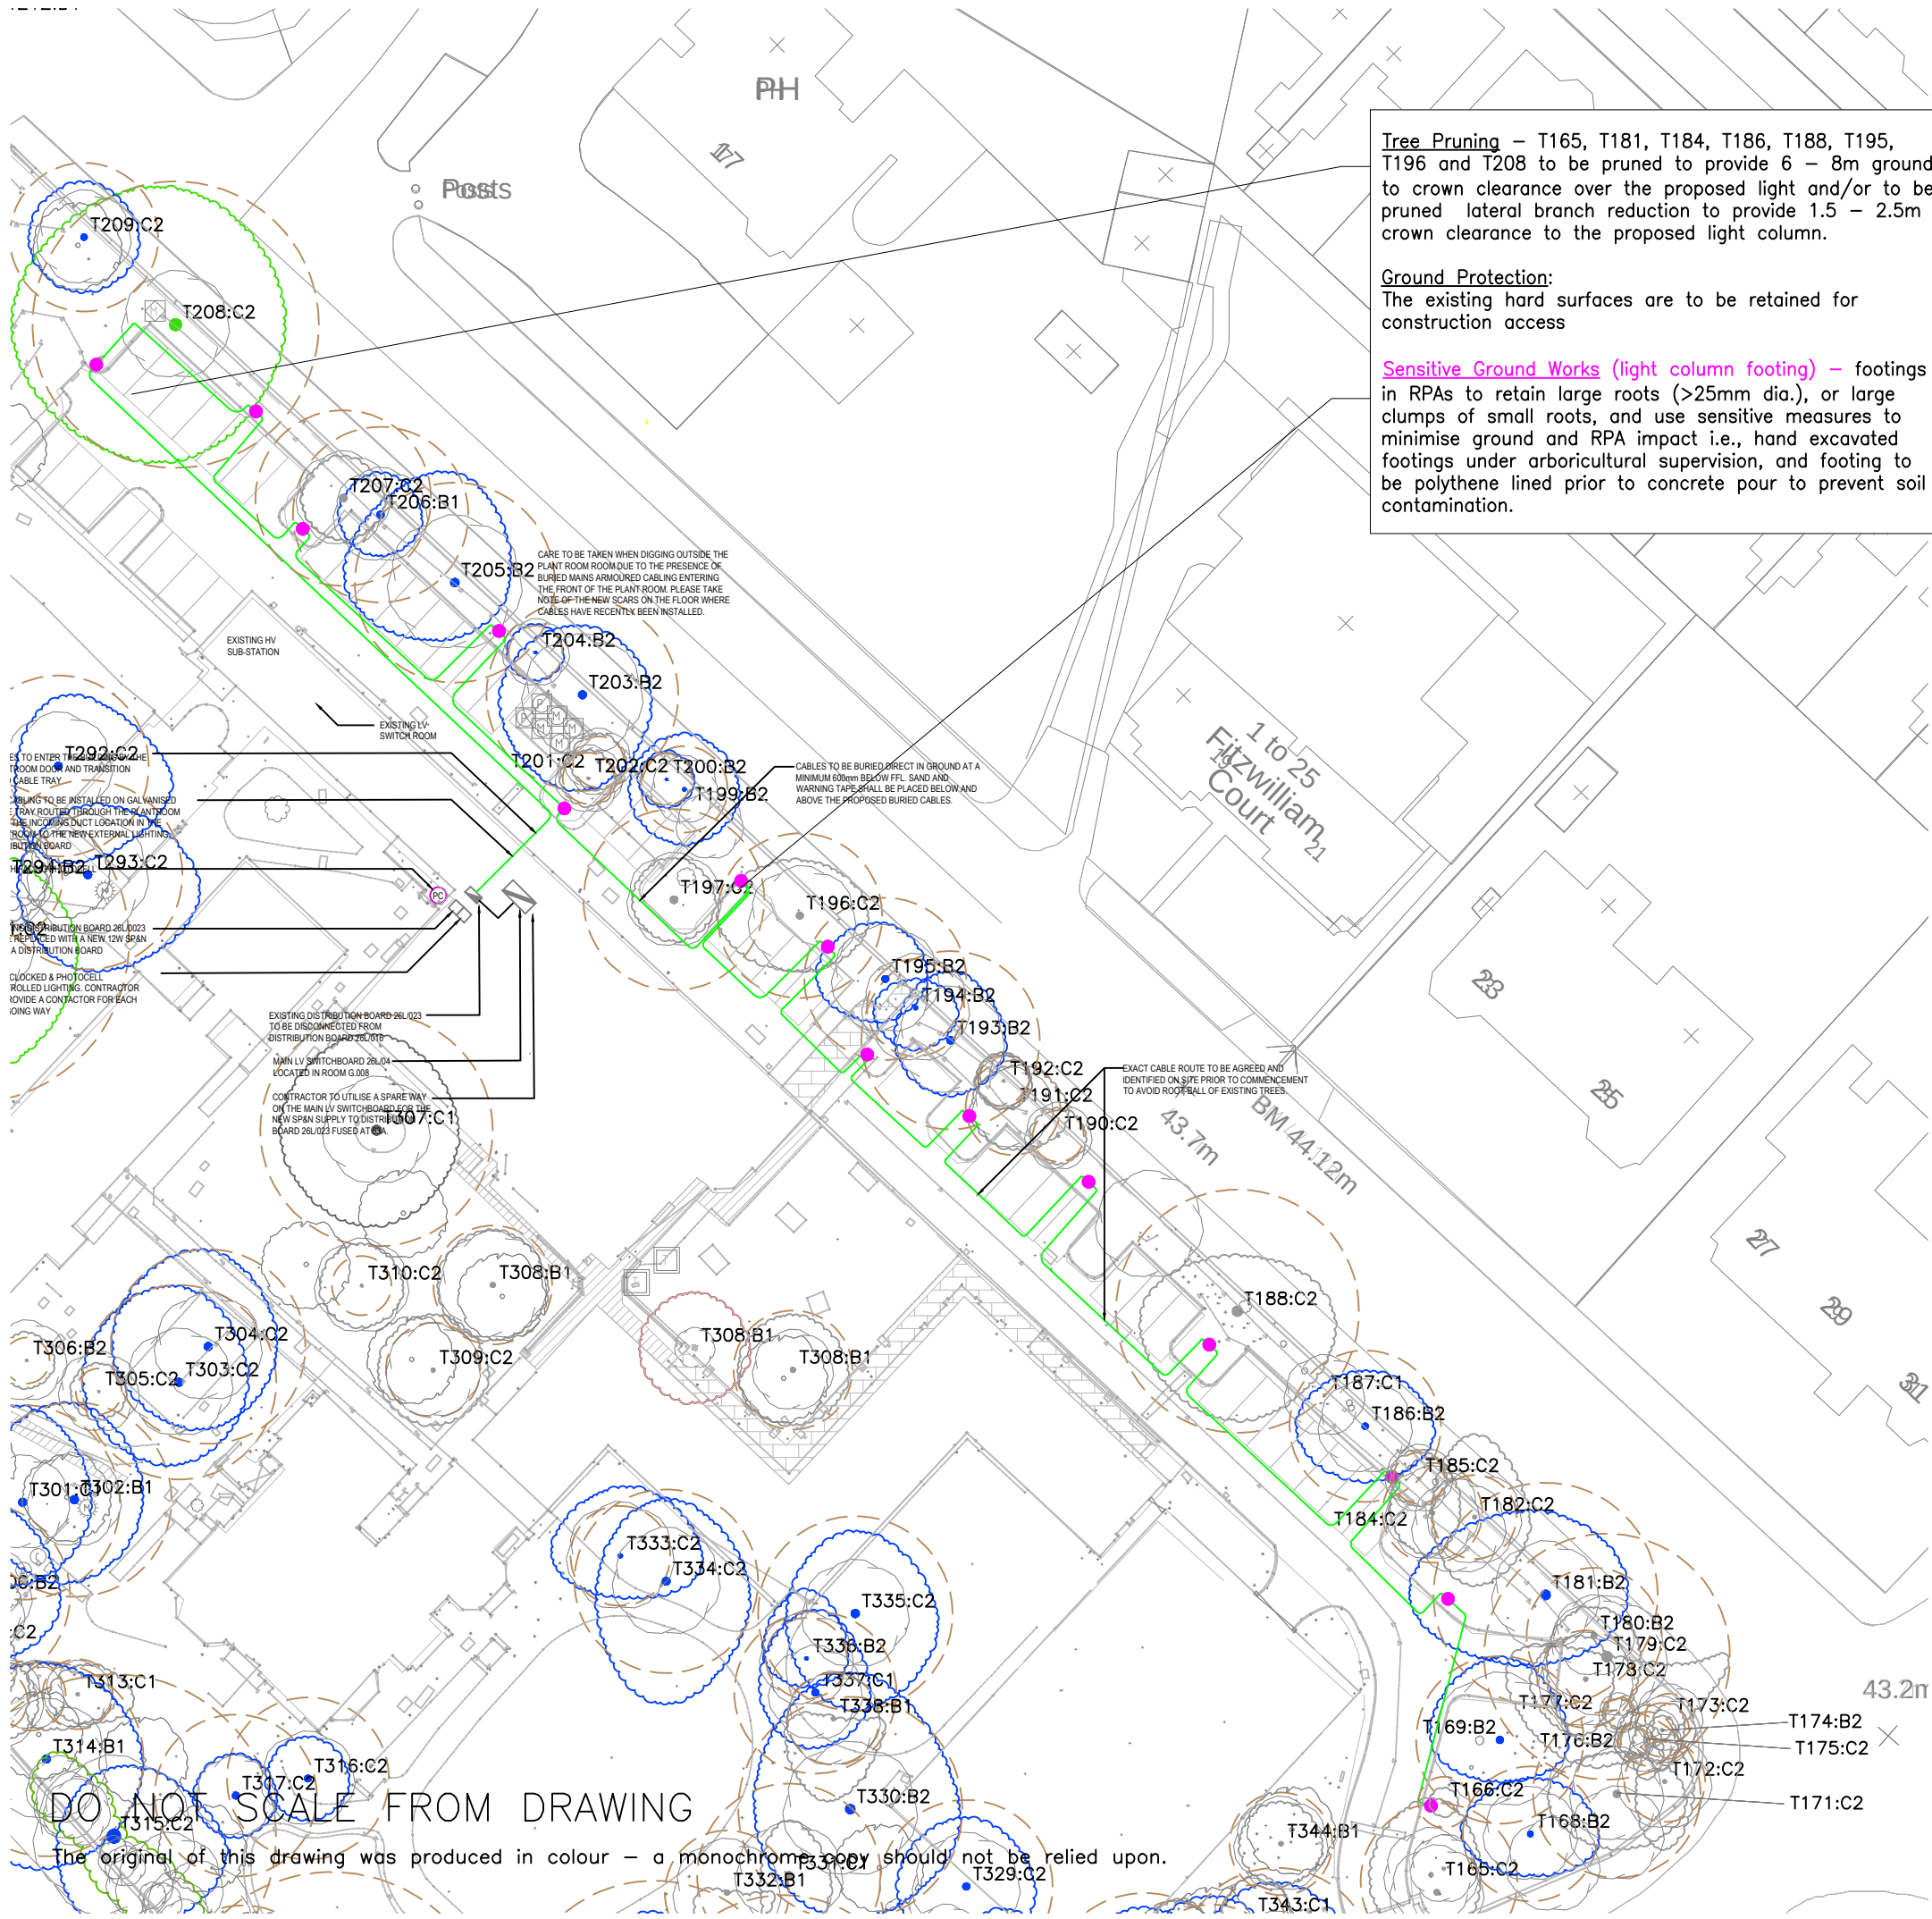
- 3.2 The proposed new lighting columns encroach the crown of the T165, T181, T184, T186, T188, T195, T196 and T208. These will need to be pruned to provide suitable ground to crown clearance and lateral clearance i.e. 6-8m ground to crown clearance and 1.5-2m lateral clearance to the proposed columns. For T165, T181, T184, T186, T195, T196 and T208, the pruning required is minor to achieve the suitable ground to crown clearance or at the outer extents of the crown.

- 3.3 The proposed new lighting column footings encroach the RPAs of T181, T184, T185, T186, T188, T193, T196, T197, T202, T205, T207 and T208. This will require sensitive ground works to minimise the ground and RPA impact i.e. manual excavations under arboricultural supervision, retain large roots (>25mm diameter roots) and large clumps of smaller roots and footing to be polythene lined to prevent soil contamination.

**Tree Pruning** – T165, T181, T184, T186, T188, T195, T196 and T208 to be pruned to provide 6 – 8m ground to crown clearance over the proposed light and/or to be pruned lateral branch reduction to provide 1.5 – 2.5m crown clearance to the proposed light column.

**Ground Protection:**  
The existing hard surfaces are to be retained for construction access
