# ARBORICULTURAL IMPACT ASSESSMENT

12<sup>th</sup> September 2024

The Wells Centre  
101 North Rd Clayton  
Manchester  
M11 4NE

The development of Air Source Heat Pump  
And Solar Panelling

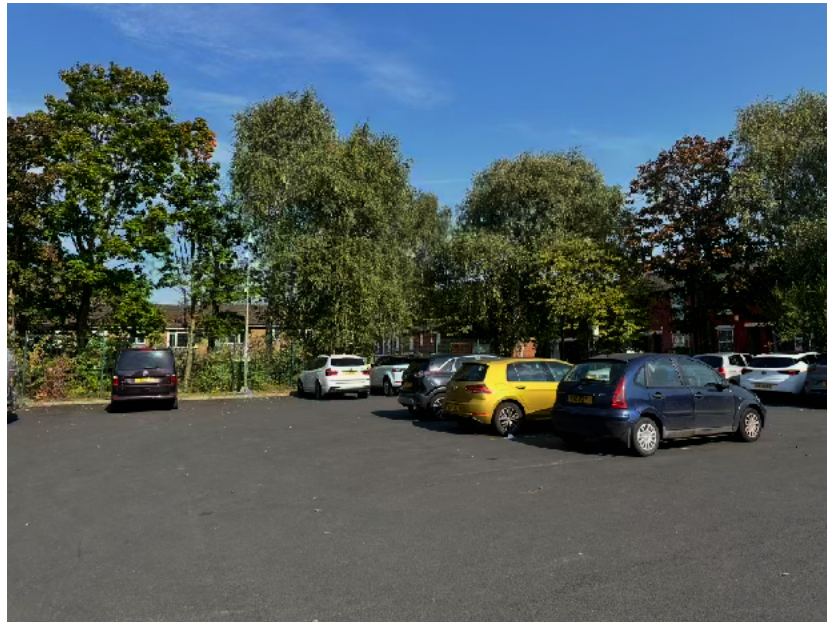
- 5.6.1 The impact on trees by the proposal for an ASHP has been considered particularly in allowing for future growth. Tree size, future growth, light/shading, leaf and fruit nuisance etc have the potential to be an issue. This applies to all trees where there is potential for indirect impact on by the proposed development.
- 5.6.2 W1 is located on the opposite side to the northern half of the car park and its entrance. This area should be utilised for the storage of building materials and site facilities. Dead tree seen left of the CCTV.

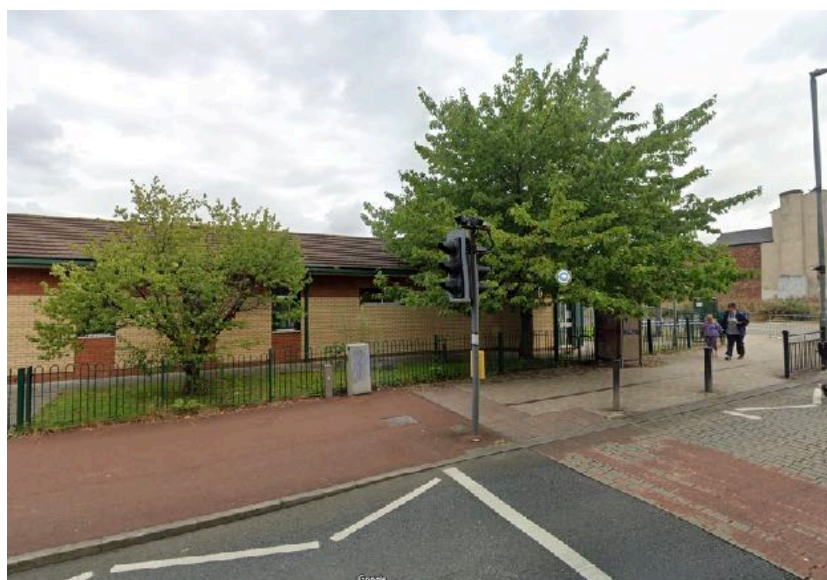
- 5.6.3 T4 cherry (*Prunus padus*) can be seen lining the southern boundary with its large spreading canopy encroaching onto the building and public highway. This will partially shade the proposed solar paneling, therefore a pollarding management plan is recommended.

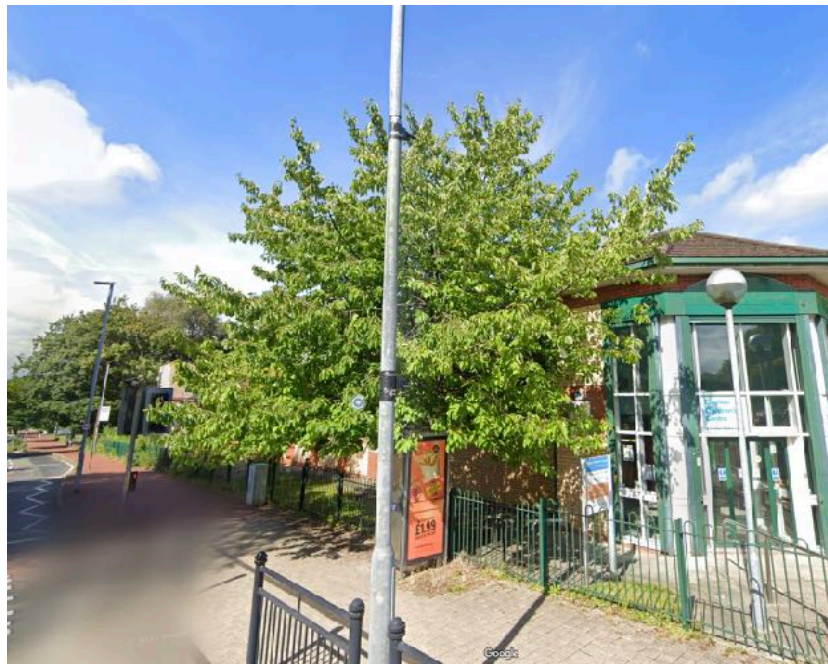
5.6.4 Trees are located in an access area which fall near to the RPA's and canopies of these trees.

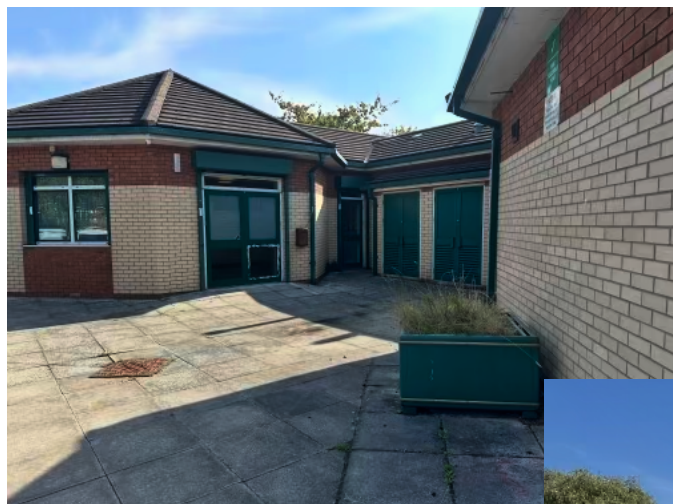
Left is looking at the location of the ASHP.

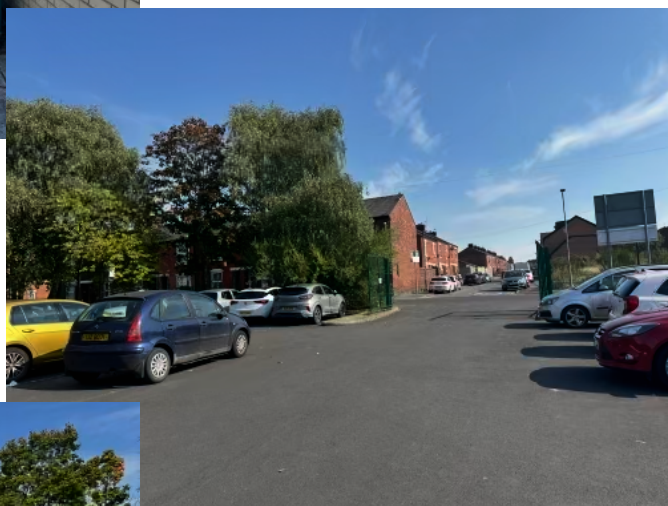
Bottom left is an area potential used for storage

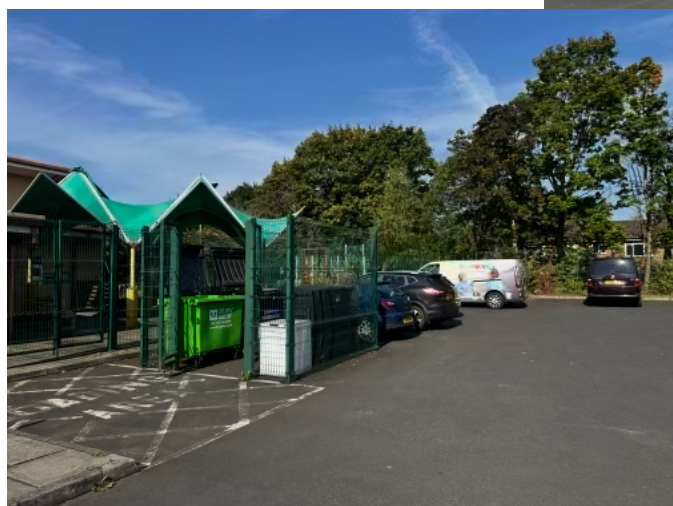
Below right is the entrance to the rear of the grounds, looking east.
