# Royal London House, 196 Deansgate

Schedule of Works & Method Statement - Level 5, Attic & Roof

July 2024

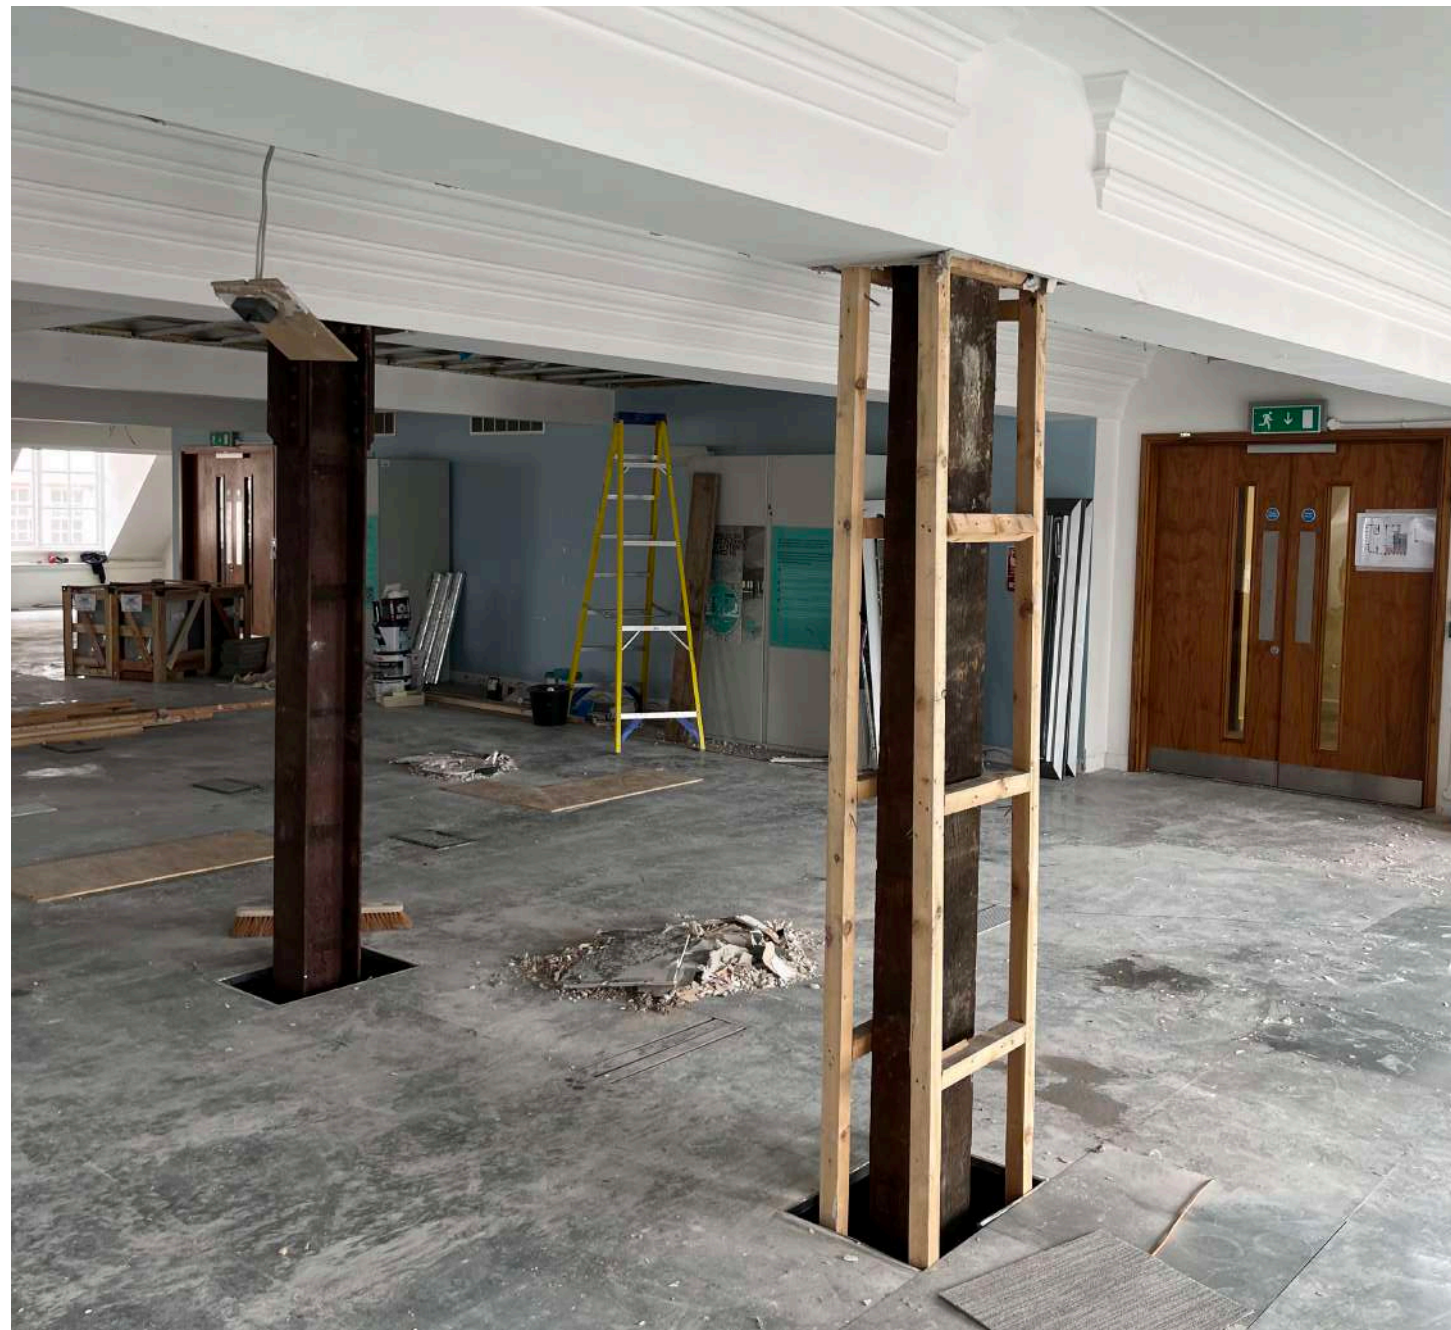
Timber column exposed following removal of non-original plasterboard lining.

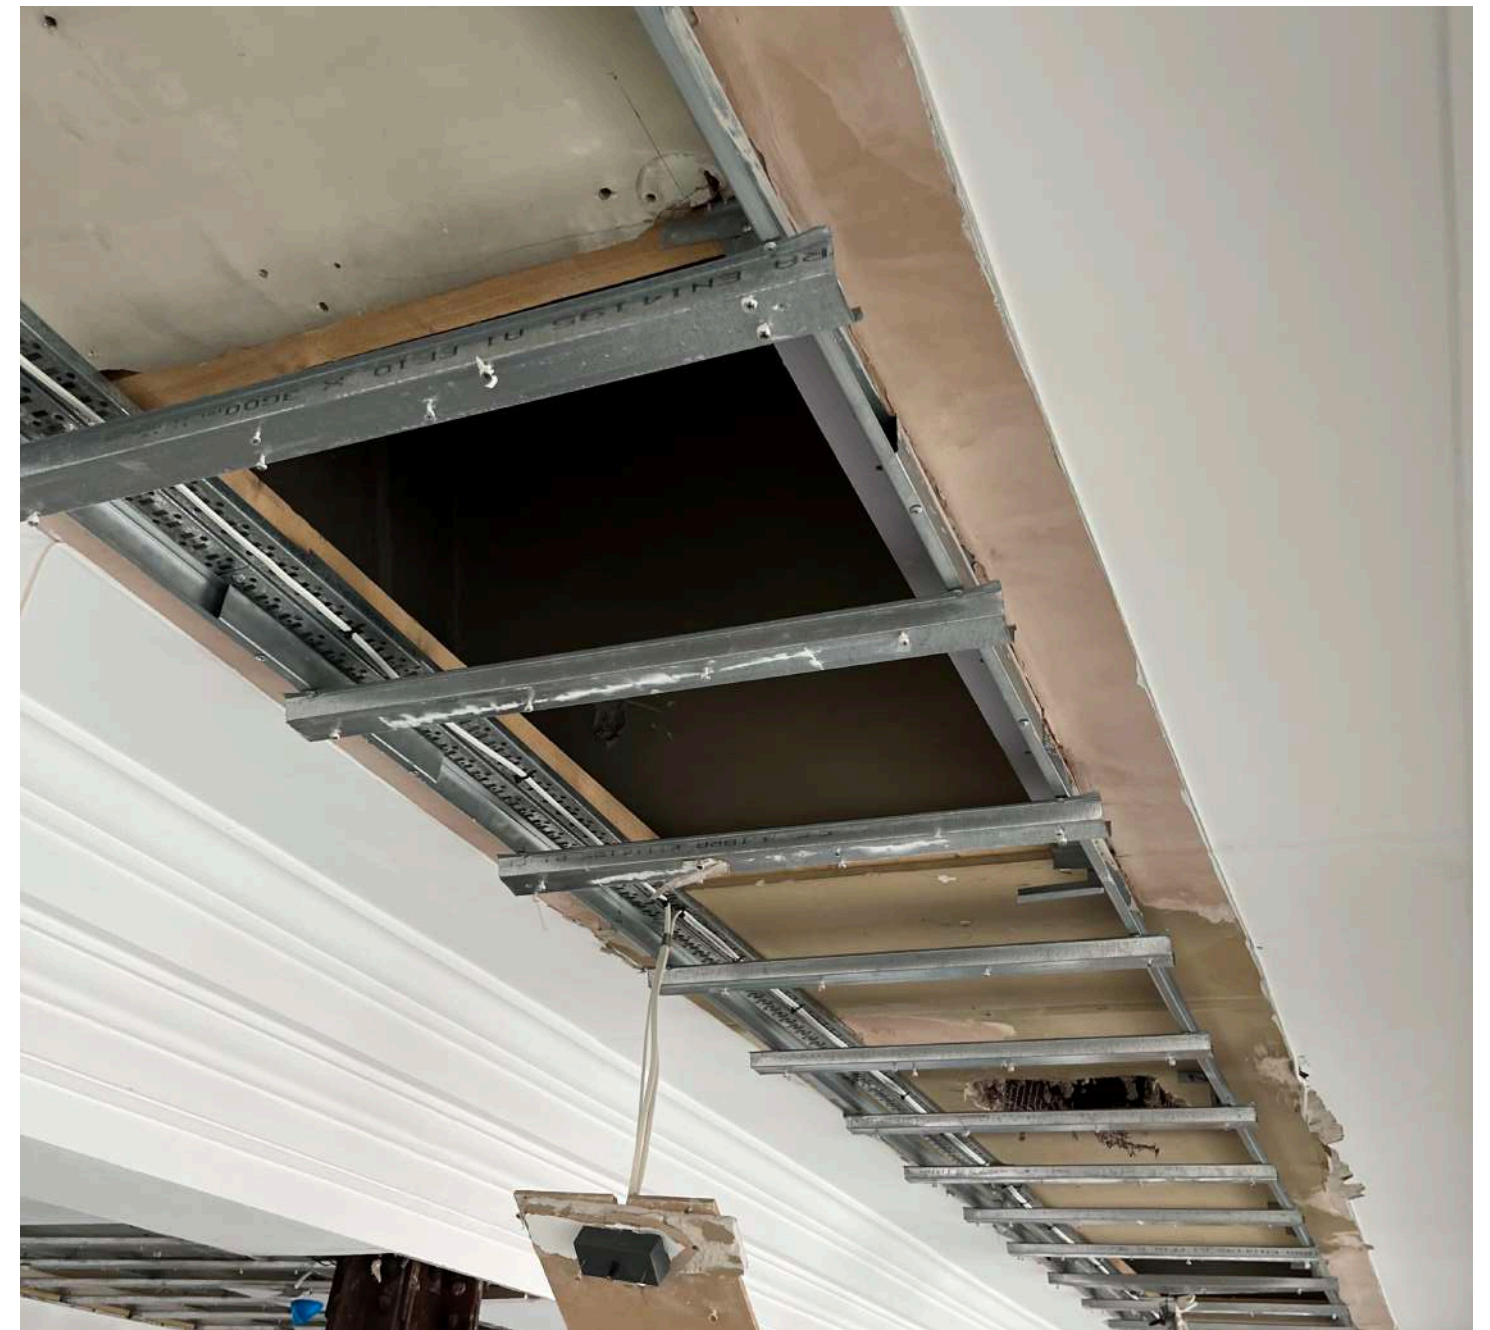
Interior of lightshafts identified within the attic following removal of the non-original drop ceiling

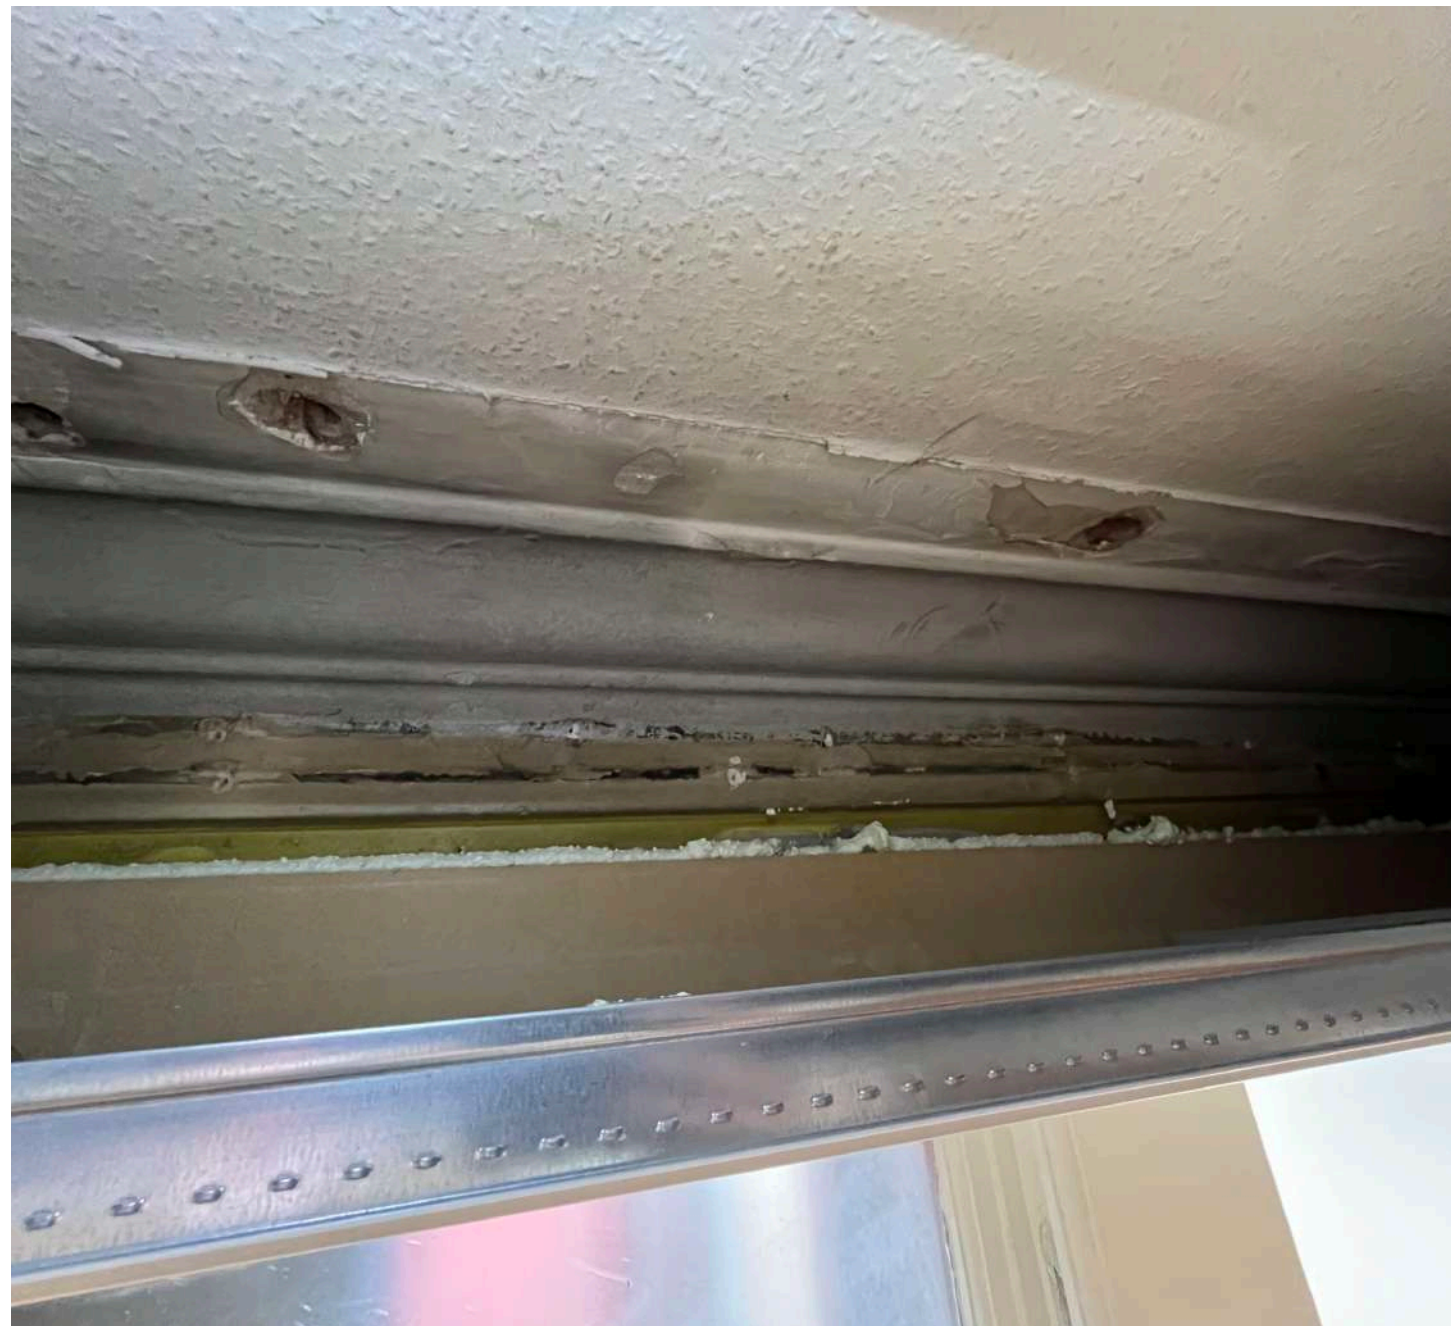
Original un restored cornicing above suspended ceilings to WCs

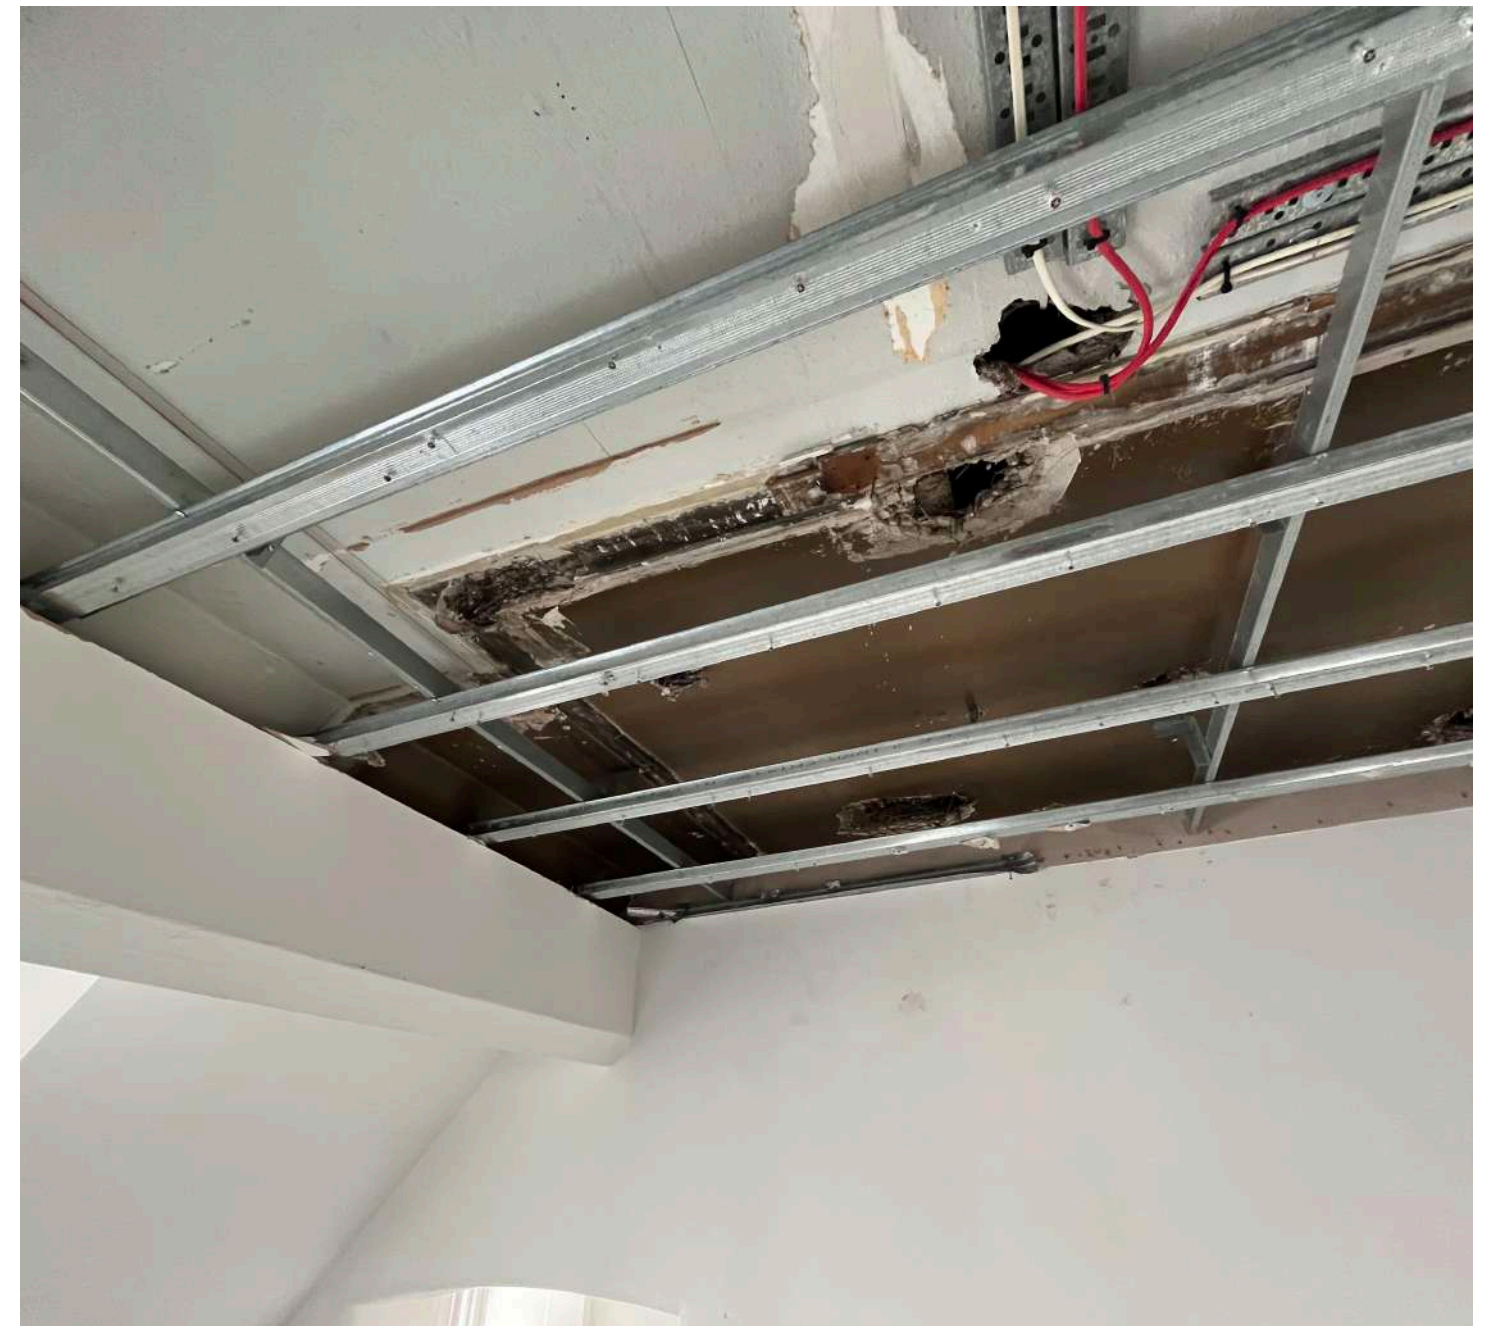
Evidence of earlier partition layout visible following removal of non-original drop ceiling

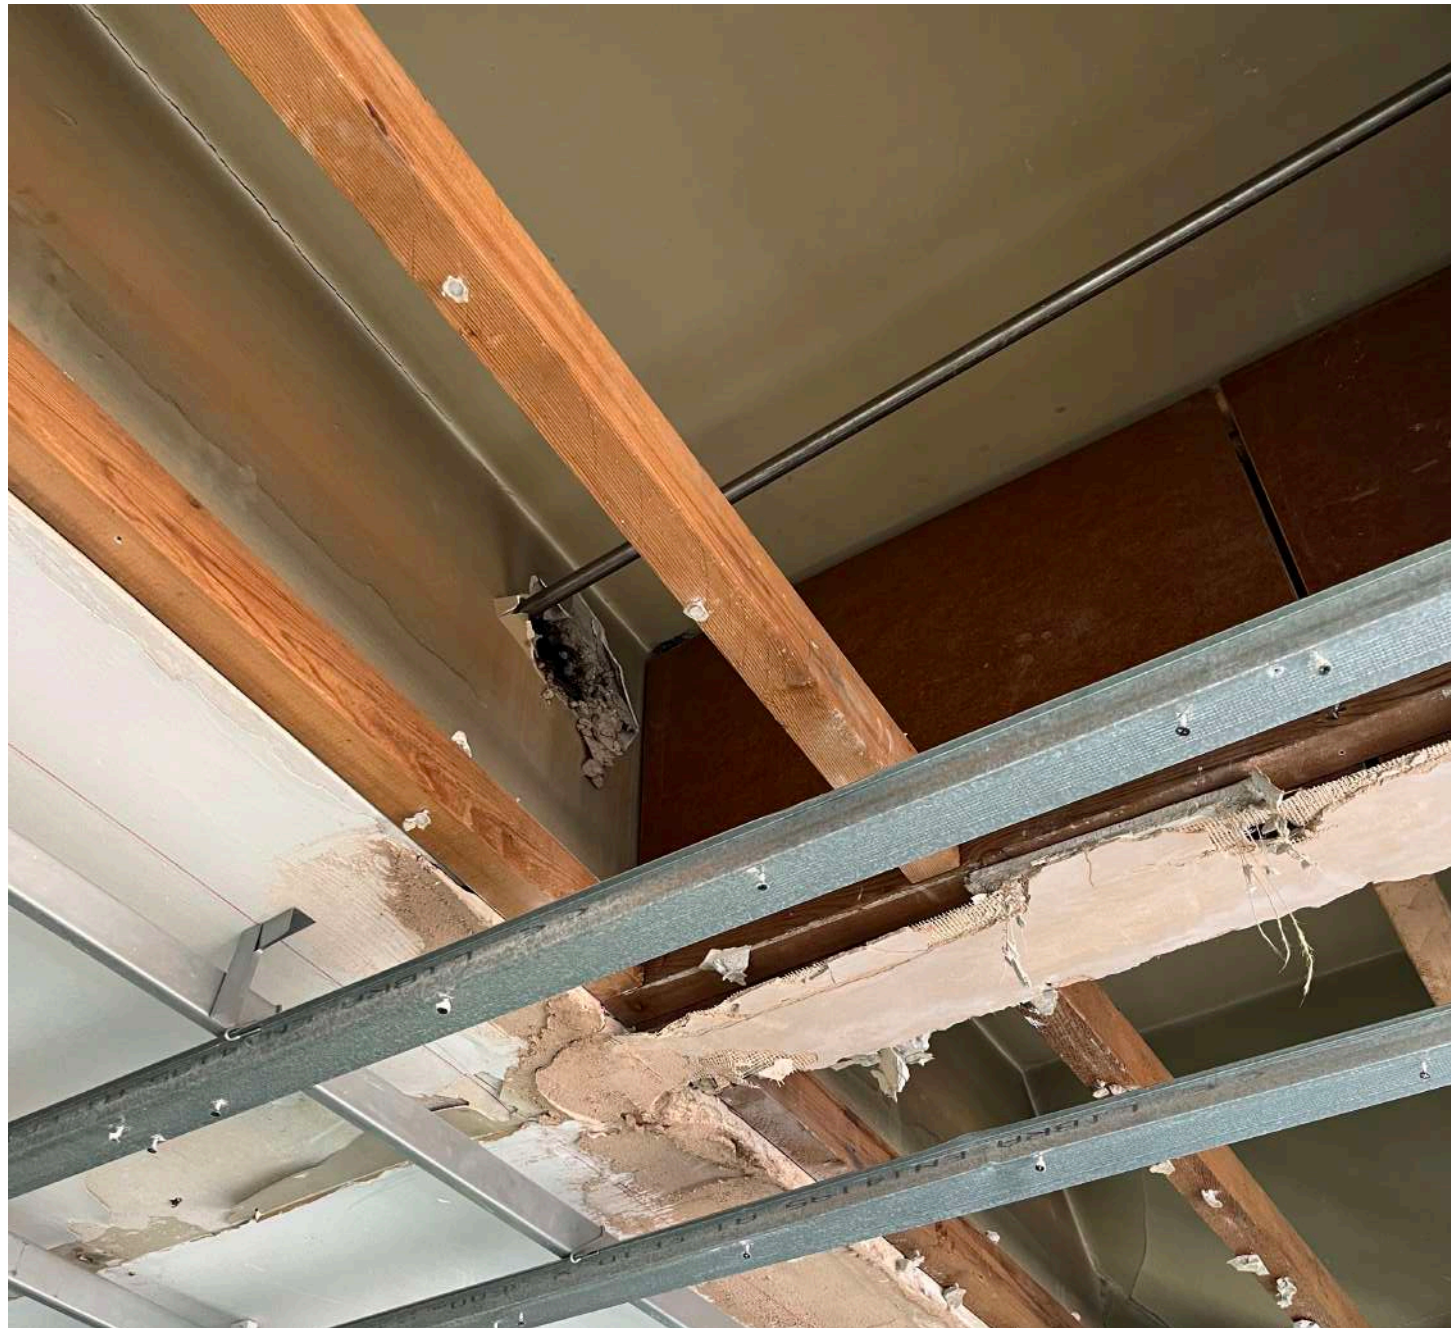
Raised area of ceiling to gable above window uncovered following removal of non original ceiling. Note retrofit stainless steel tie rod

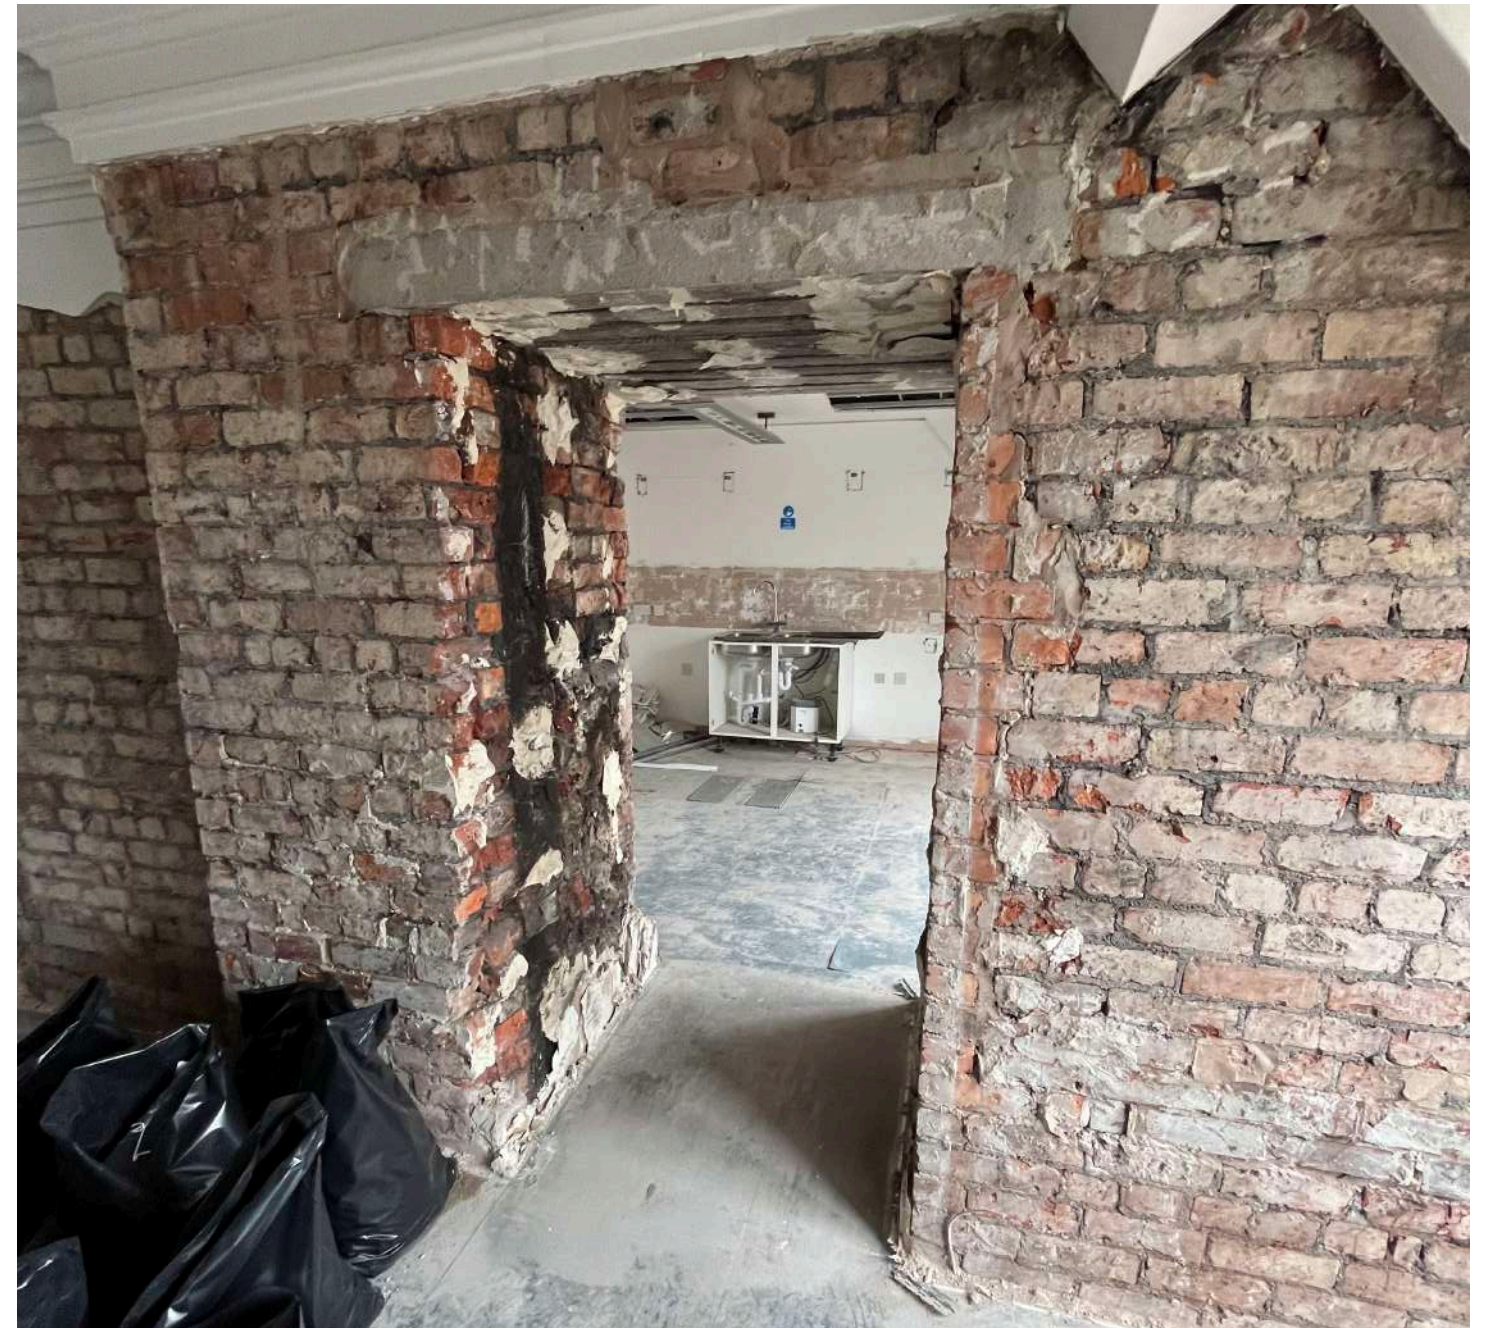
Structural intervention to chimney breast and former fire places uncovered following removal of non original plaster

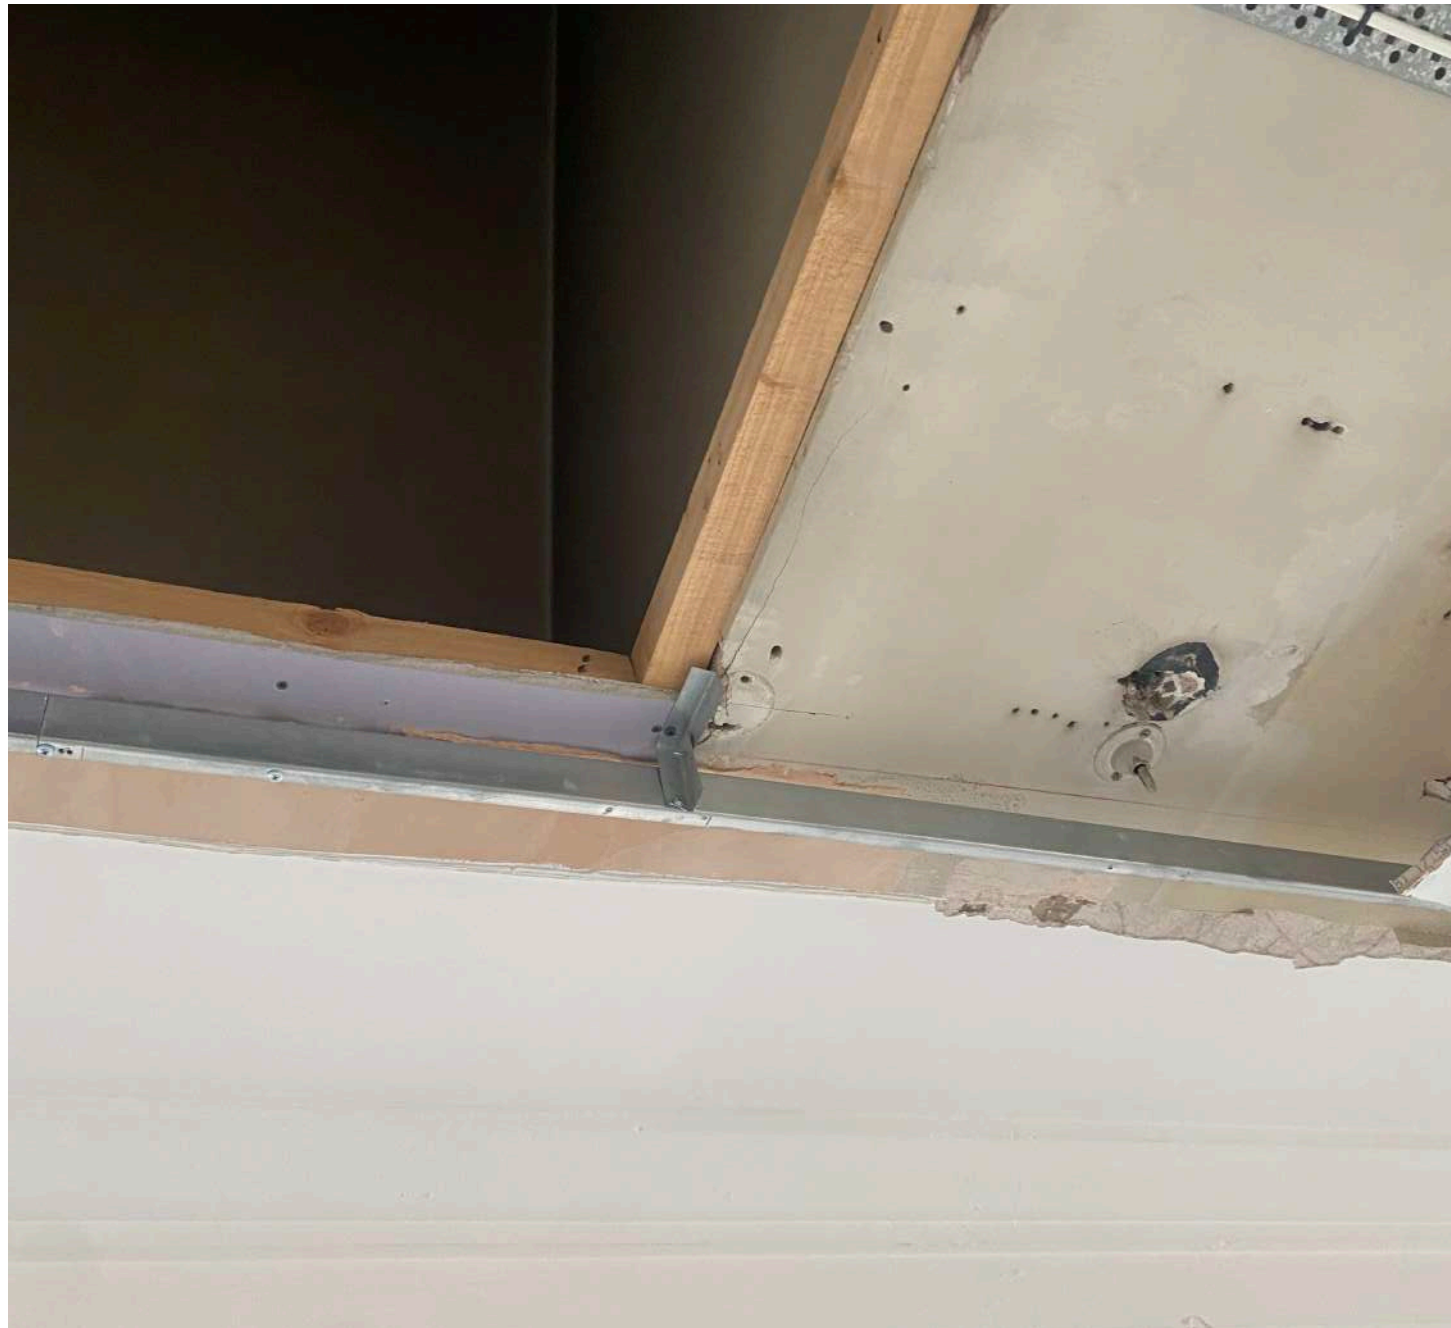
Partial infill and original plastered edge to original light shaft

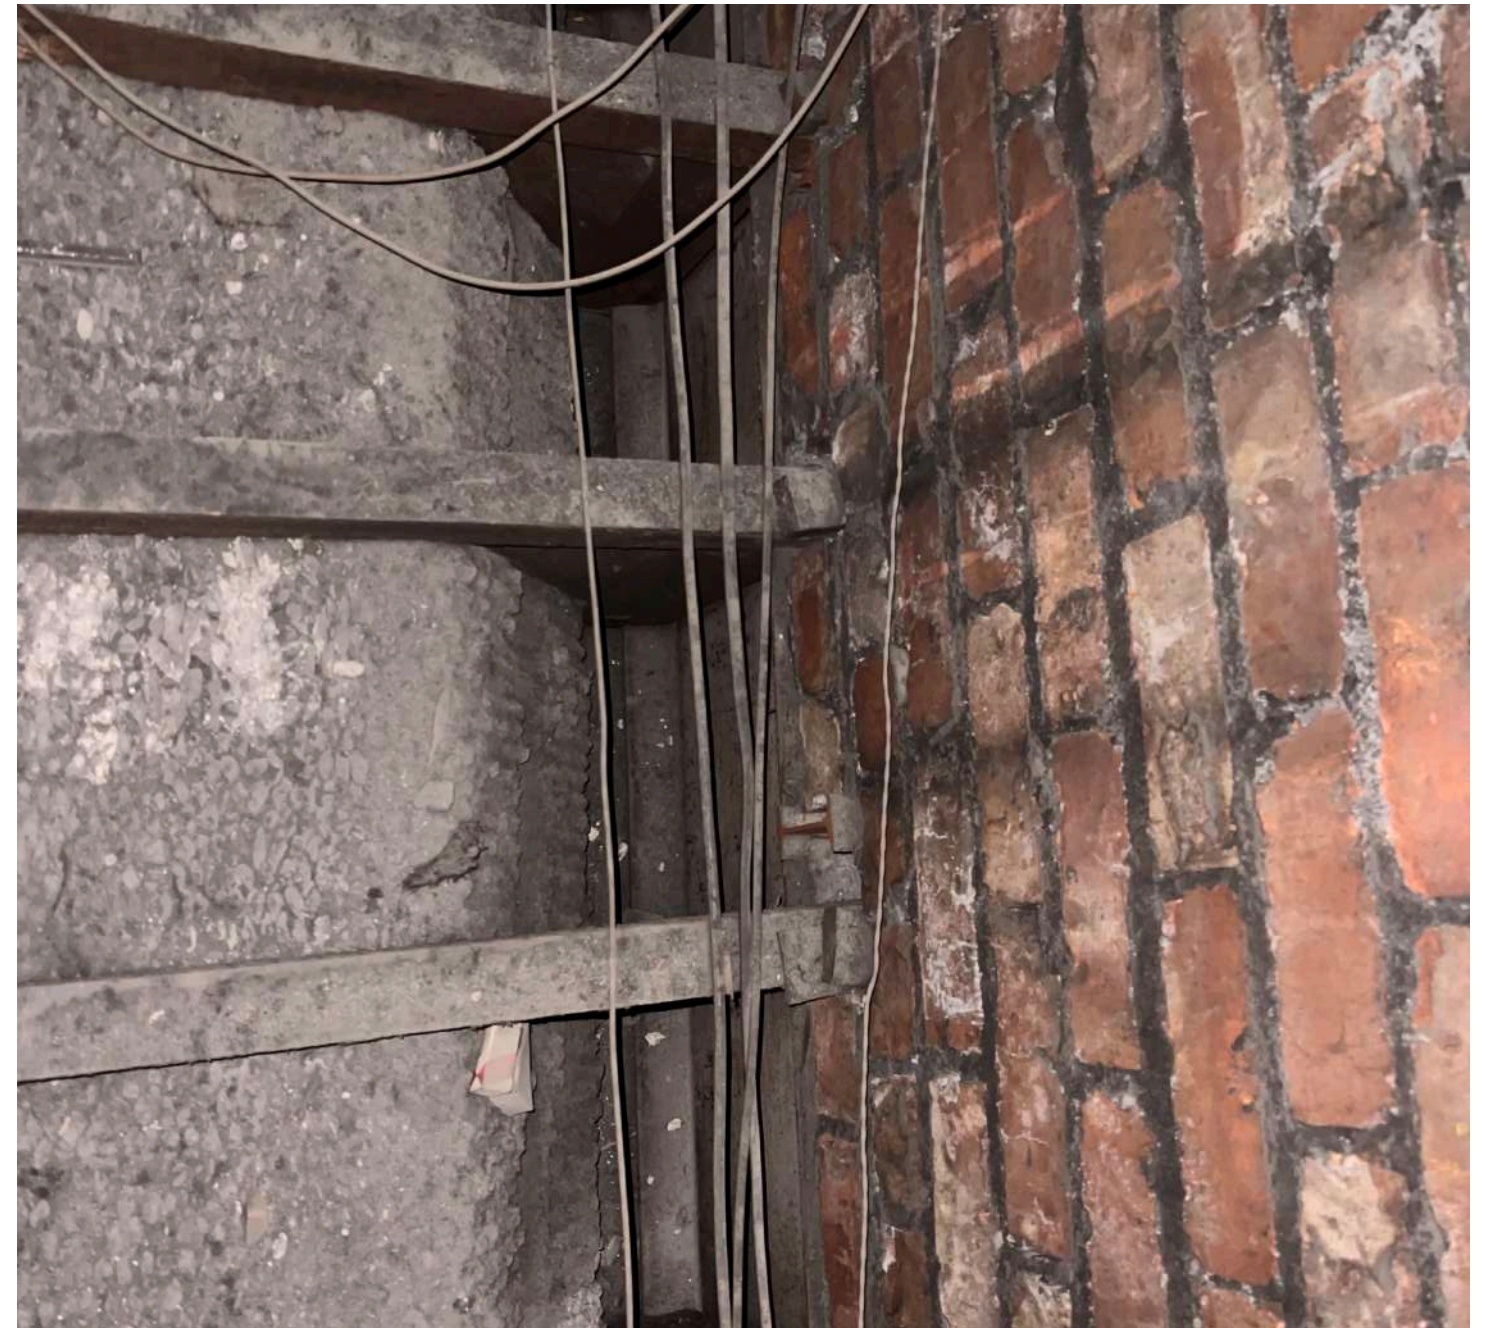
Upper side of beam and cornicing visible from within attic space

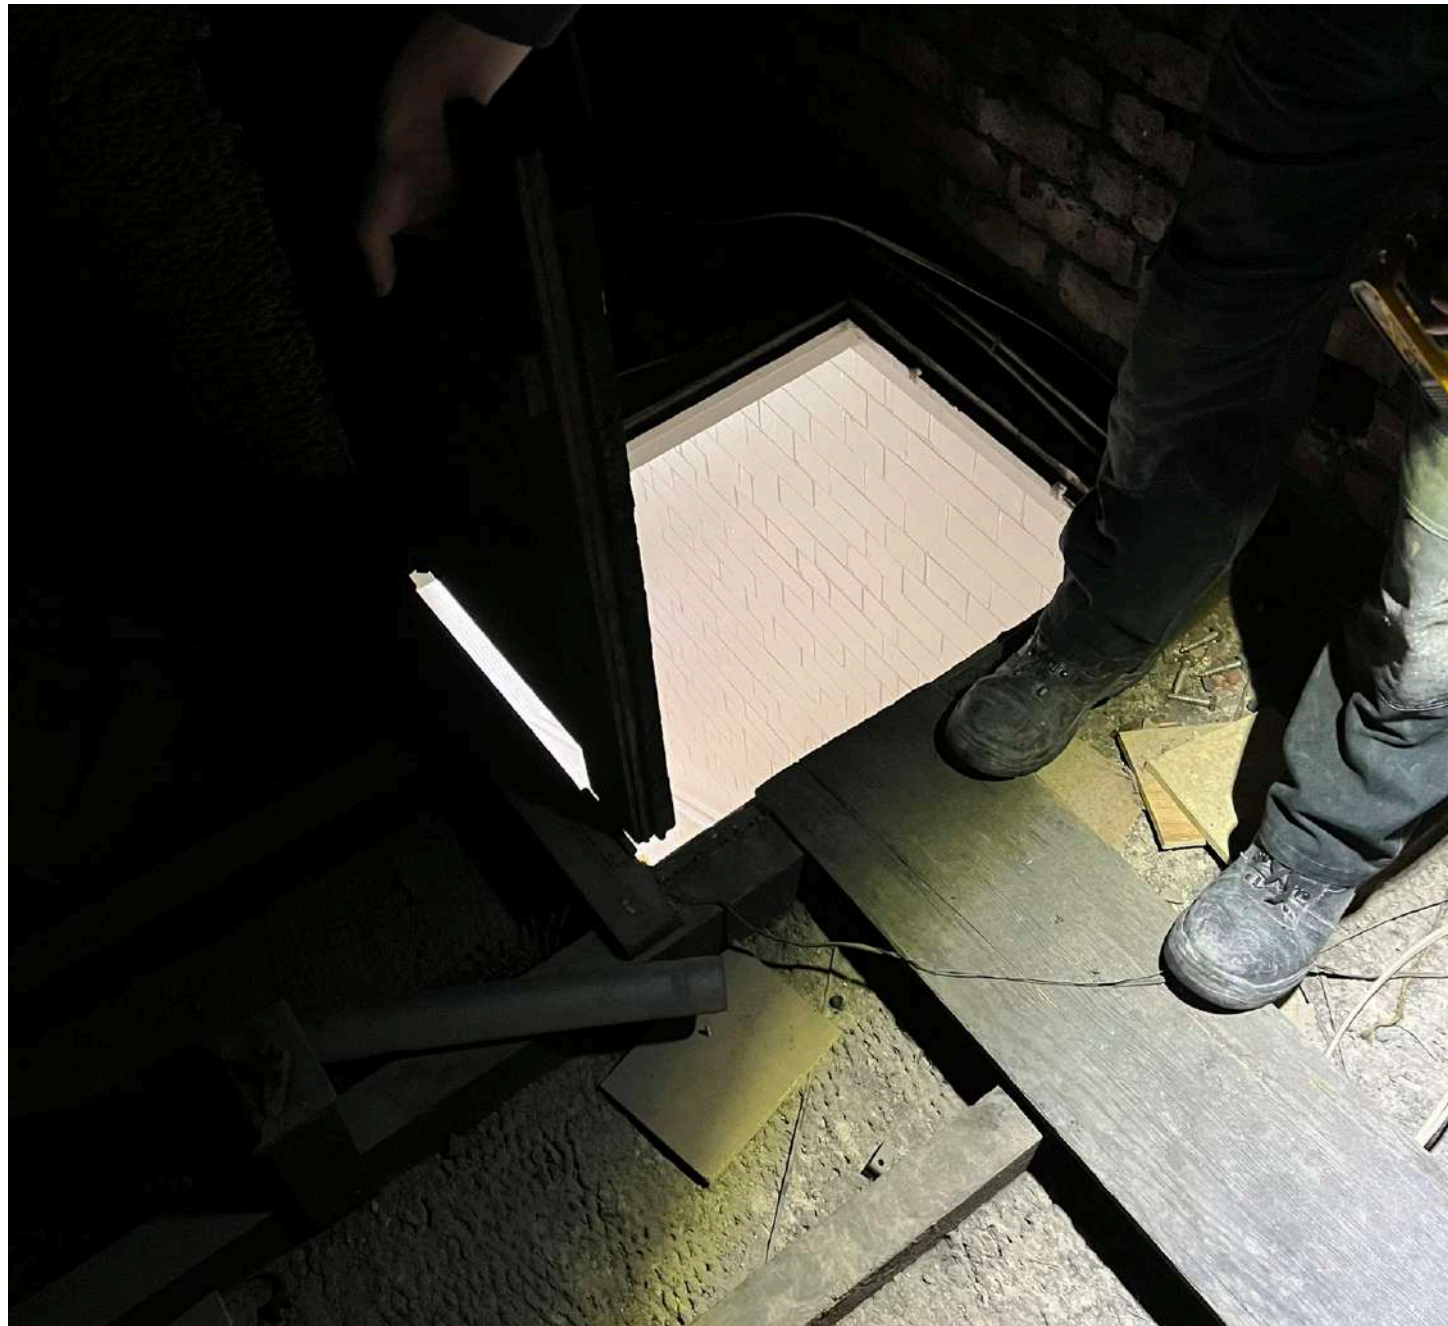
### 3.3.5 Non Rated access hatches

The loft hatches above stairs 1 and 3 are not sized for appropriate access and are not rated to a standard suitable for their escape stair locations.

The proposal is to retain the existing hatches insitu form a new ceiling below (see proposals) To maintain access new larger openings will be formed in the same vicinity at the head of the stairs to form new access/ escape points from the attic.

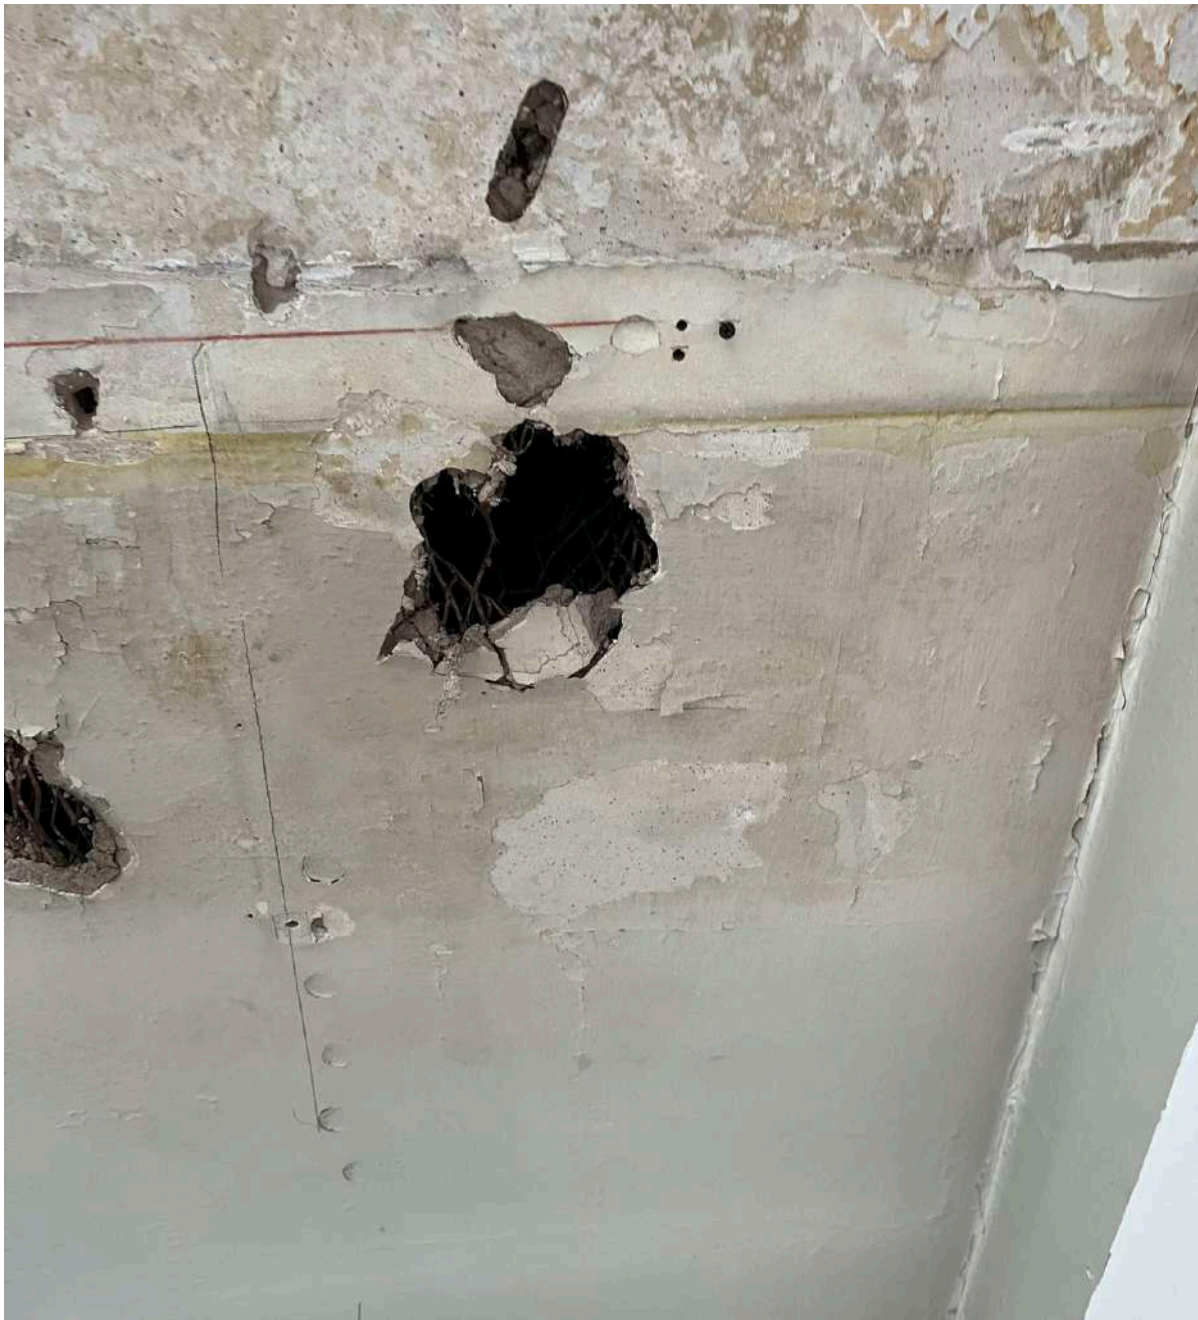
1. Missing metal substrate and missing plaster

lay in new expanded metal from above, tie in with with 1.2mm tying wire at 100mm centres. Tie by creating a 'hairpin' shape with the wire, insert from below then pull tight and twist. Take care that cut wire ends are not close to plaster surface.
