**ST****M** 24.06.24

FIRST FLOOR SOFFIT AND GRC COLUMN CLADDING

## **Contents**

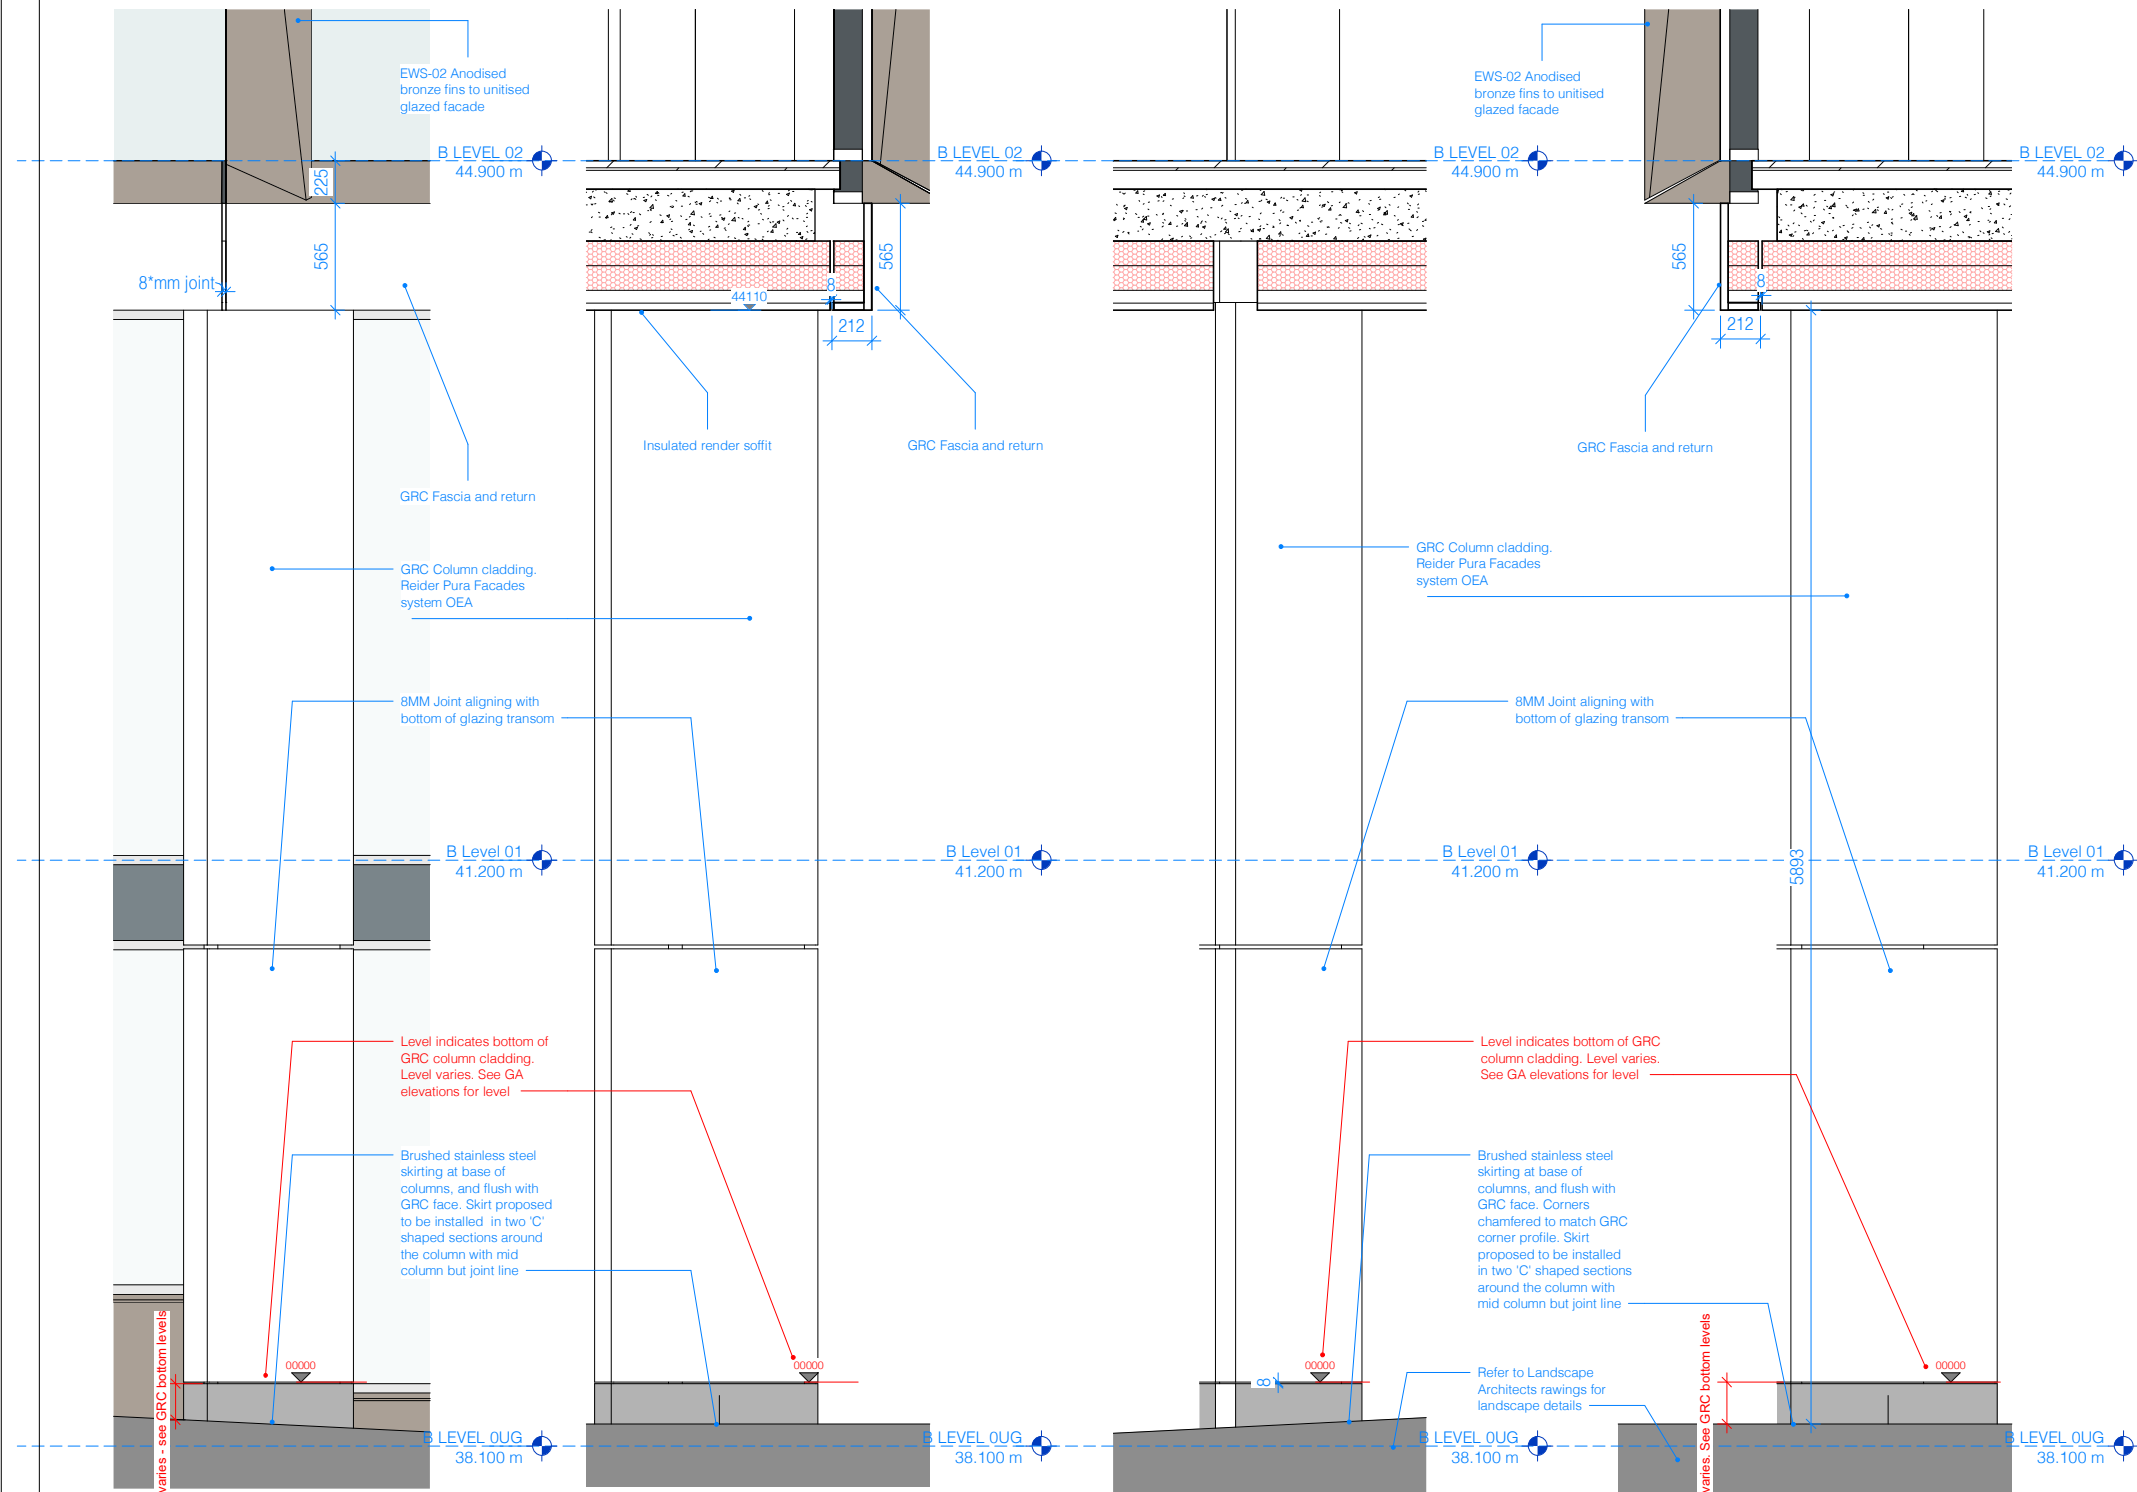
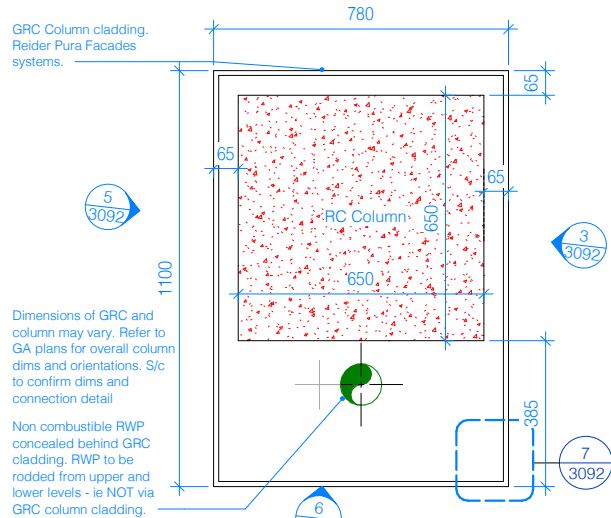
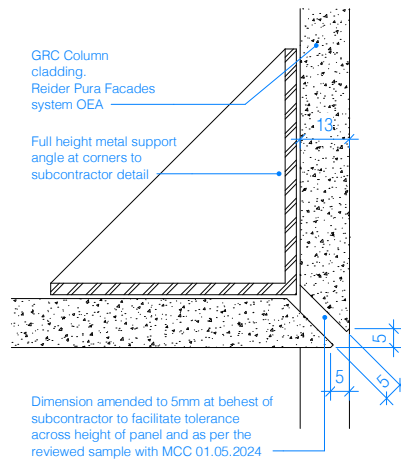
OVERALL LENGTH IS LONGER THAN  
PROPOSED BUT ACCEPTED ON  
BASIS THAT THE FRONT EDGE  
REMAINS ALIGNED WITH JUNCTION  
WITH SOFFIT.

ANGLED BRACKET AT ALL 4 NO.  
CORNERS EXTENDS FULL HEIGHT  
AND A HORIZONTAL COVER PLATE AT  
THE CORNER TO MITIGATE VIEW S  
INTO THE SYSTEM

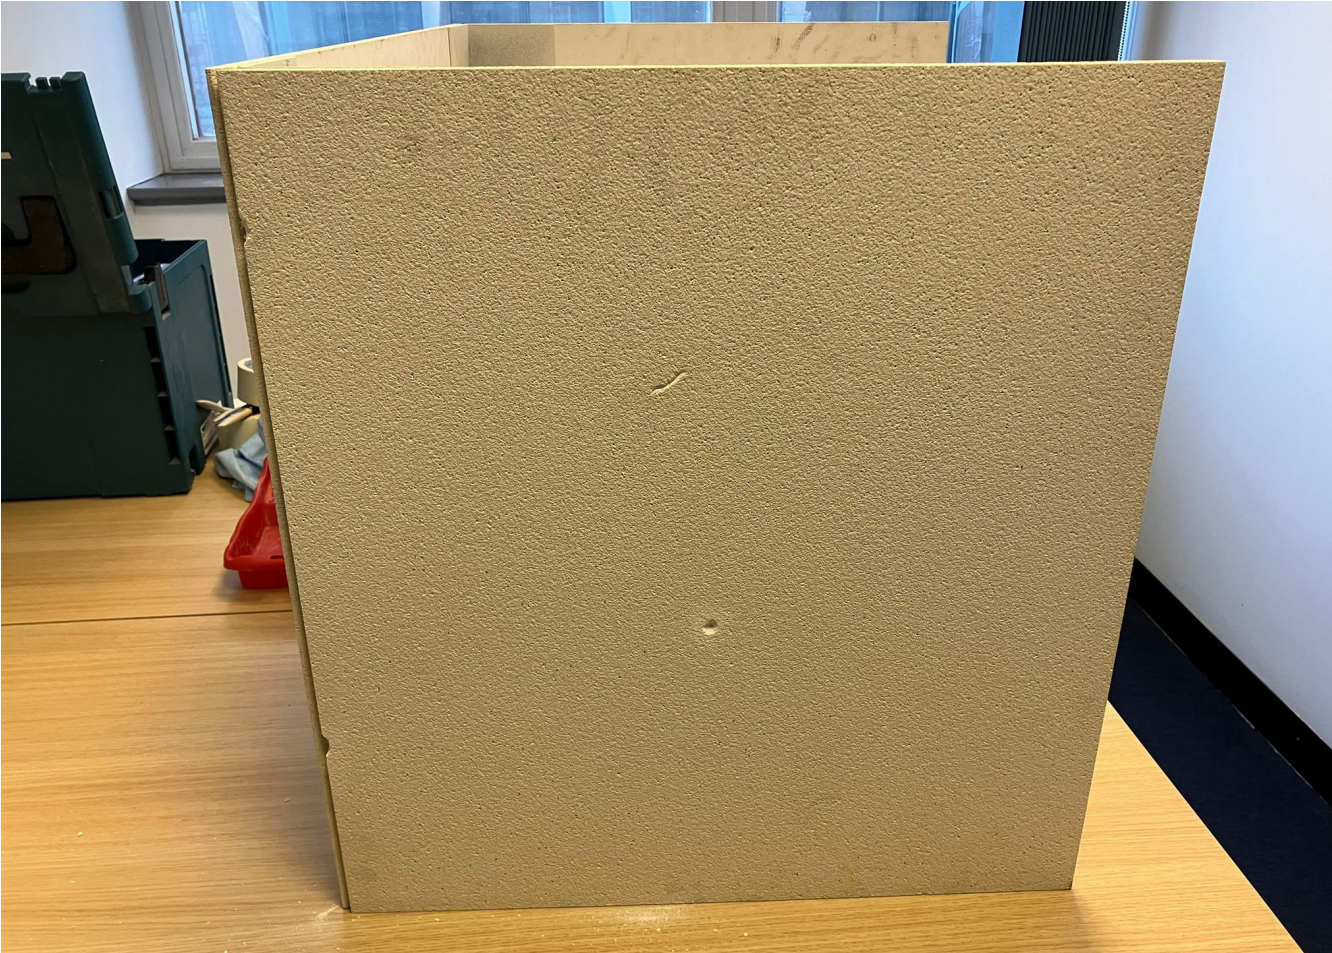
GRC sample damaged

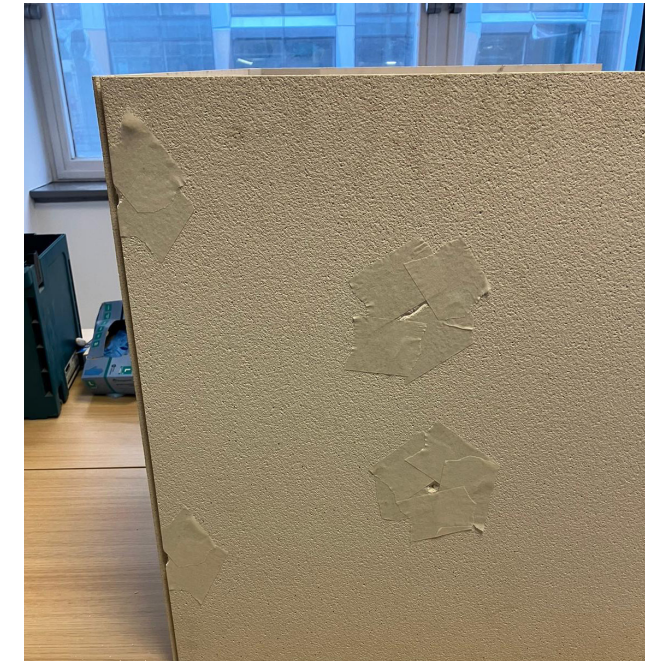
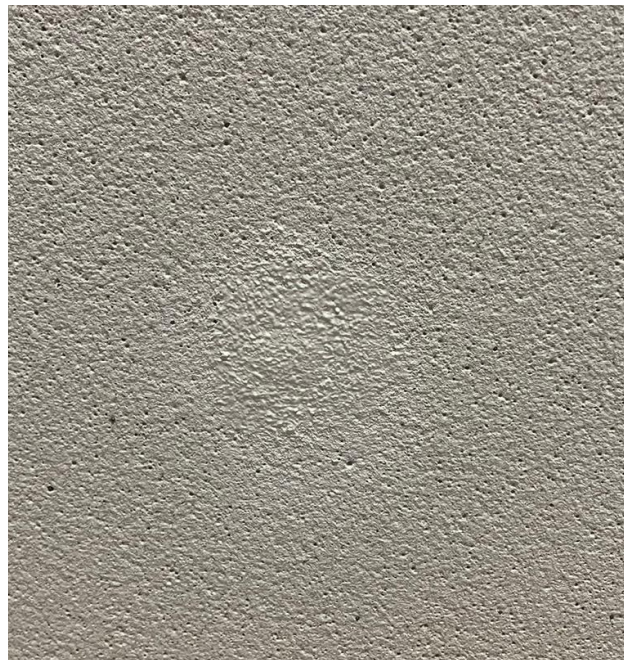
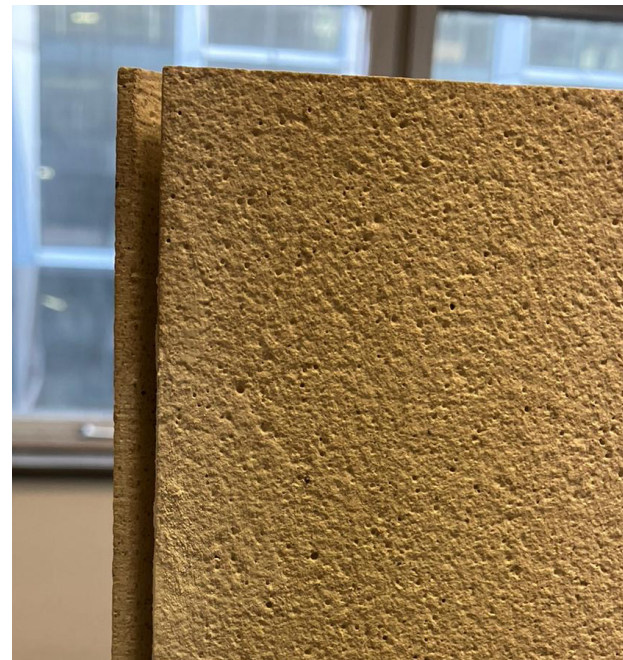
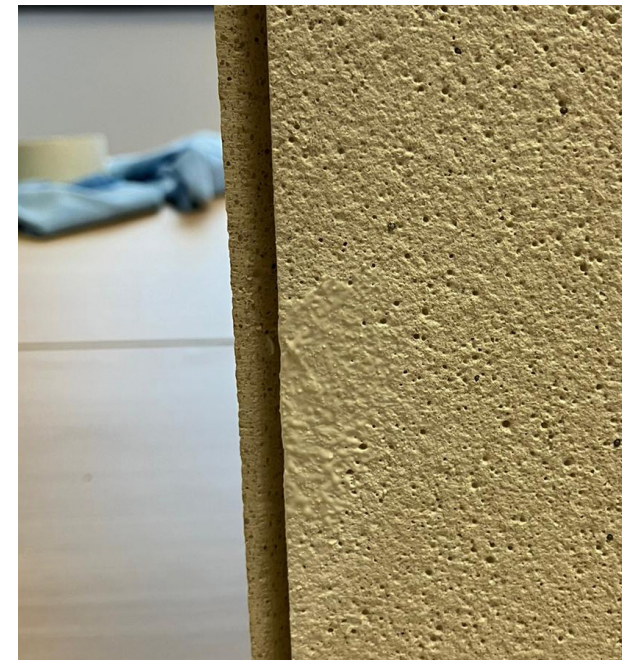
image 4 (mid repair)

image 1 (repair)

image 2 (repair)

image 3 (repair)

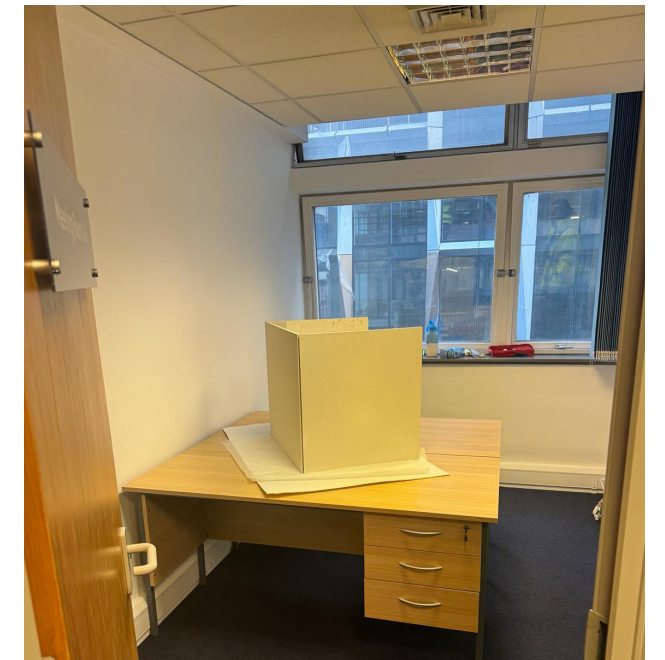
repaired sample when viewed from 5m

Sample panel reviewed internally and externally by MCC.

The repairs to the damaged panel were deemed to be unacceptable; requiring more work to reduce the visibility of the repairs.

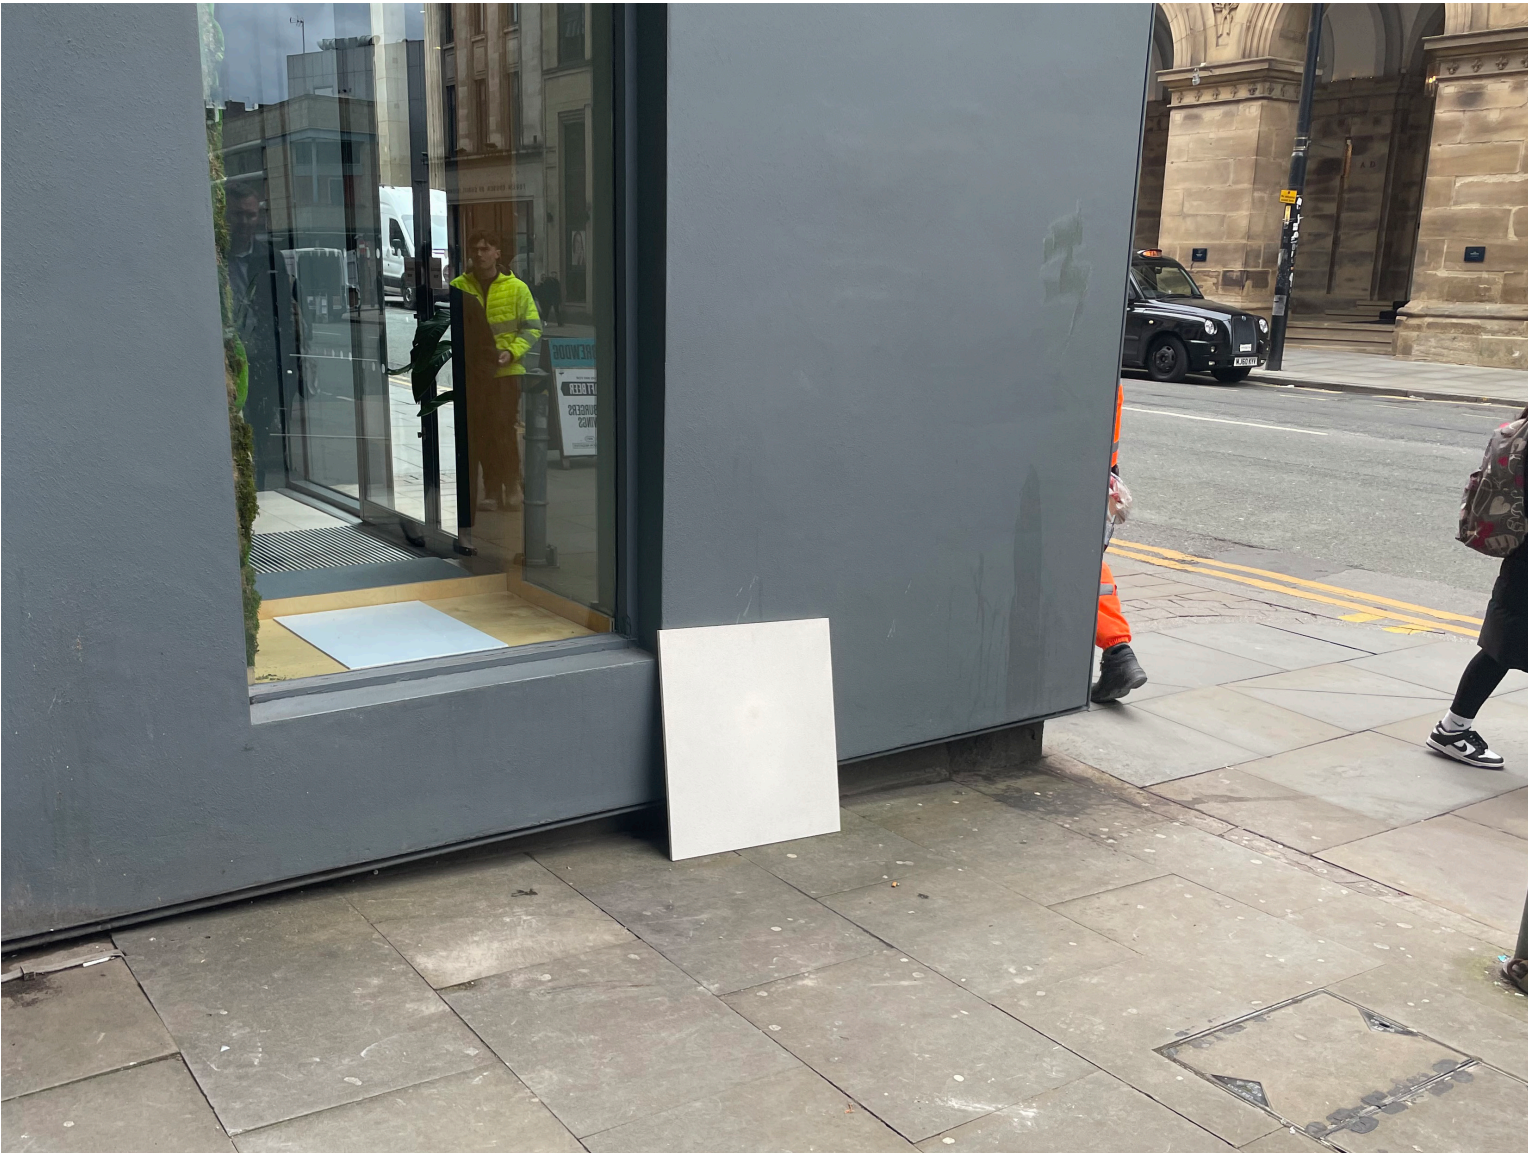
Repaired Sample Panel as viewed externally with MCC 24.05.01

Panel orally accepted by MCC

Sample panel reviewed internally and externally by MCC.

The panel had been repaired and then viewed externally at the required distance to assess.

The panel was deemed acceptable and to be used as a benchmark for the project during installion.
