DESIGN + ACCESS STATEMENT

KING STREET CHAMBERS

| PROJECT REF. | 2050 |

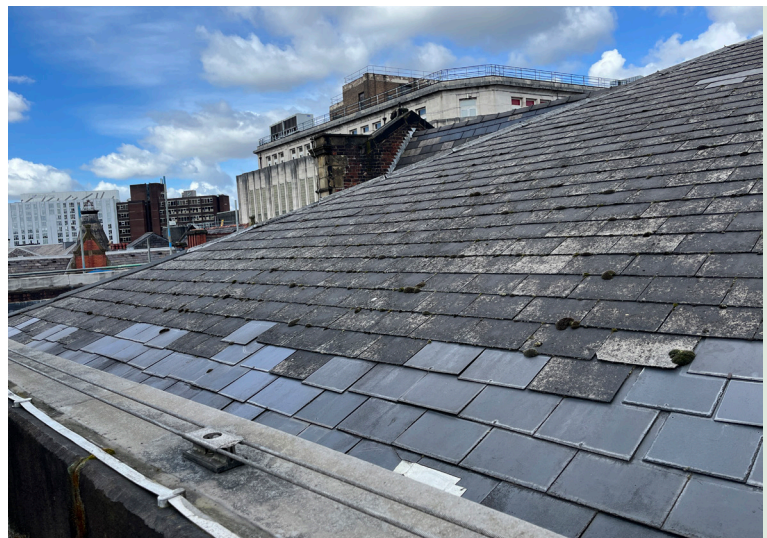
TYPICAL ROOF SLOPE

Roof coverings consist of fabricated artificial composite slates over a non breathable membrane which is typical of roof constructions in the late 20th Century. The slates are in a poor state and numerous composite slate

replacements are evident as are defects with the other, older composite slates. A recent drone survey picked up 200 broken slated areas of the roof. There is one Velux roof light and this doubles as the main roof access onto a steel deck which is used to access the mansafe system.

The existing composite slates will be careful removed and deposited of carefully off site. The batons will be removed and disposed of as will the non breathable membrane leaving the joists exposed. New breathable felt will then be installed on the joists with new treated softwood batons. Finally the new approved natural slates will be installed on the same line of the existing composite slates. New insulation will be installed along the line of the ceilings to bring the building in line with current part L regulations.

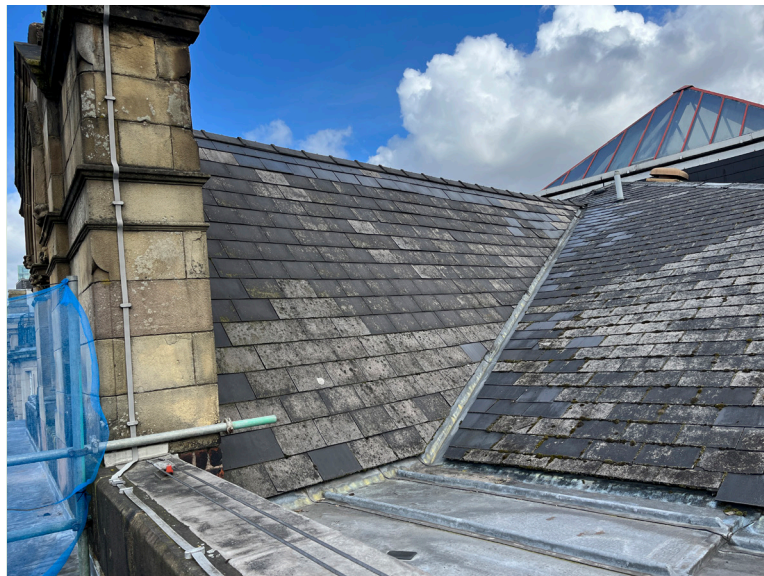
VALLEY AND FLAT ROOF SECTION SHOWING FALLEN TILES

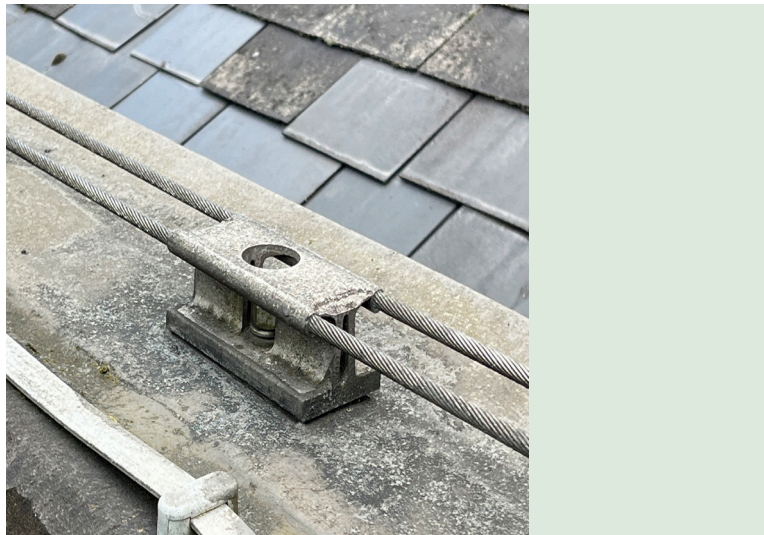
EXISTING MAN SAFE AND LIGHTNING PROTECTION

The lightning protection has partly failed and will be renewed as part of this scope of works.

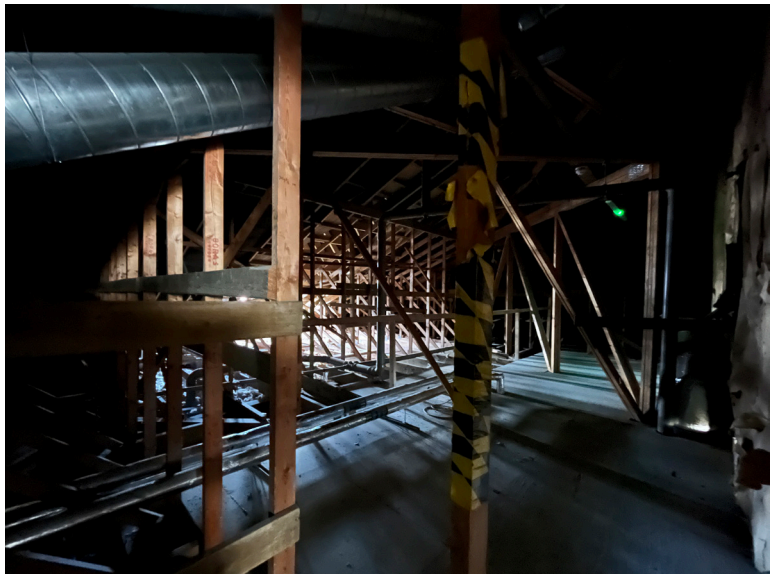
ROOF STRUCTURE

Below the tiled areas, the entire roof structure appears to have been replaced in the recent past with prefabricated timber trussed rafters. The timbers and detailing all seem typical of a late 20th Century replacement. Some insulation is present at ceiling level, but it is not thick enough to achieve the standards that would be expected to meet the current building regulations.

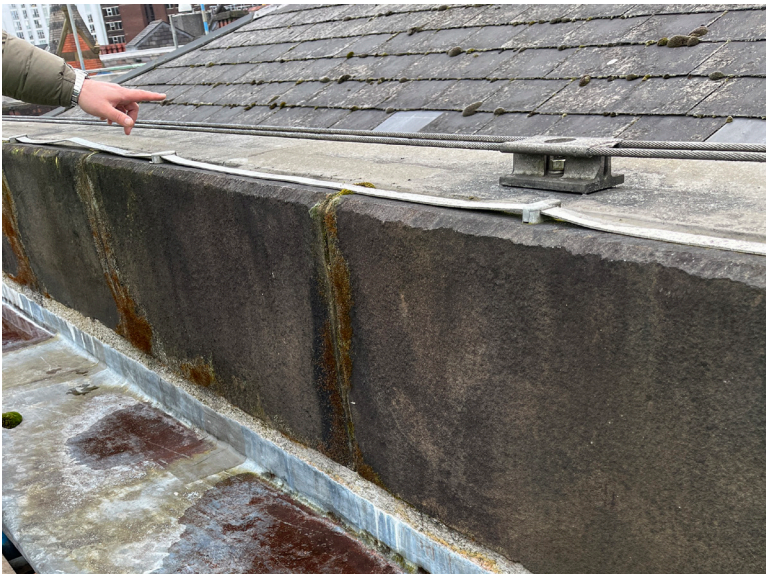
LEADED PARAPET

There are numerous examples of lengths of lead longer than the 1.5m limit between drip edges and it is not clear if the thickness of the lead is acceptable. The lead guttering is dressed into the parapet up stands and the underside of the slate roof, but in both cases these details have been found to fall short of good practice.

Lead coverings on the parapet will be renewed and extended to cover a small projecting brick detail along the inside of the gutter which is currently unprotected and considered vulnerable to water ingress.

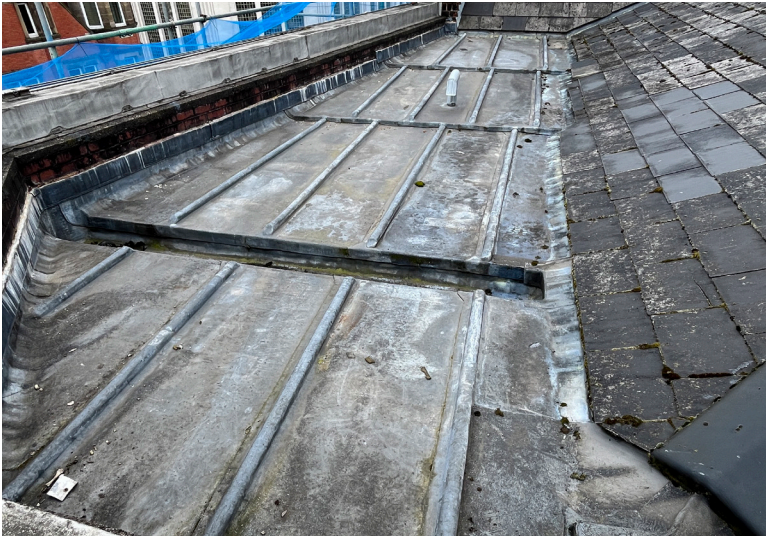
LEADED FLAT ROOF SECTION

As well as the pitched slopes, there are two areas of flat roof. These have been formed in timber and have been finished in rolled lead sheets with traditional joining details, drips and gutters. It is considered that the falls are inadequate and the detailing not robust enough for heavy rainfall scenarios.

Small sections of lead which make up these roofs currently require many joints and therefore the roof has more propensity to fail. The proposal is to replace the lead with tern coated steel. Whilst similar in appearance and detail to lead, it is more stable and can be laid in longer lengths without joints. It has been used successfully in place of lead in many historic contexts, and will be an appropriate response to the problem of water ingress to the heritage asset. On the smaller flat roof, it is not considered appropriate to use this solution as the joints will be rather cumbersome. Existing lead is to be replaced with new smaller sections of lead which will be more sympathetic as the material of choice in this instance.

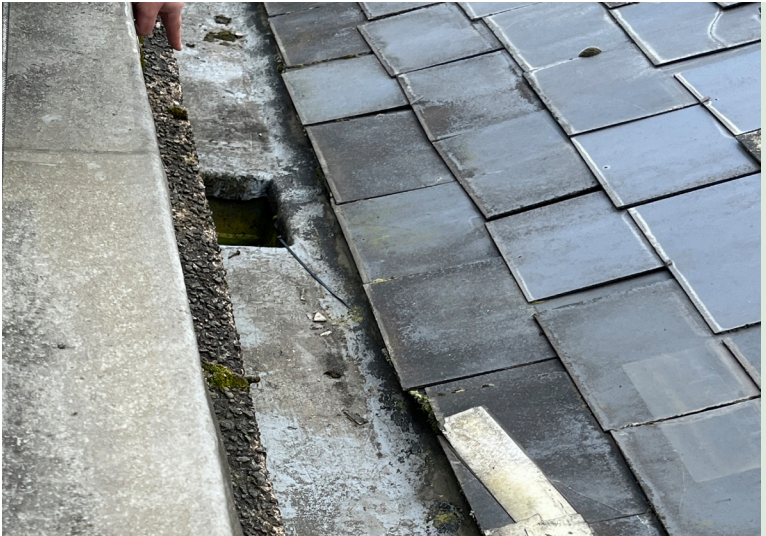
Generally the outlets that exist are not protected and often blocked causing backups and slow flows along the gutters. The present up stand flashings are not considered to be deep enough to cope with the rainfall

in a heavy downpour and so the combination of poor flows and high rainfall increases the risk of water slipping over the lead into the roof void.

DETAIL OF GUTTER AND OUTLET

| Item Ref | Heading | Description of Condition |
|---|---|---|
| 6.30 | | Ensure that outlets have suitable protection against debris. |

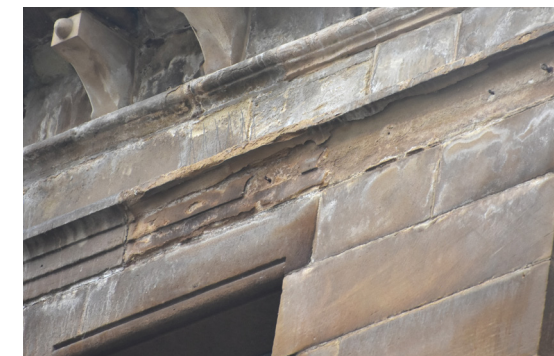
AREAS OF DELAMINATION

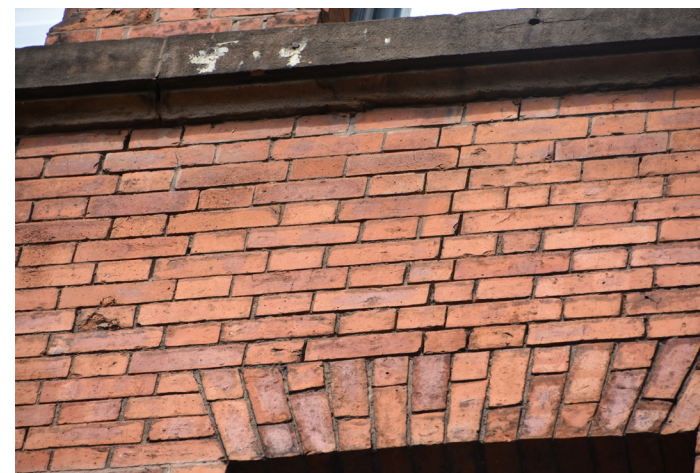
EXAMPLE OF PROPOSED AREAS OF RE-POINTING

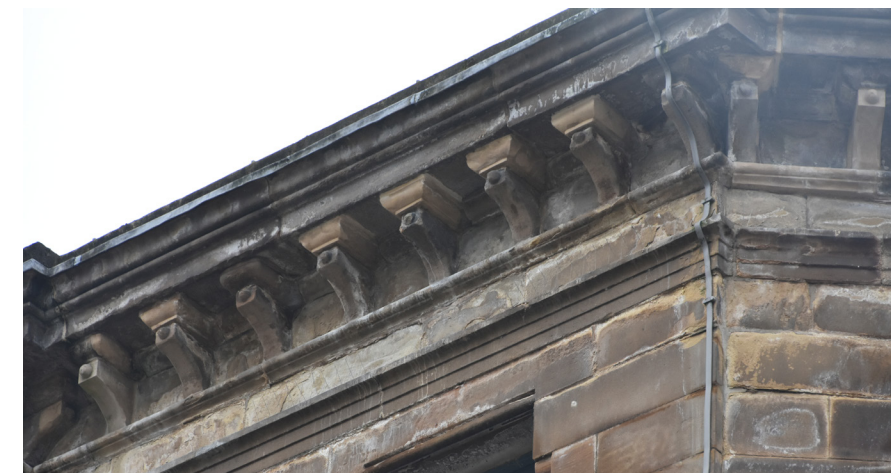
WATER DAMAGE TO PROJECTING STONE
