# Arboricultural Impact Assessment

36 Kingston Road  
Didsbury  
Manchester  
M20 2RZ

April 2024

| <b>Job no.</b> | LTC254 |

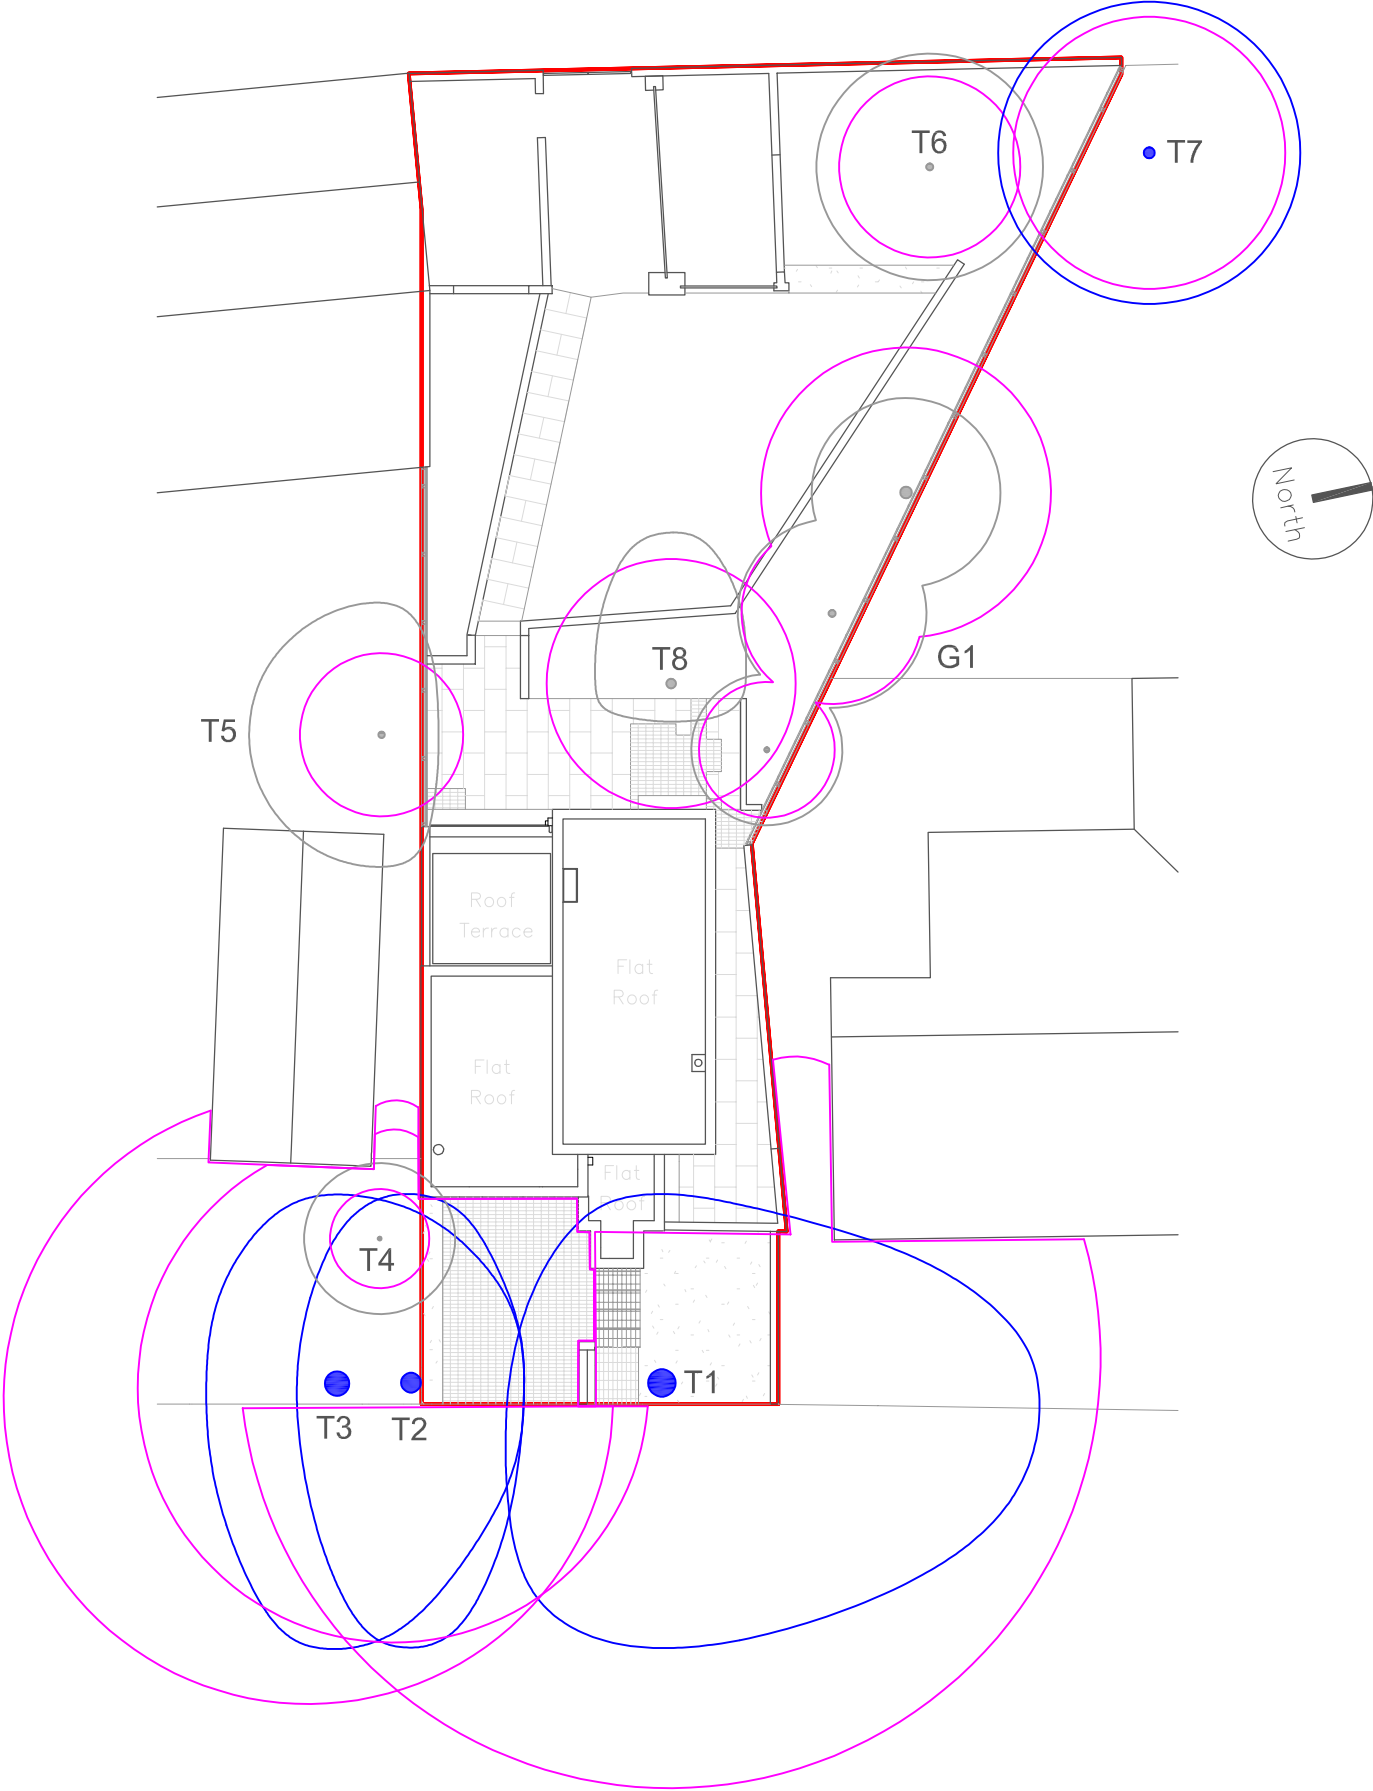
Drawing: LTC254-TSP

3.2 A tree survey identified eight individual trees and one group of trees with potential to be impacted by the proposed works. These were located both within the site and on neighbouring land. The positions of the surveyed trees in relation to the existing site are shown on the appended tree survey plan.

3.3 The retention value of the surveyed trees was categorised using the guidance given in Table 1 of BS5837 (2012), which is explained in the appended tree survey schedule. Four individual trees were categorised as moderate quality (B-category) and four trees and the group of trees were categorised as low quality (C-category).
