# Vantage Quay

## Design and Access Statement.

## 1.0 Introduction

## Vantage Quay-AEW-XX-XX-PP-A-0400-P03-Design and Access Statement

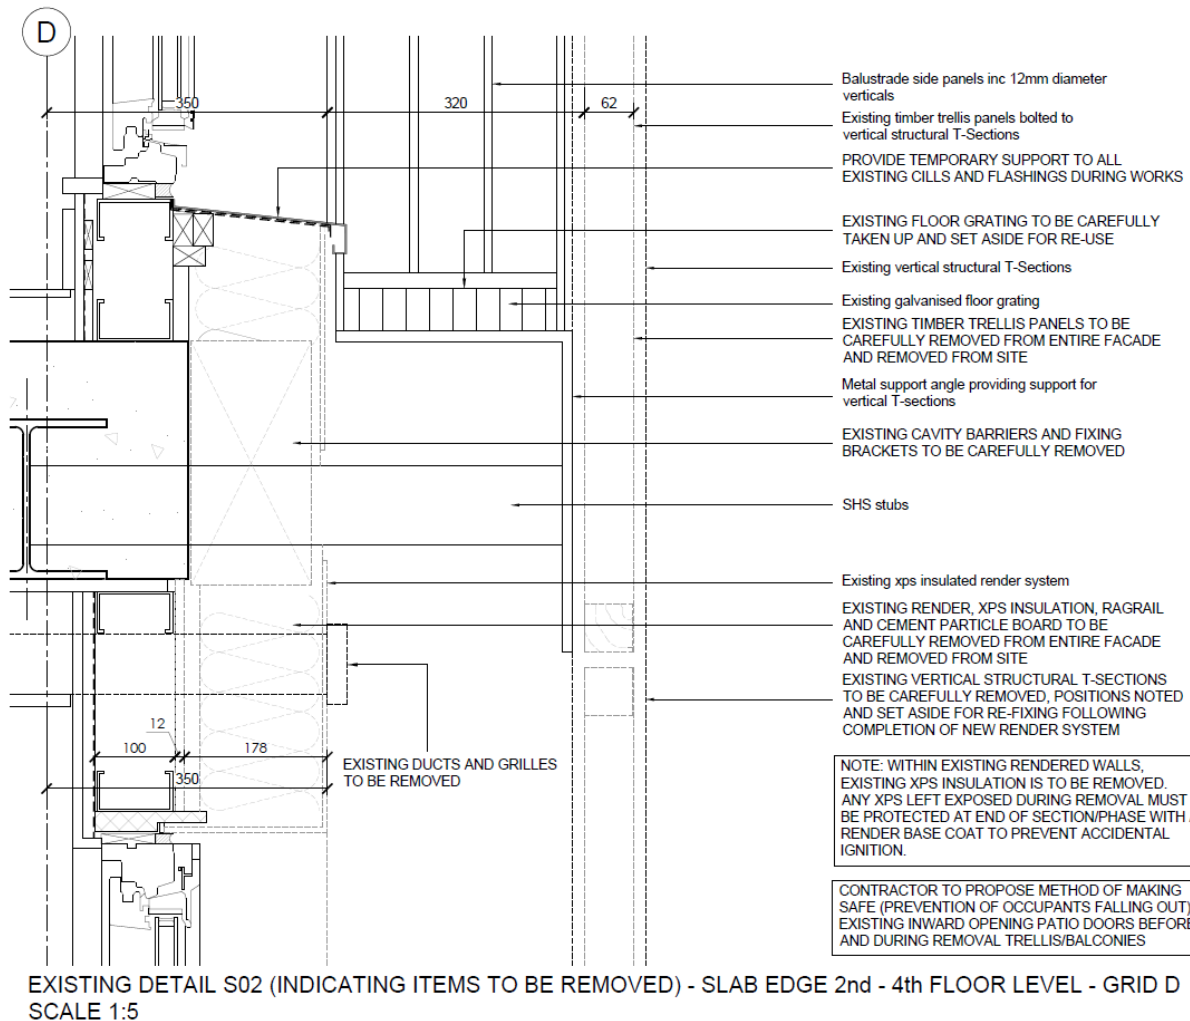
Figure 4 - Existing Sectional Detail showing system build up

- + The insulation is expanded polystyrene and combustible.
- + The drained cavity is complex to install and maintain the cavity and intumescent strips at compartment lines and openings.
- + The decorative trellis / guarding is constructed from timber which is combustible.
- + Cabling to downlights was not protected or encased in timber, combustible.
- + Party Wall junctions did not extend through to the external wall offering potential for passage of smoke/heat/flame.

- + Strip off the existing render system including render, insulation, drained cavity.
- + Strip off the existing cement particle board.
- + Install new A rated direct fix render system including A rated cement particle board sheathing, stone wool insulation.
- + Strip off existing timber trellis / guarding.
- + Install new A rated metal trellis / guarding system.

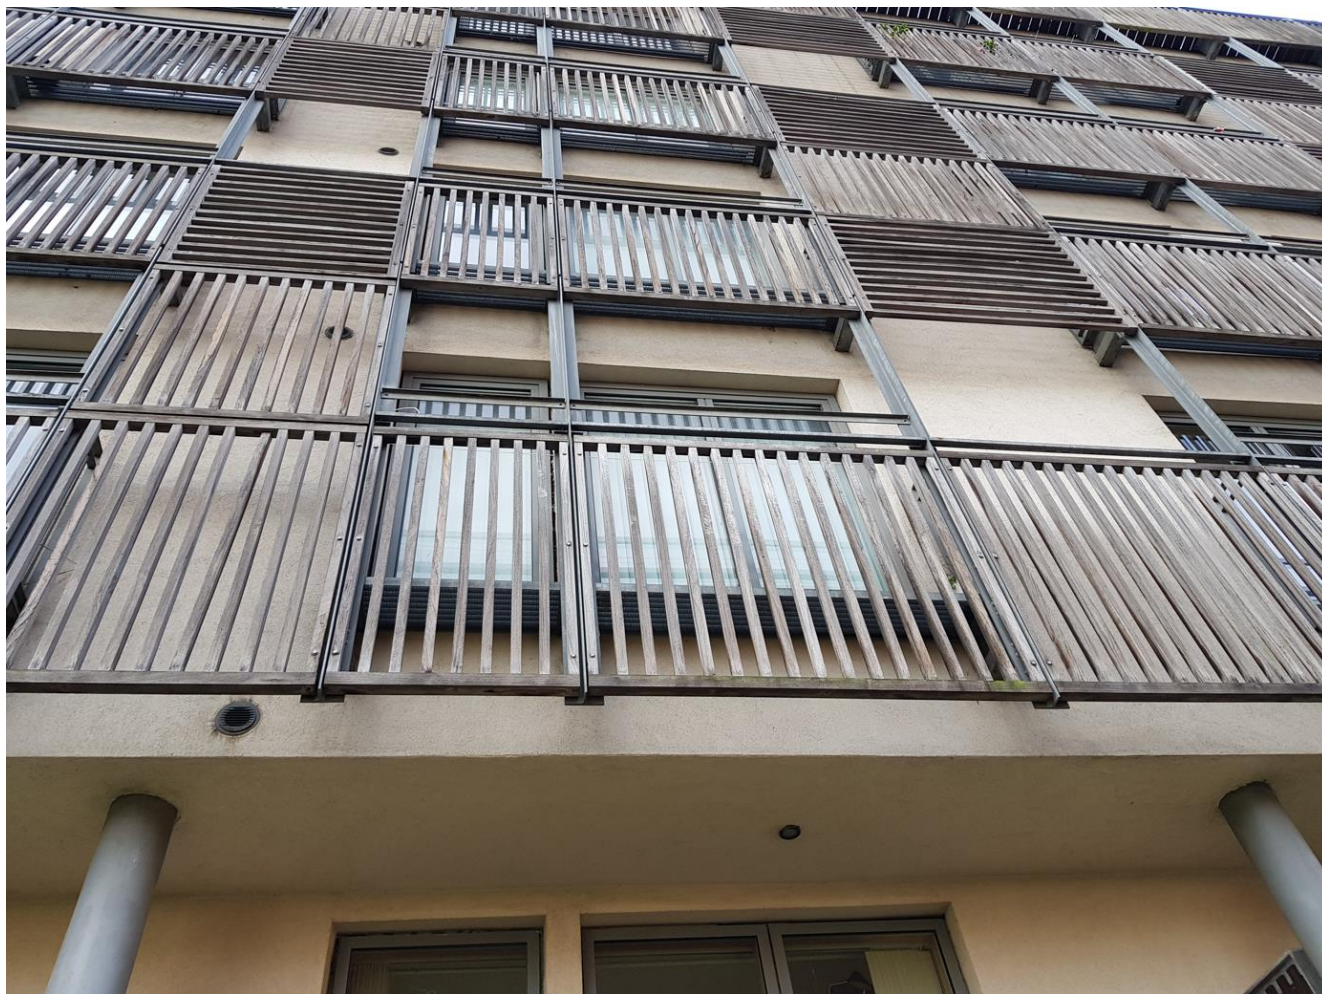
Figure 7 - Detail view of East elevation showing the cream render and timber trellis

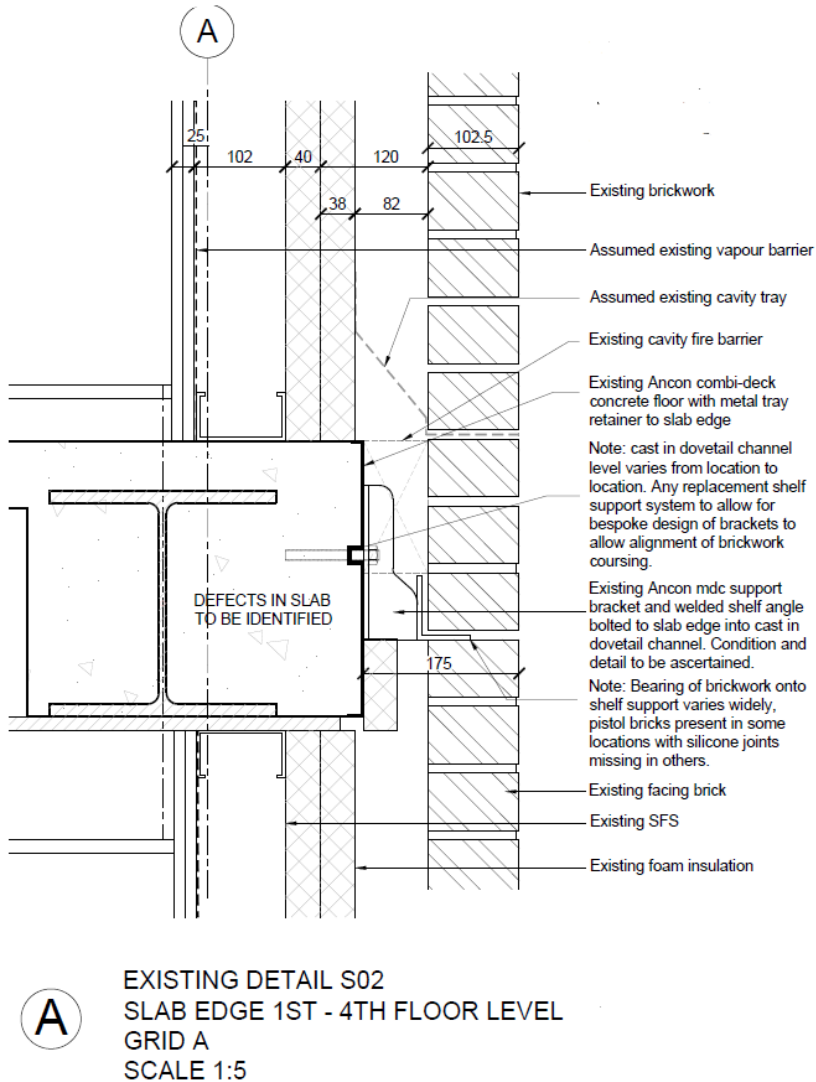
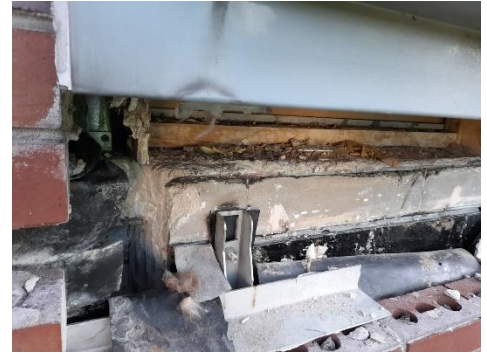
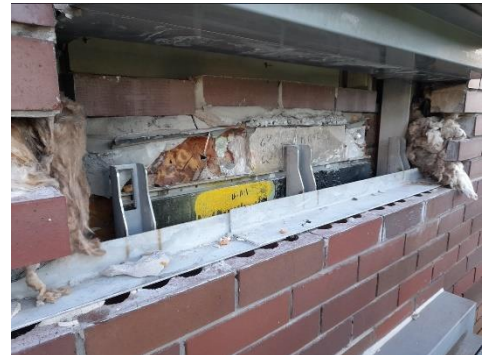
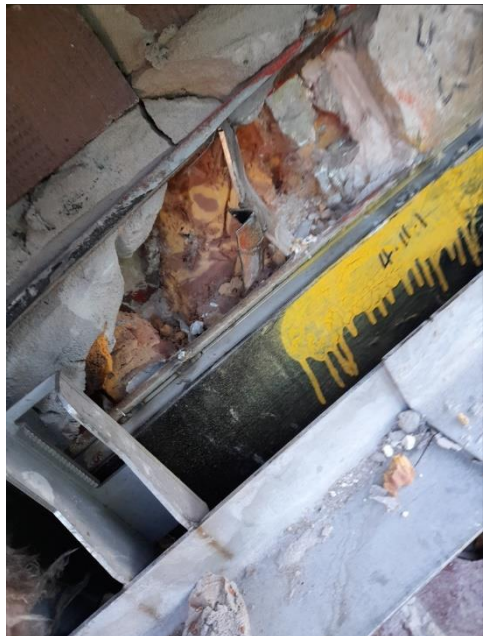
Figure 8 - Existing detail of brick cladding system showing build up

- + No cement particle board sheathing was present in the system – this is very unusual in this system and not advised.
- + Inadequate and insufficient cavity barriers and closers at compartment lines and openings increasing the risk of fire spread through the cavity, especially given the combustible insulants.
- + Phenolic insulation is combustible.
- + PIR insulation is highly combustible.
- + Poorly installed support system for the brick cladding.
- + Combustible timber decking to the balconies – the stacking of 4 balconies created a fire spread risk up the façade.
- + Poor condition of uneven face of the concrete slab – see opening-up photographs above.

- + The very poor condition of the concrete floor slab edge. Widespread spalling, cracking, pitting was noted and in some cases the slab was incomplete. The slab edge was not in a condition to securely fix the cladding support into.

- + Shelf support angle lengths incomplete, areas of brickwork are bearing onto the masonry below potentially overloading the shelf angles in lower panels.

- + Bolts fixing the brick shelf support brackets into the concrete were missing.
- + Issues with the seating of the bricks on the shelf support angles. Standard bricks rather than pistol bricks were used resulting in thin / inadequate joints.

- + No horizontal movement joints resulting in the brick support shelf angles not acting as structurally intended and the loading being transferred through the brick cladding to the ground.

- + Strip off the existing brick cladding system including brick work, cavity barriers, cavity trays, brick support system, insulation.
- + Carefully take out the top course of stone cladding, clean and set aside for reuse.
- + Install new A rated rock wool insulation within the metal SFS framing.
- + Install new A rated cement particle board sheathing and A rated breather membrane to the face of the SFS frame.
- + Install new A rated rock wool insulation to partially fill the drained cavity.
- + Install new cavity barriers and closers to compartment lines and openings.
- + Install new brick cladding and Ancon support system and ancillary components. Include for re-bedding of the top course of salvaged stone cladding and replace any damaged stone cladding.
- + Strip off the timber decking to the balconies.
- + Install new A rated metal decking to the balconies.

- + Existing Ancon combi-deck concrete floor with metal tray retainer to slab edge. Retainer to be cut off to top 100mm to ensure integrity and insulation of proposed horizontal cavity fire barriers.
- + Spalls and voids in the concrete to be filled using Fosroc Renderoc hb30 high performance fibre reinforced concrete reinstatement mortar.
- + Small cracks in concrete to be injection sealed with Nitofill lv epoxy resin injection grout by Fosroc.
- + Where full reinstatement of the concrete slab is required, new reinforcement to be position and filled with RC32/40 concrete.

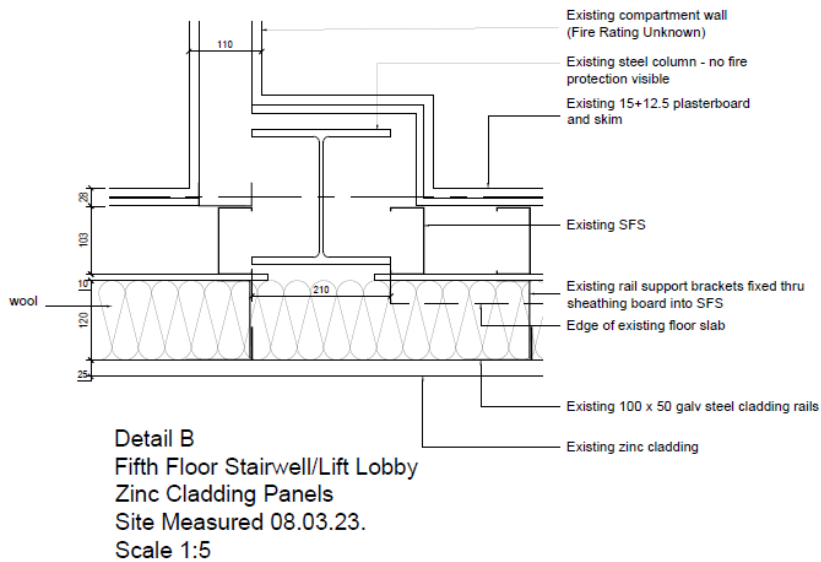
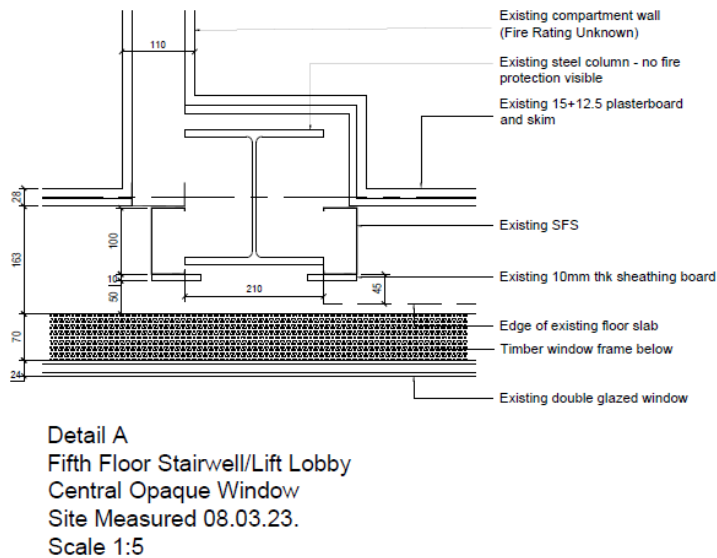
Figure 13 - Plan details showing build-up of zinc cladding

- + Non-compliant sheathing board.
- + No cavity barriers evident on the vertical compartment line between the staircase and lift lobby.
- + Obscure glazed windows on the vertical compartment line between the staircase and lift lobby. Glass is not a suitable material for a panel against which a cavity barrier abuts.

- + Carefully strip out the existing zinc panels on the line of the vertical compartment between the stair and Lift Lobby and set aside for reuse.
- + Carefully strip out the existing glazing panels on the line of the vertical compartment between the stair and Lift Lobby and remove from site.
- + Install Vermiculux panels on the face of the steel column flanges to create a suitable sub strate for the new cavity barriers.
- + Install new vertical cavity barrier.
- + Reinstate the salvaged zinc panels.
- + Install new zinc panels in lieu of the glazed panels.

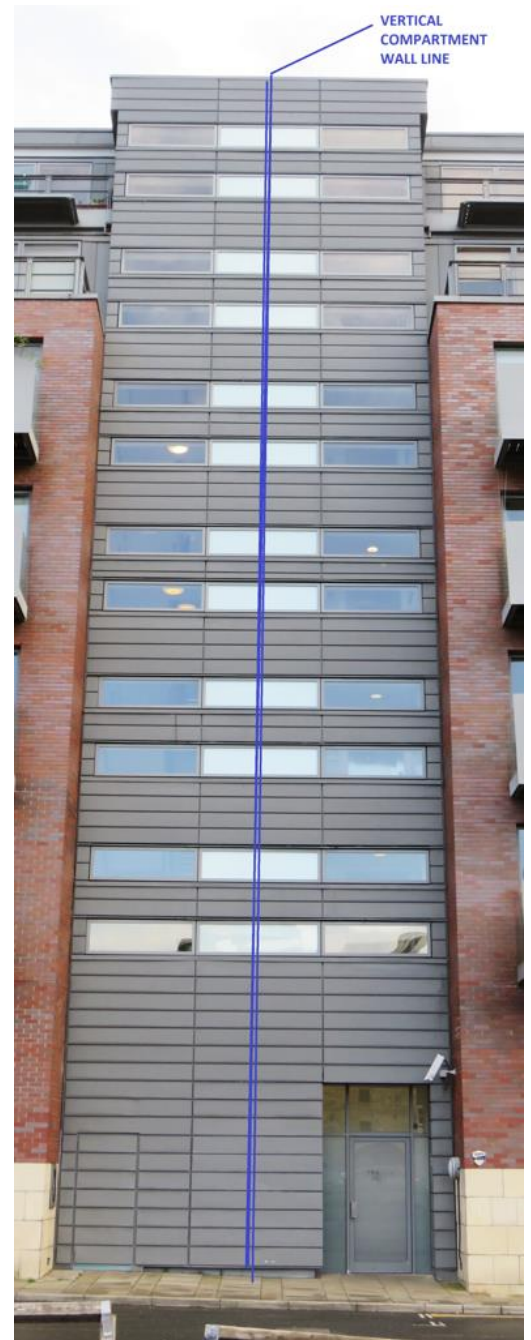
Figure 12 - View of stair core with vertical compartment superimposed as a blue line

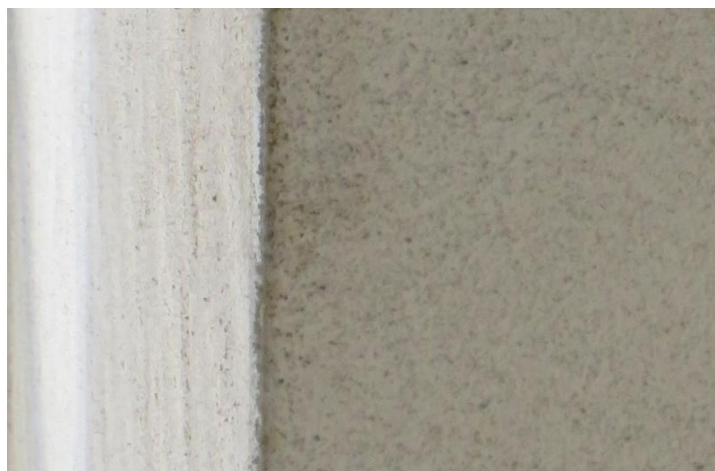
Figure 19 – Photograph of the existing render to be removed. The new render system finish will be colour matched.

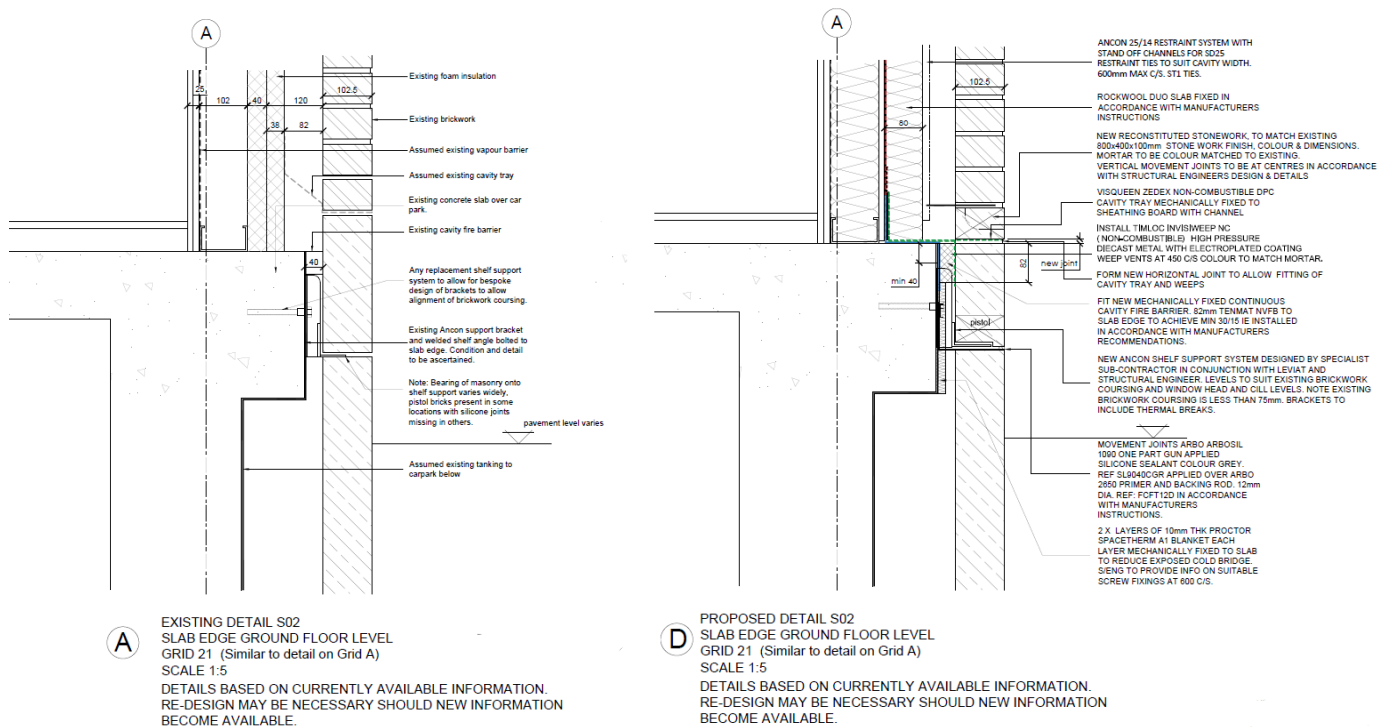
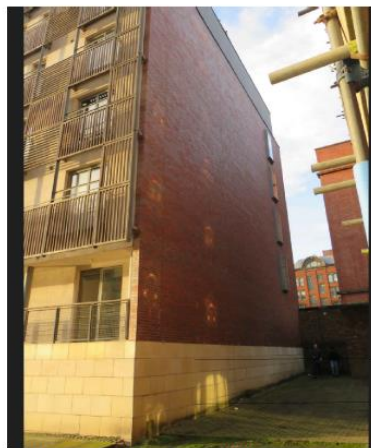
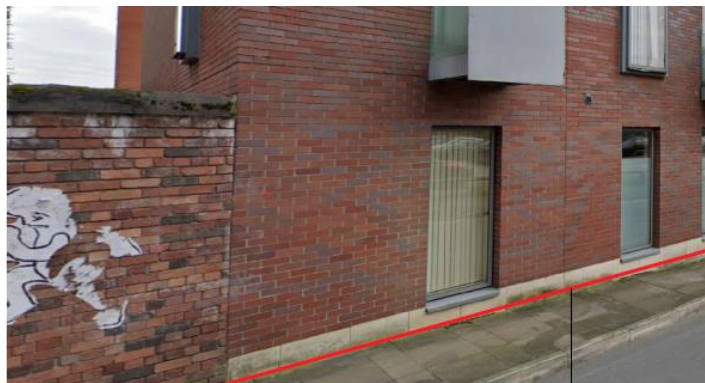
GABLE ELEVATION STONE PLINTH

- + The top course of stonework onto which the brick cladding sits bears on to the first shelf angle of the Ancon support system.
- + There is a breach in the horizontal compartmentation.
- + The concrete floor slab edge is currently uninsulated and is consequently a cold bridge which will create potential condensation and heat loss risks.

The following works will be carried out to remediate these issues - The top course of stone will need to be carefully removed, cleaned, and set aside for reuse to enable: -

- + The brick support system to be removed and replaced with a new system.
- + A horizontal fire barrier and ancillary components to be fitted to close the compartmentation breach.
- + Insulation installed to the slab edge.
- + Re-bedding of the existing salvaged stone to enable the new brick cladding to be installed.
