## HERITAGE IMPACT ASSESSMENT - ADDENDUM NOVEMBER 2023

This Heritage Impact Assessment addendum has been drafted to support planning applications reference **36699/FO/2023** and **136701/LO/2023**.

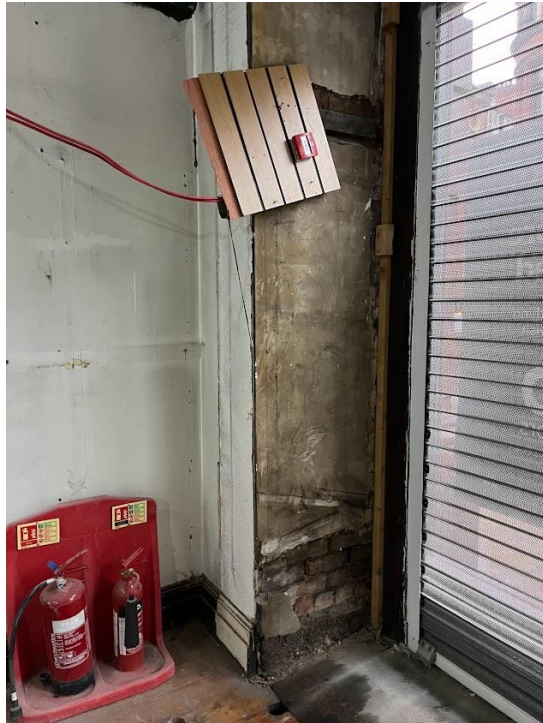
1

The wall is currently in a patchwork of colours with fixing holes visible from the previous fitout. The plaster is in average/poor condition and the skirting is partly missing.

New timber panelled glazed lobby - hardwood infill panels with soft joint to be scribed around decorative plaster cornice - to be paint finished. Soft joint between header panel and cornice using Comriband or similar. Header panel to be painted out to match lobby.

Existing fixing partitions for the previous retail unit fitout will be used.

Skirtings will be retained and repainted. New softwood painted skirtings will be installed where missing.

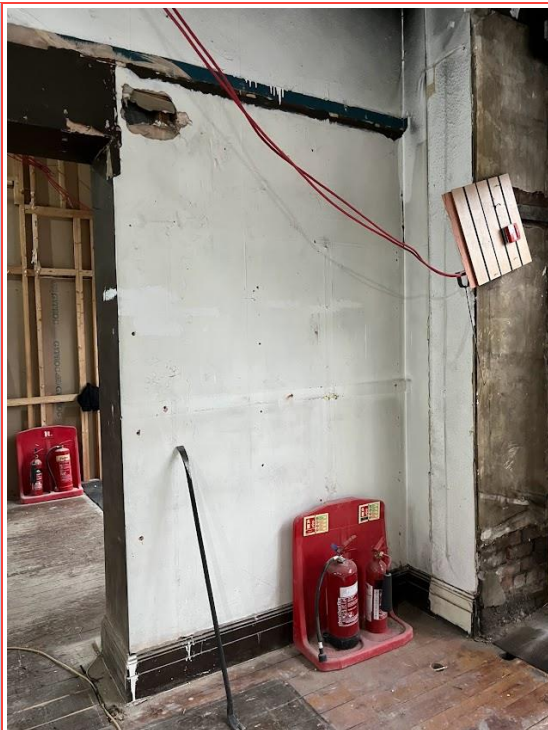
2

The wall is currently in a patchwork of colours with fixing holes visible from the previous fitout. The plaster is in average/poor condition. Tidying up the wall and removing redundant fixing holes will have a beneficial impact.

The original skirtings hold aesthetic significance but are in need of repair, replacement (where missing) and redecoration. The proposal will retain and enhance the original historic fabric. This will have a beneficial impact.

Original timber skirting (where present) will be retained and patch repaired where required.

Plaster at high level is in reasonable condition, it will be made good and decorated so that the decorative details are viewed in the context of painted plastered finish, with the top of the panelling finishing at a consistent height throughout.

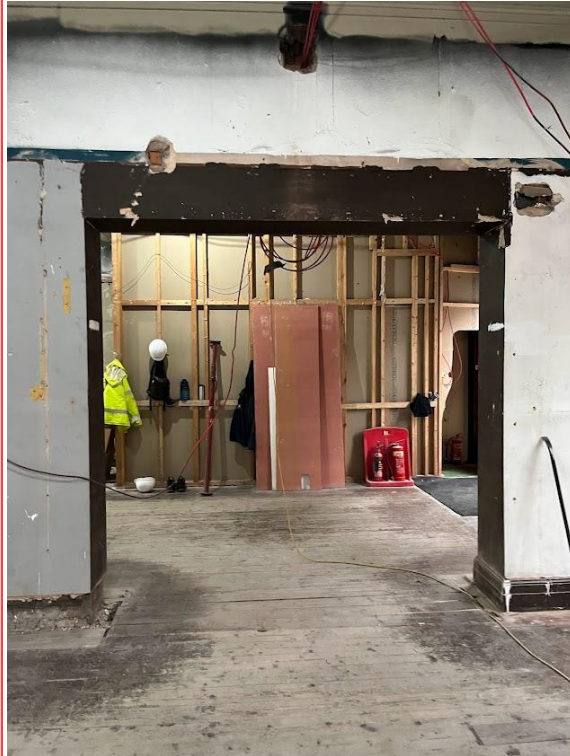
3

New stud partitions will scribe around skirting and would not disturb the original cornicing which is higher than the opening to be filled. There will be no harm caused to the historic features or significance of the building.

Existing openings along this wall will be infilled with 206mm jumbo stud mf and plasterboard party wall comprising of 2no layers of 15mm fireline each side of 146mm stud, cavity filled with batt insulation.

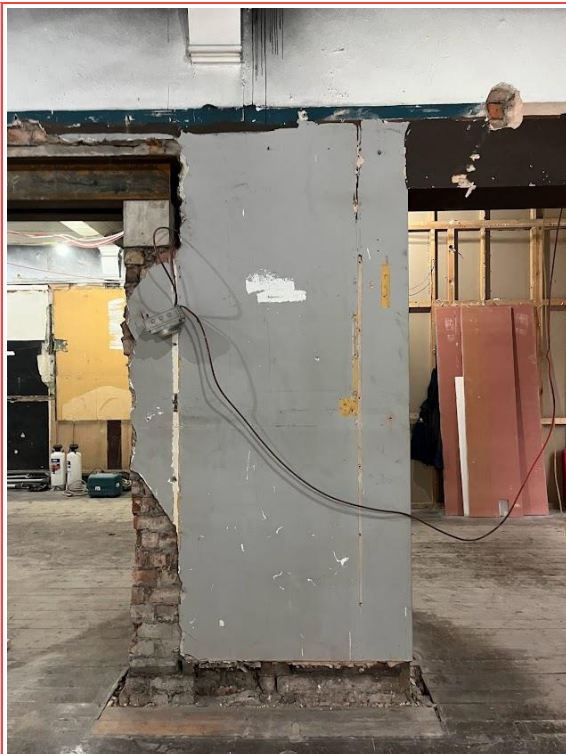
4

The plaster around the openings is in poor condition with steel supports and sections of brickwork exposed. The remaining plaster is in poor decorative finish with various colours, fixing holes and flaked paint.

Bespoke tongue and groove softwood panelling to be fixed on softwood grounds, fixed into mortar joint to masonry, to receive paint finish. The existing plaster would be stabilised and retained under the new panelling.

Existing cornice to be repaired where damaged, template to be taken of cornice and reproduced as required in fibre reinforced plaster for reinstatement where missing.

Plaster corbels to be repaired / replaced.

New softwood painted skirtings where missing.

Existing timber floor will be retained, stained, sanded and sealed.

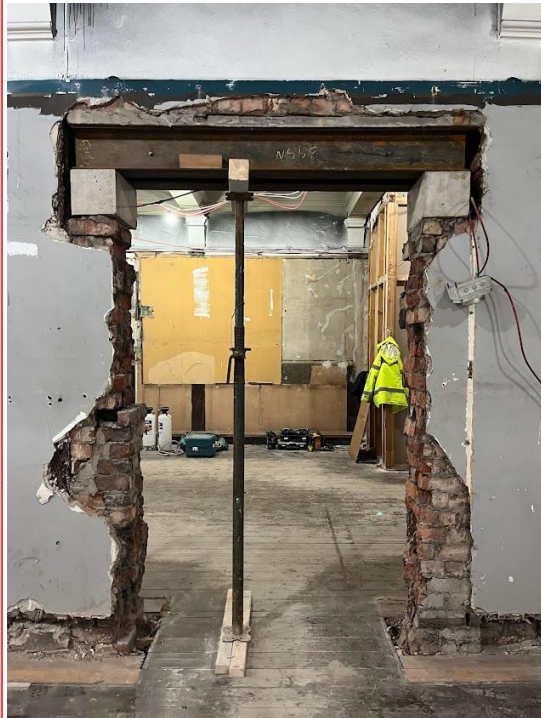
5

The plaster around the openings is in poor condition with steel supports and sections of brickwork exposed. The remaining plaster is in poor decorative finish with various colours, fixing holes and flaked paint. Stabilisation works are required as the wall/opening is not structurally sound. No skirting is present.

Bespoke tongue and groove softwood panelling to be fixed on softwood grounds, fixed into mortar joint to masonry, to receive paint finish.

Existing cornice to be repaired where damaged, template to be taken of cornice and reproduced as required in fibre reinforced plaster for reinstatement where missing.

Plaster corbels to be repaired (as required) and redecorated.

New softwood painted skirtings where missing.

Existing timber floor will be retained, stained, sanded and sealed.

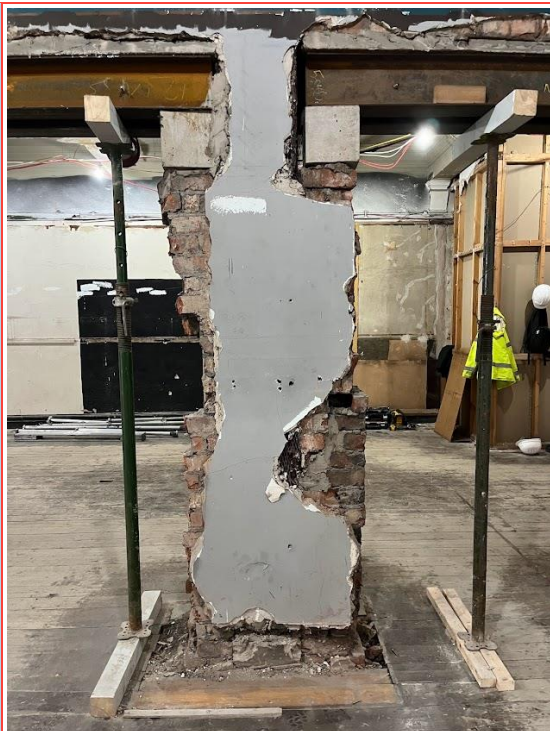
6

The plaster is in poor condition with sections of brickwork exposed. Supporting beam and concrete blocks visible where the opening was created in the past. Stabilisation works are required as the wall/opening is not structurally sound. The remaining plaster is in poor decorative finish with various colours, fixing holes and flaked paint.

The works proposed reflect those detailed in Reference Photo 5.

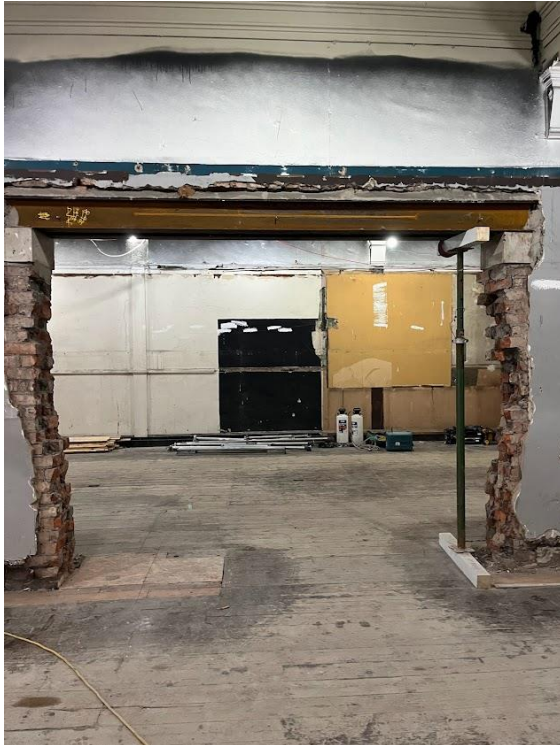
7

The plaster around the opening is in poor condition with sections of brickwork exposed. Supporting steel and padstone (non-original) visible where the opening was created in the past. Stabilisation works are required as the wall/opening is not structurally sound.

The works proposed reflect those detailed in Reference Photo 5.

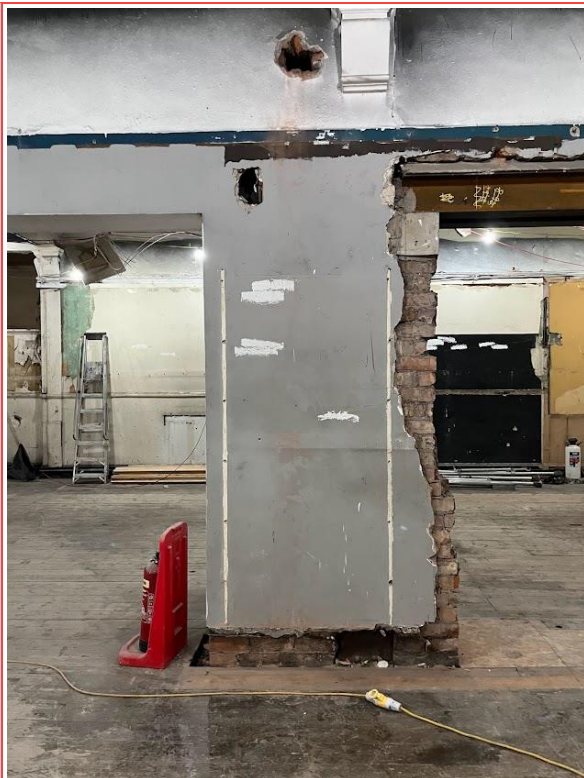
8

The plaster around the opening is in poor condition with sections of brickwork exposed. Supporting steel and padstone (non-original) visible where the opening was created in the past. Stabilisation works are required as the wall/opening is not structurally sound.

The works proposed reflect those detailed in Reference Photo 5.

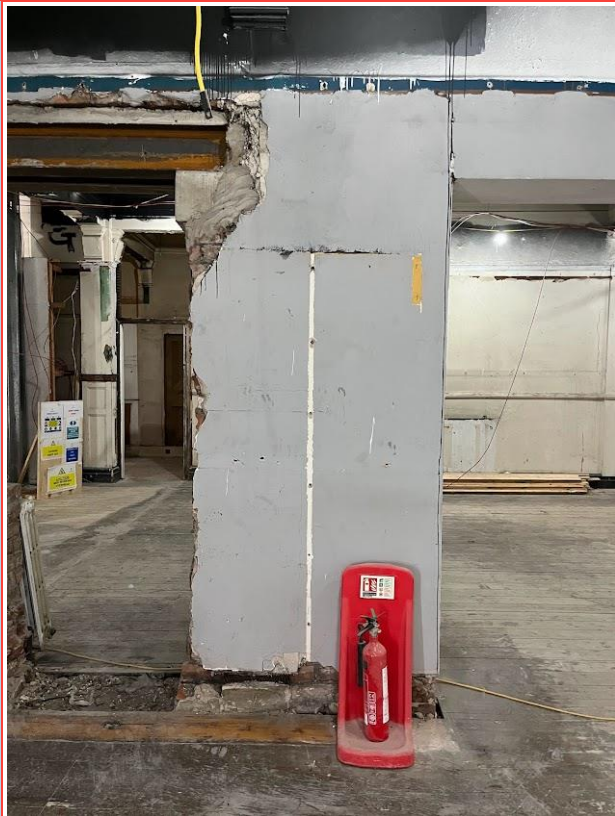
10

The plaster around the left opening is in poor condition with sections of brickwork and cement exposed. Supporting steel and padstone (non-original) visible where the opening was created in the past.

The works proposed reflect those detailed in Reference Photo 5.

Areas of missing flooring will be wood matched and stained to match the retained wooden floorboards.

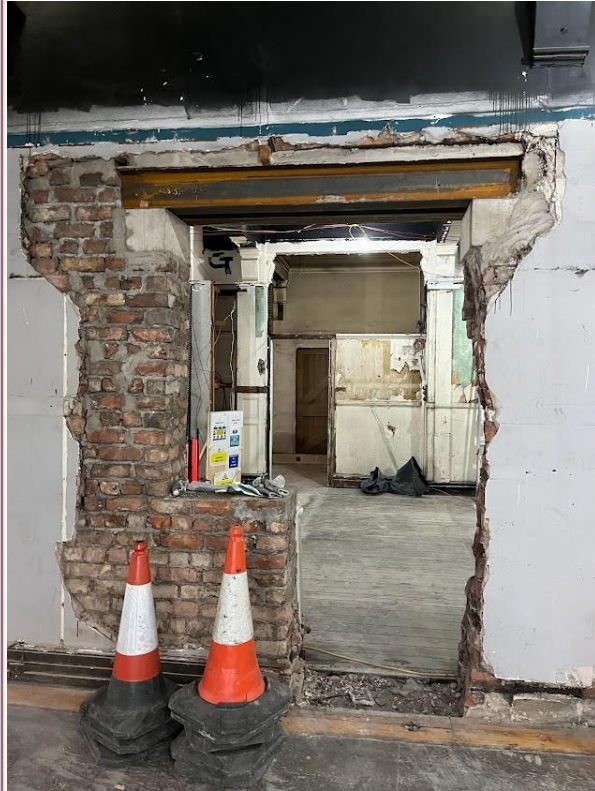
11

The plaster around the opening is in poor condition with sections of brickwork exposed. Supporting steel and padstone (non-original) visible where the opening was created in the past.

Some skirting is present, other sections are missing.

The works proposed reflect those detailed in Reference Photo 5.

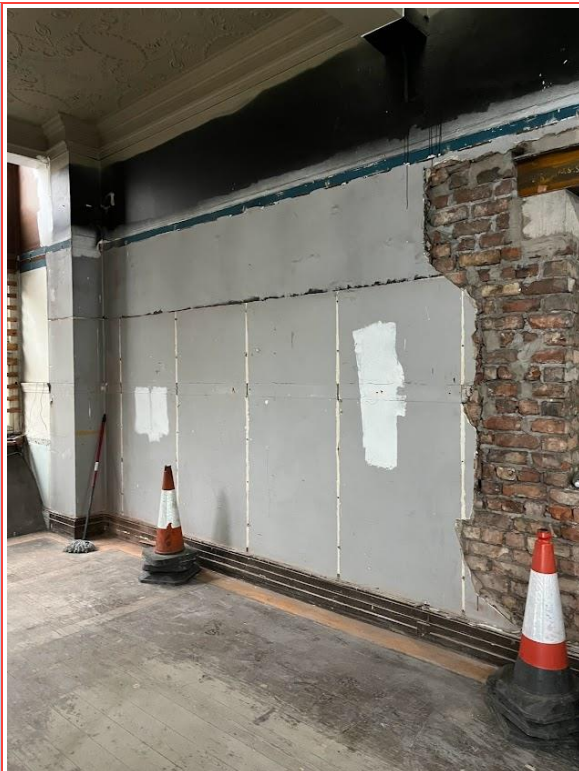
12

The plaster is in poor condition with sections of brickwork exposed. The remaining plaster is in poor decorative finish with various colours, fixing holes and flaked paint.

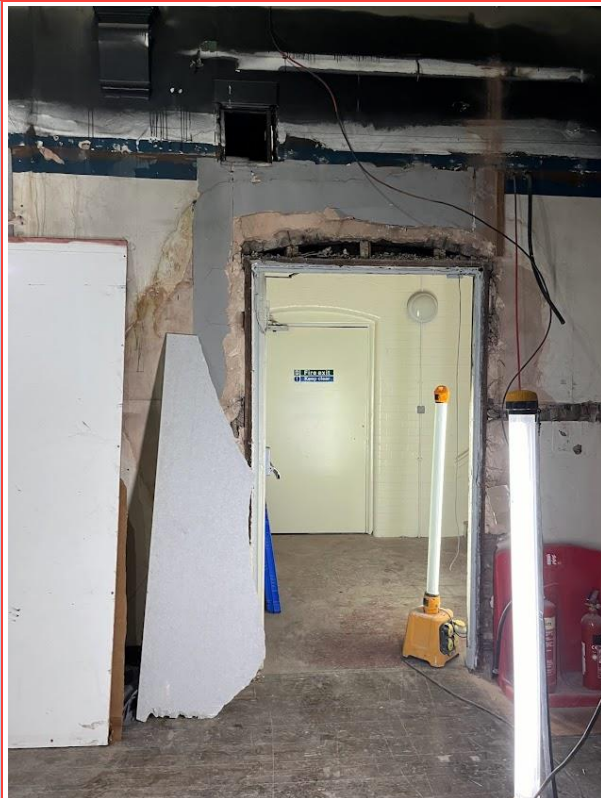
16

The plaster is in poor condition with sections of modern plaster and vent opening. The remaining plaster is in poor decorative finish with various colours, fixing holes and flaked paint.

The plaster does not hold special aesthetic or historical significance, it has been clearly altered and needs repairing.

Suspended ceilings, flooring and new stud walls are required as described at Reference Photo 12.

The existing door will be removed and replaced with new reduced width door opening formed in 60minute MF and plasterboard partition.

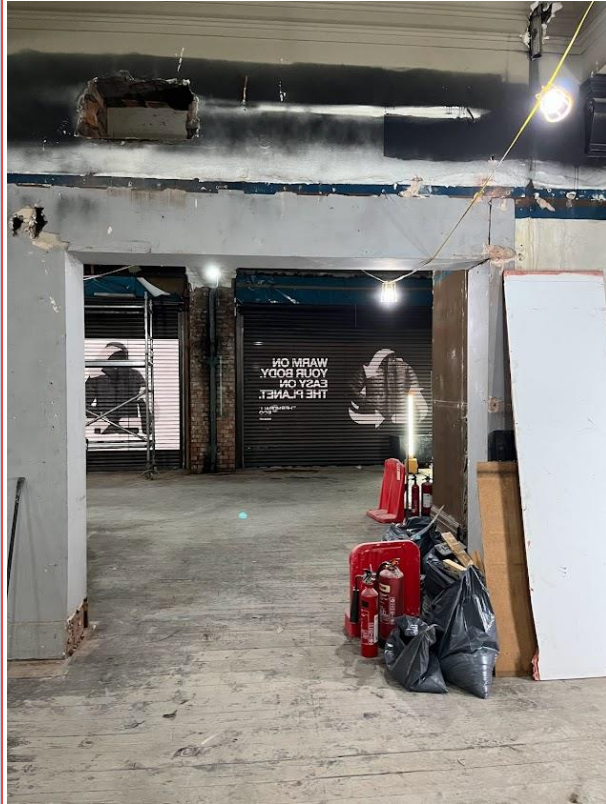
17

The plaster is in poor condition with sections of modern plaster and an opening at high-level in the brickwork.

Bespoke tongue and groove softwood panelling to be fixed on softwood grounds, fixed into mortar joint to masonry, to receive paint finish.

Existing cornice to be repaired template to be taken of cornice and reproduced as required in fibre reinforced plaster for reinstatement where missing.

The opening will be retained. New softwood painted skirtings will be installed where missing.

Existing timber floor will be retained, stained, sanded and sealed.

Existing original ceiling to be exposed throughout guest facing areas, fully repaired and painted. The submitted drawings show the location of the exposed cable tray which will provide containment for wiring and fixing of light fittings, ceiling fans and air conditioning.

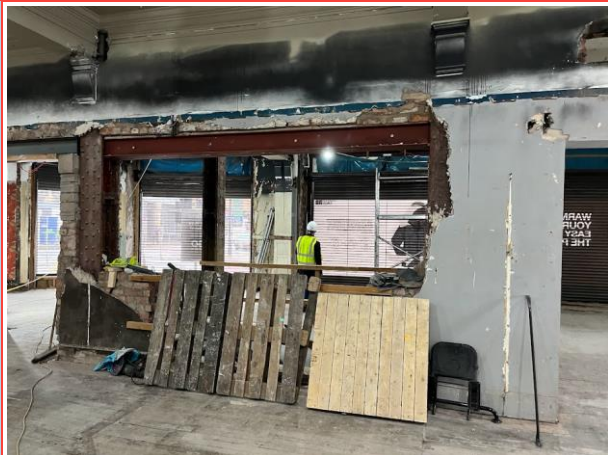
18

It was agreed during the recent site visit that this section of wall is in poor condition of limited heritage value.

A new glazed screen will be installed where the existing opening is, formed in oak hardwood with reclaimed stained-glass panels. Fully upholstered bench and seating in front of the screen will be free standing.

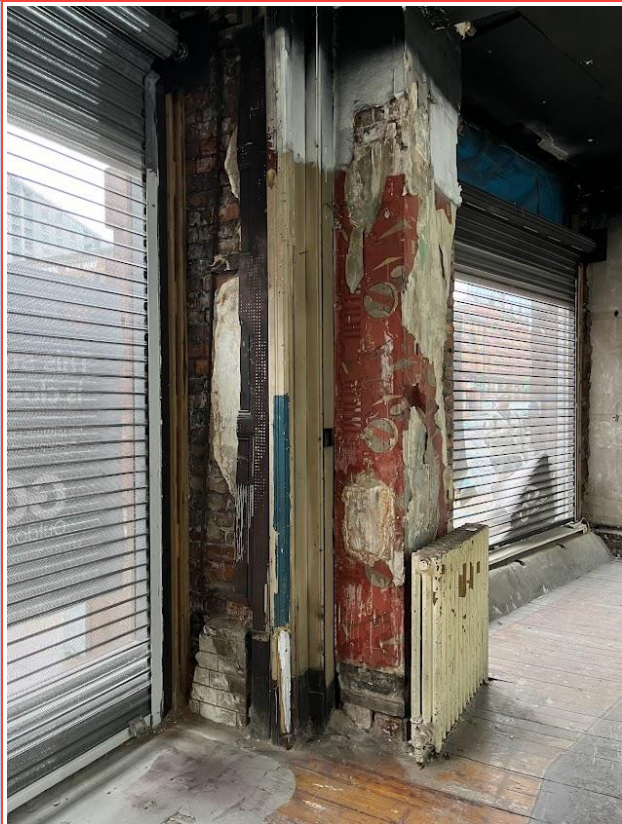
30

This area at the front of the unit is in poor condition. It contains areas of exposed brickwork, wooden finishes, peeling wallpaper and a redundant iron radiator. There are two discrete areas in the unit where there is wallpaper showing musical notes. The wallpaper has some historic interest showing the previous use of the space, it has not been well preserved, it is in poor condition and is peeling. The wallpaper is not consistent with the aesthetic of the proposed fit out and taking this into account along with the condition and limited significance it has been agreed with MCC that it is not possible to incorporate this within the design.

The roller shutters will be removed. The radiator will be removed.

The existing cornice will be repaired and template to be taken of cornice and reproduced in traditional fibre reinforced plaster for reinstatement where needed. Lime plaster to be reinstated / repaired. 300 x 300 mm square softwood timber bead. 15 x 70 mm tongue and groove softwood panelling to be fixed on softwood grounds, fixed into mortar joint to masonry and will have a paint finish.

New softwood painted skirtings will be installed where missing. See plan 03(30) drawing F.

Glazing to be installed, to replace fascia board.

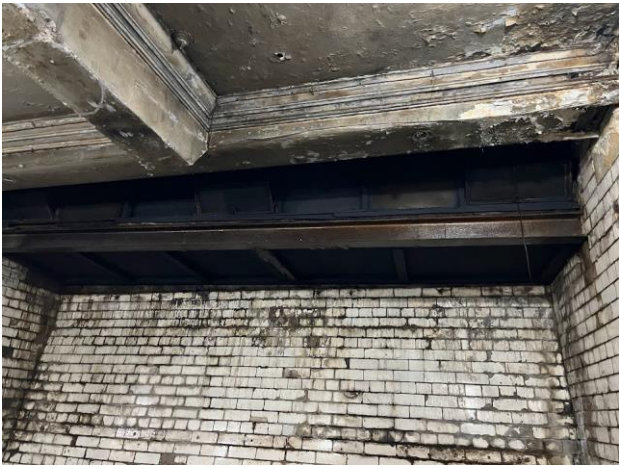
| Reference Photo | DESCRIPTION OF PROPOSED WORKS | SIGNIFICANCE OF HERITAGE ASSET AND ASSESSMENT OF IMPACT |
|---|---|---|
| <p>5B</p> | <p>Existing former pavement lights at high level to be made fully watertight.</p> <p>Water damaged areas of existing plastered ceilings, beams and cornice will require repair using appropriate lime renovation plaster. Section of cornicing which are beyond repair will be replaced with new cornicing to match using traditional fibre reinforced plaster.</p> | <p>This will help to preserve the bricks and cornicing from further water damage therefore providing a positive impact.</p> |

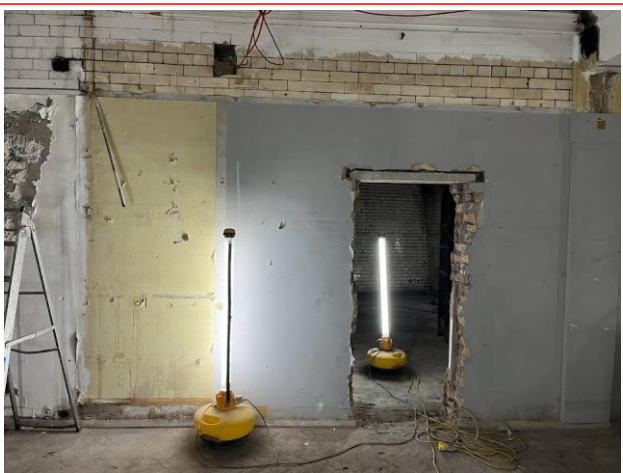
Due to the slurry on the wall, removal of the plaster will likely damage the original brickwork underneath. Therefore, to minimise harm the slurry will be retained. Moreover, we will be exposing the brickwork on the other side of the wall and so overall there is a neutral impact.

| 12B | | <p>This wall will be replastered.</p> <p>Existing wood herringbone parquet flooring to be retained. To be stripped, sanded and resealed.</p> |

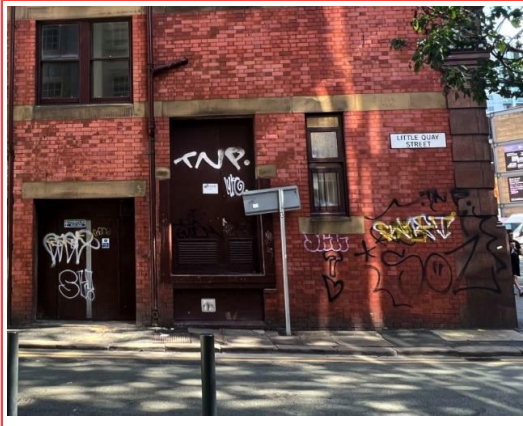
| Reference Photo | EXT 5 | DESCRIPTION OF PROPOSED WORKS | SIGNIFICANCE OF HERITAGE ASSET AND ASSESSMENT OF IMPACT |
|---|---|---|---|
| | | <p>Existing redundant white upvc extract fan to be removed, opening to be reglazed. All glazing will be obscured using frosted vinyl to match the existing paintwork, applied on the internal side of window.</p> <p>New louvres proposed.</p> | <p>The existing windows detract from the conservation area and the attractiveness of the building. This is the back of house area where the tills were in the previous retail unit, and wooden slats and fabric are visible through the glazing which looks untidy.</p> <p>This area will contain the kitchen in the proposed fit out. For practical reasons vinyl is proposed. It will be internally applied and easily removable in the future. It will avoid untidy views of the fit out being visible from the street. Removing graffiti, the upvc fan and replacing the louvres will have a cumulative beneficial impact.</p> |
| | | <p>Graffiti on brickwork to be removed.</p> <p>Existing doors to be repainted to match the window frames.</p> <p>This area (left to right) comprises the fire exit doors, the lift area which is outside of the tenant's demise, and the future DDA and baby change area.</p> | <p>This is a functional, back of house, elevation that has been altered over time to introduce louvres and extract fans. The graffiti detracts from the quality of the conservation area and heritage asset.</p> <p>The proposal will have a beneficial impact by tidying up the elevation and removing graffiti.</p> <p>The paint colour will match the existing.</p> |
