FEDERATION  
COOPERATIVE WHOLESALE  
NEW CENTRAL PREMISES - MANCHESTER

Hanover House  
And E-Block,  
Manchester

**HERITAGE STATEMENT:**

Significance Appraisal and Impact Assessment

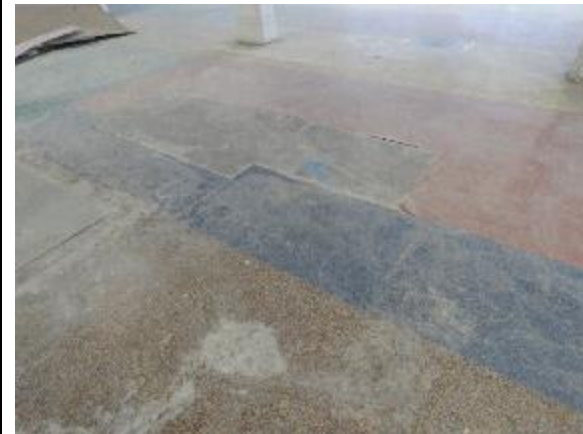
**Figure 55:** Non-significant floor coverings over earlier timber flooring.

| <b>Floor</b> | Removal of modern vinyl and OSB board to floors before repairing timber floorboards. Section of floorboards to be removed to enable the staircases to be installed. | The proposed work will have a <b>negligible adverse impact</b> on the floor, although the removal of the modern floor finish and OSB board is beneficial, the removal of the sections to create the new stair access and potential overlay of the floor has an adverse impact due to the removal of historic fabric. |

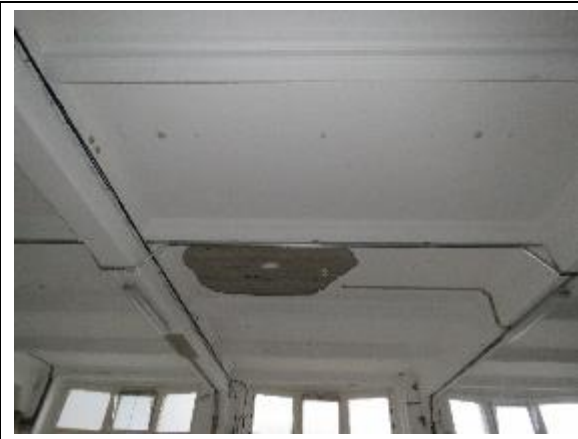
**Figure 68:** View of ceiling with section of failed plaster.

| <b>Ceiling</b> | Patch repair of plaster to 2no. ceiling locations and re-decoration. | The proposed works will have a <b>negligible beneficial impact</b> through bringing the ceilings back into good condition. |

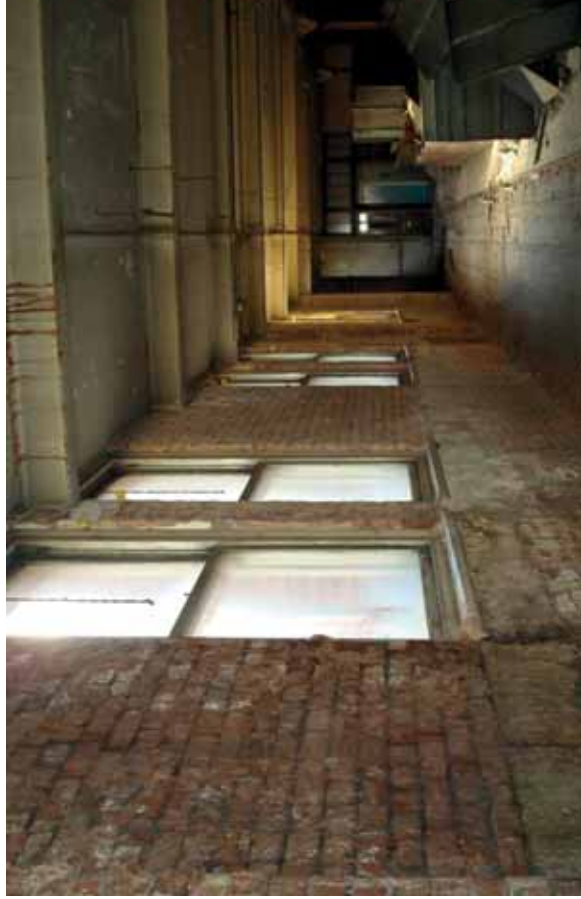
**Fig. 6.1.5.** 2011. General view of the 4<sup>th</sup> floor showing the original ceiling with exposed steel beams. The wall and floor finishes have suffered the effects of water damage.

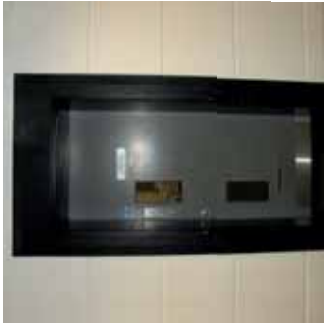
**Photo 63. HB.3F.15** – Typical architrave found on 3<sup>rd</sup> floor, disfigured by later interventions.
