**Project:** 23\_5837\_06\_45  
**Site:** 4 Middleton Road, Crumpsall, Manchester, M8 5DS  
**Client:** Shalshelles College.

| Document Title: | Tree Survey & Arboricultural Impact Assessment |
| Project Title: | 4 Middleton Road, Crumpsall, Manchester, M8 5DS |

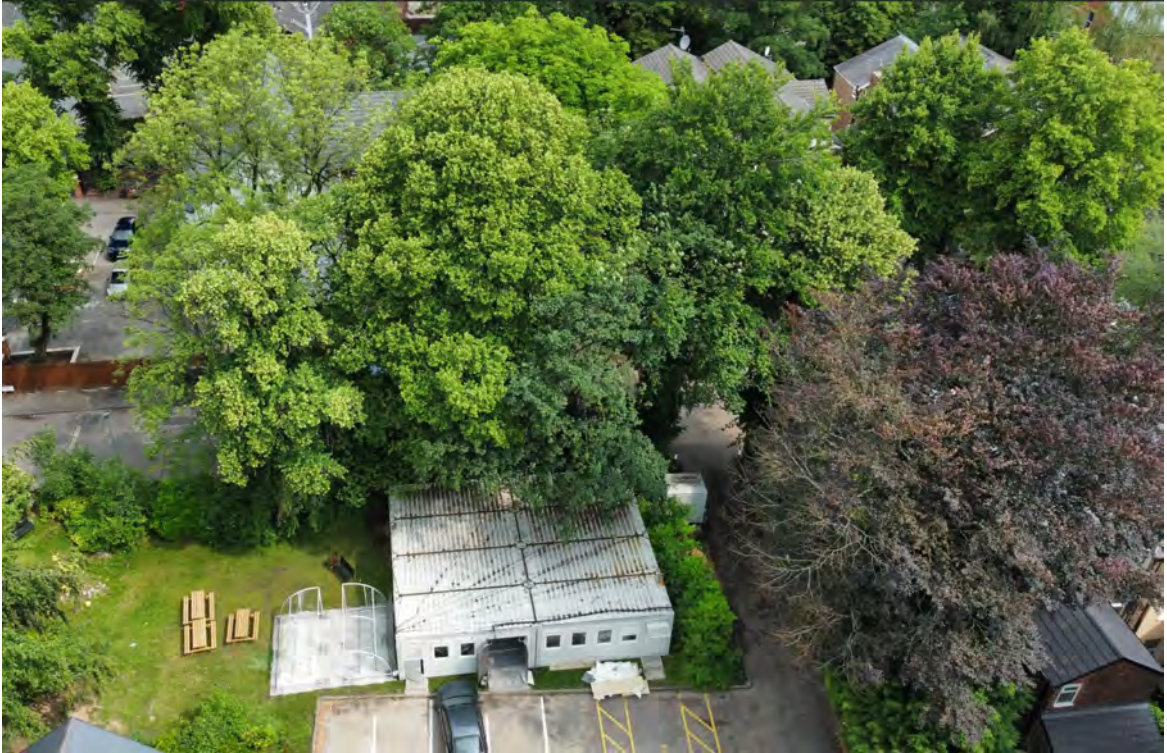
*Aerial image plate showing trees T7 to T19.*

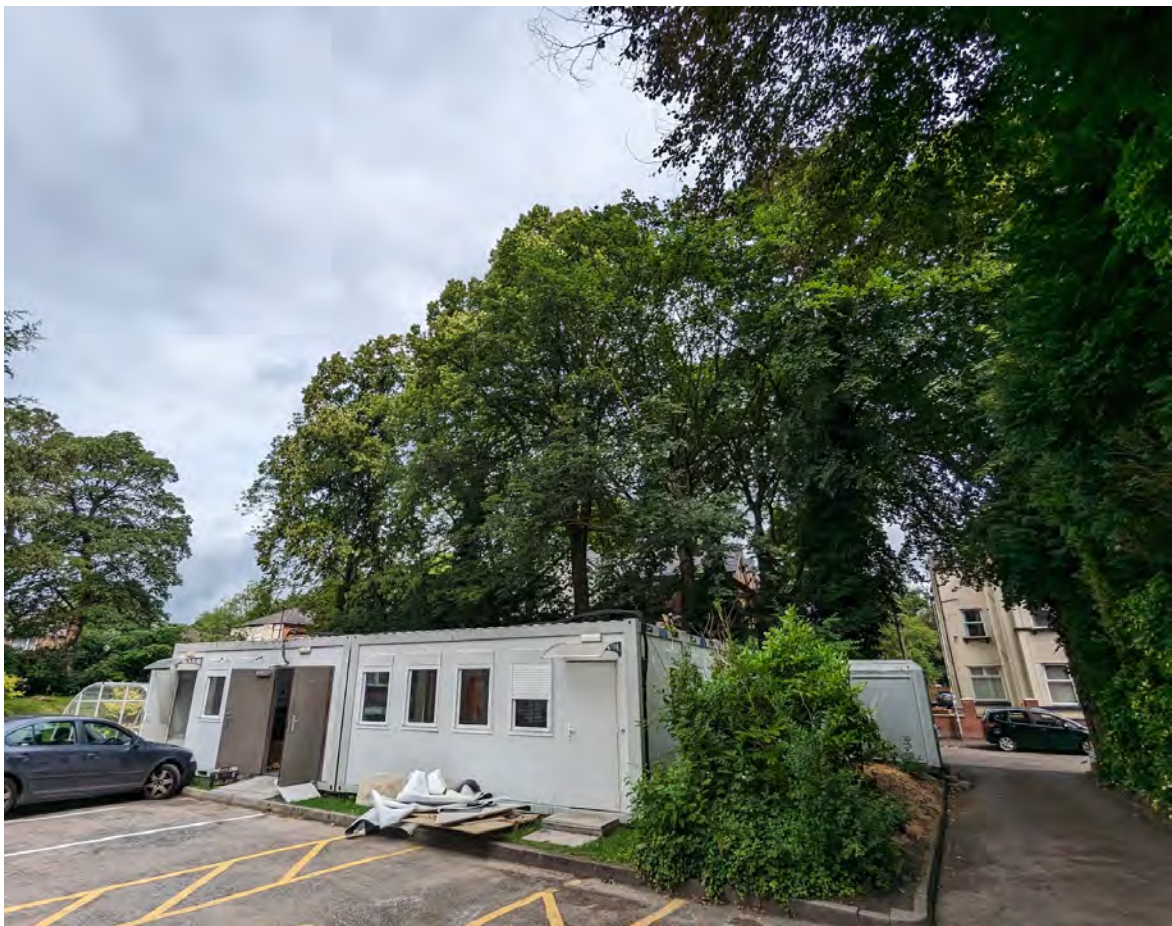
*Photographic plate showing T7 to T19.*

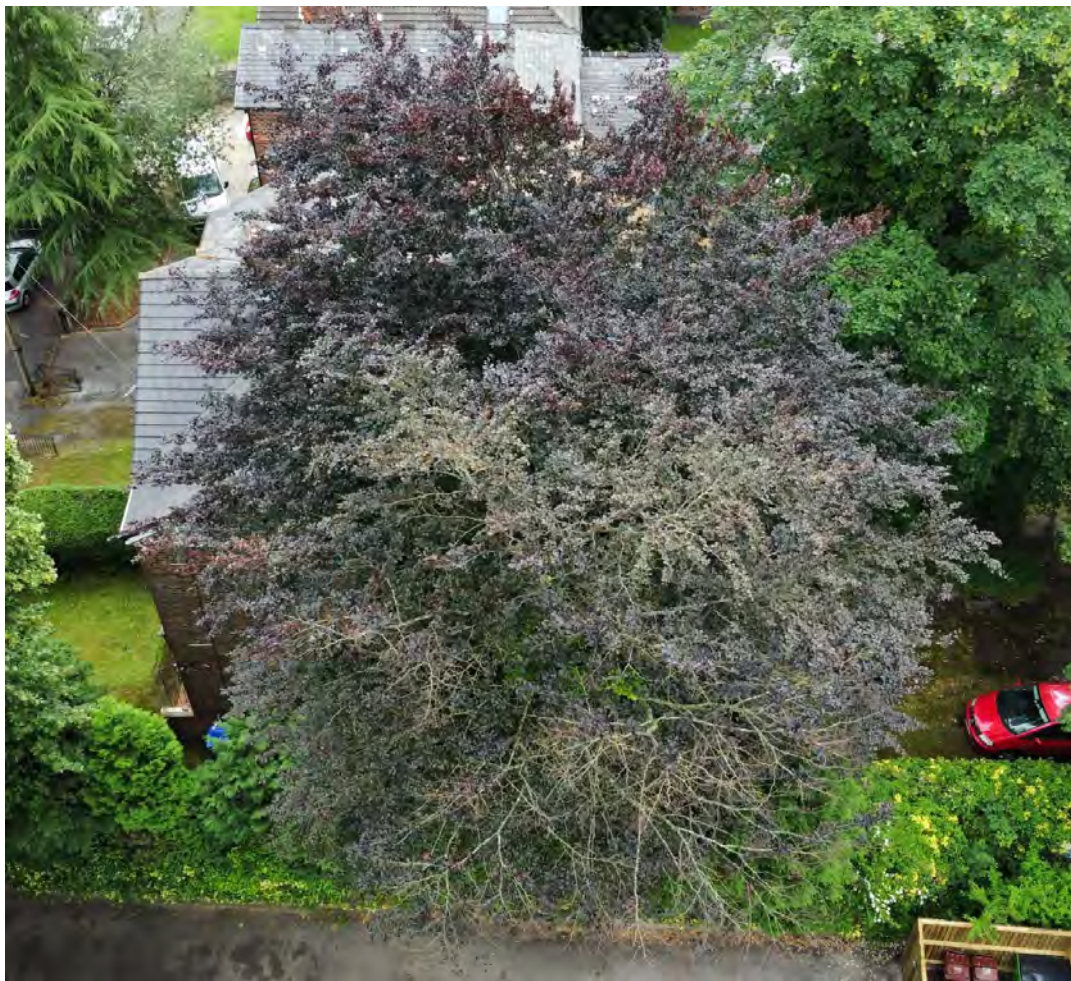
*Aerial image plate showing T25 with dieback present in the west side of the crown.*

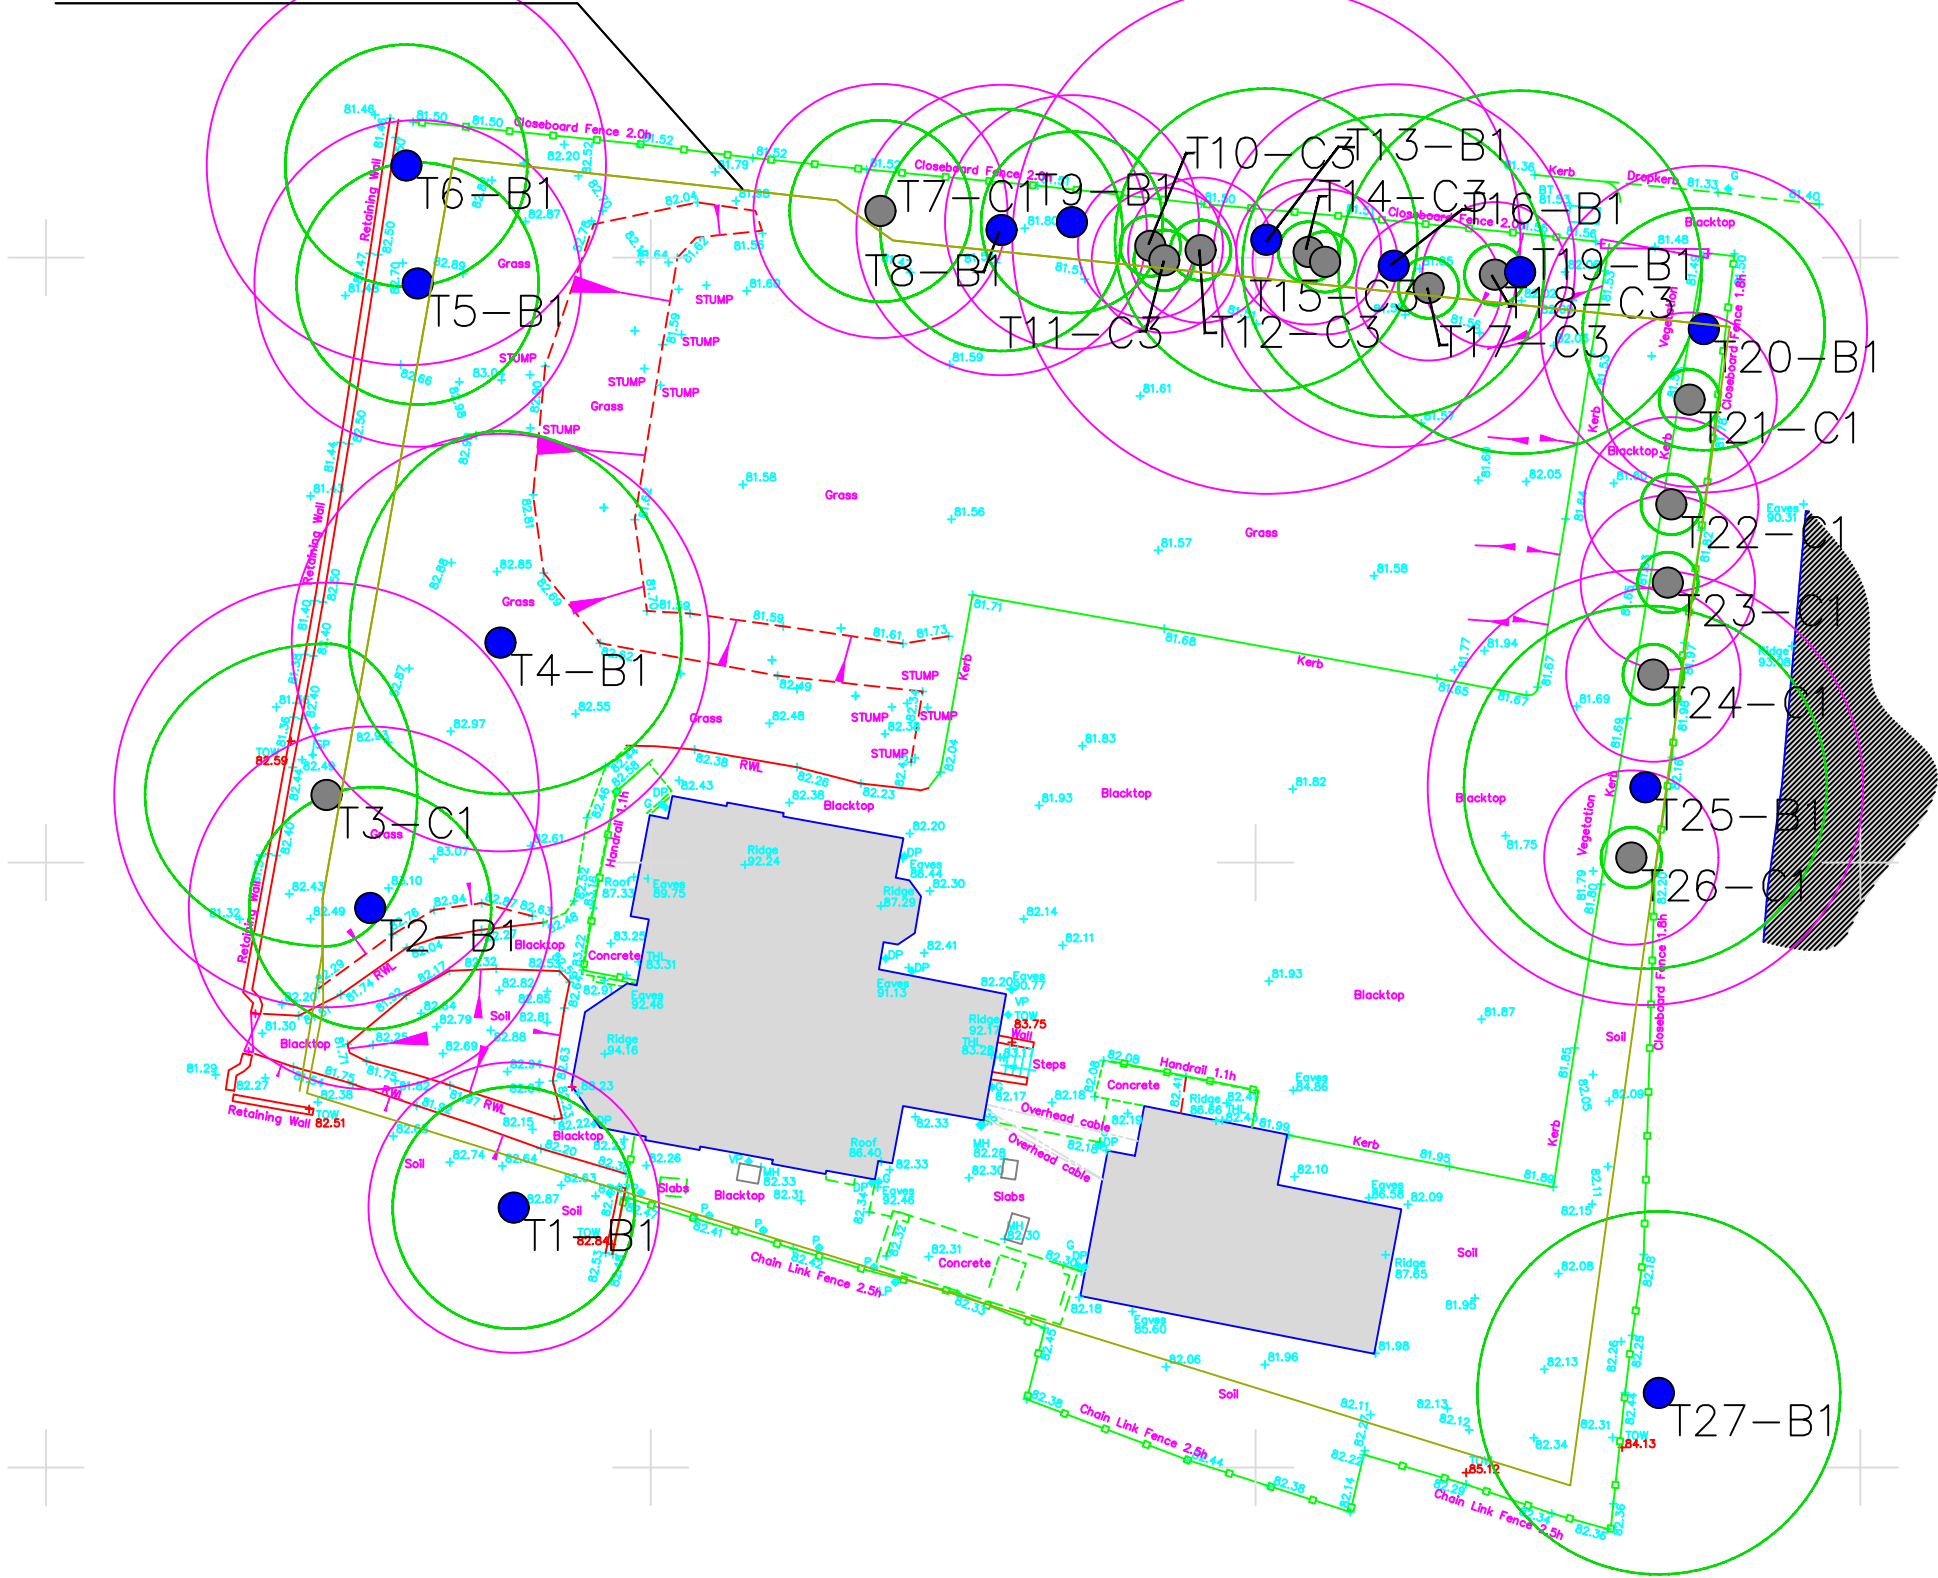
4.5.1. The security fence will be located within the radial root protection area of T1 to T27. Three options are available for the implementation of the fence posts in this area

Proposed weld mesh security fencing

1. The fence post can be dug by hand under the supervision of the project arborist. If any roots 25mm or below are discovered they may be pruned back using clean and sharp secateurs.
2. If the posts are to be driven in then each post location is required to be checked with a probe inserted into a minimum depth of 600mm in order to identify if any significant roots are present. If significant roots are discovered then the post location must be adjusted to avoid the roots. If no roots are present within the post location then the post can be driven in.
3. If concrete is to be used then the post hole will be required to be sleeved using sturdy plastic sheeting, ie 1200 gauge DPM, to prevent cement leachate entering the soil within trees' rooting areas.
