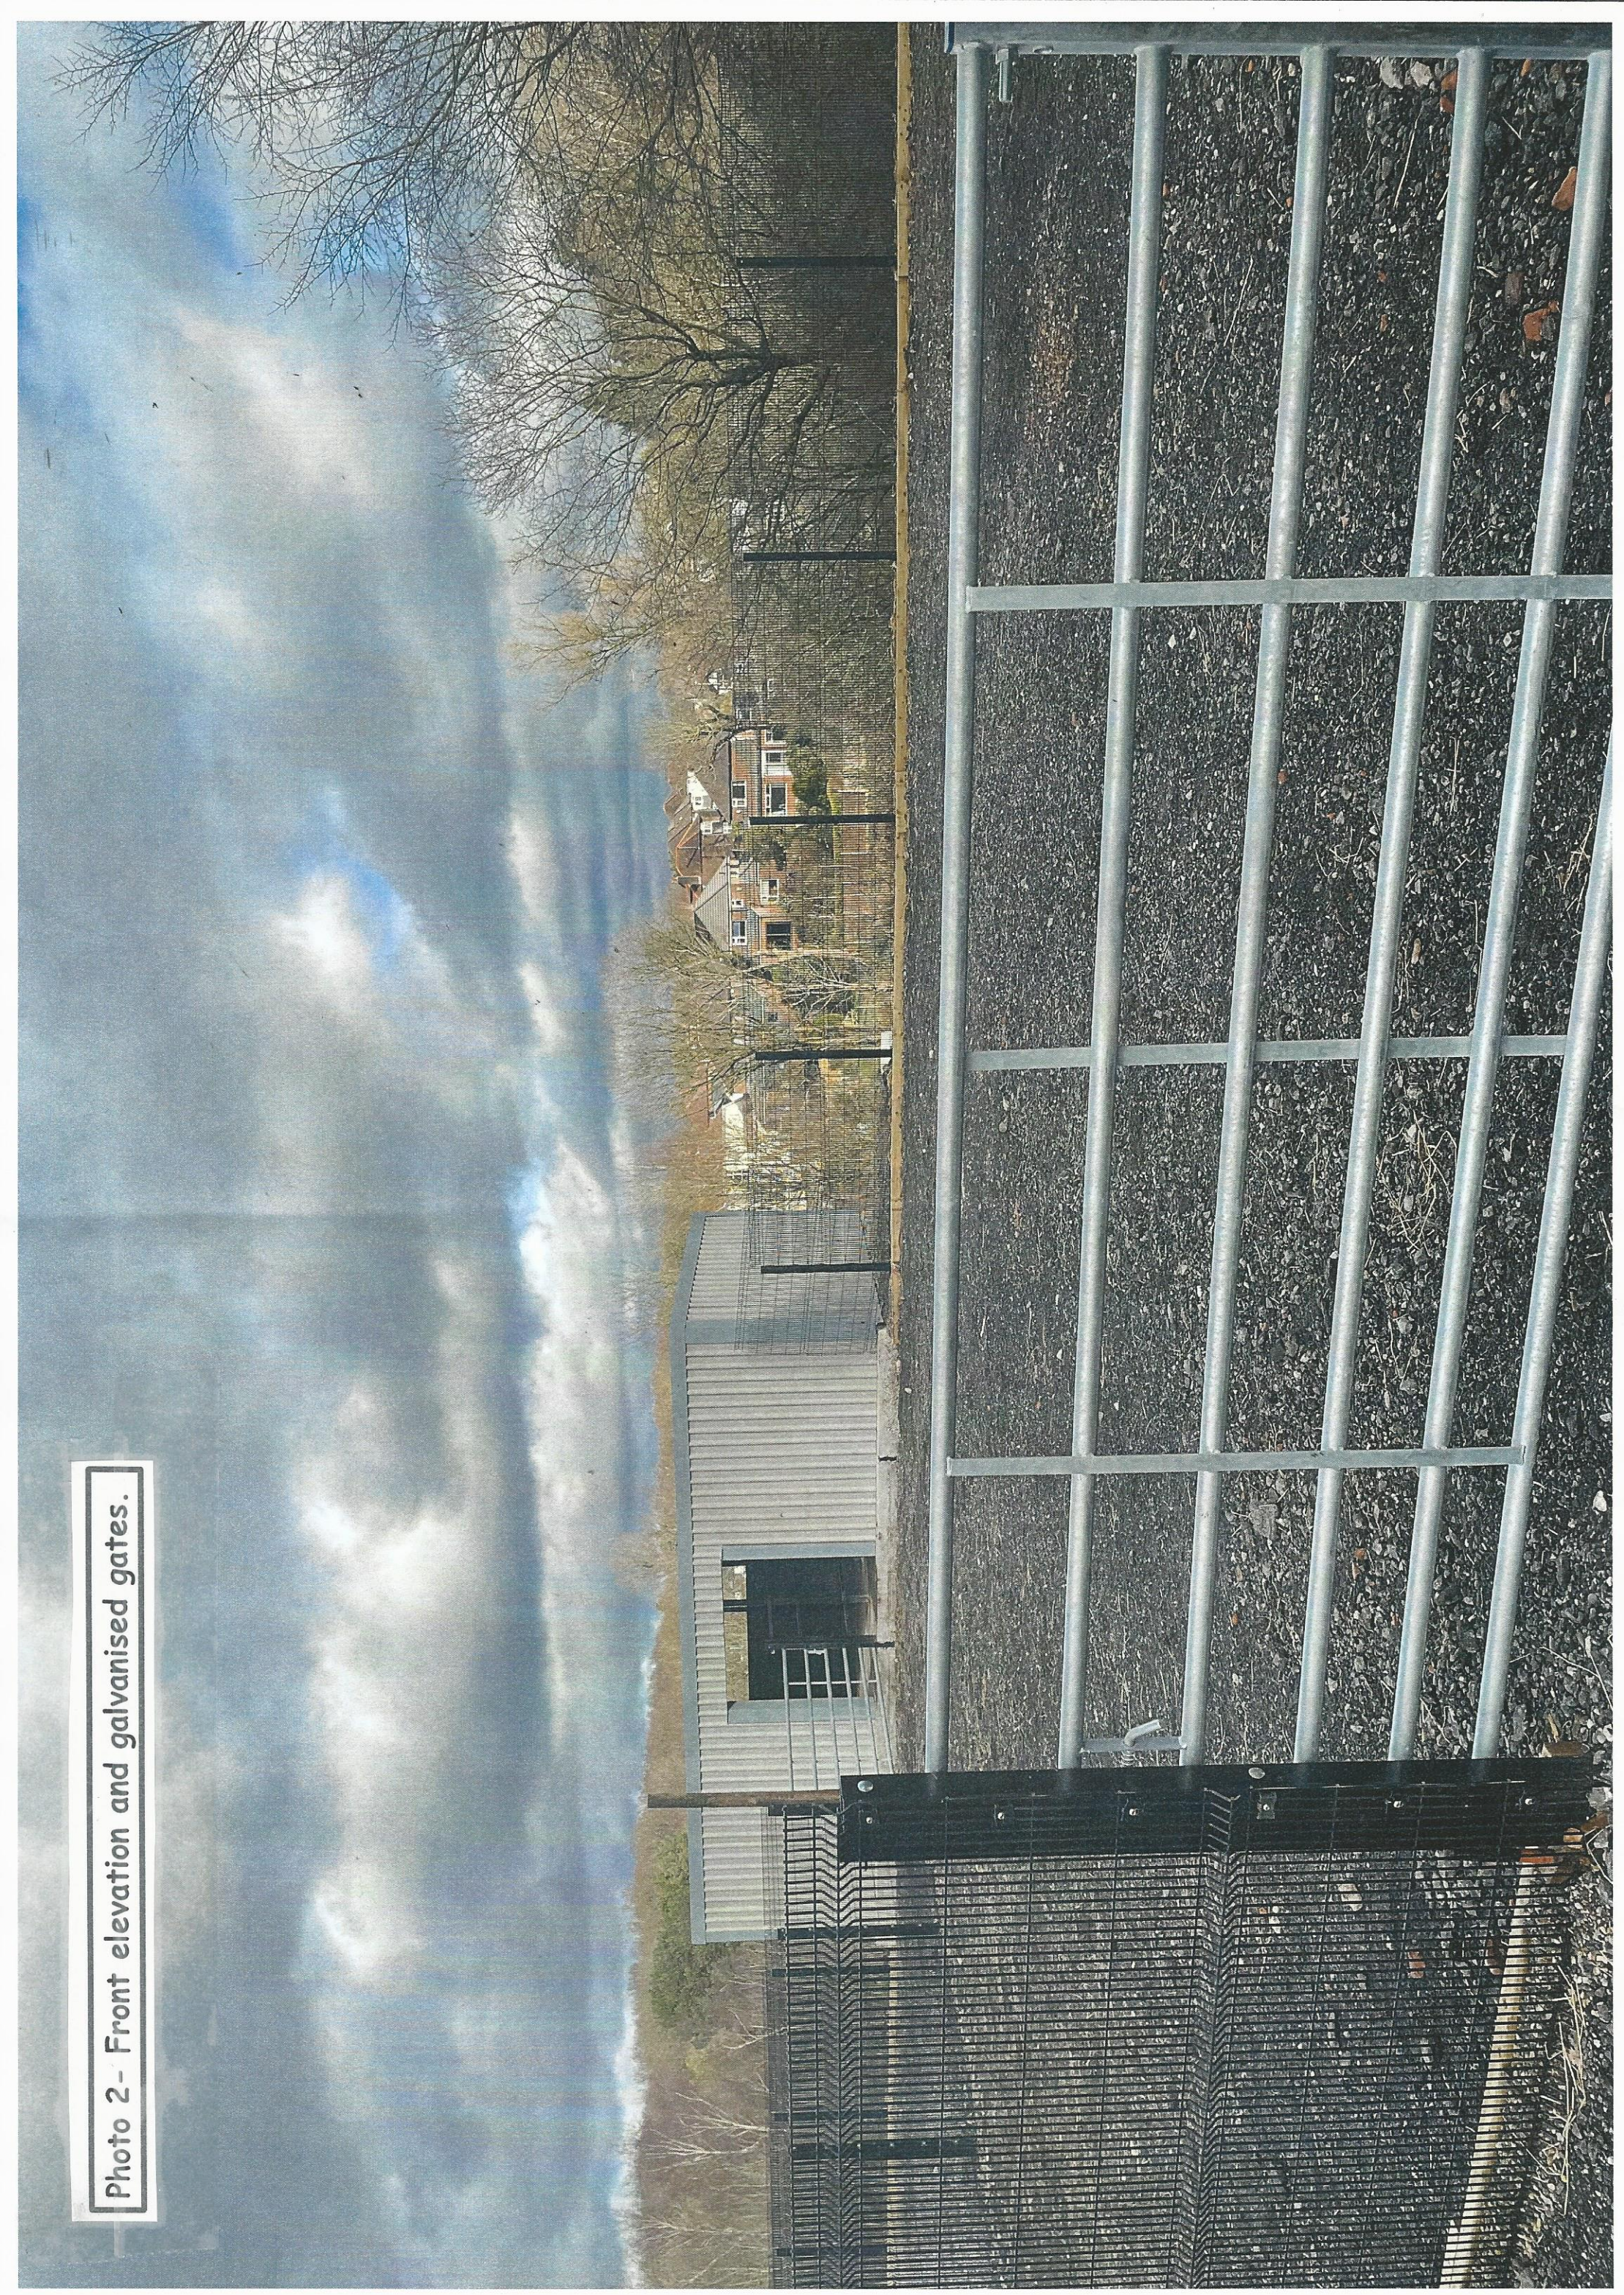
Photo 2- Front elevation and galvanised gates.
