# 182 BURNAGE ROAD, MANCHESTER

## Preliminary Bat Roost Assessment Report

*July 2023*

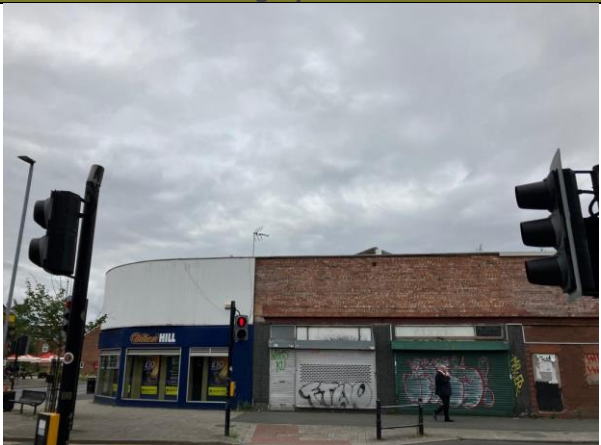
3.2.1. The site consisted of multiple two storey and single storey commercial units, most were vacant excluding the William Hill Betting Shop located on the south-eastern aspect of the buildings. The eastern and western aspects of the buildings consisted of red bricks throughout, this was found to be in moderate condition with some missing mortar identified. The missing mortar created some small gaps, the crevices were minor, and it is unlikely that they will lead into any further openings, they are not anticipated to be suitable to support crevice dwelling bat species.

| Feature | Photograph |
|---|---|
| Eastern aspect of the building | |

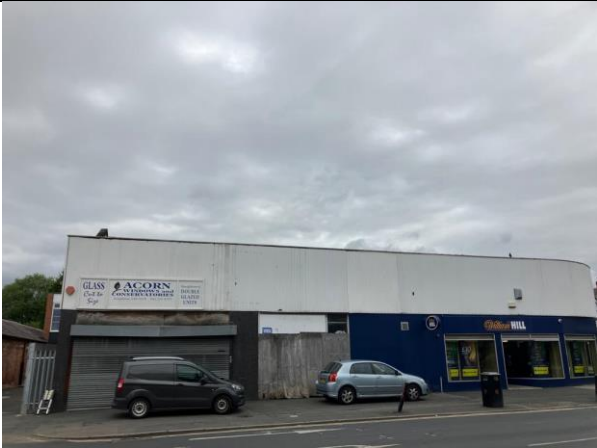
3.2.2. The southern aspects of the buildings consisted of metal sheets along the walls of the buildings, these were located above the commercial units which includes the vacant buildings and one building which is still currently open as a William Hill Betting Shop. Small gaps were identified along the top of the metal sheets, it is unknown if they lead any further to create a suitable roosting feature or possibly lead into the internal aspect of the dwelling. The northern aspect of the building was attached to a One Stop Shop (not included within the assessment), the brickwork along the buildings was connected to this shop.

| <p><i>Southern aspect of the building</i></p> | |

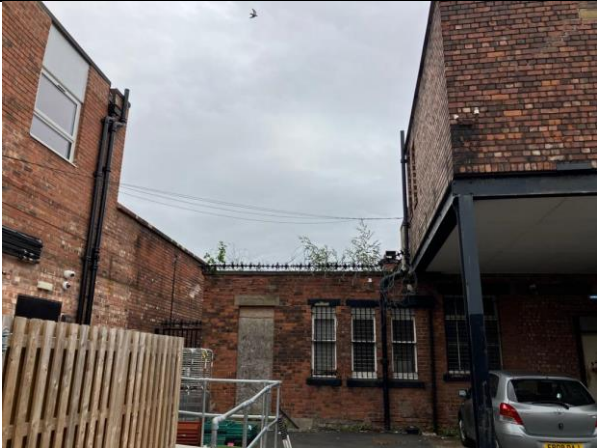
| <p><i>Western Aspect of the building.</i></p> | |

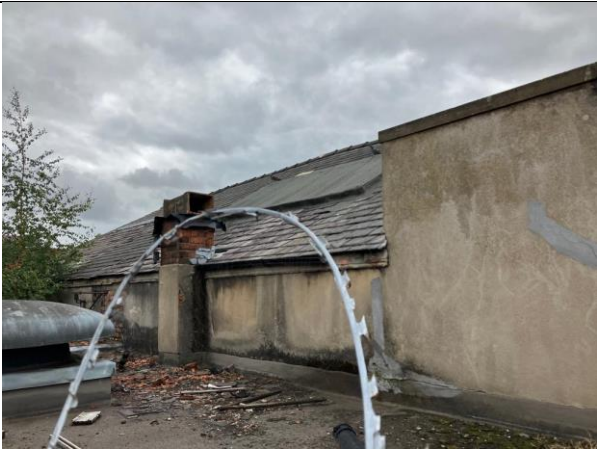
3.2.3. There was a very limited view of the roof on all aspects of the dwellings, a ladder was used on the western aspect of the buildings which allowed an inspection of the slate tiles located on the northern aspect. This identified a flat roof which connected to the elevated, pitched slate tile roof. The flat roof was found well sealed throughout this

inspection, it should be noted that not all of the flat roof was visible on this aspect, and it is possible that there were PRF's located out of sight, which would have been unobserved. The slate tile roof consisted of slipped and lifted tiles on this aspect, these were identified as a PRF as they may provide suitable shelter for local bat populations. It should be noted that internal access into this anticipated loft space was not possible, and it is unknown if there is internal access points into the dwelling along these tiles. It should also be noted that only the northern aspect of the slate tiles was visible and there could be more PRF's along the elevated slate tile roof which were missed throughout the survey.

| <p><i>Roof visible using ladders for the inspection.</i></p> | |

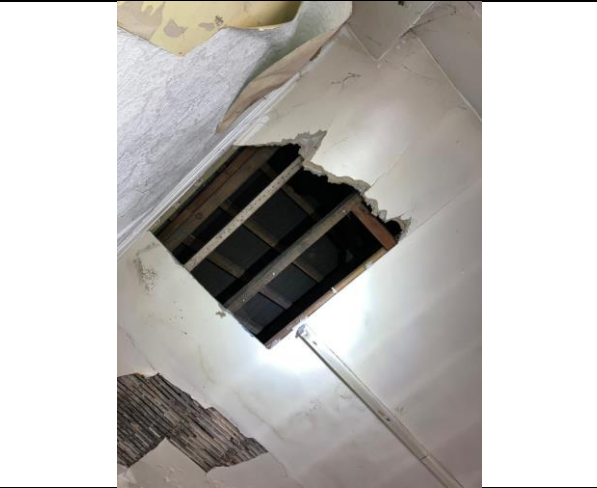
3.2.6. A singular loft space was visible throughout one of the buildings located southeast of the commercial units, this was separated internally from the building mentioned in point 3.2.5. by internal walls. The loft space consisted of roofing felt with supporting wooden beams, this was visible from the ground floor as the ceiling had also collapsed (Please refer to photos in table 3.1). There were no access points to further assess this loft space and it is unknown if bats are present within this area. There was no evidence of pigeons within the building and no obvious access points were identified. The William Hill Betting Shop was located on the southeastern aspect of the buildings, this was an active shop which is still used, this is not anticipated to provide any roosting features along the ground floor. There was no access to a potential first floor above this shop and therefore it is unknown if bats are present in this area.

| <p><i>Loft space area which was visible in one building.</i></p> | |

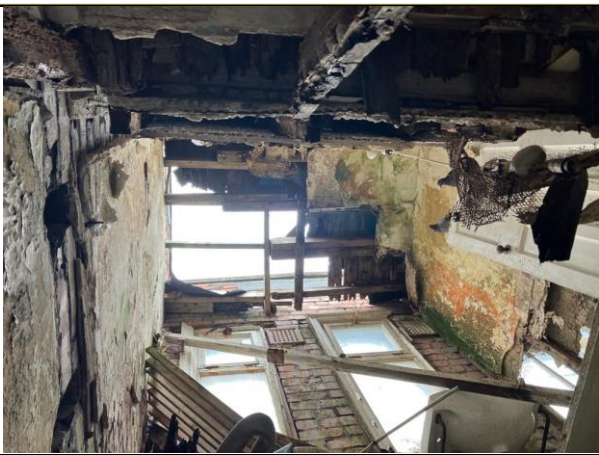
3.2.5. The second building along could be accessed throughout the survey which consisted of previously sealed rooms along the ground floor, numerous holes were identified along the roof on the ground floor where the ceilings and external roof had collapsed. A staircase was located within this dwelling however the first floor surrounding this staircase was found to have collapsed, therefore was considered unsafe to access. This collapsed area showed a large gap along the roof of the building, allowing internal access throughout the building. It should also be noted that a large number of pigeons (*Columba livia domestica*) were found within the building, that are anticipated to be utilising this large access point. This gap allows access throughout the building which may also be used by bats.

| <p><i>Large gap identified located at the staircase.</i></p> | |

- 4.3.1. Pigeons were identified throughout the building and can access the building through the large gap that leads externally. Pigeons nest all year round and therefore a suitably qualified ecologist should undertake a nesting bird check no more than 48 hours prior to removal. If nesting activity is observed, the nest(s) should be left in situ until the young have fledged. A suitable buffer will be maintained and determined by the ecologist.

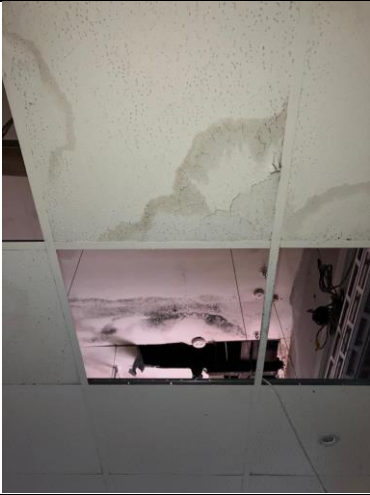
| <p><i>Holes throughout ceiling.</i></p> | |
