# **Tree Survey BS5837:2012**

Land at Lathbury Road, Manchester, M9 5GN

Jigsaw Homes Group

Revision B - October 2023

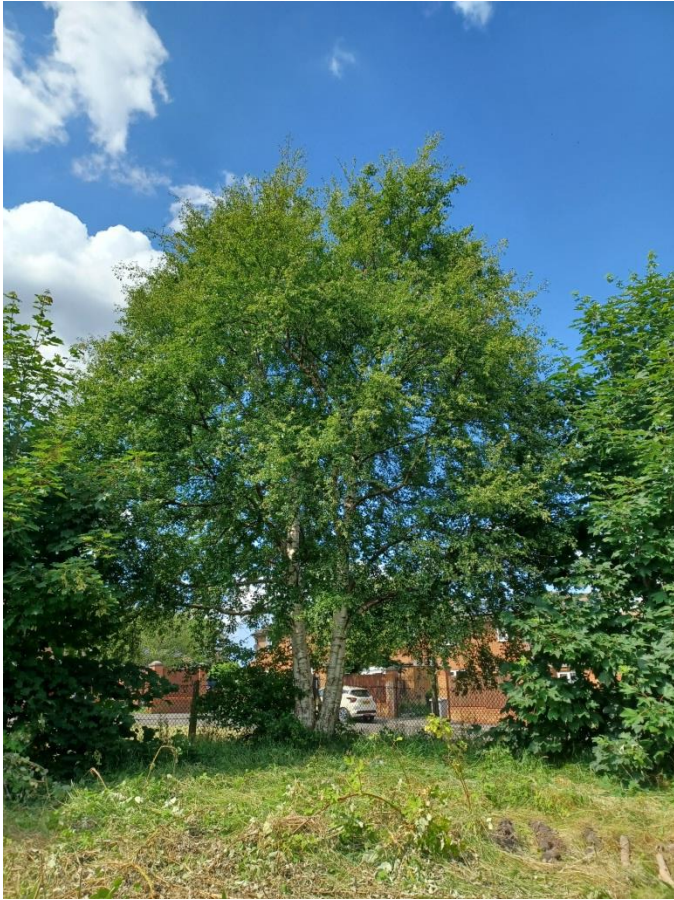
Photograph 1: Tree T1

| Tree reference | Species | Life stage | Estimated height (metres) | Estimated crown height (metres) | Estimated crown spread (metres)<br>N<br>W S E | Stem diameter (mm) | Physiological condition | Structural condition | Observations | Estimated remaining contribution (years) | Retention category |
|---|---|---|---|---|---|---|---|---|---|---|---|
| T1 | Silver birch<br><i>Betula pendula</i> | EM | 12 | 2 | 5<br>3 4<br>4 | Twin<br>292<br>339 | Good | Good | Twin-stemmed from base | 20+ | B1 |

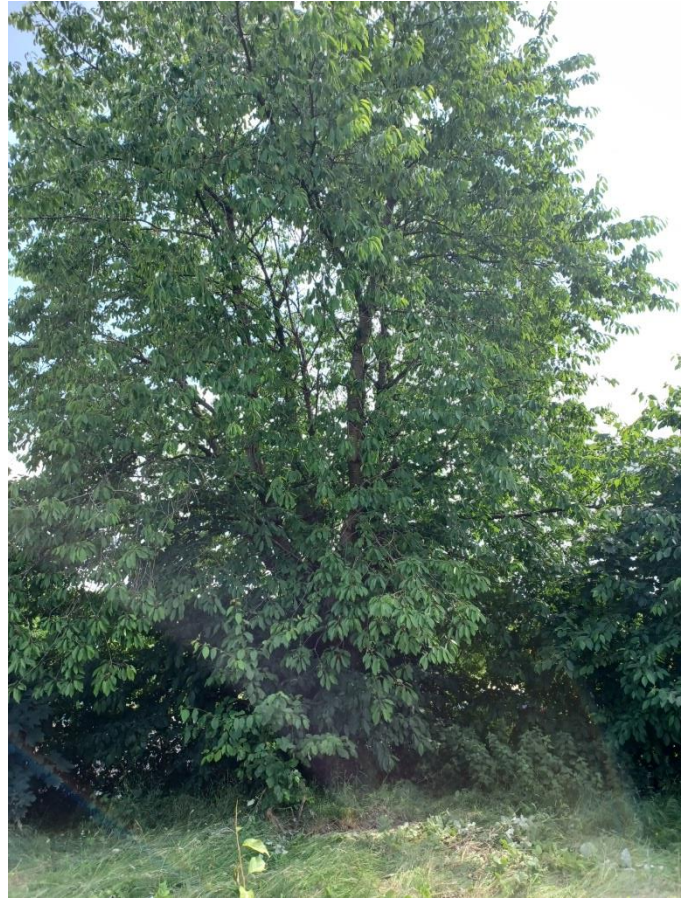
Photograph 2: Tree T2

| Tree reference | Species | Life stage | Estimated height (metres) | Estimated crown height (metres) | Estimated crown spread (metres)<br>N<br>W S E | Stem diameter (mm) | Physiological condition | Structural condition | Observations | Estimated remaining contribution (years) | Retention category |
|---|---|---|---|---|---|---|---|---|---|---|---|
| T2 | Cherry<br><i>Prunus avium</i> | M | 16 | 1.5 | 7<br>6 6<br>8 | 789 | Good | Good | Large cherry in corner of site. Good canopy cover and large number of fruits present. | 40+ | A1 |

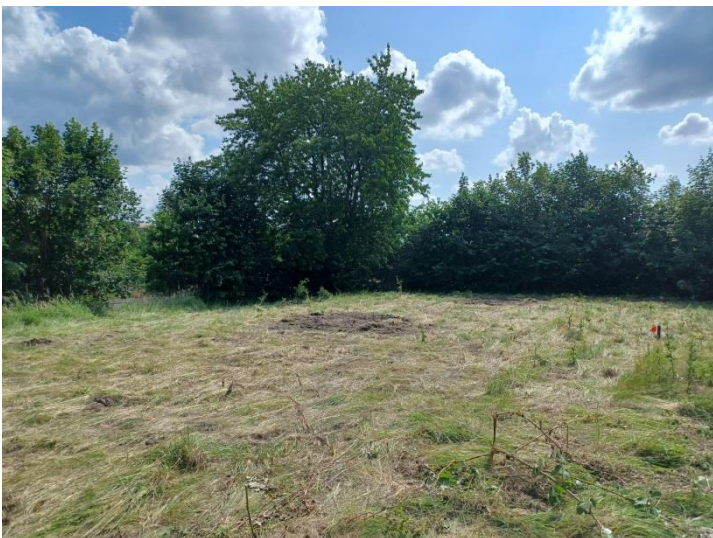
Photograph 3: Tree T2 with groups G2, G3 & G4

| Tree reference | Species | Life stage | Estimated height (metres) | Estimated crown height (metres) | Estimated crown spread (metres)<br>N<br>W S E | Stem diameter (mm) | Physiological condition | Structural condition | Observations | Estimated remaining contribution (years) | Retention category |
|---|---|---|---|---|---|---|---|---|---|---|---|
| G2 | Sycamore & Cherry | Y | 6 – 8 | 0.5 | 3<br>3 3<br>3 | Average multi-stem<br>90 | Good | Poor | Group of self-seeded multi-stemmed sycamore with shorter cherry saplings spreading from adjacent cherry tree. Poor growth form. | 20+ | C2 |
| G3 | Sycamore & Cherry | Y | 6 | 0.5 | 2<br>2 2<br>2 | Average<br>70 | Good | Poor | Group of 2 or 3 self-seeded multi-stemmed sycamore with several young cherry saplings. Poor growth form. | 20+ | C2 |
| G4 | Sycamore & Ash | Y | 5 – 6 | 1 | 2<br>2 2<br>2 | Average multi-stem<br>180 | Fair | Poor | Small group of two sycamore trees and one ash tree – all self-seeded and multi-stemmed. Also a small ash sapling showing ash dieback infection <i>Hymenoscyphus fraxineus</i> . Poor growth form. | 20+ | C2 |

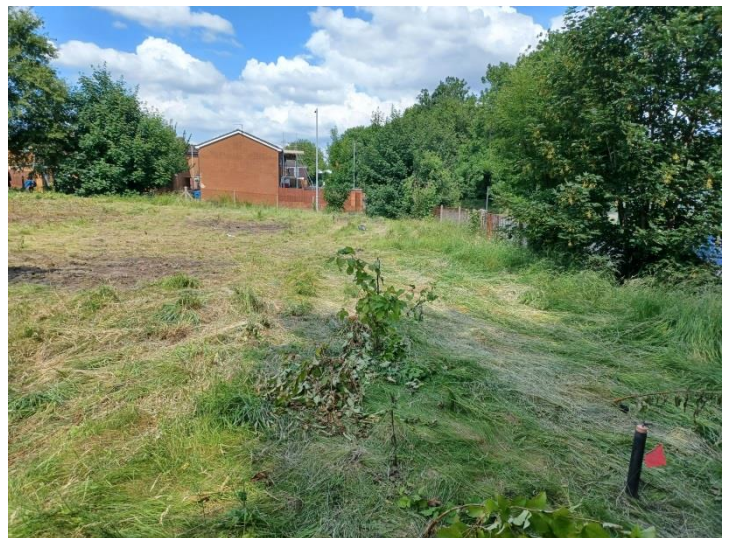
Photograph 4: Groups G4, G5 & G6

| Tree reference | Species | Life stage | Estimated height (metres) | Estimated crown height (metres) | Estimated crown spread (metres)<br>N<br>W S E | Stem diameter (mm) | Physiological condition | Structural condition | Observations | Estimated remaining contribution (years) | Retention category |
|---|---|---|---|---|---|---|---|---|---|---|---|
| G5 | Sycamore & Ash | Y | 6 – 7 | 0.5 | 2<br>2 2<br>2 | Average<br>73 | Fair | Poor | Group of several self-seeded multi-stemmed sycamores with a couple of ash trees and some ash saplings. Ash saplings showing signs of dieback infection <i>Hymenoscyphus fraxineus</i> . Poor growth form. | 20+ | C2 |
| G6 | Sycamore | Y | 8 | 0.5 | 2<br>2 2<br>2 | Average<br>71 | Good | Poor | Group of approximately 6 self-seeded sycamore trees. | 20+ | C2 |
