# ARBORICULTURAL IMPLICATIONS ASSESSMENT AND METHOD STATEMENT

LAND ADJACENT VIRGIL STREET  
CORNBROOK  
MANCHESTER  
M15 4ED

July 2023

Job Number 5145

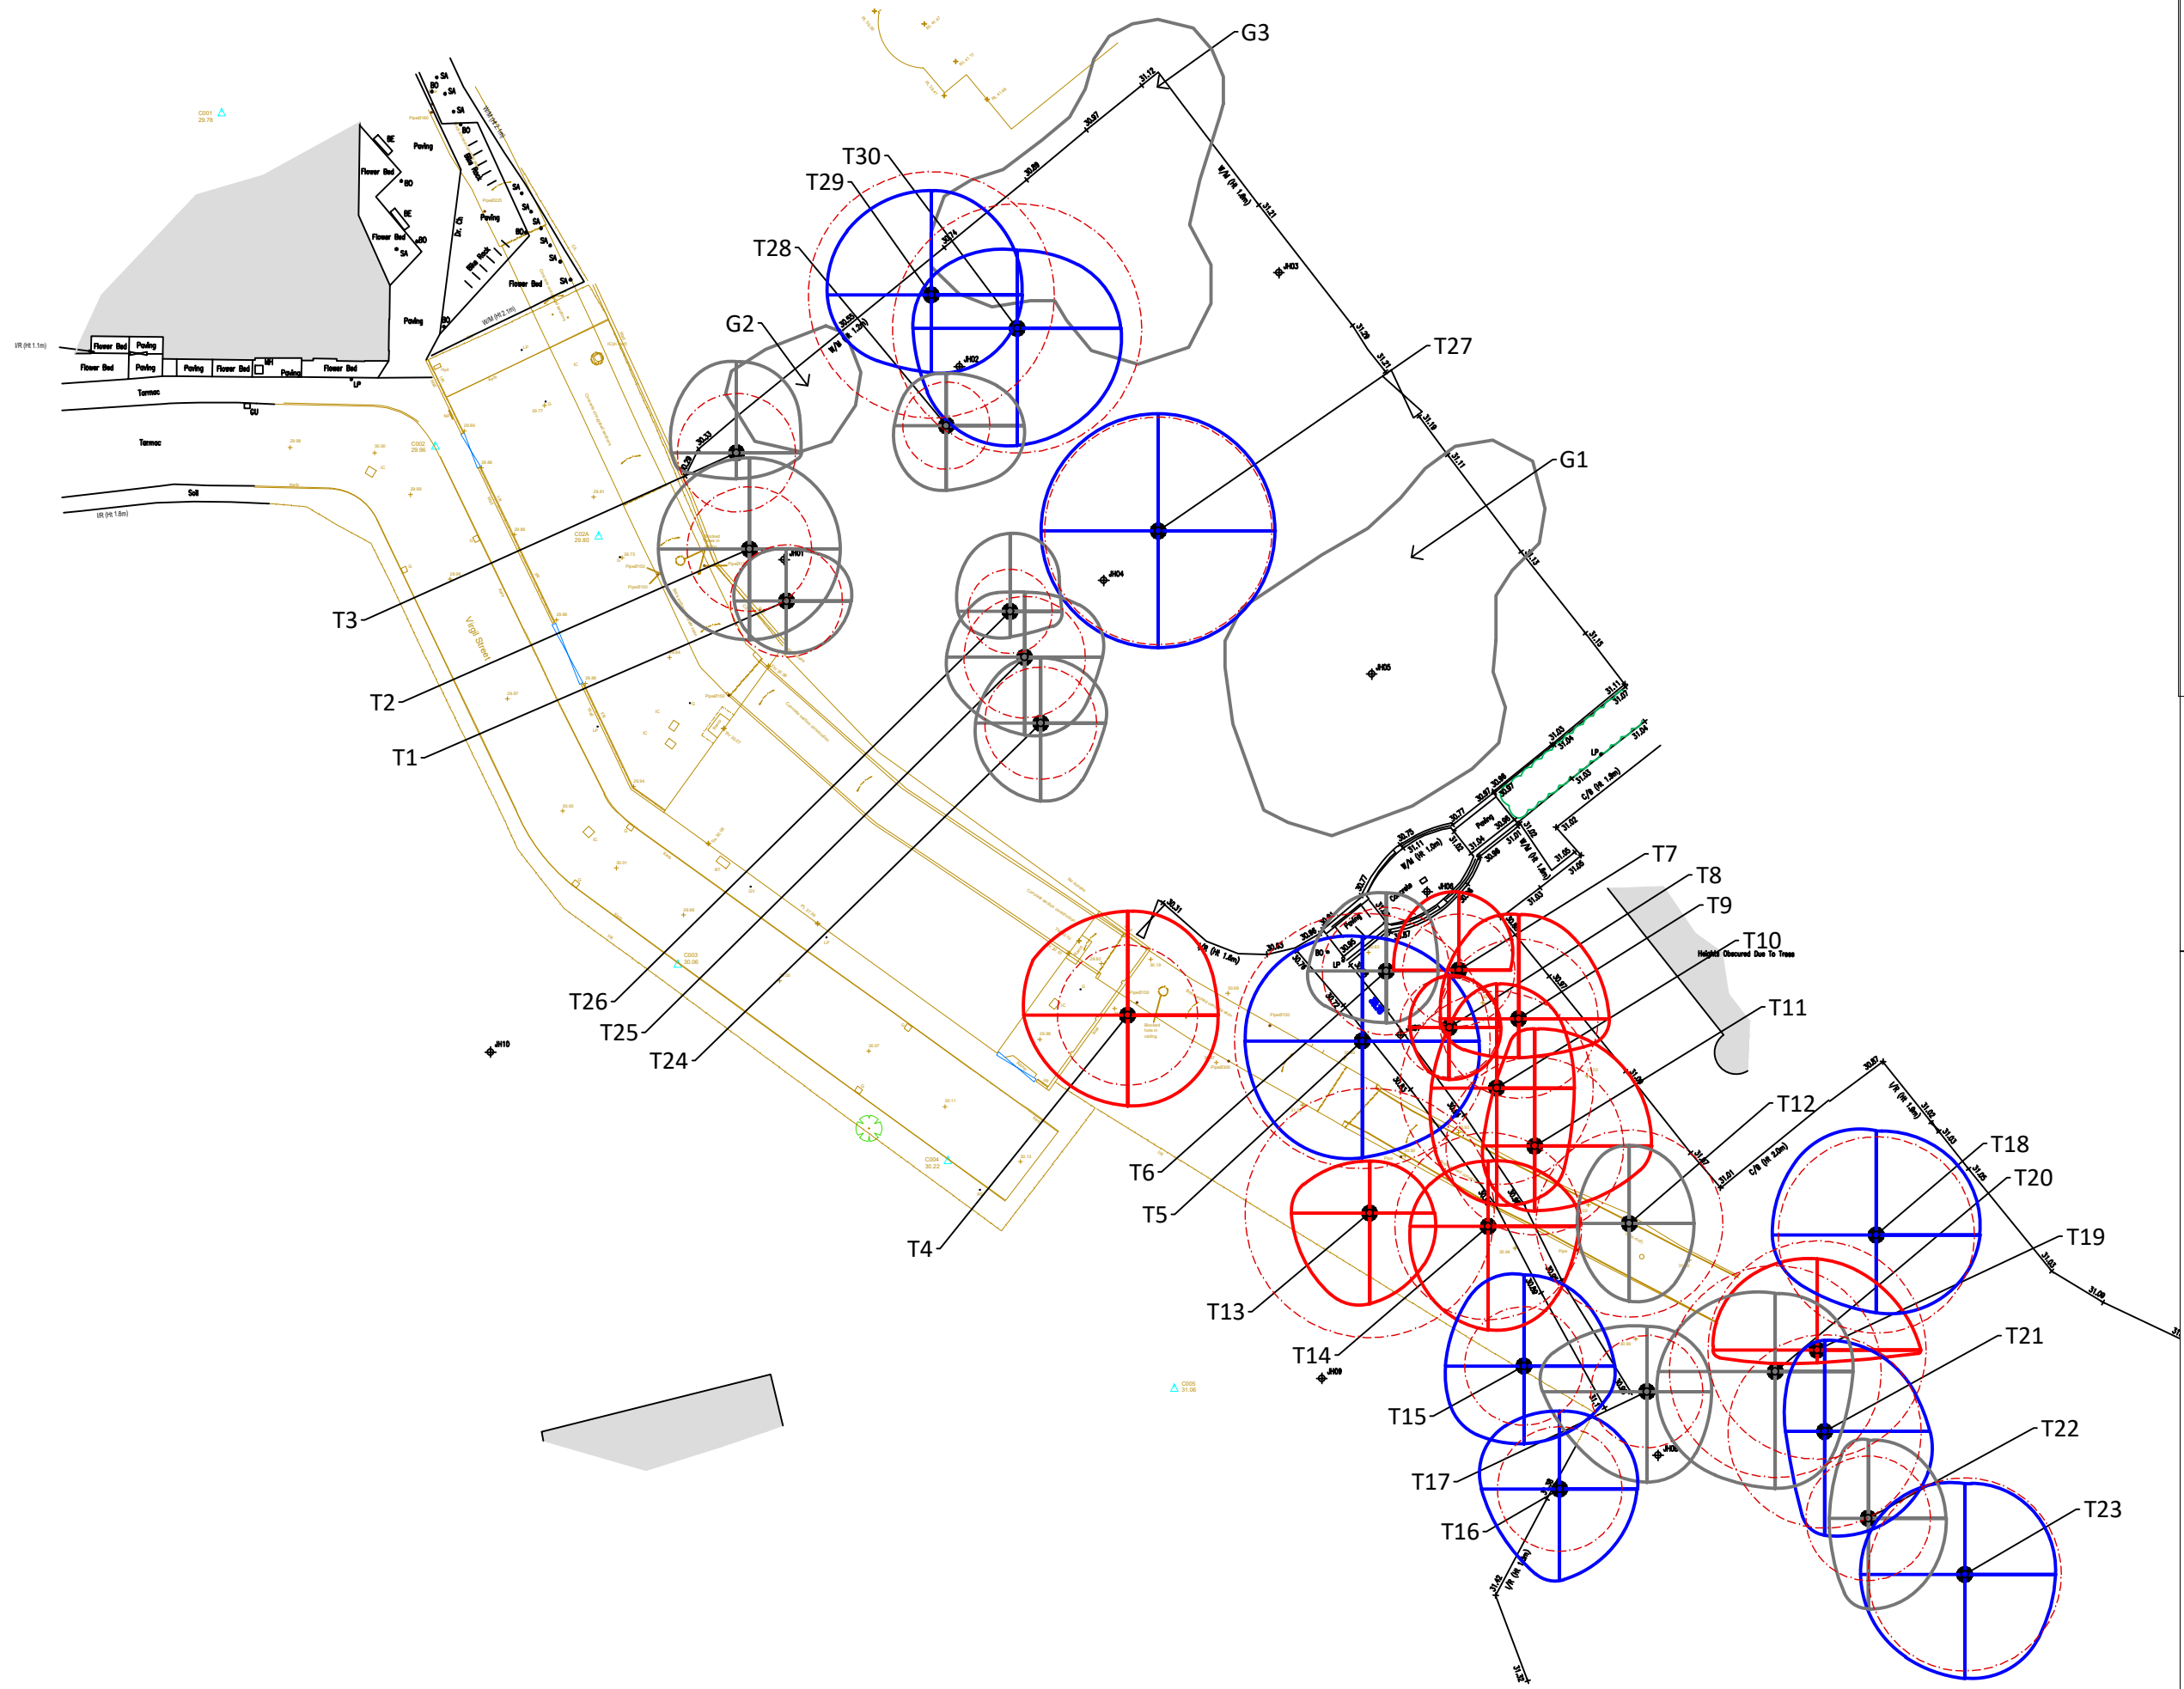
| Arboricultural Data Sheet: Land adjacent Virgil Street, Cornbrook, Manchester, M15 4ED    Date of Survey: 06/01/23    Weather: Overcast    Surveyor: PM | | | | | | | | | | | | | | | | |
|---|---|---|---|---|---|---|---|---|---|---|---|---|---|---|---|---|
| T4 | Norway Maple | 450 | 14 | M | 8 | 7 | 7 | 8 | 2.5 | B/C | Locate close to the building. Significant fire damage on the stem, which will rapidly decay. Reasonable overall form and vigour. Minor deadwood present. Very low potential. | Fell to ground level. | 5-10 | U | 91.61 | 5.40 |

| Tree No. | Species | Dbh (mm) | Height (m) | Age | Crown Spread | | | | Crown C | Cond R | Observations and Comments | Preliminary Recommendations | ERC (Yrs) | TQC R | RPA (m²) | RPA Circle Radius (m) |
|---|---|---|---|---|---|---|---|---|---|---|---|---|---|---|---|---|
| T7 | Whitebeam | 360 | 8 | M | 6 | 4 | 0 | 5 | 2 | C/D | Exhibits major stem decay, imminent risk of complete failure. | Fell to ground level, grind out stump and replace. | 0-5 | U | 58.63 | 4.32 |
| T8 | Whitebeam | 320 | 10 | M | 4 | 4 | 4 | 3 | 3 | C/D | Exhibits major stem and basal decay, imminent risk of complete failure. | Fell to ground level, grind out stump and replace. | 0-5 | U | 46.32 | 3.84 |
| T9 | Bird Cherry | 510 | 11 | FM | 8 | 7 | 3 | 6 | 1.8 | B/C | A large specimen with reasonable vigour but has some decay present in the lower stem and base. There is also the presence of the decay fungus <i>Ganoderma spp</i> on the eastern side at base. Crown asymmetry due to group. Low potential. | Fell to ground level, grind out stump and replace. | 5-10 | U | 117.67 | 6.12 |
| T10 | Norway Maple | 620 | 16 | M | 8 | 6 | 9 | 5 | 4 | C | Has suffered major limb loss at 2m on the northern side and western side resulting in extensive stem decay, which will be rapidly hollowing out. Exhibits major crown asymmetry with very low potential. | Fell to ground level, grind out stump and replace. | 5-10 | U | 173.90 | 7.44 |
| T11 | Norway Maple | 570 | 16 | M | 9 | 9 | 5 | 4 | 3 | C | A poor specimen with an acute northern lean. Exhibits major stem decay on the eastern side, most likely due to fire damage. Hollowing out near base. Very low potential. | Fell to ground level, grind out stump and replace. | 5-10 | U | 146.98 | 6.84 |
| T13 | Elm | 800 | 10 | M | 4 | 5 | 7 | 6 | 3 | D | A dead tree multi-stemmed at base. | Fell to ground level and replace. | n/a | U | 289.53 | 9.60 |
| T14 | Bird Cherry | 600 | 10 | FM | 5 | 7 | 8 | 6 | 1.8 | C | A large specimen with reasonable vigour but has stem decay present. Broken lower branch. There is also the presence of the decay fungus <i>Ganoderma spp</i> on the northern side at base. Crown asymmetry due to group. Low potential. | Fell to ground level, grind out stump and replace. | 5-10 | U | 162.86 | 7.20 |

| Tree No. | Species | Dbh (mm) | Height (m) | Age | Crown Spread | | | | Crown C | Cond R | Observations and Comments | Preliminary Recommendations | ERC (Yrs) | TQC R | RPA (m²) | RPA Circle Radius (m) |
|---|---|---|---|---|---|---|---|---|---|---|---|---|---|---|---|---|
| T19 | Norway Maple | 700 | 16 | M | 7 | 8 | 1 | 8 | 1.8 | C/D | This tree has suffered major limb loss due to included union. The remainder of the stem is fragile and there is significant decay present. | <b>Fell to ground level, grind out stump and replace.</b> | 0-5 | U | 221.67 | 8.40 |
