## **DESIGN, ACCESS & HERITAGE STATEMENT**

### Broomcroft Hall Boundary Wall, Didsbury, Manchester, M20 2RU

## PN 8529 BOUNDARY WALLS, REPLACEMENT OF SECTION OF BOUNDARY WALL WITH HEDGE, BROOMCROFT HALL, DIDSBURY, UNIVERSITY OF MANCHESTER.

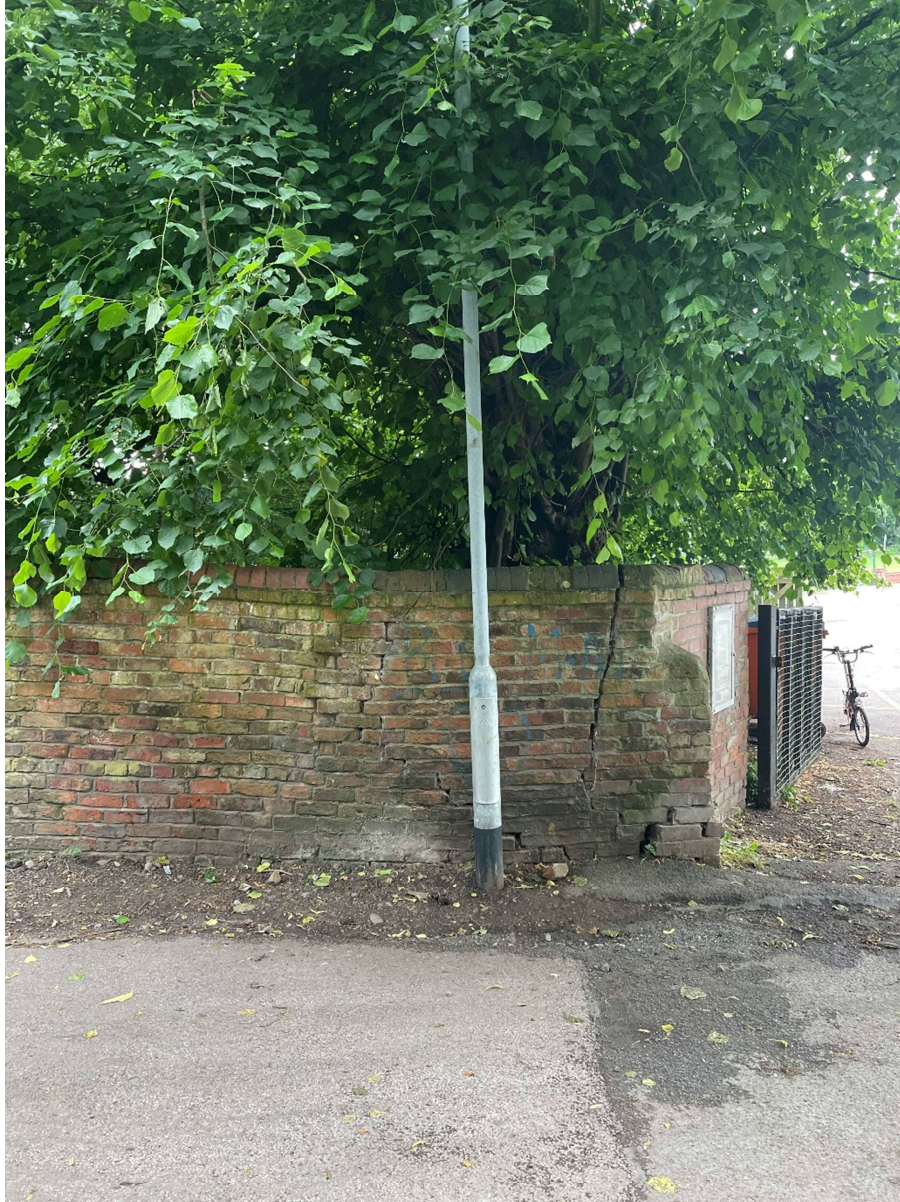
- 2.21 The 4-metre section of wall has suffered structural movement, with cracking in several areas and displacement of bricks at the base of the pier. The University has taken advice from a Structural Engineer who has advised that the movement is progressive, and the wall is unstable and needs rebuilding. Appendix 1, Email 1.

It is clear that the adjacent tree has grown too large and physically damaged this brickwork, to the extent that the wall is now unstable and must be taken down. Rebuilding is not thought to be feasible as any new foundation excavations would sever the main roots of the tree, leading to further instability.

**Photo 1.** Damaged wall section along Ford Lane

- 2.11 Planning permission is sought to replace a 4-metre section of Broomcroft Hall's brick boundary wall with a hawthorn hedge.

The best alternative would be an organic solution, such as a hedgerow, or a mesh fence with posts located away from any vulnerable roots.

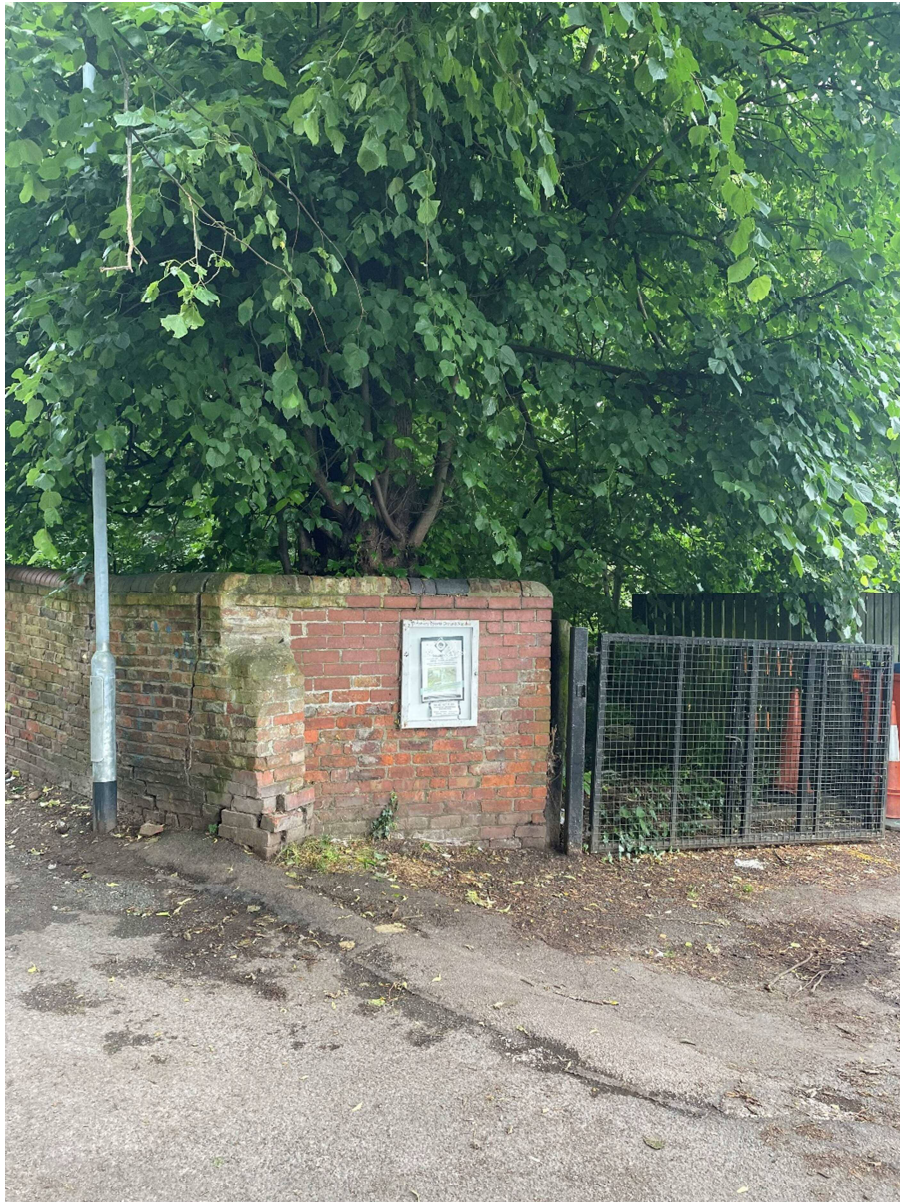
- 2.22 The damaged wall is adjacent to a pavement on Ford Lane, with a return at the entrance to Didsbury Sports Ground, as shown in Appendix 1, Photos 1 and 2.

**Photo 2.** Return wall section at entrance to Sports Ground

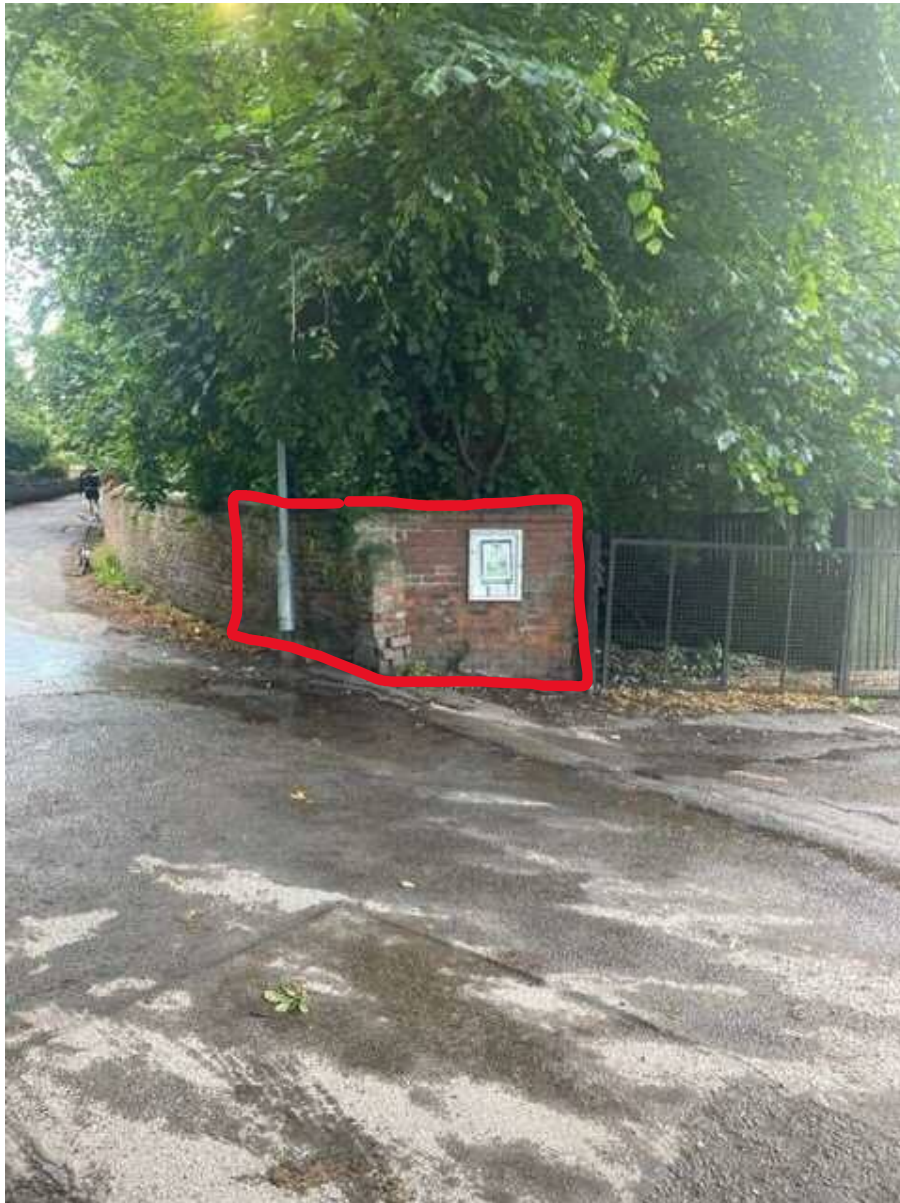
- 2.23 Immediately behind the section of damaged wall is a lime tree, approximately 80 years old. It is likely that the close proximity of the tree to the wall has caused the wall to move and become unstable. The University has been advised by a tree consultant that we cannot rebuild the wall without having significant implications to the health of the tree. Appendix 1, Email 2. It is therefore proposed to remove the wall and to replace it with a hedge in order to retain the tree. Photos 3 and 4 in Appendix 1 show the damaged wall section that we propose to remove.

**Photo 3.** Red outline shows the proposed wall section to be removed

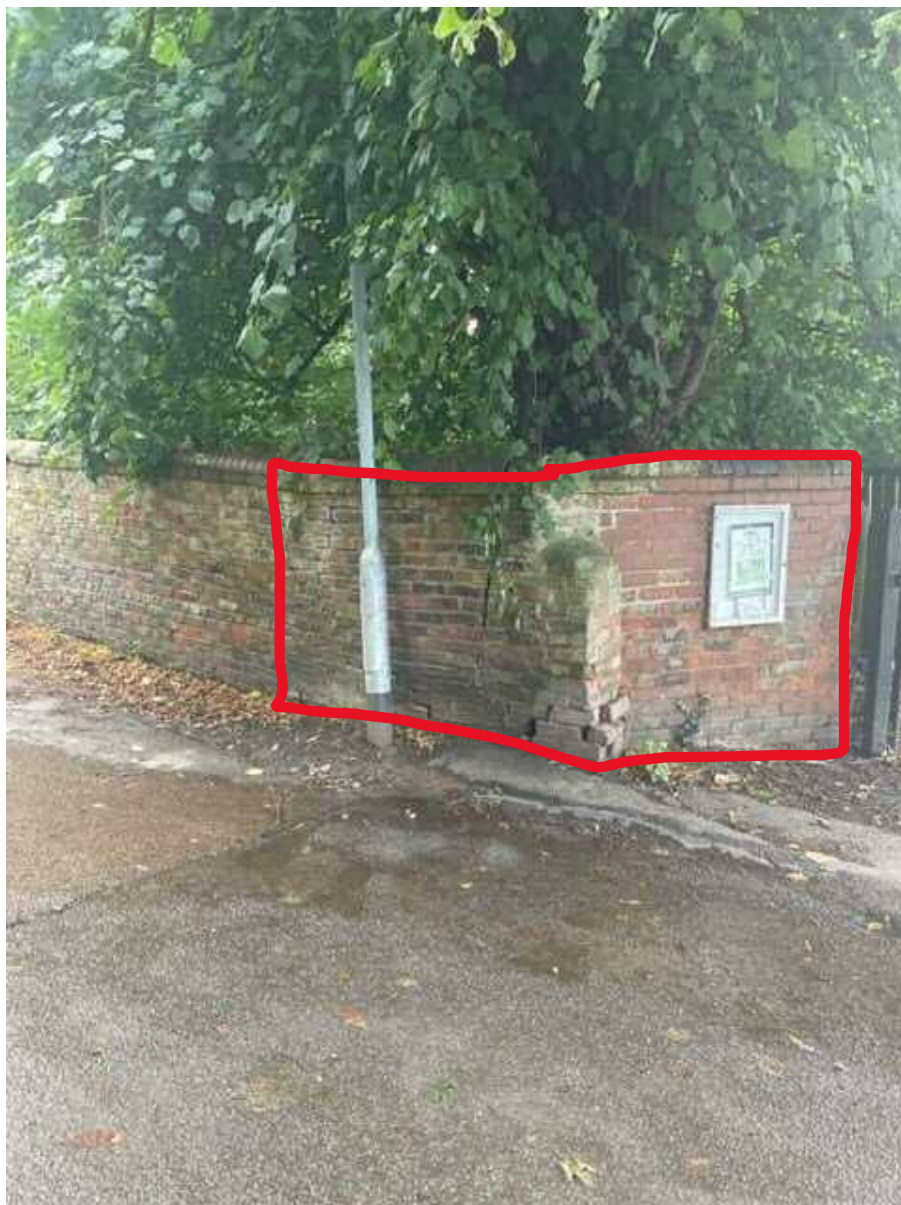
**Photo 4.** Red outline shows the proposed wall section to be removed
