## HERITAGE IMPACT STATEMENT

Ashburne Hall (Central Block), Old Hall Lane, Wilmslow Road, Fallowfield, Manchester, M14 6HP

1.1 This statement forms part of a listed building consent application to replace the high-level asphalt flat roof covering and carry out masonry repairs to the brick parapet walls adjacent the flat roof on Ashburne Hall (Central Block).

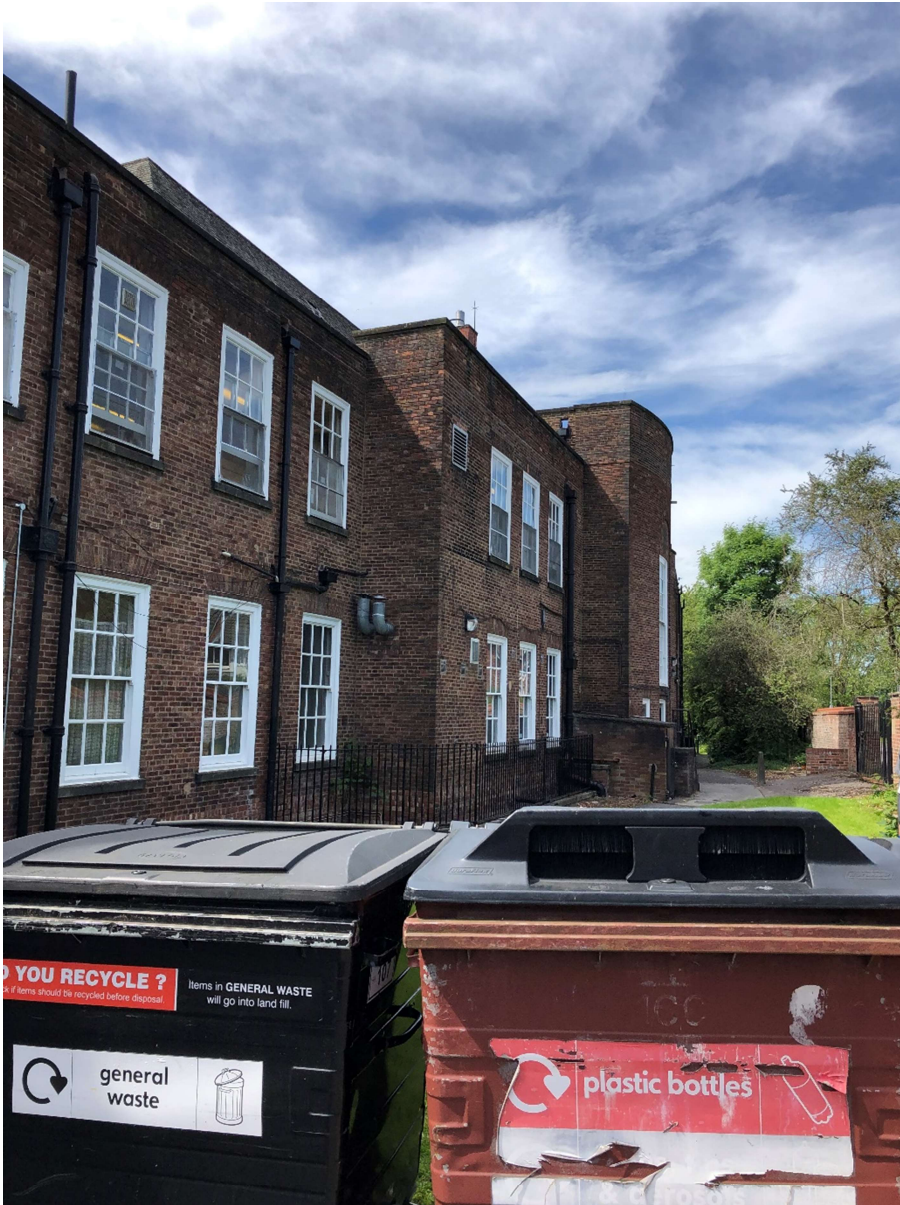
Parapet walls: The parapet walls are constructed from brick and capped with stone copings. The parapet walls are in poor condition arising from dampness and thermal movement. It is proposed to repair defective mortar joints using lime mortar, take off and re-bed the stone copings with the addition of lead DPC (bitumen coated for high bond) bedded in lime mortar to protect the parapet walls from rainwater penetration. Beneath the coping underside the coping drip, a lead flashing edge will be exposed but will not look out of place.

**Photo 1:** Rear view showing parapet walls to asphalt flat roofs.

2.3 Take off stone copings to parapet walls (photos 1-8); re-bed in lime mortar on new lead DPC (bitumen paint coated for high bond). Carry out localised repairs / rebuilding of cracked brickwork to parapet walls.

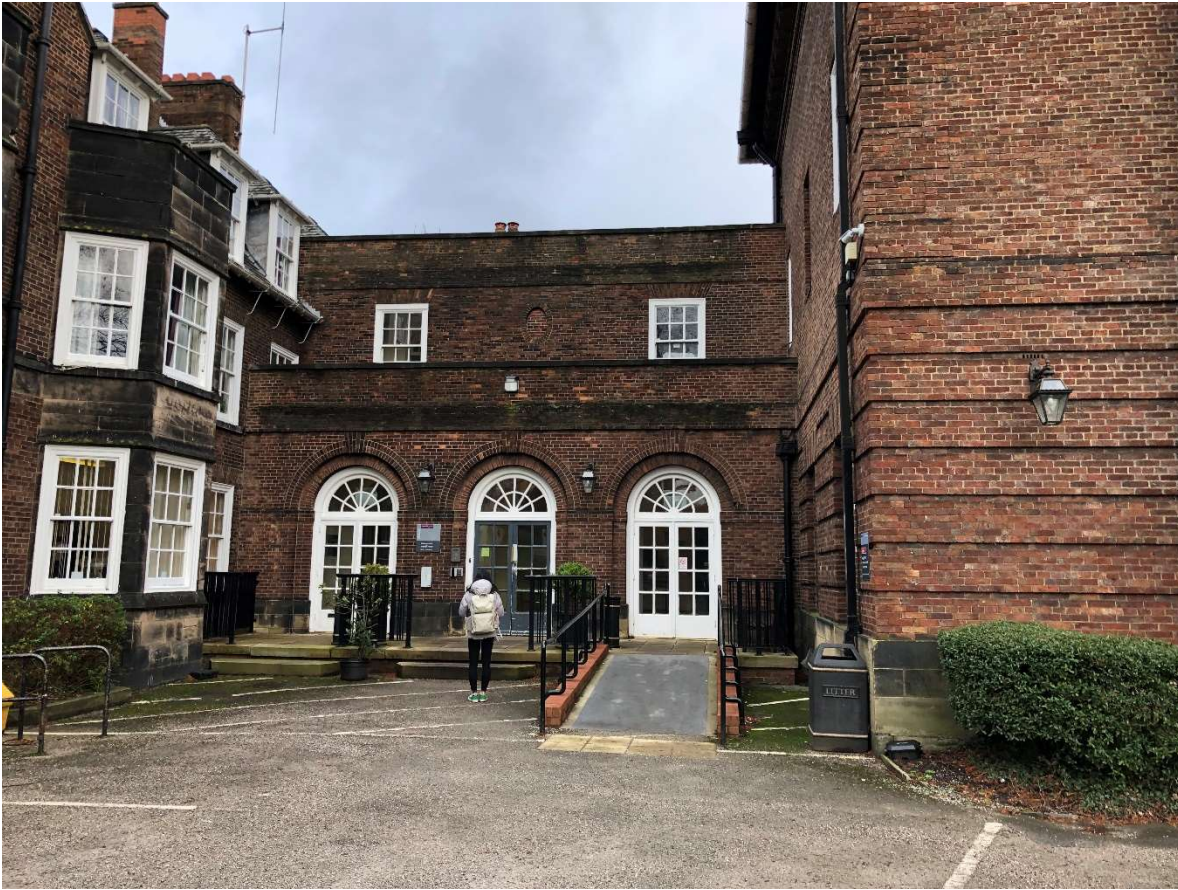
**Photo 2:** Front elevation showing parapet walls.

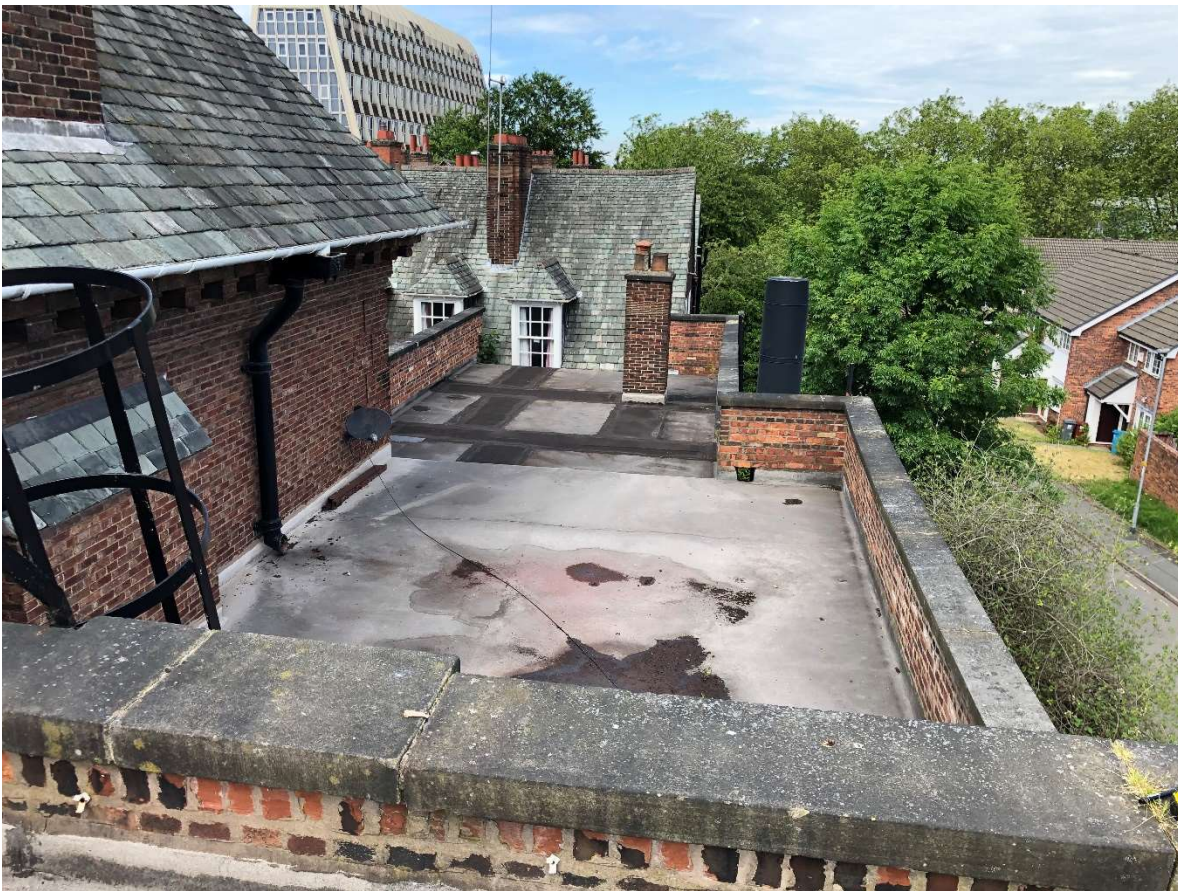
4.1 Roof covering: The existing flat roof covering is asphalt and patch repaired with felt due to roof leaks that have resulted in damage to the internal plastered ceilings with sections on lime plaster detaching from the concrete roof soffit. The proposal is to remove the defective asphalt and overlay with insulation board and polymer modified asphalt, finished with stone chippings and solar reflective paint, colour grey. The addition of insulation board will thermally improve the building, using polymer modified asphalt is in-keeping with the original roof finish. The insulation board will slightly raise the level of the roof, but is concealed behind the parapet wall and will have no impact on the external appearance of the building. The asphalt roof will be finished with stone chippings and solar reflective paint, colour grey, to protect the asphalt roof finish from thermal movement. The roof will only be visible from three overlooking dormer windows to student bedrooms and a kitchen.

**Photo 3:** View of roofs 1, 2 & 3, showing slate pitched roof and asphalt flat roofs with patch repairs.

2.1 To remove existing asphalt roof covering (Photos 3-8) and replace with PIR insulation board and mastic asphalt covering, dressed up wall abutments and finished with lead flashing chased into brickwork.

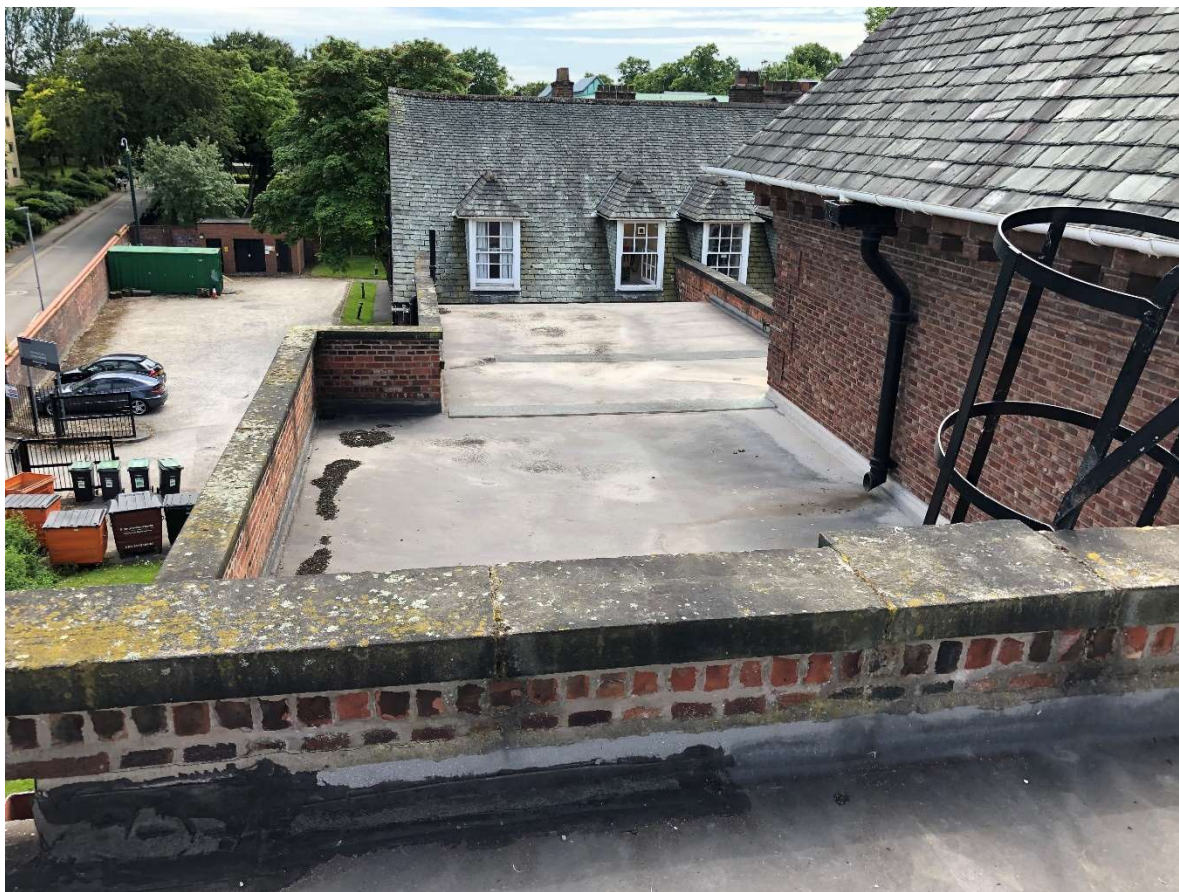
**Photo 4:** View of roofs 5, 6 & 7. Showing slate pitched roof and asphalt flat roofs with patch repairs.

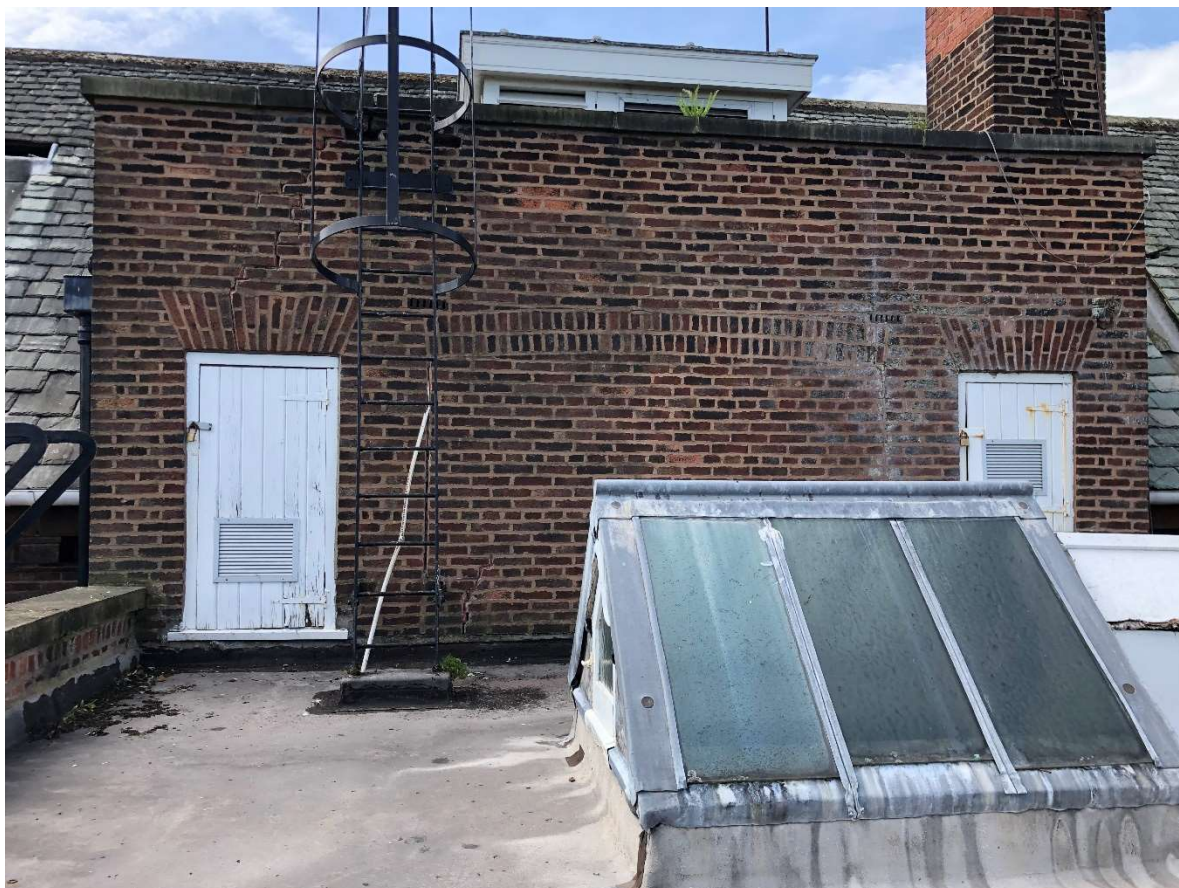
**Photo 5:** View of roof 4 showing glass lantern light over stairwell.

2.4 Replace lead flashings to lantern light. (Photo 5)

2.5 Replace corroded hooped ladders with new lightweight aluminium hooped ladders. (Photos 5 & 6)

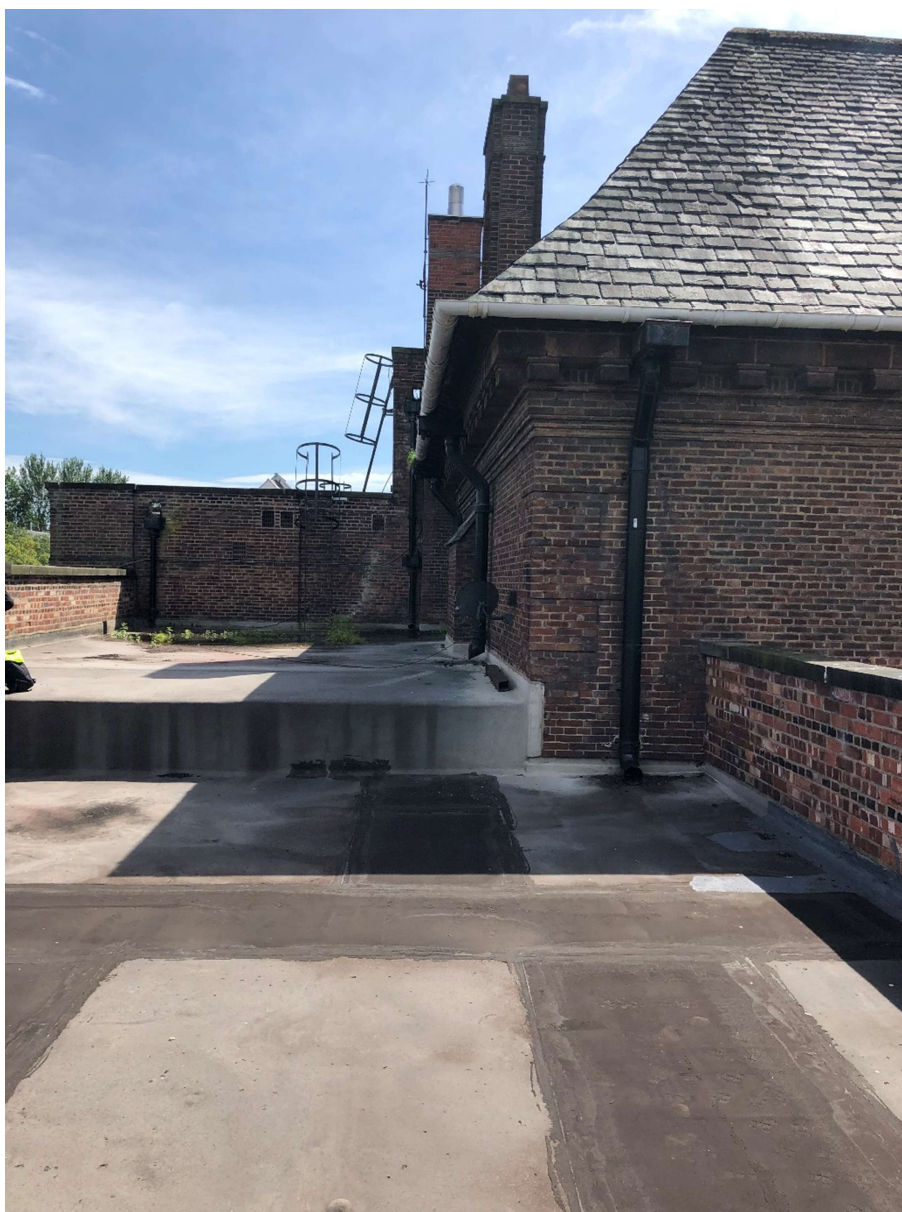
**Photo 6:** View of roofs 2 & 3 towards roof 4 parapets and hooped ladder. Note RWPs discharging onto flat, altered to suit raised flat roof level.

2.2 Carry out minor alterations to existing cast iron rainwater pipes discharging onto flat roof (photos 6 & 7); cast iron pipes to be reduced in length to suit raised flat roof level to accommodate PIR insulation board.

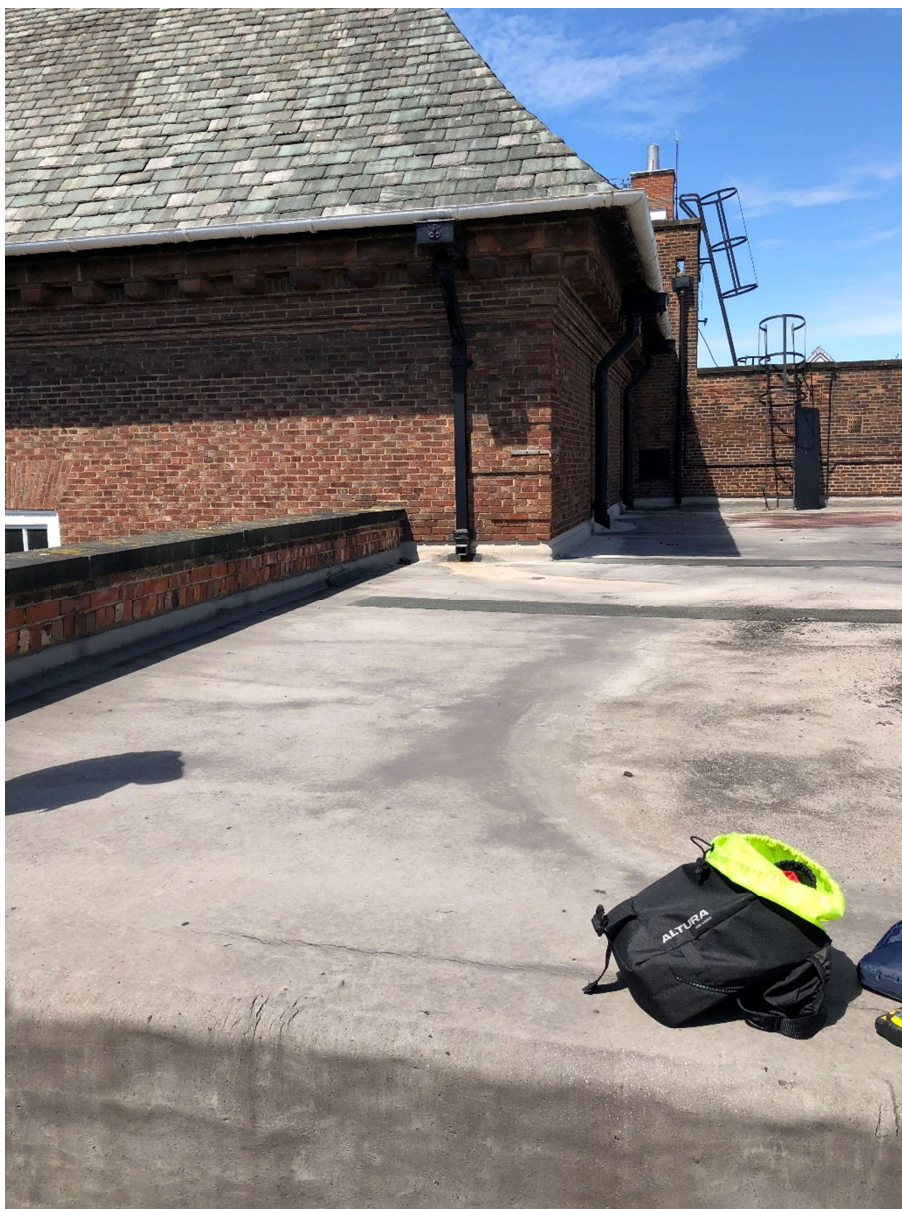
**Photo 7:** View of roof 5 towards roof 4 parapet and hooped ladder. Note RWPs discharging onto flat, altered to suit raised flat roof level.
