Atelier  
Heritage

86 Princess Street  
**Heritage Statement**

Client: LWP Eastbrook Property

Date: August 2023

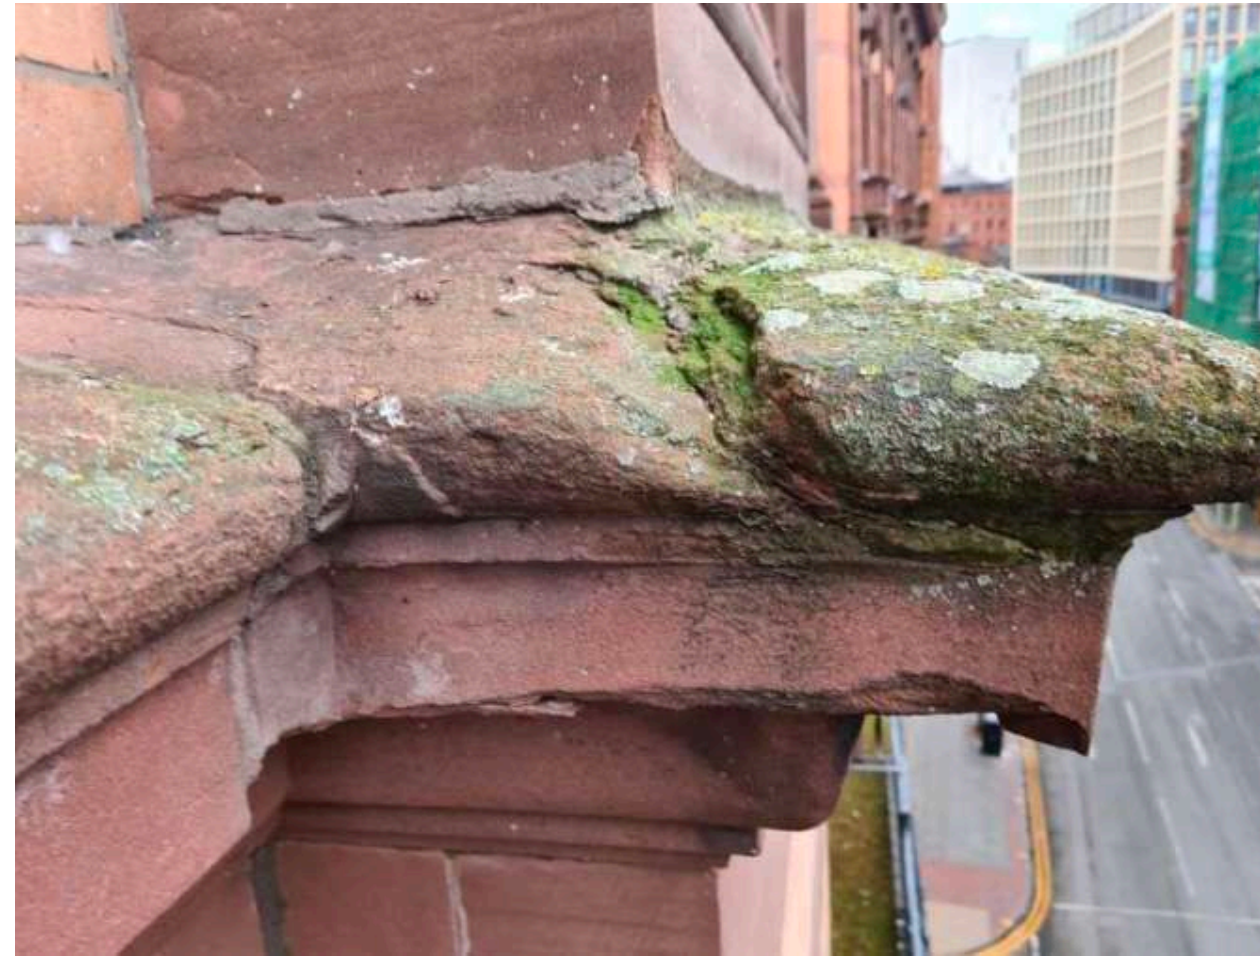
Image 9: Location reference A02, 5

Location reference: A02, 5; A07, 09

Description: Extended stone corner piece eroded, forming water channel. Potential to break away.

Proposed works: Methodology 1 Urgent immediate repair to stabilise fabric. Phase 1: Temporary repair to pin piece with resin bound dowel to prevent falling/movement of masonry. Drilling of limited sized holes in stone to allow pinning back to stable stone surface. Dowel end to be recessed by 10mm minimum and plugged with matching stone piece. Removal of loose/friable stone faces.

Phase 2: Carefully remove existing damaged stone piece using hand tools (stone saws, sharp chisels). Insert matching newly formed piece, hand finished and to include discrete masonry mark, edge bedded. Secure to stable stone with resin bound stainless steel dowels. Perimeter joints to be minimal width and to be pointed with lime mortar to match stone.

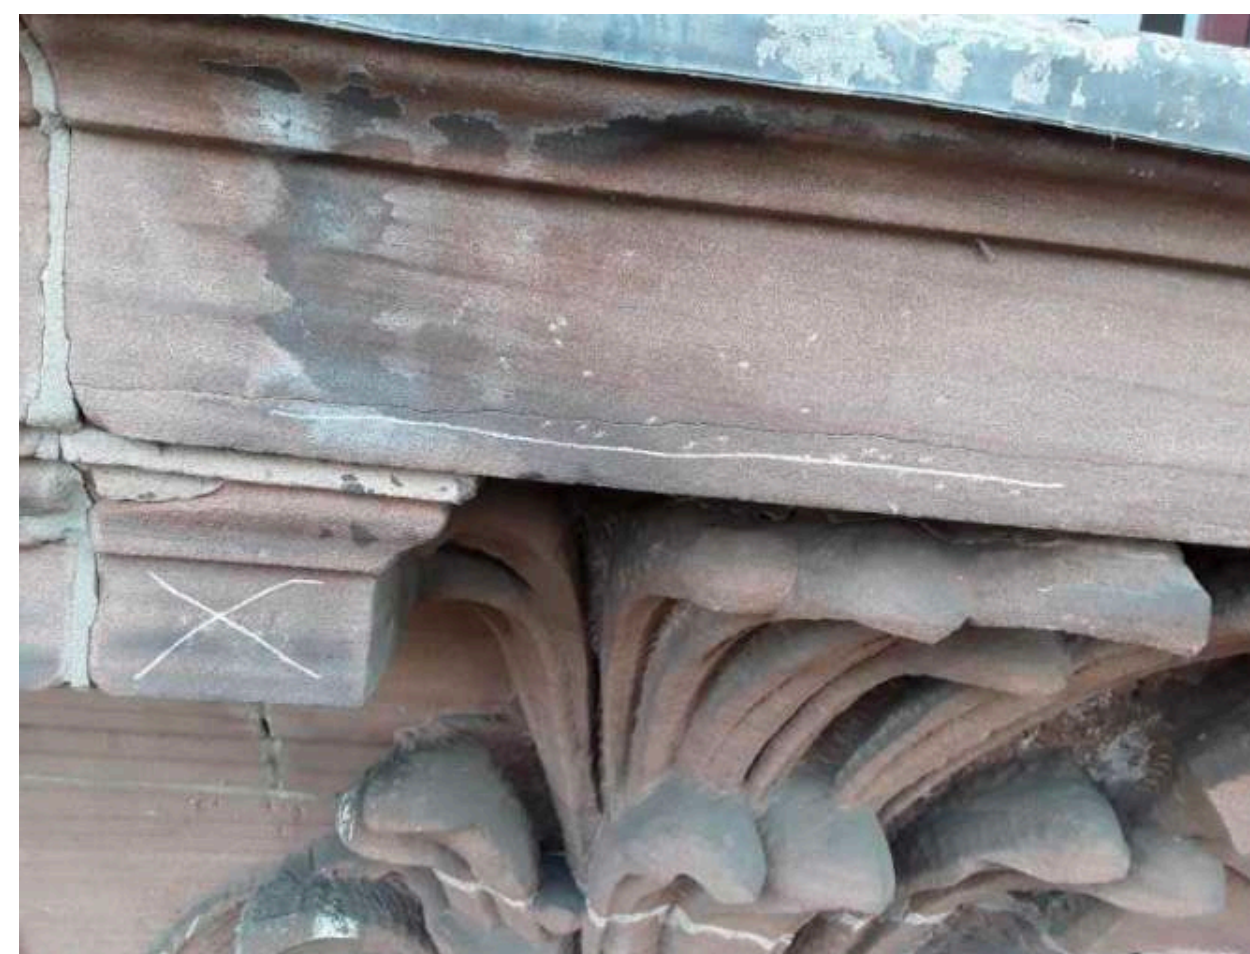
Image 10 (Left top), location reference A04 7

Location reference: A04, 7

Description: Loose stone details

Proposed works: Methodology 2 Refix loose stone. Drill through existing stone to form hole to take resin bound stainless steel or resin dowels of minimum necessary diameter. Pin fractured piece back to solid stone. Dowel ends to be recessed 10mm and plugged with matching stone piece. Impact: Neutral. Minimal holes are considered necessary to ensure stone is secured. Enhancement of condition and appearance of elevation, eliminating risk of falling debris and offering long-term protection of build fabric.

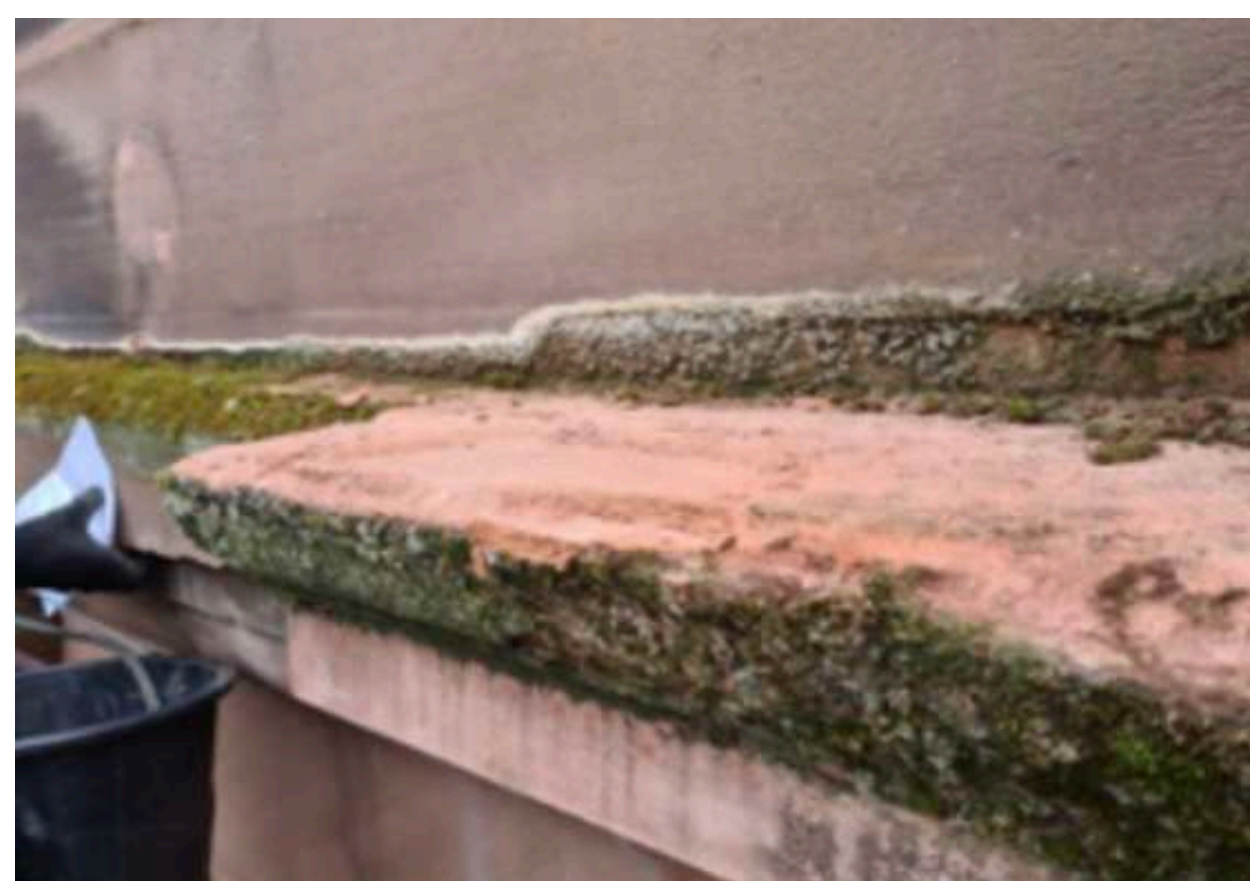
Image 11 (Left bottom), location reference A07, 4

Location reference: A07, 4; B01, 5(1); B05, 5(1); B05, 8(3)

Description: Badly eroded stone cill with exposed edges, at risk of further deterioration. Extent of erosion prevents localised cut out and replacement.

Proposed works: Methodology 3 Carefully remove existing cill, replace with new version to match existing. New will be horizontally bedded as there are limitations on stone supply (single piece prevents edge bedding). Replacement to be bedded in lime mortar, to match that on wider elevation. Impact: Neutral. The loss of historic fabric is considered to be both necessary and justified in order to ensure safety and integrity to the façade. Replacement of a like for like piece will have no adverse effect upon significance. Condition will be enhanced and there is a clear long-term benefit to the protection of the listed building.

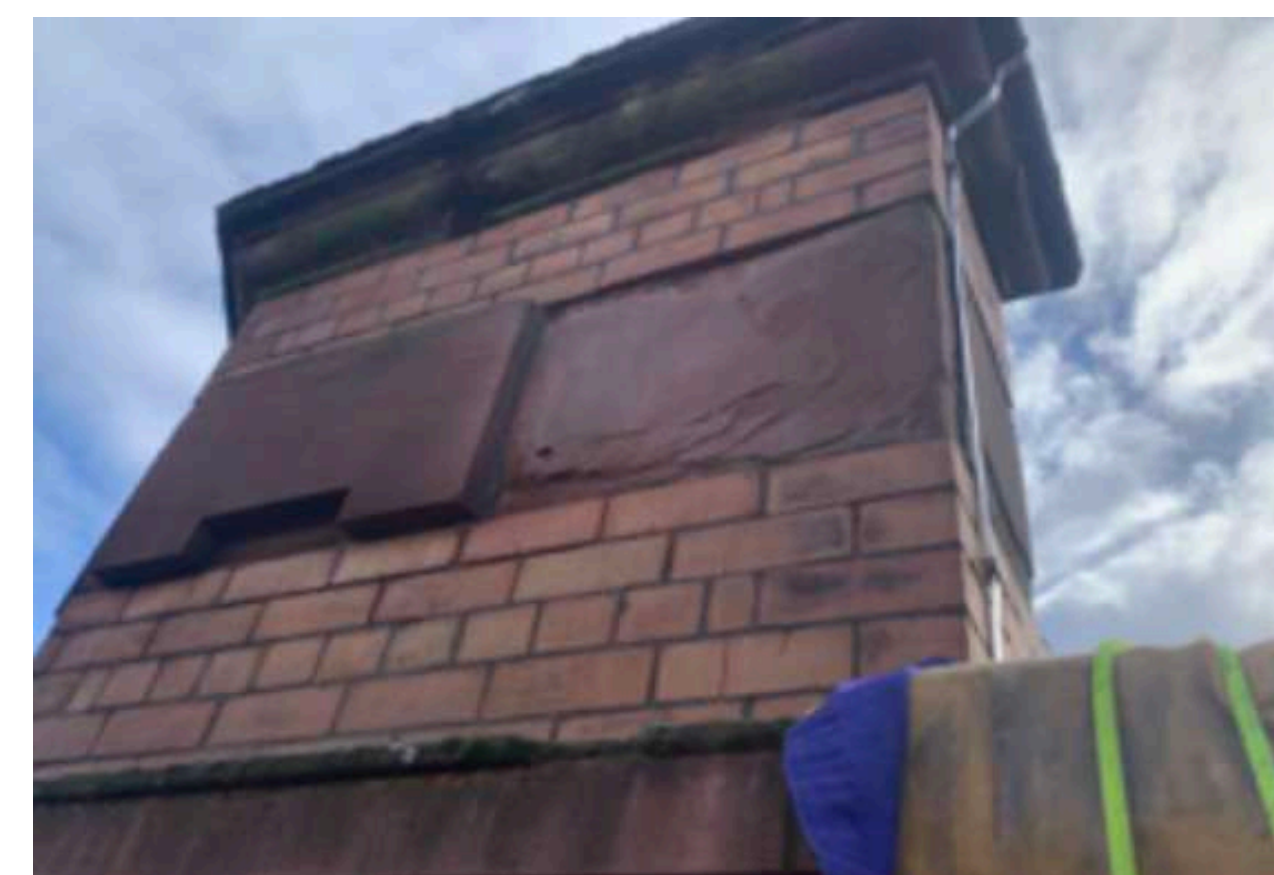
Image 13 (Right bottom), location reference B02, 9

Location reference: B02, 9

Description: Eroded stone face to high level, chimney.

Proposed works: Methodology 4

Phase 1: Urgent, immediate repair to stabilise fabric. Careful removal of delaminated stone face (using hand tools) to a depth sufficient to leave stable surface only. Phase 2: Careful cutting out of damaged stone with hand tools (sharp chisel, stone saw); installation of new stone piece to match (sourced from St Bees quarry), edge bedded; finish to match original with no artificial distressing and to include discrete stone mason mark; repoint with lime mortar to match wider elevation.

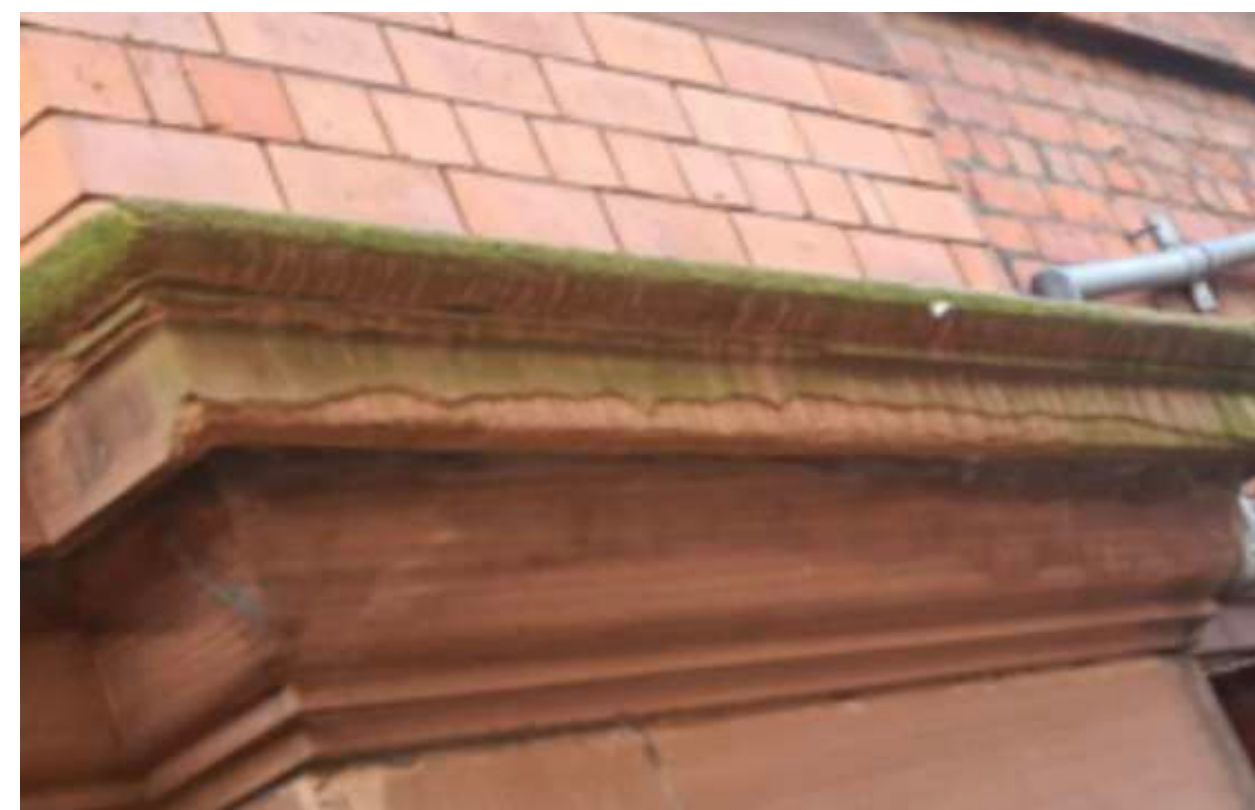
Image 14: Location reference B06 5(3)

Location reference: B06, 5(3); A05, 9

Description: Loose, delaminated stone to stone cornice

Proposed works: Methodology 6

Replace high level stone detail where loose, degraded and missing parts of surface are evident. Surface to cornice badly eroded with edges exposed, at high risk of further deterioration. Extent of damage will not allow for local repair and requires new piece of stone. Existing stone to be carefully removed and replaced with new piece to match and bedded in lime mortar to match that on wider elevation. New stone to be horizontally bedded (due to quarry limitations).

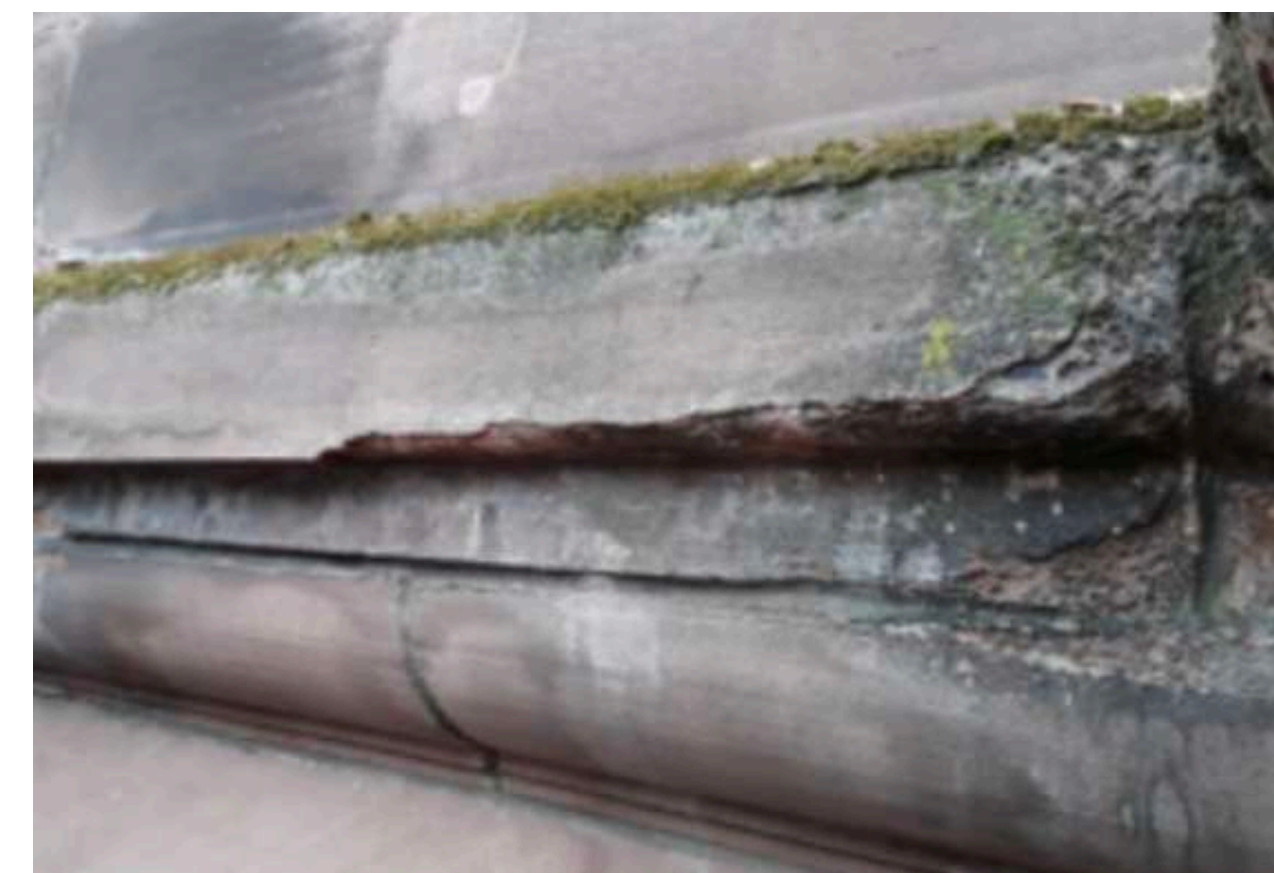
Image 15: Location reference A06 3(1)

Location reference: A06, 3(1); A07, 5; A07, 5(2); B01, 3(1); B01, 3(2); B01, 5(3); B03, 7(2); B05, 2(1); B05, 6(1); B05, 6(2); B05, 6(3); B06, 2(2); B06, 4(1)

Description: Weathered horizontal surface with dishing to original stonework.

Proposed works: Methodology 7.

Carefully cut out damaged stone to sound base, using hand tools only such as sharp chisels and stone saws. Install prepared new stone to match existing, hand finished and to include discrete masonry mark. Fix using resin bound stainless steel dowels repoint all perimeter joints with lime mortar to match examples on wider façade. Size and extent of replacement piece can only be confirmed upon inspection from scaffold, but replacement will be of minimum size required.

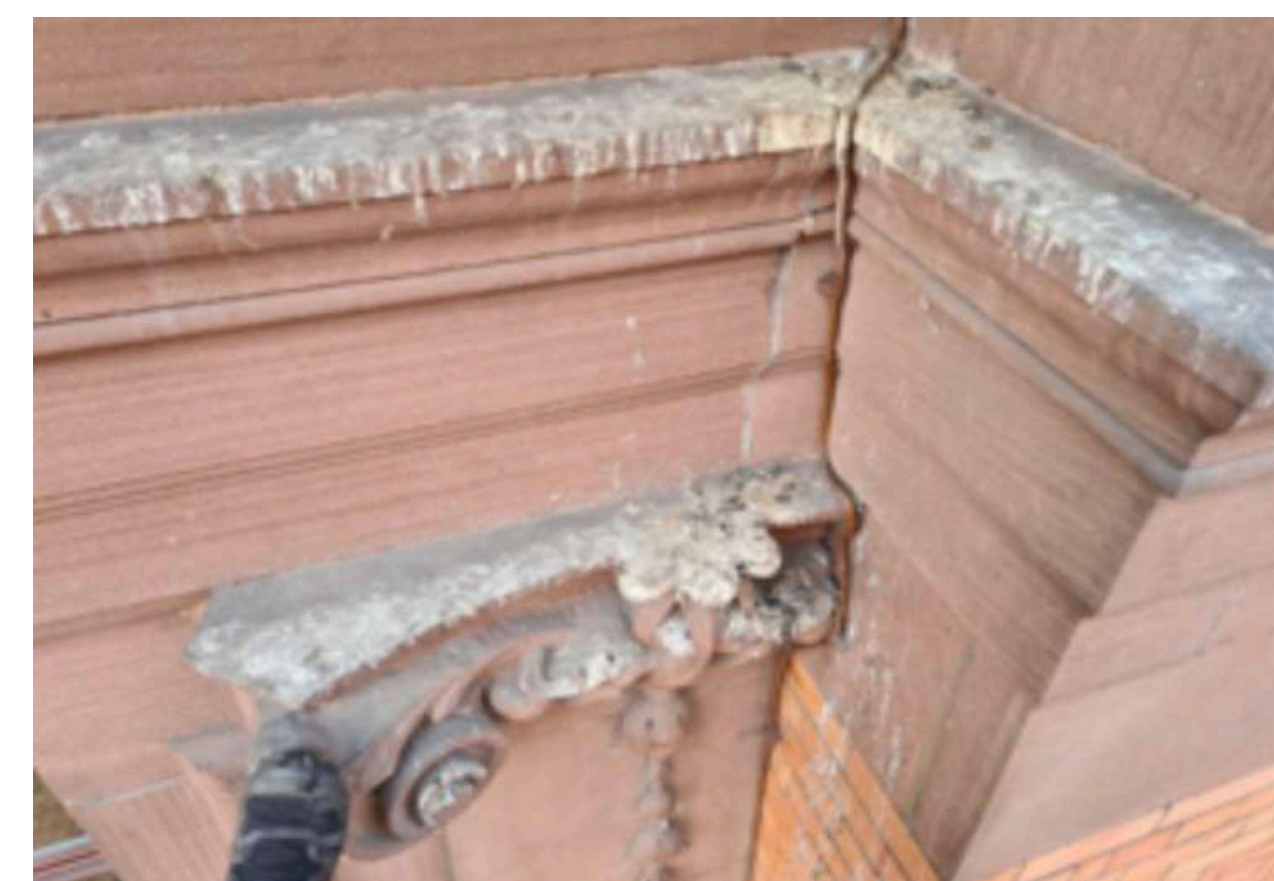
Image 16: Location reference GC1

Location reference: GC1

Description: Tops and front of ledges down the building.

Proposed works: Methodology 08

Careful removal of guano build-up using high pressure steam cleaning system.

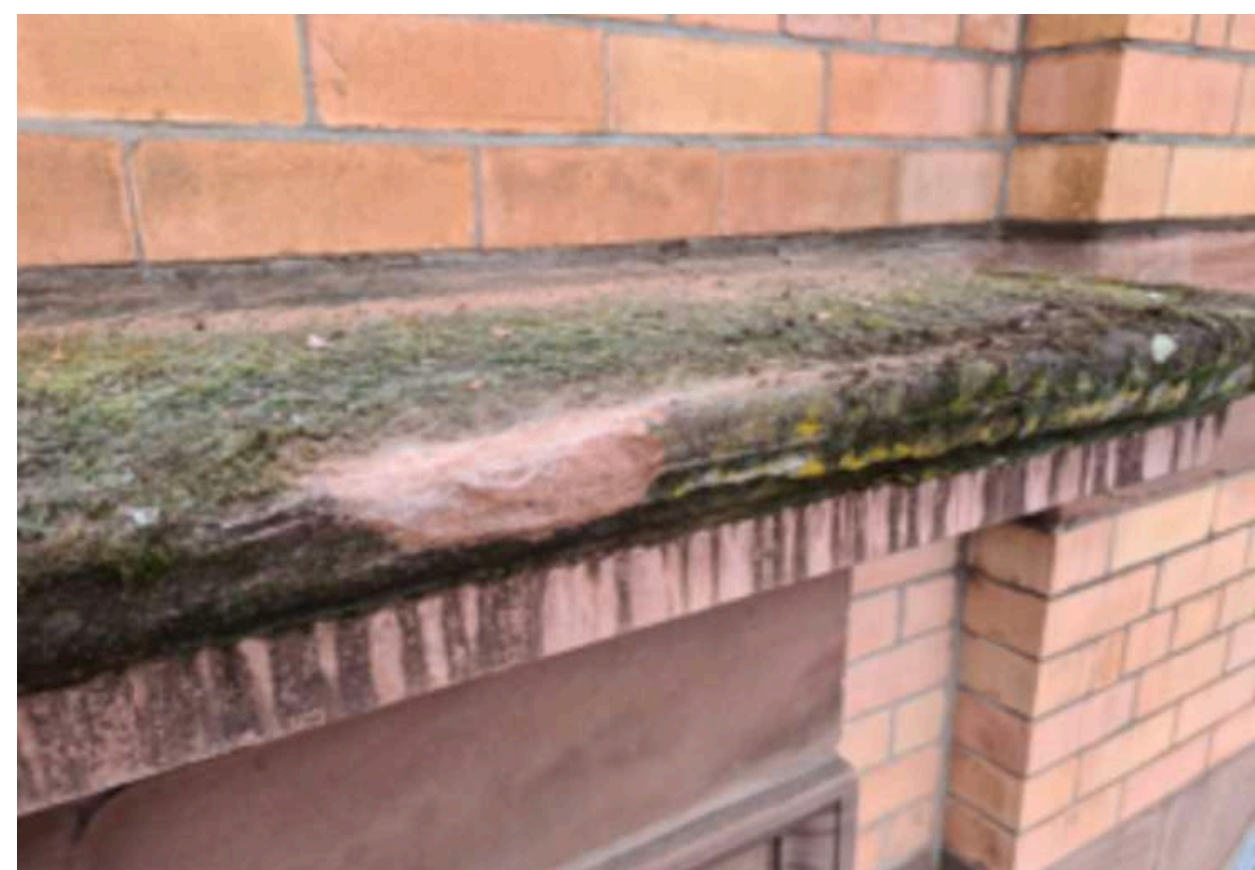
Image 17: Location reference A02 8(3)

Location reference: A02, 8(3); B03, 4(1); B05, 4(1); GC2

Description: Balconies, ledges down the building.

Proposed works: Methodology 09

Initial removal of biological growth with high pressure steam cleaning system to allow for inspection. Repair will depend on findings, either i) careful removal of damaged cement screed with hand tools; localised cut out of eroded stone material to sound stone base; replacement in matching stone, set and bedded in lime mortar or ii) careful removal of existing damaged material and complete replacement with matching stone piece, set and bedded in lime mortar. New stone requires horizontal bedding due to quarry limitations. Minimal increase in fall to outer edge. Eroded pointing to be raked out and repointed with lime mortar. Cement replacement edge indents to be inspected and replaced with sandstone version if necessary.

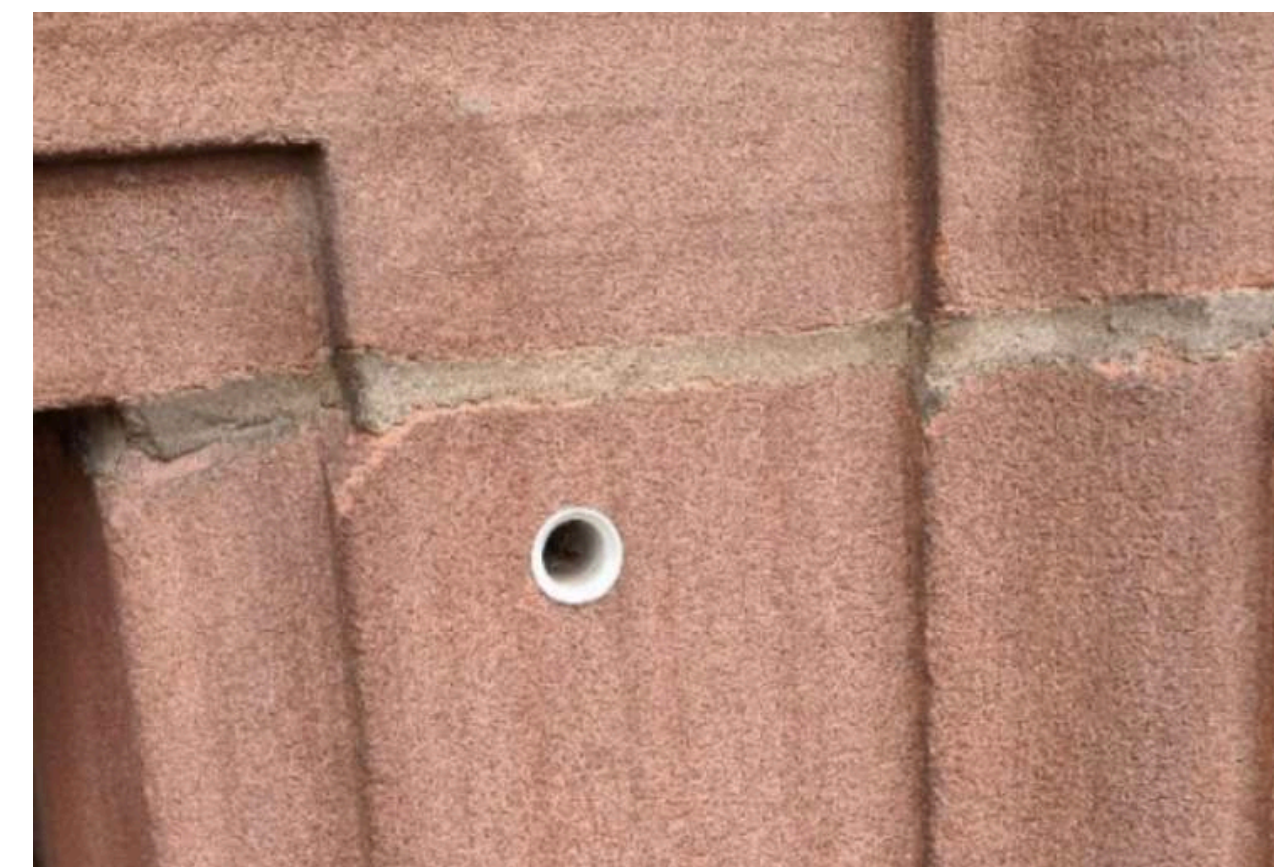
Image 18: Location reference GC3

Location reference: GC3

Description: Scaffold plug left in stonework.

Proposed works: Methodology 10

Remove existing hole plug and replace with moulding mortar repair in lime putty mix to match stone colour and texture.

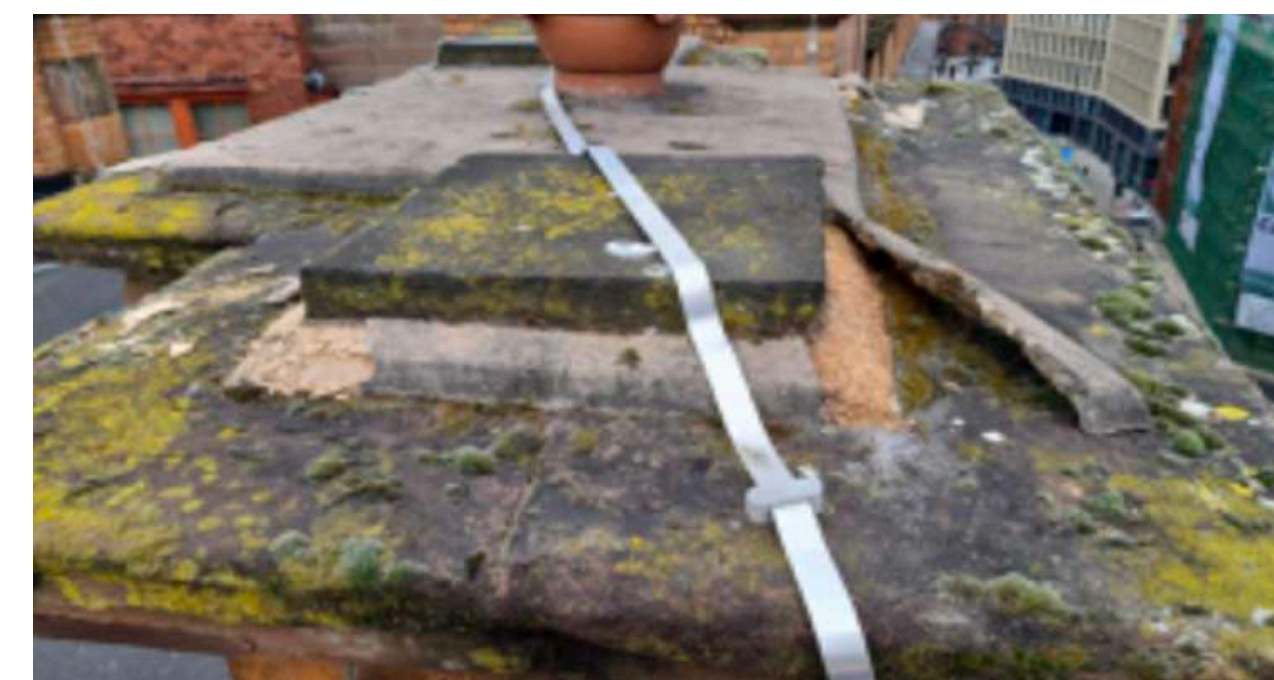
Image 19: Location reference GC4

Location reference: GC4

Description: Chimney flaunches.

Proposed works: Methodology 11

Careful removal of all damaged cement flaunching. Repoint chimney with lime based mortar to match wider elevation. Strong lime based mortar flaunching over reclaimed brick/stone pieces in profile to match examples on wider elevation. Impact: Neutral. Removal of damaged material is a positive action, replacing with similar will not be harmful to fabric or visual appearance and will extend the life of the façade.

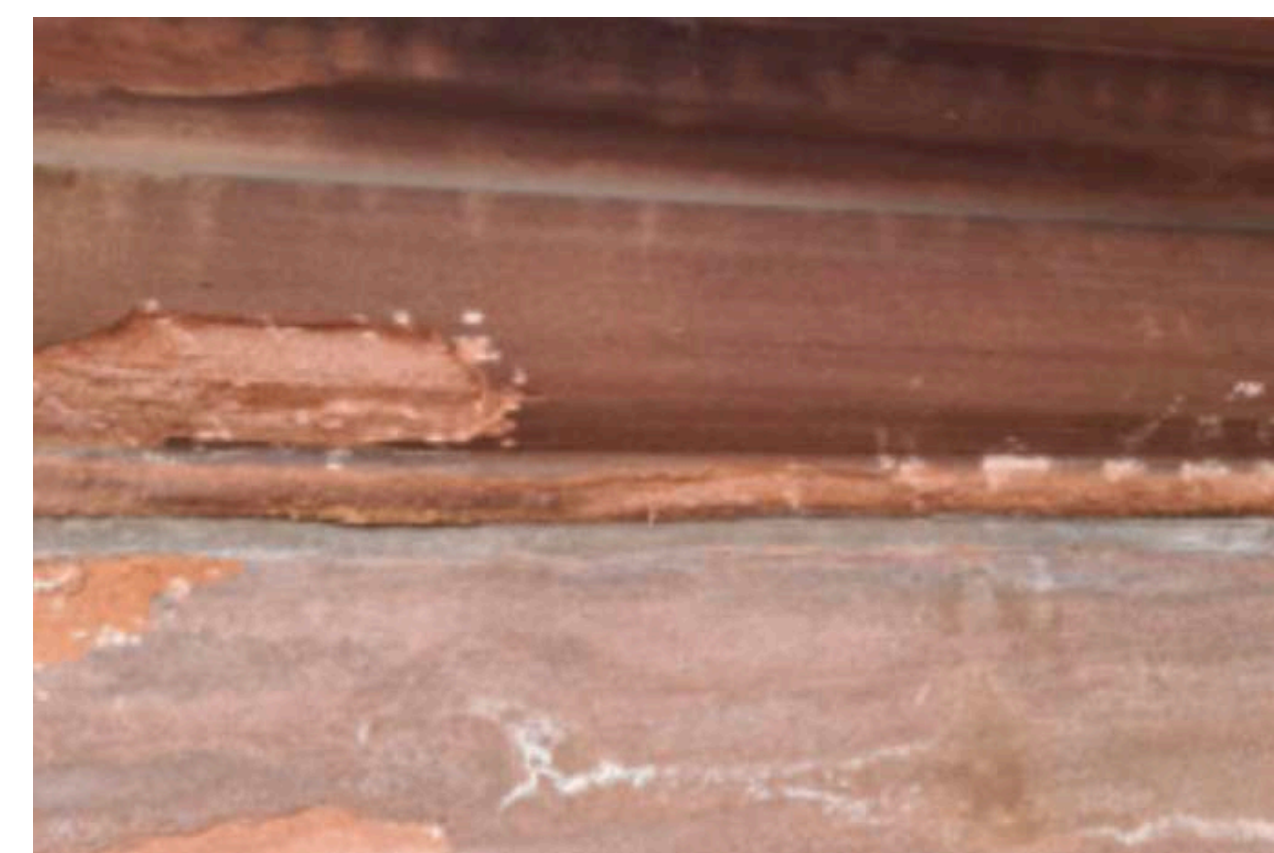
Image 20: Location reference A02 8 (2)

Location reference: A02, 8(2); B06, 2(1)

Description: Stonework details.

Proposed works: Methodology 13

Impact: Careful removal of damaged stone detail with hand tools (sharp chisels and stone saws) to sound stone base; install replacement stone piece in matching profile, hand finished to match original with no artificial distressing; repointing with lime-based mortar to match wider elevation. Stone to be edge bedded.

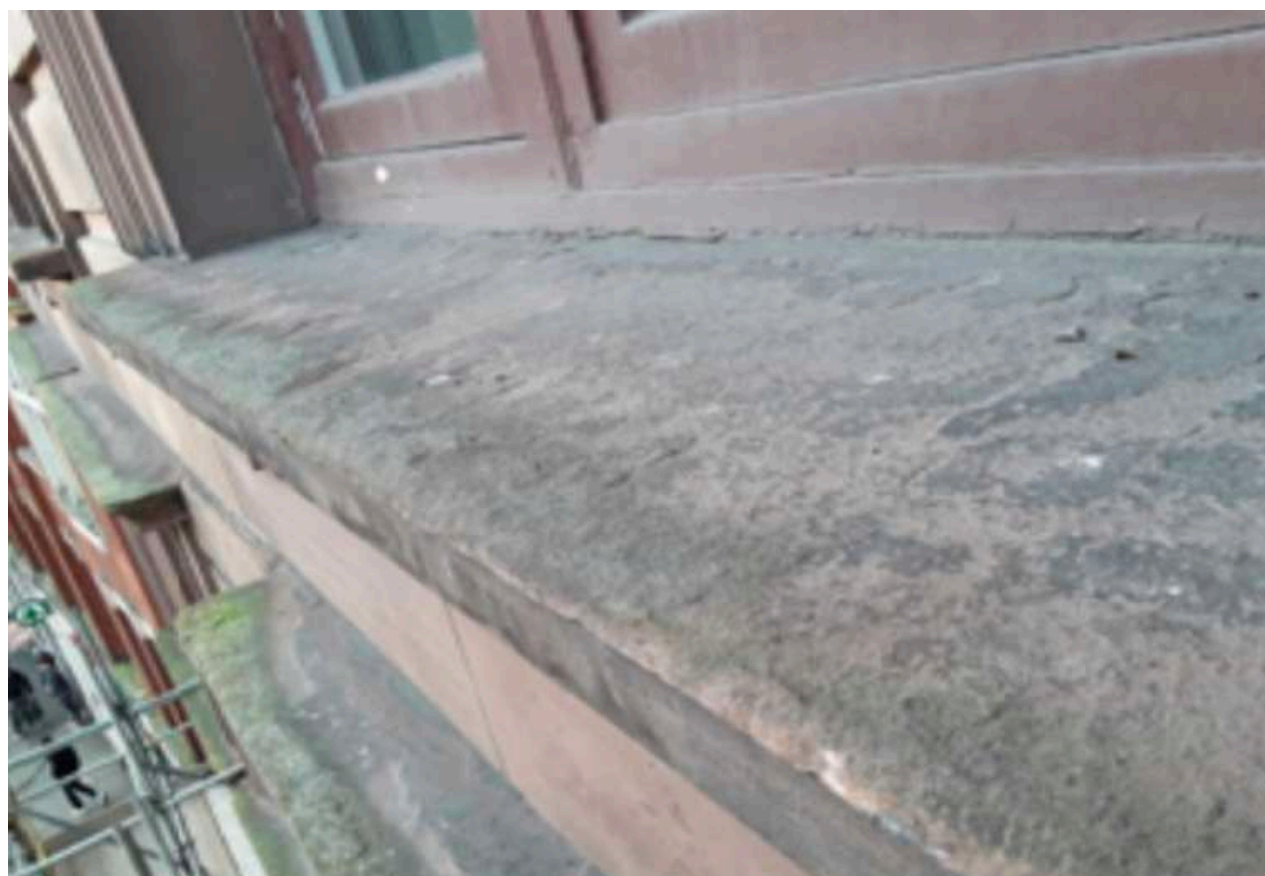
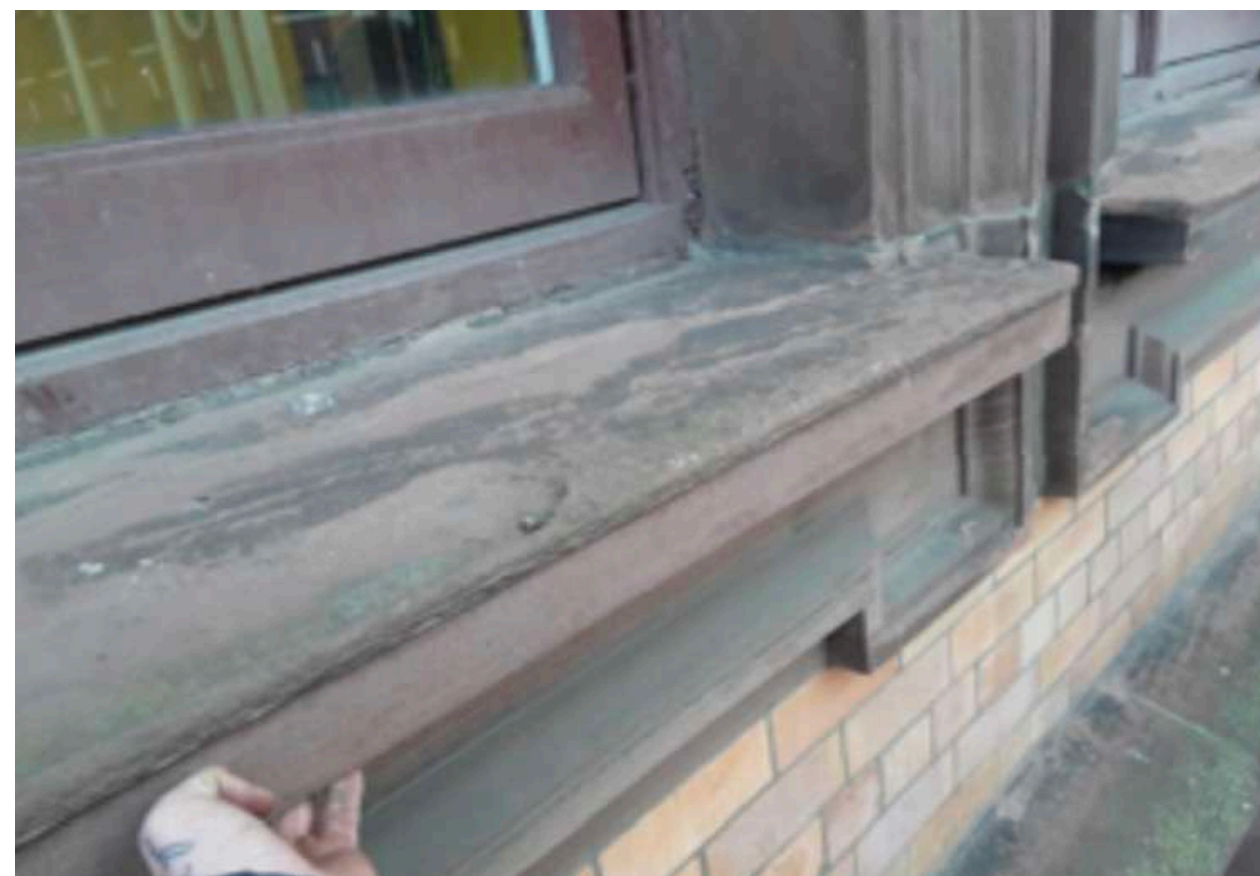
Images 21, 22: Location references A04, 3(1) and A04, 4(1)

Location reference: A04, 3(1); A04, 3(2); B06, 4(2)

Description: Stone window ledges and cills.

Location reference: A04, 4(1); A07, 5(3); B03, 8(1)

Description: Spalling vertical stone surfaces.

Proposed works: Methodology 15

Stone cleaning using high pressure steam cleaning system.

Proposed works: Methodology 16

Brush down loose stone and friable material.

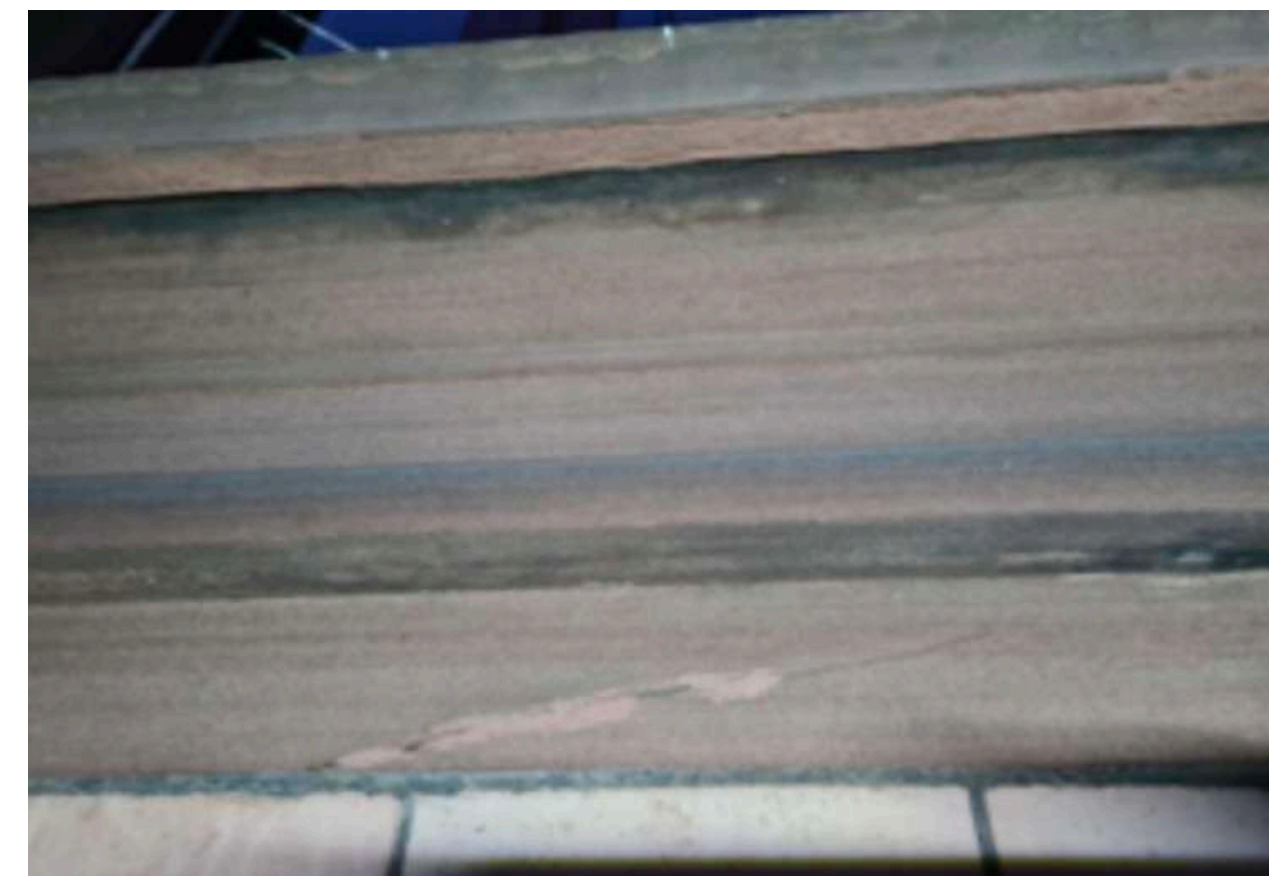
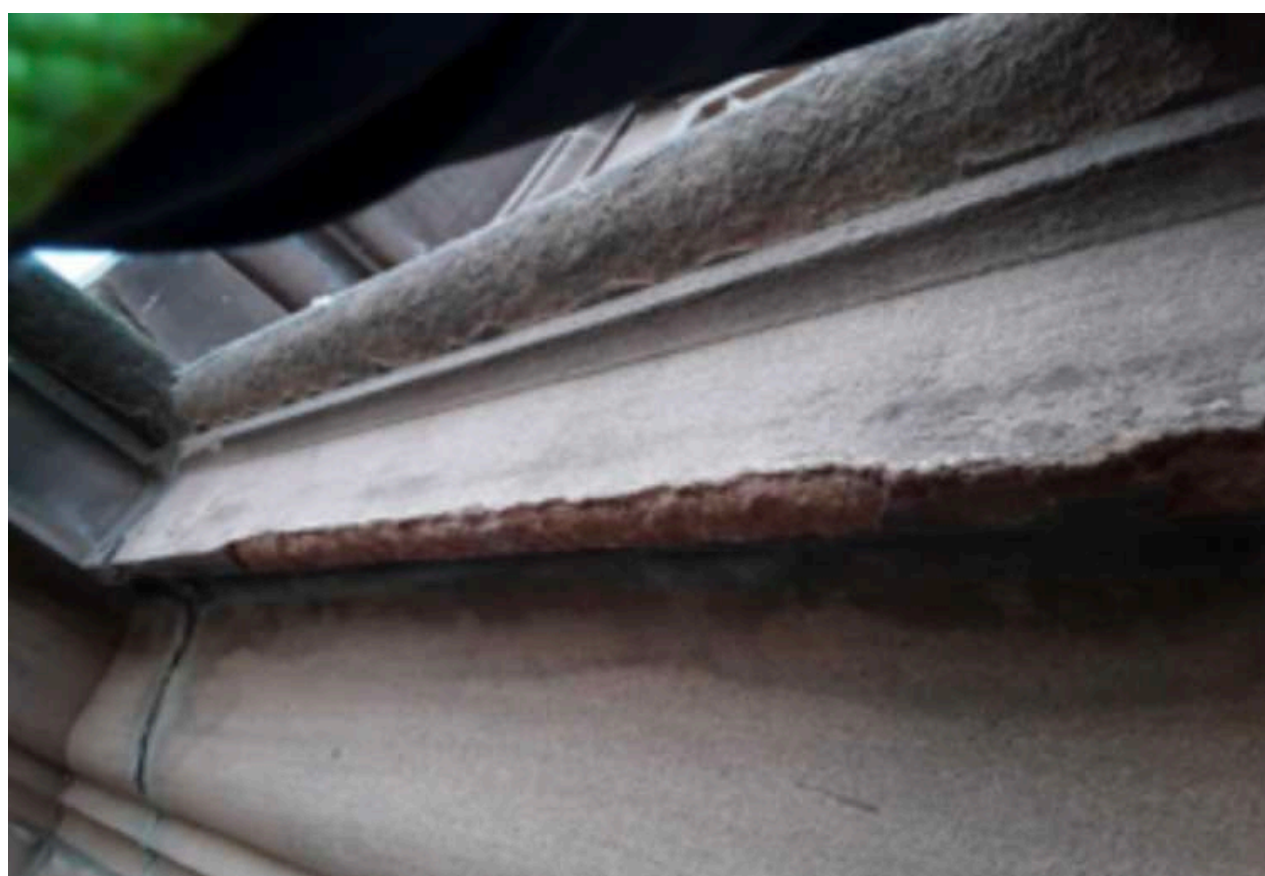
Images 23,24: Location references A04, 5(1); A07, 2(1)

Location reference: A04, 5(1); A05, 5(1)

Description: Stone cills with dishing.

Location reference: A07, 2(1); A07, 8

Description: Stone window reveal head and coping ledge.

The surface of the stone window reveal, head, is badly eroded and has significant edges exposed, increasing its risk of rapid decay. Localised patch repair of stone is not feasible due to proportion of cut out required. (this will be reviewed when scaffolded access is possible). Old piece carefully removed and new stone to be cut to match size and form of original to be horizontally bedded to match existing/natural bedding due to limitations on sizes available from the quarry (edge bedding is not possible in a single piece of stone). New stone to be fully bedded in lime mortar as used elsewhere.

Proposed works: Methodology 17

Localised stone cill eroded/dished stone to be cut out to a sound stone base and replaced with matching stone piece, bedded and pointed in lime mortar to match surrounding examples. Inspection of edge indents and raked out and replaced with new to match, if required. Eroded pointing to be raked and repointed in lime mortar. Should investigation show that localised repair is not possible, full replacement of cill is proposed by careful removal of existing and replacement with new version in stone (St Bees quarry) with lime mortar to joints.

Proposed works: Methodology 19

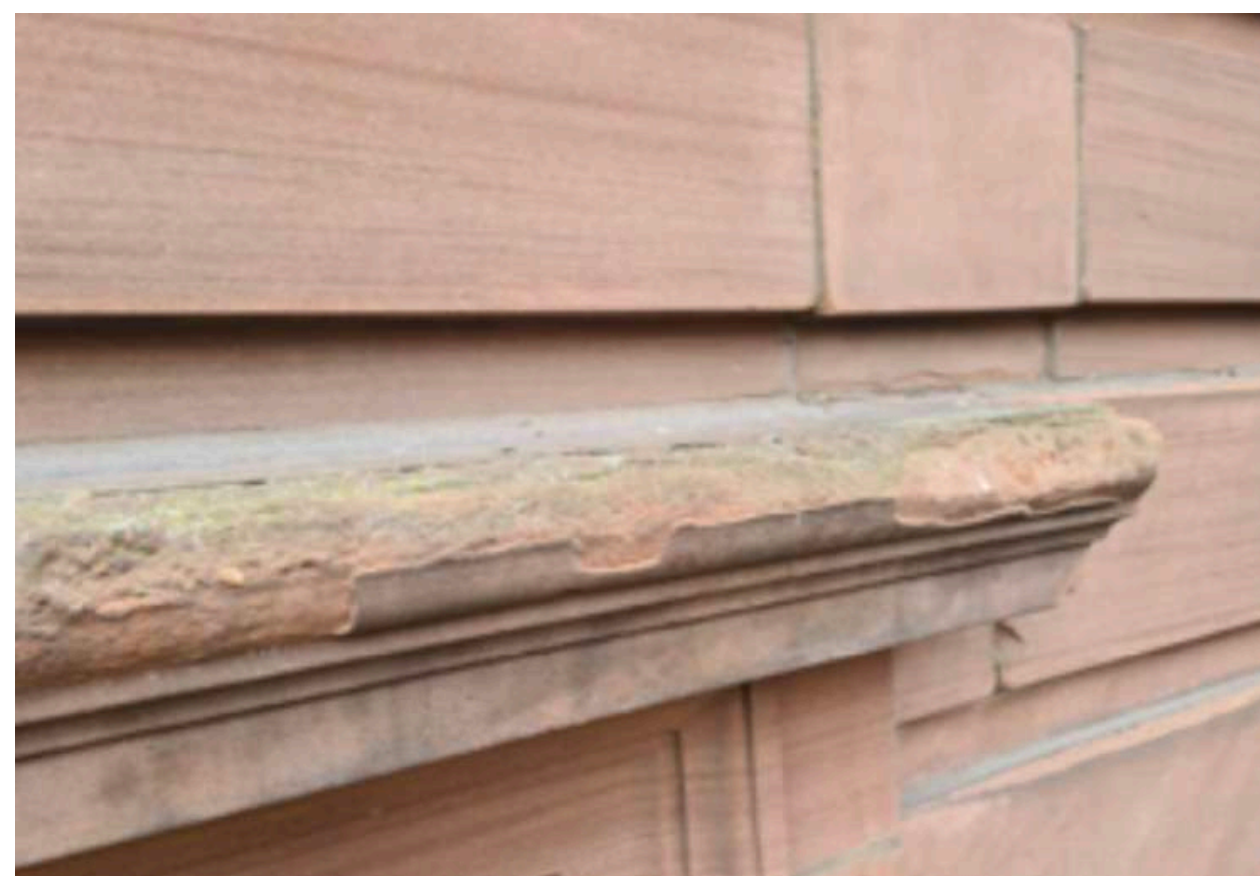
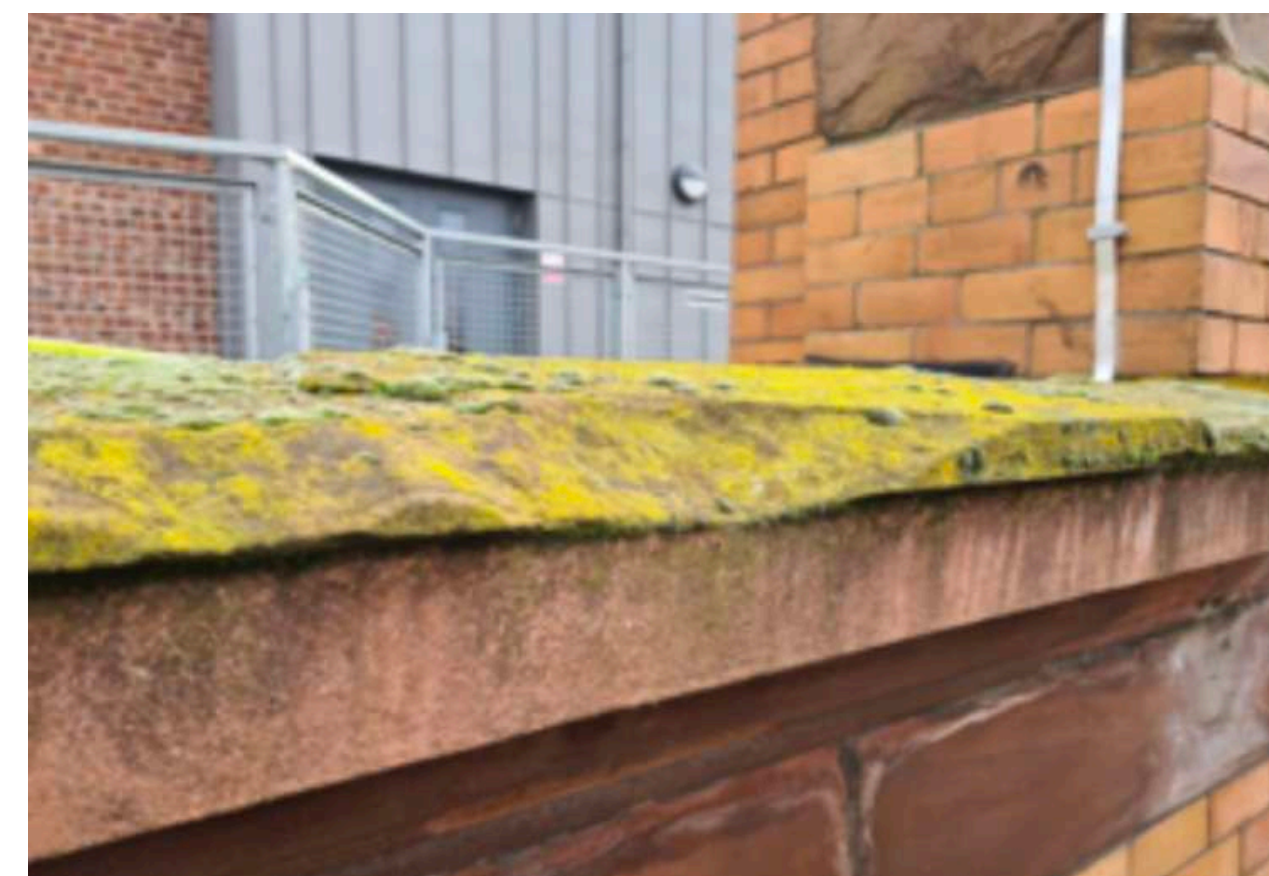
Images 25, 26: Location references B01, 5(2); B05, 8(1);

Location reference: B01, 5(2)

Description: Cement based mortar to stone detailing.

Location reference: B05, 8(1); B06 8(1)

Description: Biological growth to stonework.

Proposed works: Methodology 20

Removal of cement based mortar from cracks and fill with lime based moulding mortar to match stone, assuming existing cement can be removed avoiding harm.

Proposed works: Methodology 21

Phase 1: Remove biological growth build-up with high pressure steam cleaning system. Phase 2: Closely inspect stone from scaffolding. Localised dished stone to be cut out to sound stone base and replaced with matching stone in lime mortar and pointed to match elsewhere. Eroded pointing to be carefully raked out to remove loose fabric and repointed with lime mortar. Full replacement of stone piece to match existing will be considered if the extent of erosion is such that localised indent repairs cannot be carried out successfully, in which case new stone in form and size to match original will be used (St Bees) and joints filled with lime mortar.
