1<sup>st</sup> February 2023  
**Our Ref: P.1717.22**

## **Re: Badger Activity Report for Louisa Street, Openshaw**

Ascerta has been instructed by Westchurch Homes to carry out an extended badger activity survey at the site Louisa Street Works, Openshaw.

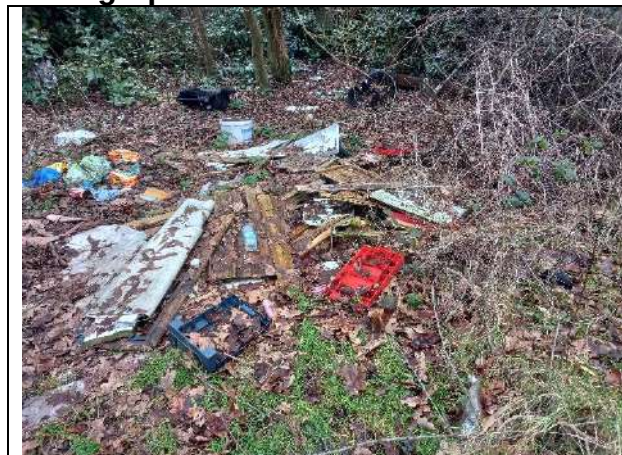
The scrub habitat that borders the southern and western site boundaries as well the park to the south, is used by dog walkers, for recreational use by member of the public and is prone to regular human disturbance evident through the large amount of fly tipping and litter distributed throughout the park. The evidence of human disturbance, as well as habitats within the site, can be viewed in photographs 1-4 below.

Photograph 1: Litter and fly tipping present in Louisa Park

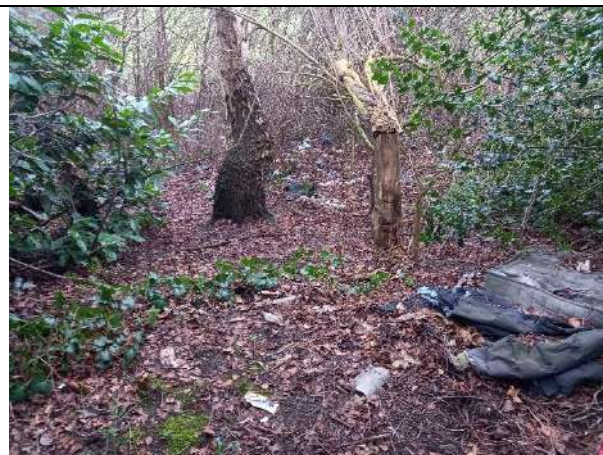
Photograph 2: Fly tipping and litter immediately south of the site

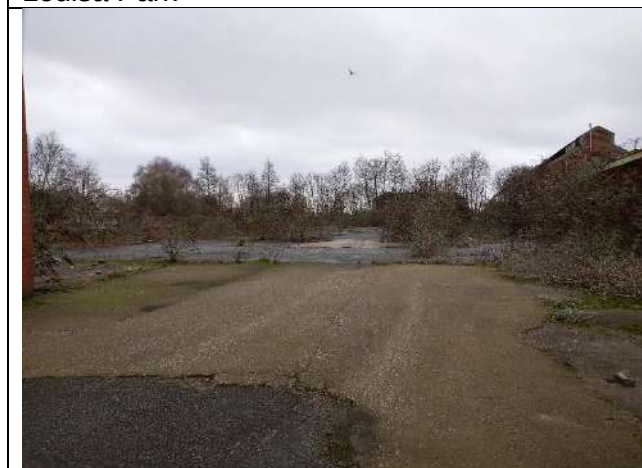
The site is predominately concrete hardstanding with scattered scrub and tall ruderal, making for unsuitable sett building habitat for badger. The site is also securely fenced on all boundaries, restricting access onto site for any foraging or commuting badger.

Photograph 3: Concrete hardstanding that comprises the majority of the onsite habitats

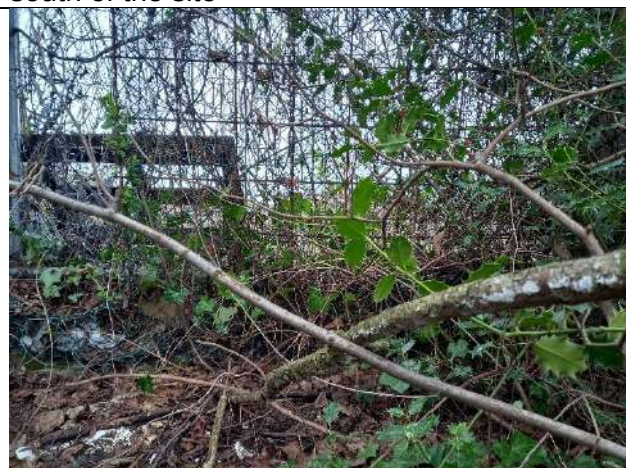
Photograph 4: Fencing that surrounds the site

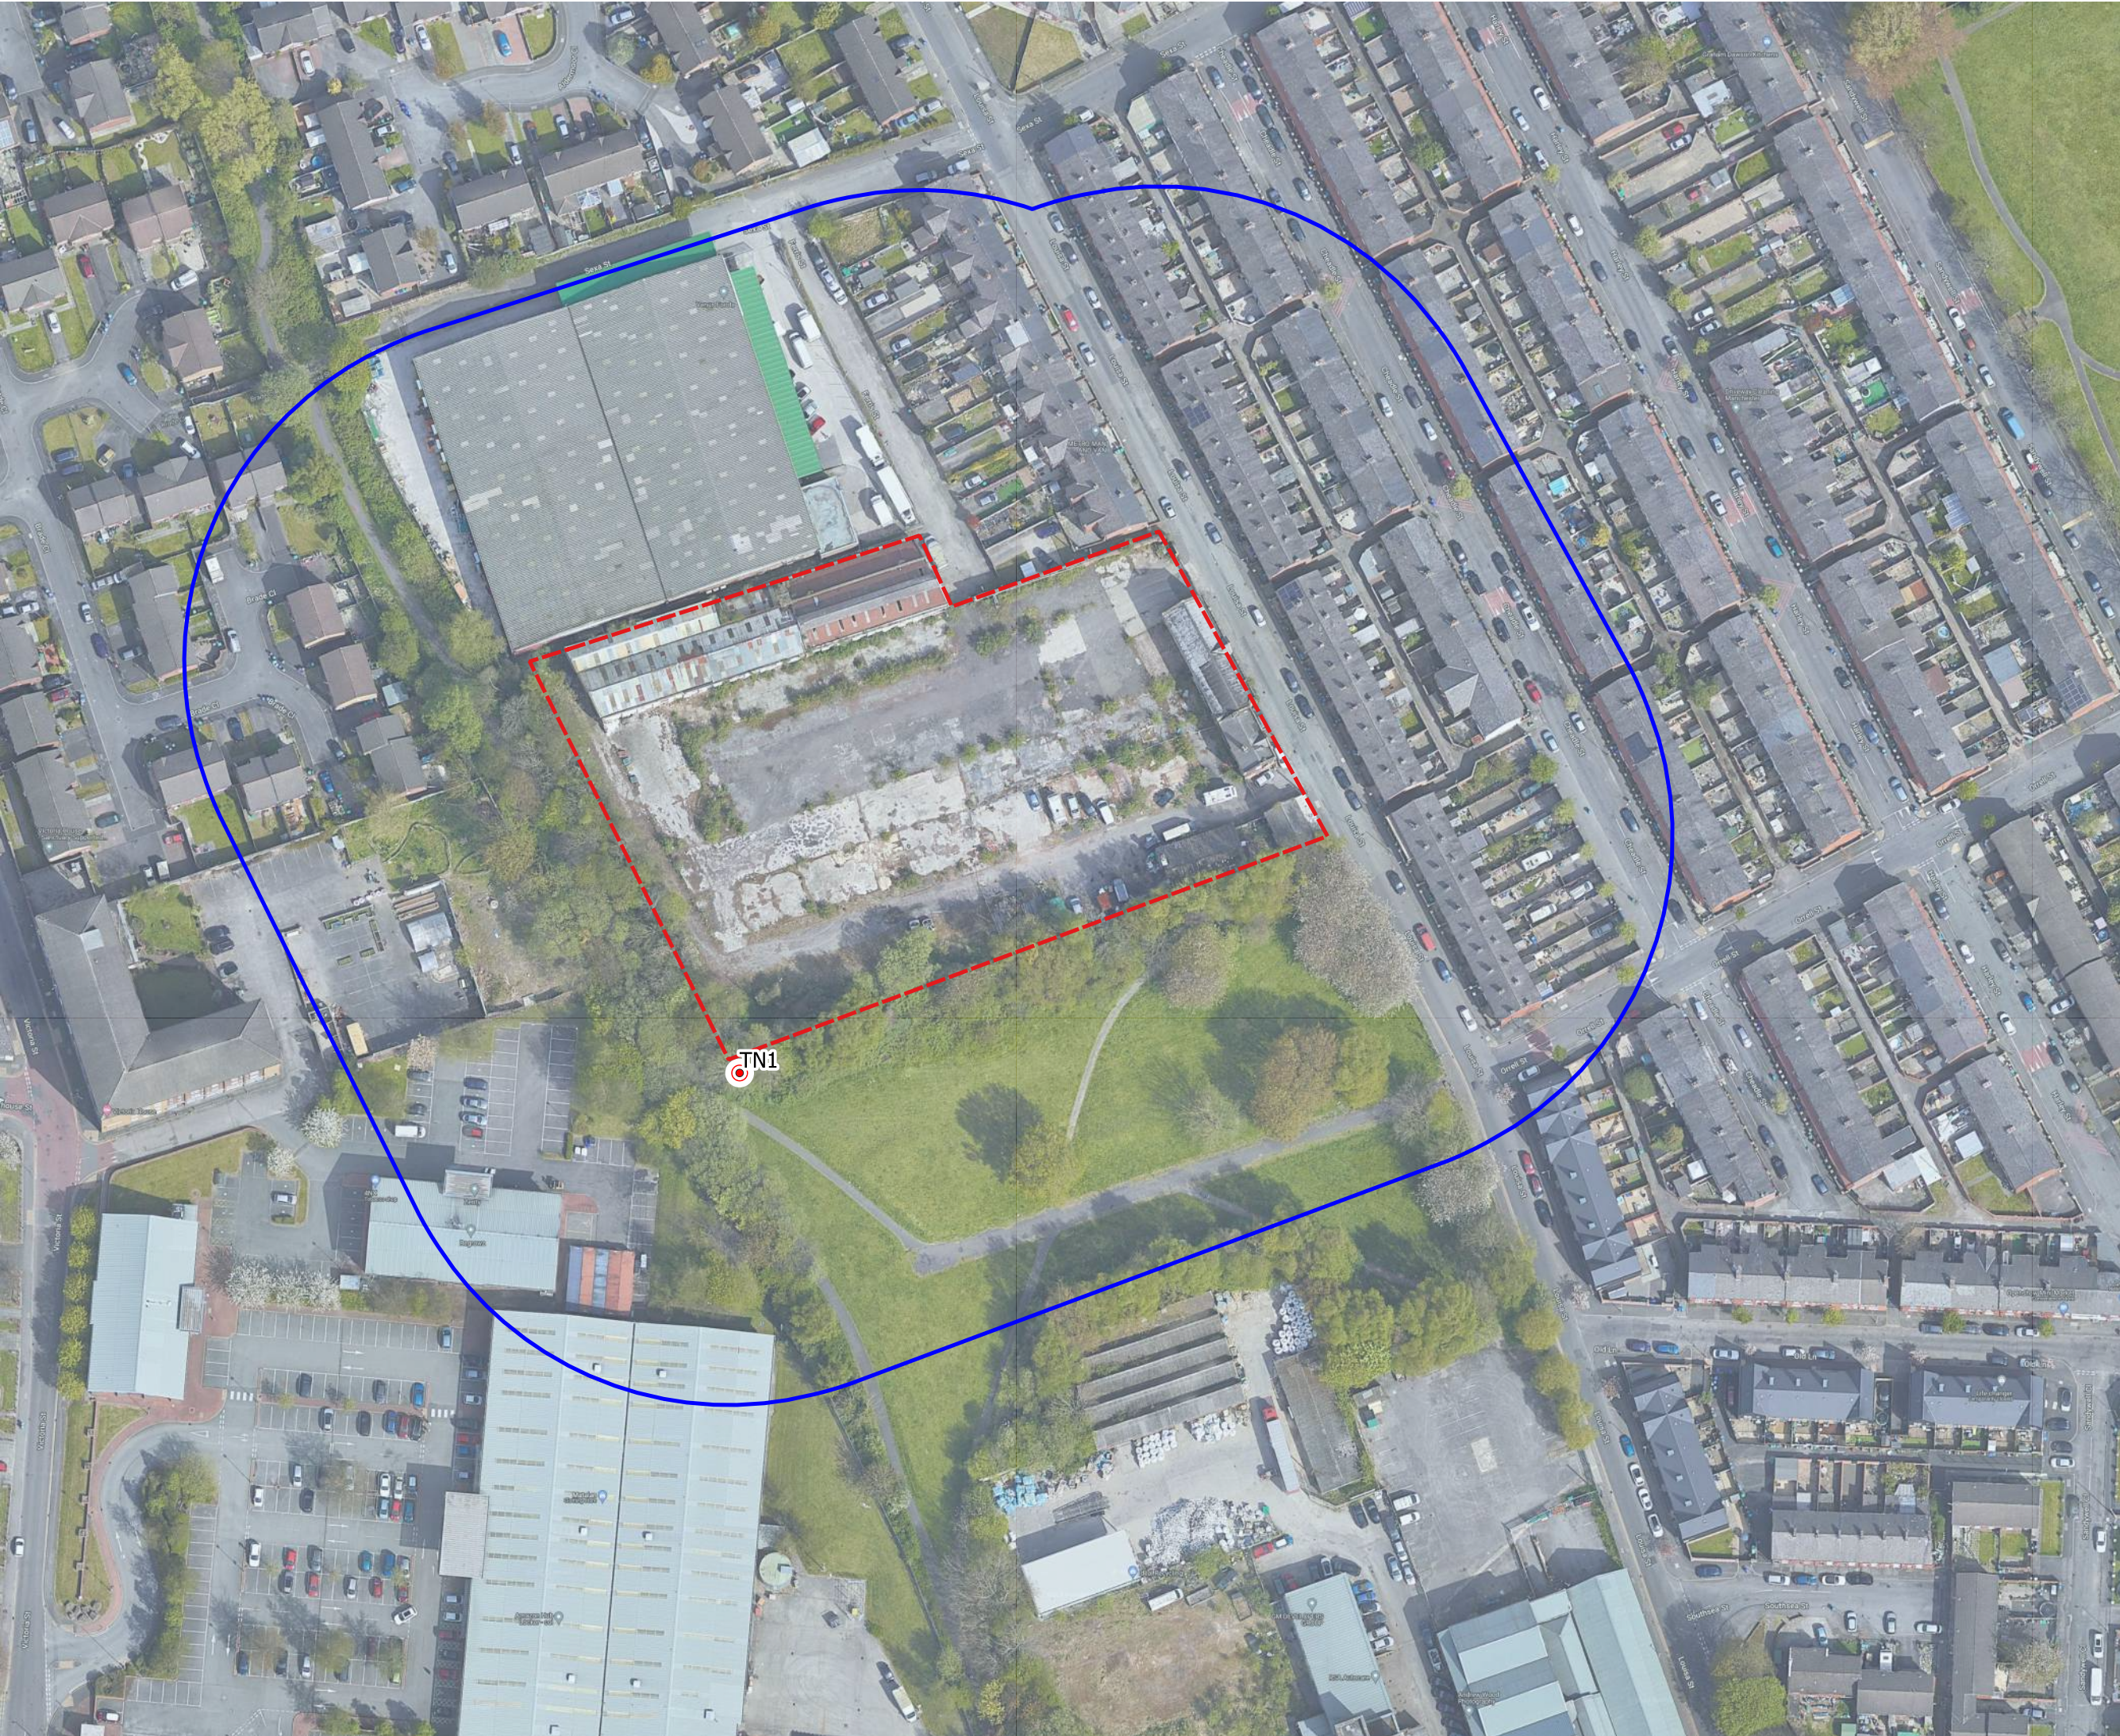
DRAWING TITLE:  
Badger Activity Survey

During the survey, no signs of badger activity (setts, paths, footprints, snuffle holes and latrines) were found within 50m of the site. The search radius has been plotted on a plan (*P.11717.22.03 Badger Activity Survey* in Appendix 1).

A record for an outlier sett (TN1 on plan P.1717.22.03, Appendix 1) was returned approximately 5m south-east of the site in 2021. This outlier sett was not identified during the badger activity survey. The scrub habitat that borders the southern site boundary as well as the park to the south, is frequented by dog walkers and is prone to regular human disturbance evident through the large amount of fly tipping and litter distributed throughout the park. It is possible that this outlier sett has

since been disturbed and covered due to amount of human disturbance and high volume of fly tipping and litter.

As badger are active within the wider area and a sett have been recorded within 30m of the site, it is recommended that Reasonable Avoidance Measures (RAMs) will be implemented during site works in order to avoid harm to any potential badger. These will include:

As badgers are active in the area, and the site is directly connected through Stockport Canal Branch to a main badger sett recorded approximately 600m north of the site, it is recommended that an updated survey for badger, including all habitats within 30m of the site, is undertaken prior to the start of works as badger can dig new setts at any time.
