# **Site Tree Appraisal**

***2 – 4 – 6 Delaunays Road, Crumpsall, Manchester M8 4QS***

**‘BS 5837 2012: Trees in Relation to Design, Demolition and Construction – Recommendations’**

Ref: RTS/26072023

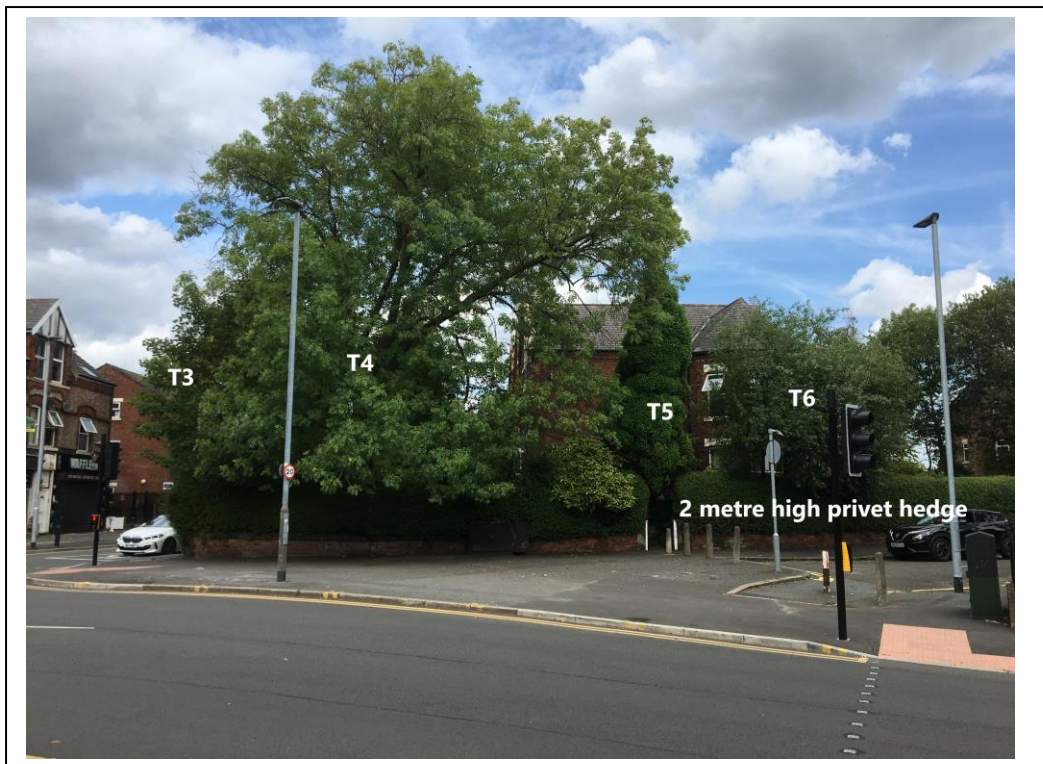
Photo 01

**3.3** No trees are anticipated to be affected by the proposed repair works to the building façade. The proposed construction of a new brick and timber wall, however, will require some tree removals. The existing boundary wall is believed to only be founded on Victorian style brick stretchers. This existing wall will have to be demolished together with the brick stretchers. The new wall construction will then need to be built to modern building standards, and will therefore, require founding on a concrete strip foundation. Given the proximity of the existing trees to the boundary wall, several of them will require removal due to foreseeable root damage that is likely to occur during excavation works for the foundations. The 2-metre-high privet hedgerow, adjacent and parallel to the existing boundary will also have to be removed (photo 01).

**3.4** The most significant tree that would require removal to facilitate the new boundary wall construction is the large Ash tree (T4), see photo 01. Aside from noting very early signs of Ash Die-Back disease (ADB) *Hymenoscyphus fraxineus*, consent under Conservation Area Legislation had previously been granted by Manchester Council to remove T4 due to damage it is causing to the boundary wall; (078965/TCA/2006/N1 dated 3<sup>rd</sup> May 2006). Unfortunately, the tree has not yet been removed and damage to the existing boundary wall has become worse, removal of T4 is now required to construct a new wall.

| Tree No | Species | Height (M) *<br>Crown Height above GL | DBH (mm) * | Crown Spread (M) * | Height to Lowest Branch (M)<br>Direction of Lowest Branch | Age Range | Condition | RPA Radius (M) | RPA Square metres | BS 5837 Category Rating | Observations and Comments |
|---|---|---|---|---|---|---|---|---|---|---|---|
| T4 | <b>Ash</b><br><i>Fraxinus excelsior</i> | <u>17.0</u><br>3.0 | 830 | N – 6.0<br>S – 9.0<br>E – 7.0<br>W – 7.0 | <u>4.0</u><br>S | Mature | Fair | 9.9 | 307 | C1 | A large tree close to and pushing the boundary wall; The tree is also showing very early signs of Ash Die-Back disease (ADB). |

| Tree | Tree Work | Priority |
|---|---|---|
| T1, T2, T3, T4, T5, T6, T7 & T14. Privet hedgerow along Delaunays Road and Westbury Road. | Fell to ground level and grind out the remaining stumps | Prior to any other site works |
