Knightbridge Properties | Milford House No. 29 Ardwick Green North, Manchester, M12 6DL

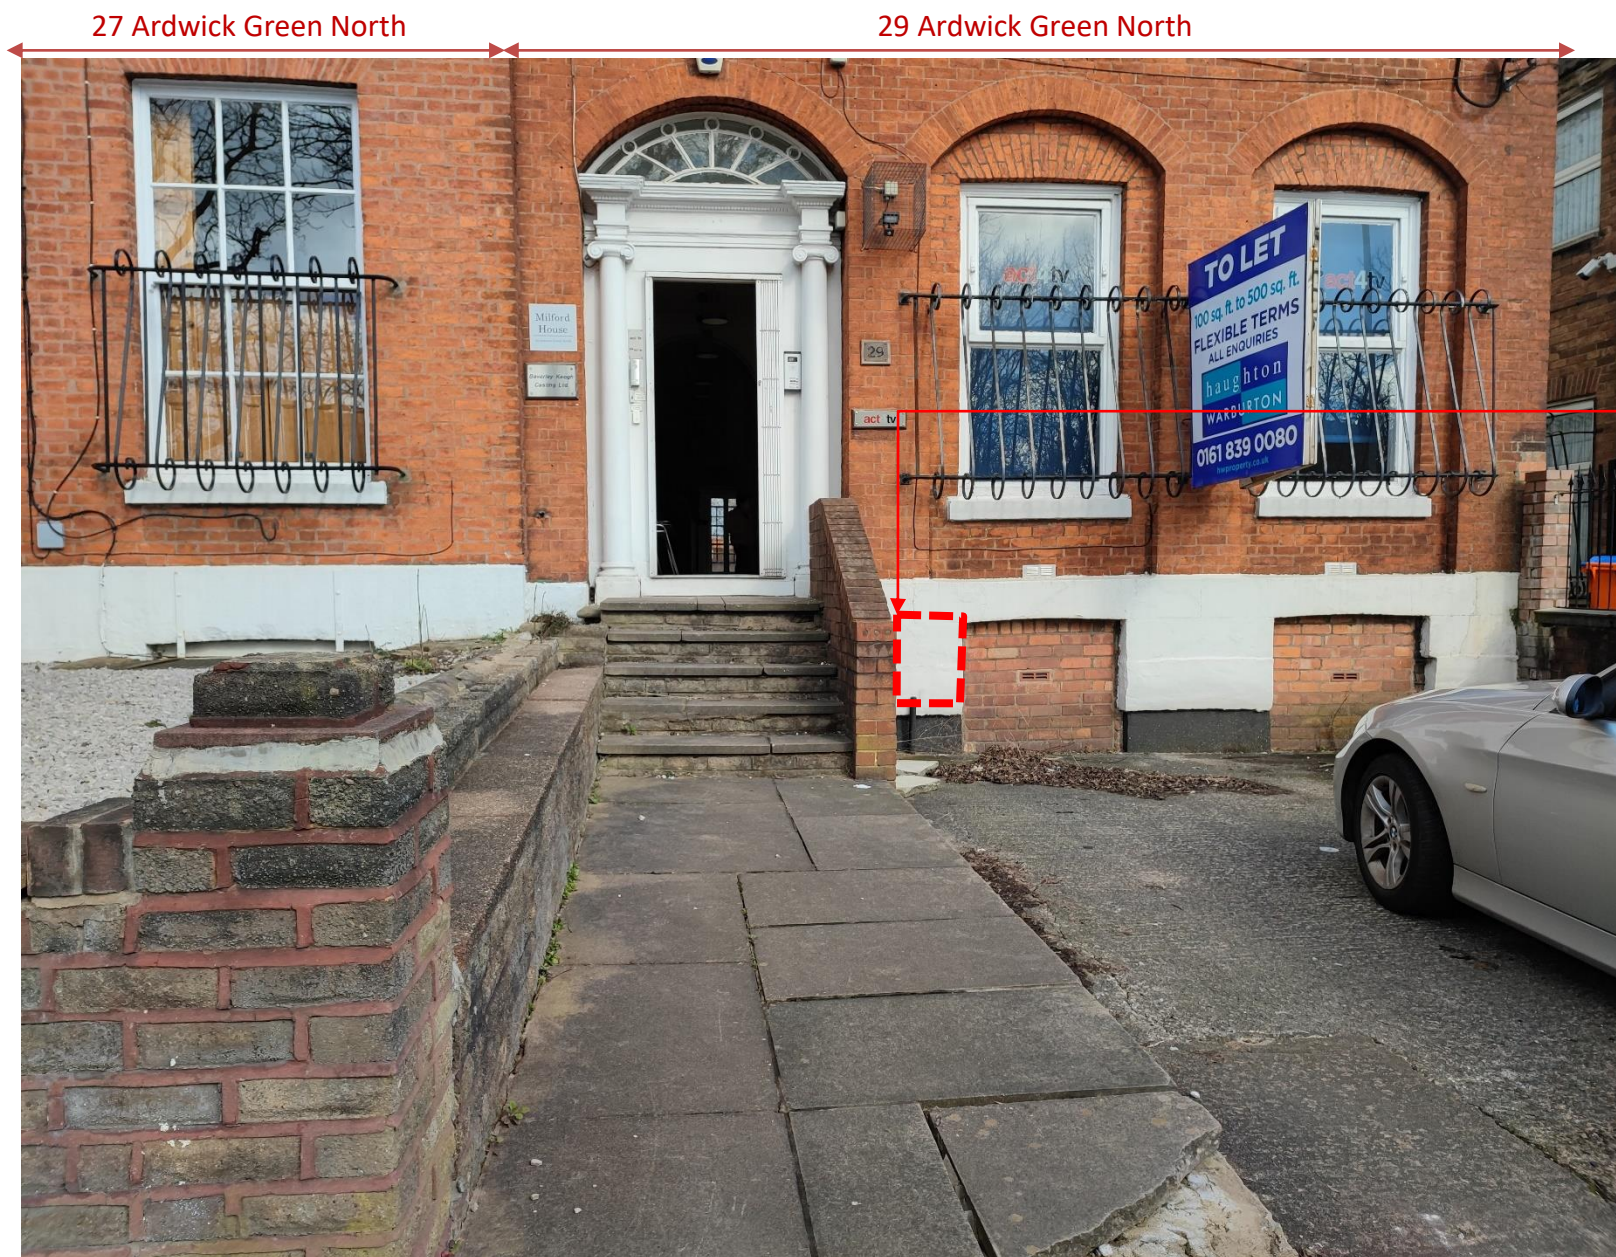
Figure 01 – Front Elevation view towards to the main entrance  
Provision of an EV charging point

Provision of EV  
Charging Point

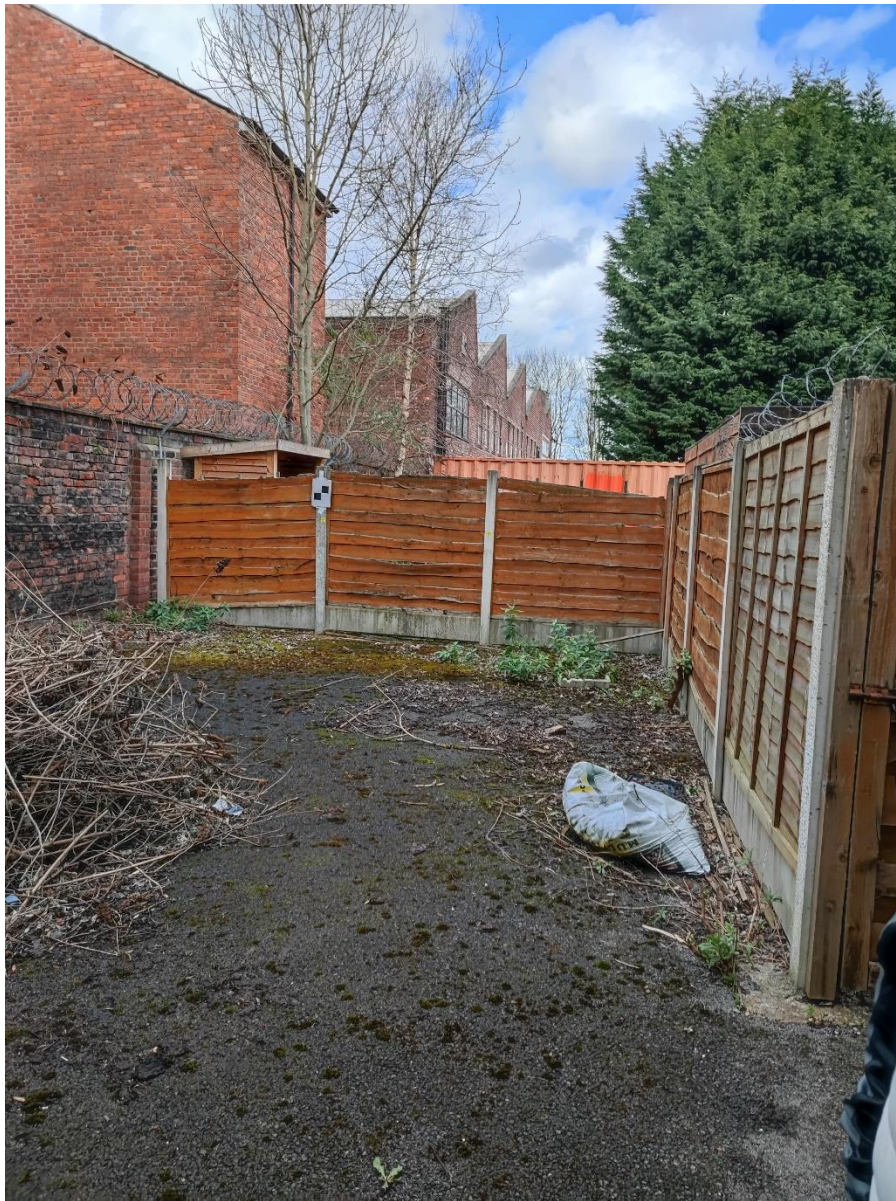
Figure 03 – View Northeast towards existing rear boundary treatment  
Timber fence to make good

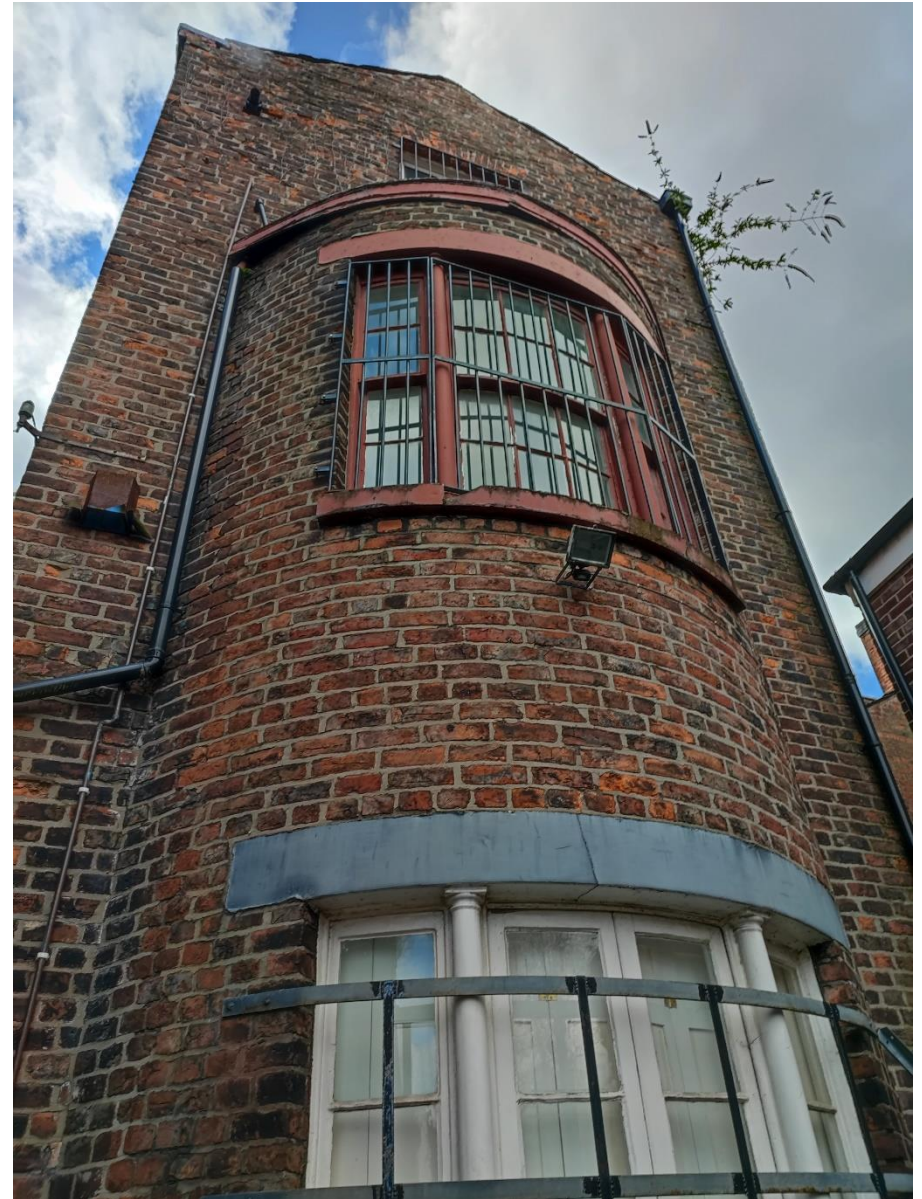
Figure 06 – Close up view Southwest towards rear windows  
Metal security bars to be removed. Windows to make good or like to like replacement where required.

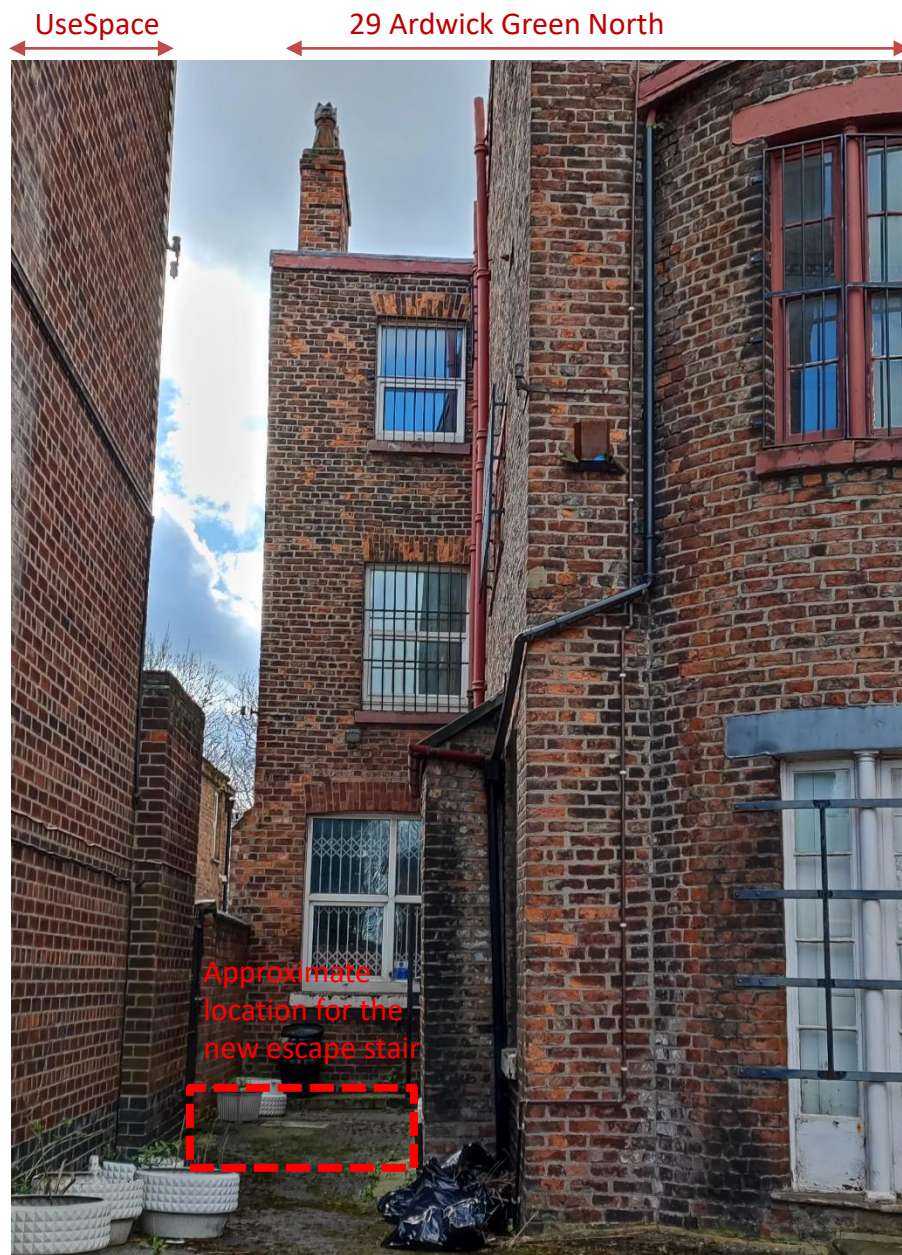
Figure 07 – View Southwest towards rear elevation  
Existing ground to be excavated for new escape stair to the basement  
association with handrail on the ground level

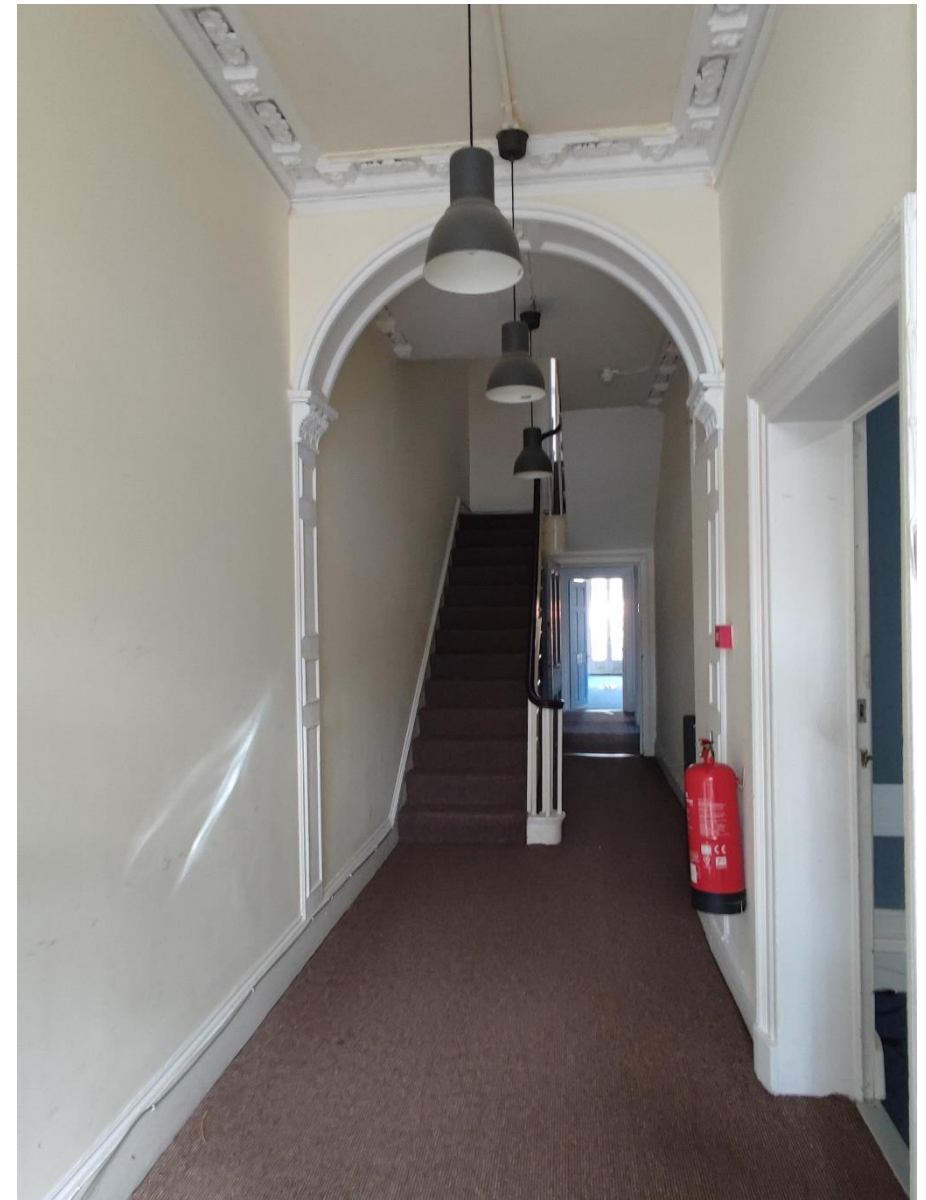
Figure 10 – View Northeast towards exiting staircase.  
New fired rated door with glazed panel to be install to back of the  
existing arch feature to from residents' security entrance.

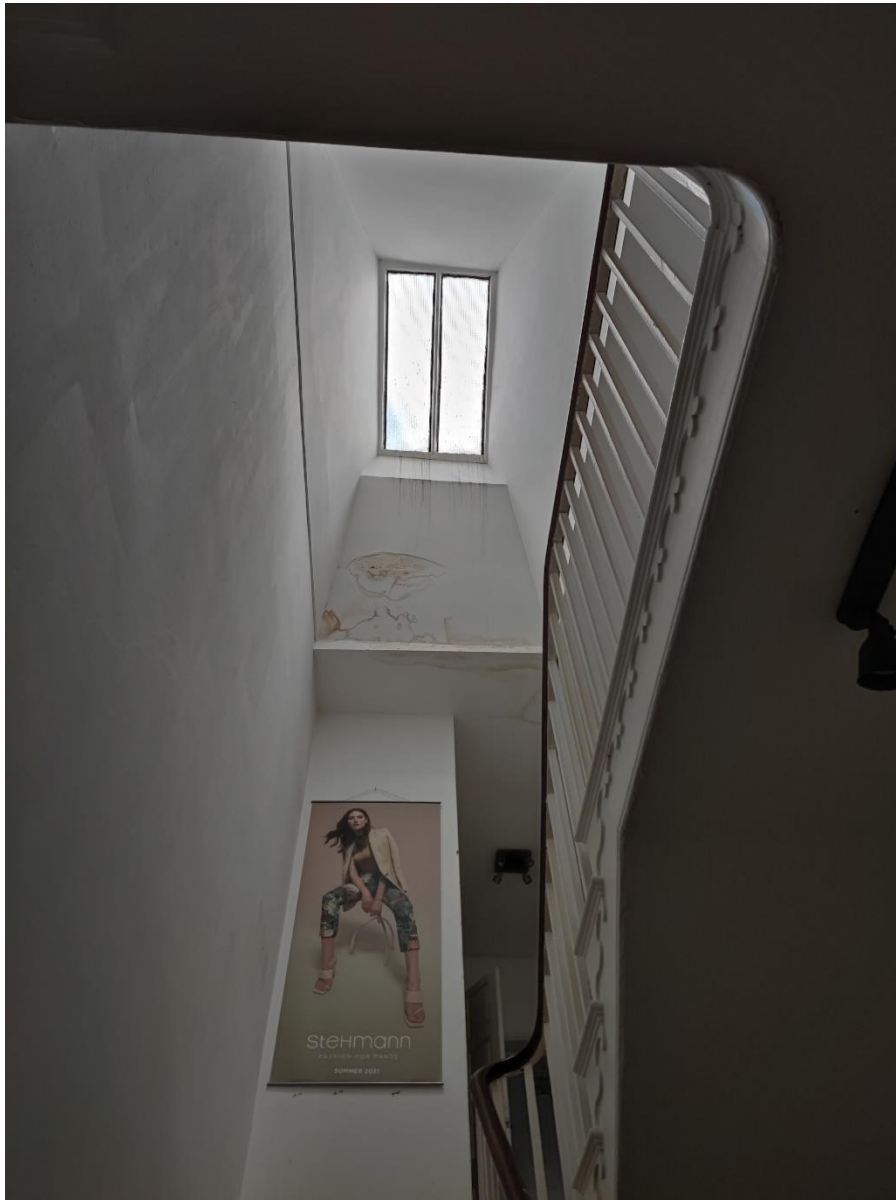
Figure 11 – View Northeast towards existing rooflight  
No change to the staircase feature, handrail and rooflight.  
Make good where is required.

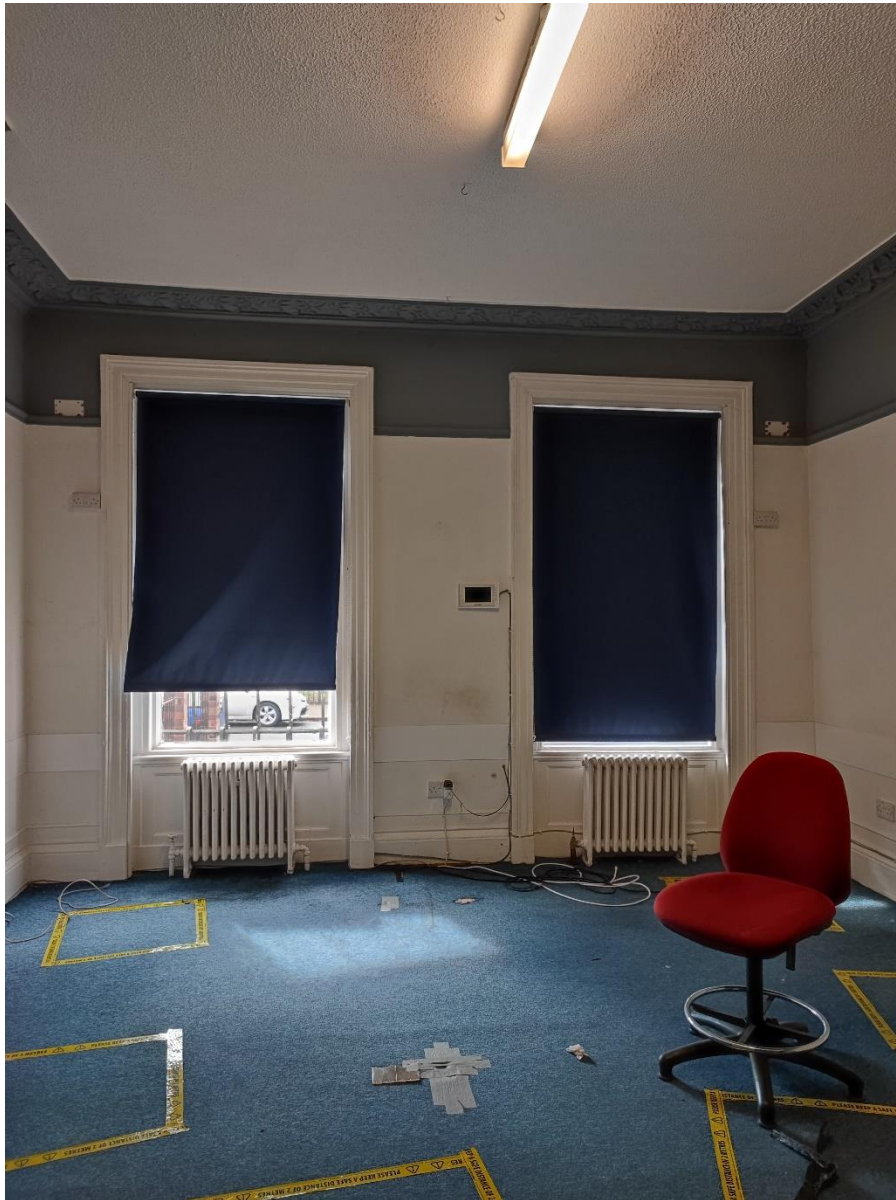
Figure 13 – View Southwest from the front office  
Installation of new light fixtures

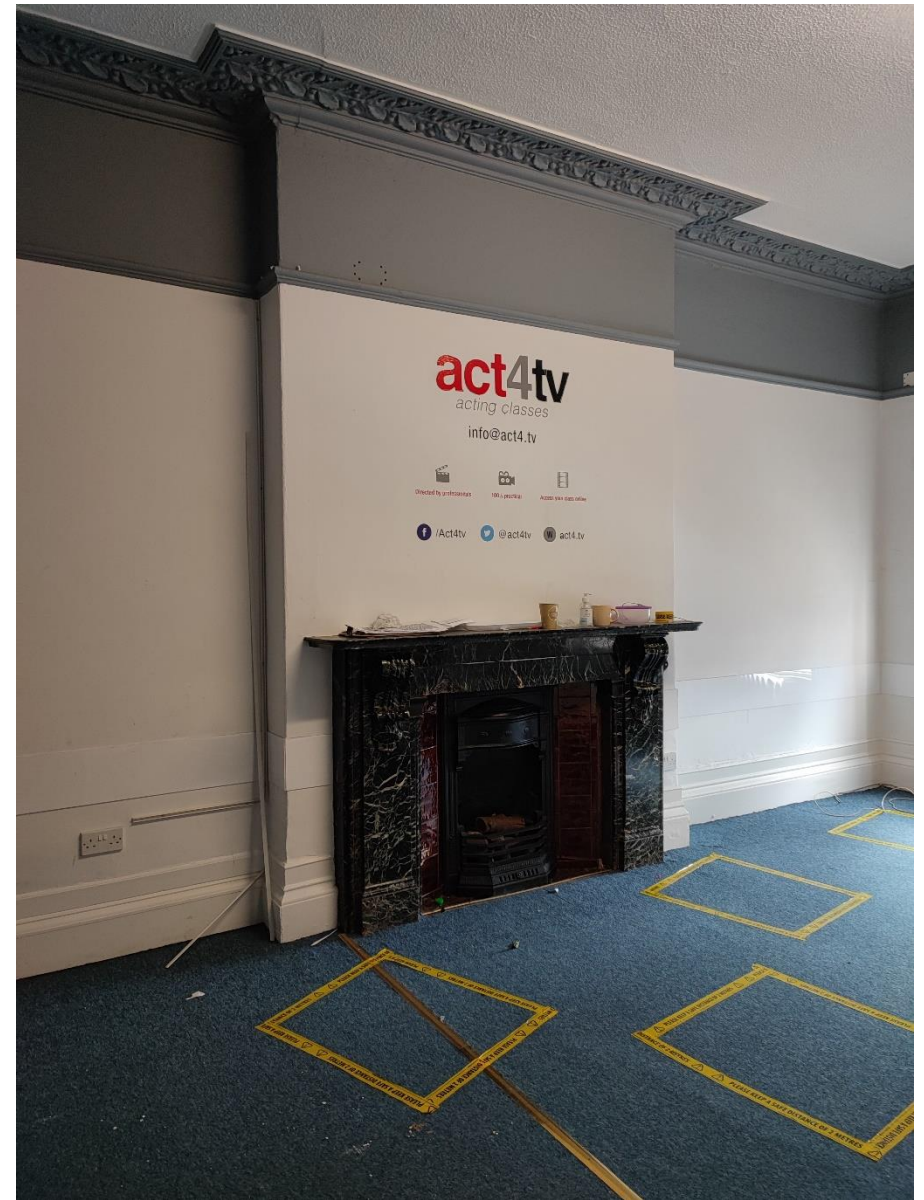
Figure 14 – View East towards the existing chimney breast fireplace  
from the front office. Flooring / Wall: make good where required.

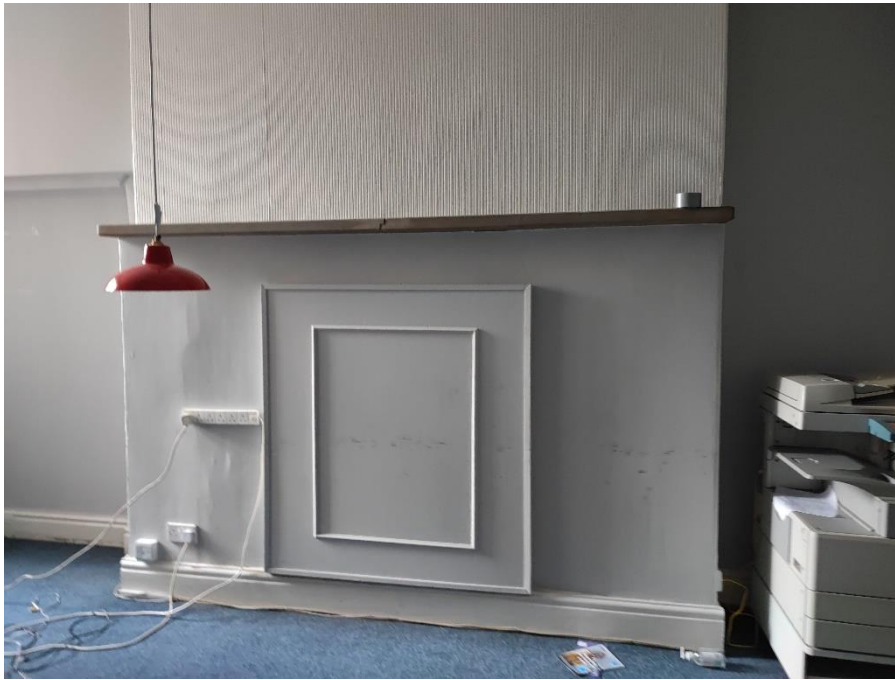
Figure 15– View East towards the chimney breast from the middle office room.  
Make good where required.

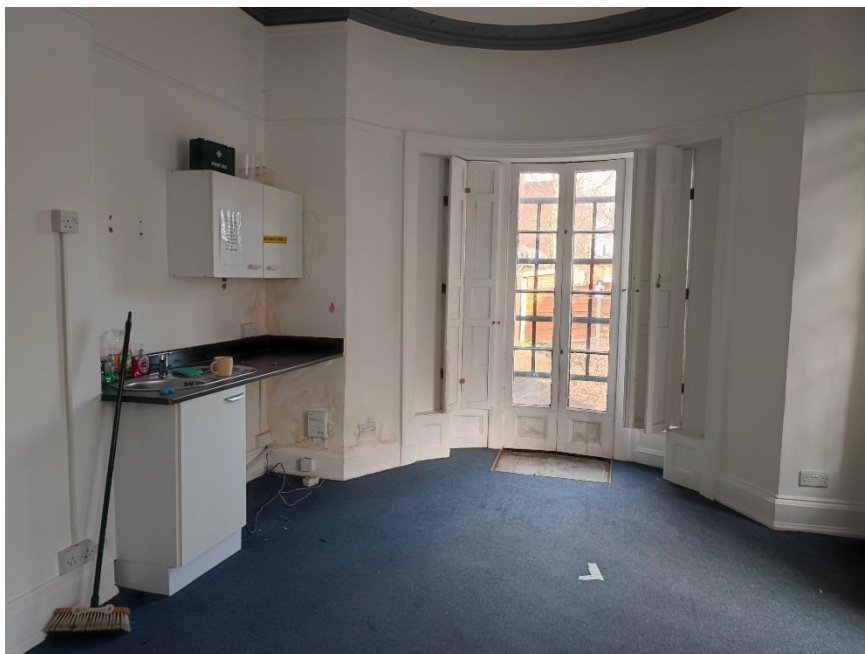
Figure 17– View Northeast towards rear yard from the rear office room. Existing kitchenette to be removed. Make good where required.

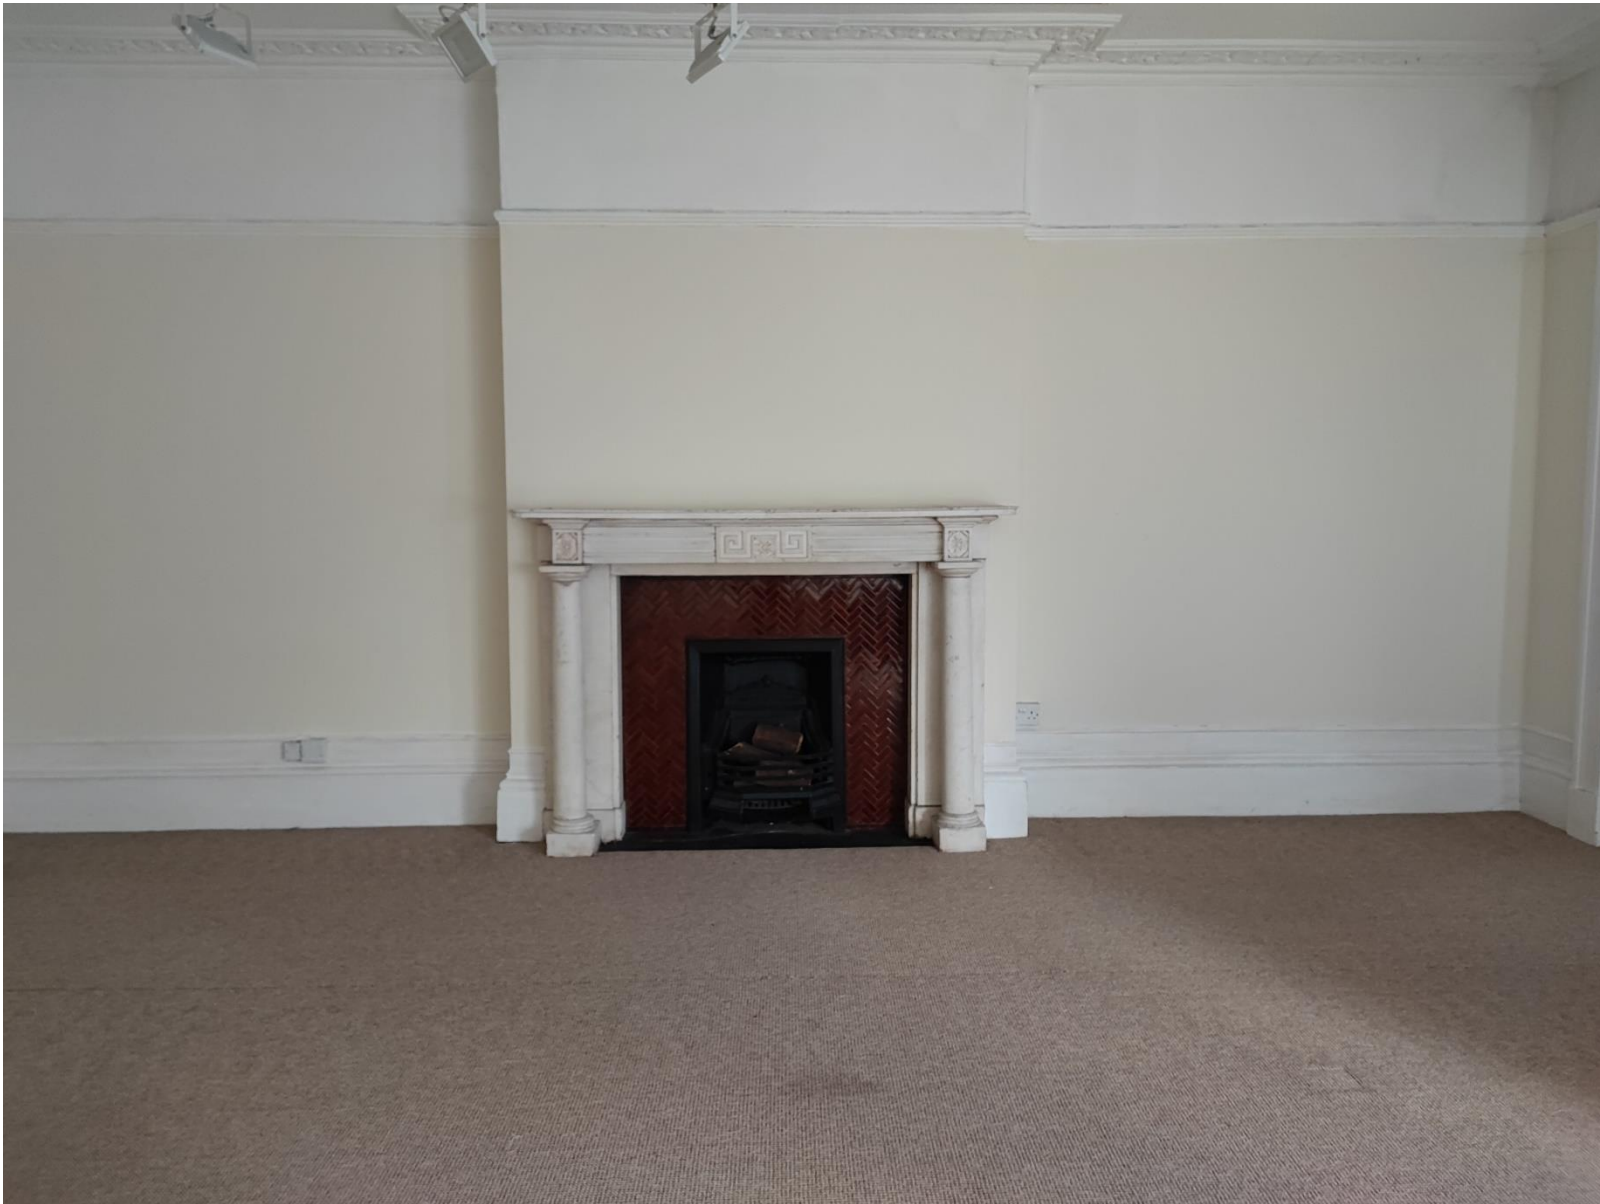
Figure 19 – View East towards the existing chimney breast fireplace from the front room.  
Replace existing Light Fixtures. Make good where required.

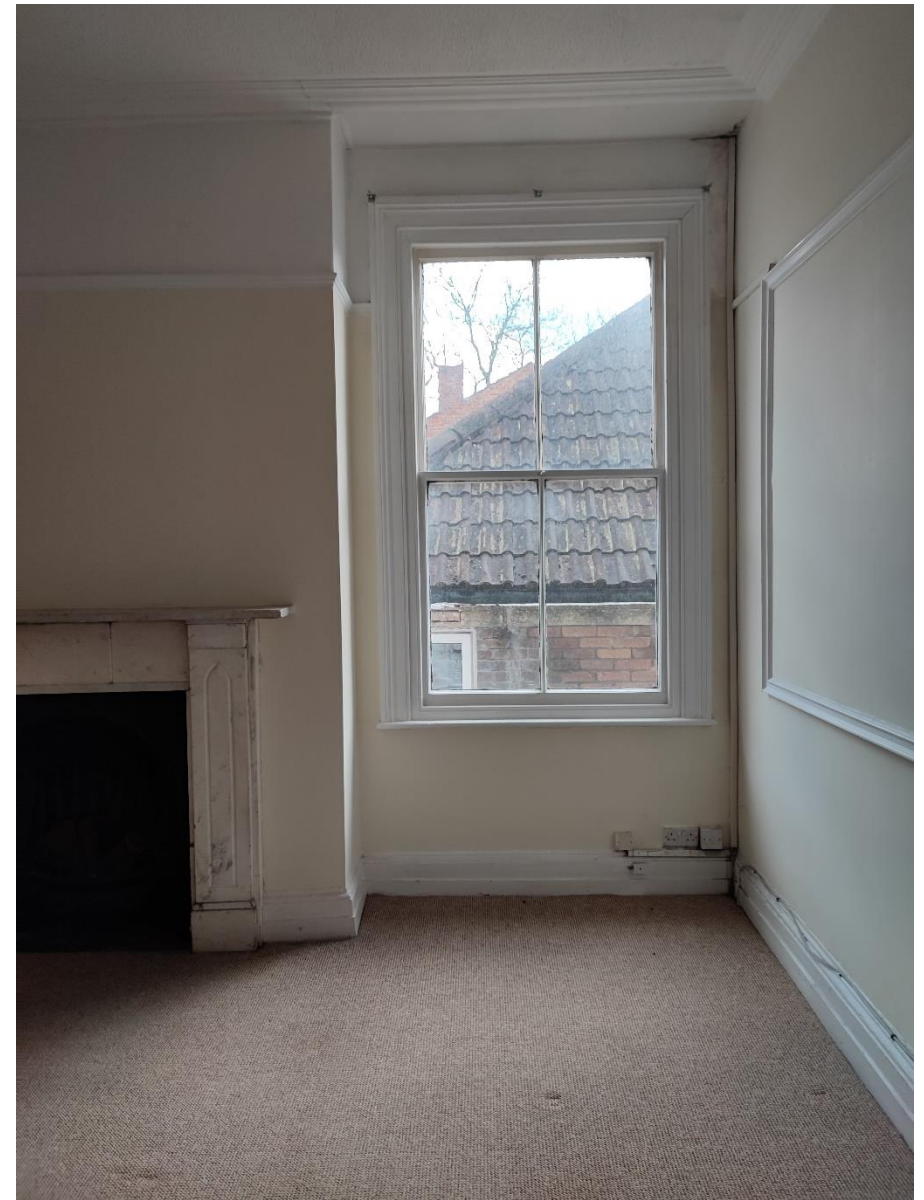
Figure 21 – View East from the middle room towards existing chimney breast fireplace and window.  
Make good where required.

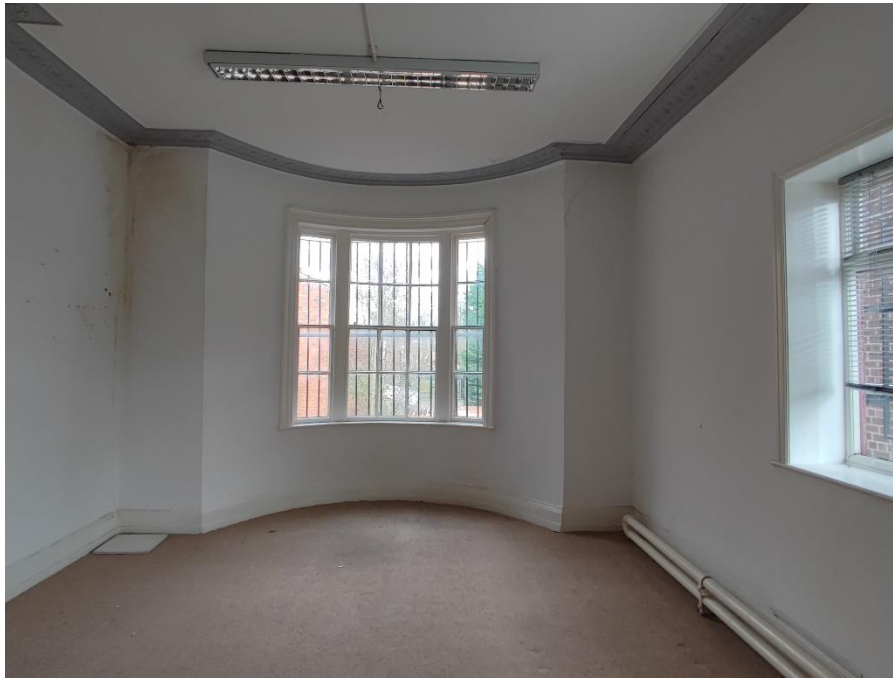
Figure 22 – View Northwest from the rear room.  
Replace existing light fixtures.

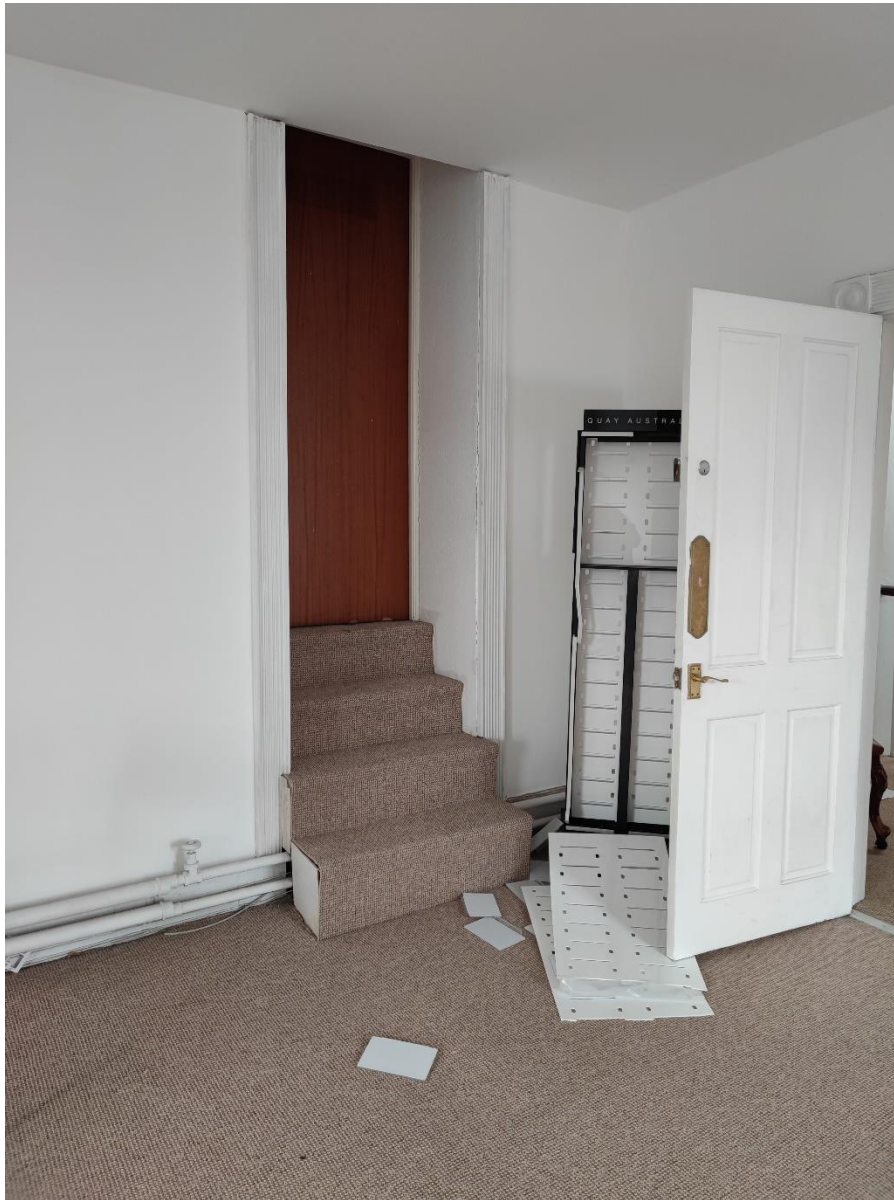
Figure 24 – View North from the front towards the existing passway to No 27 Ardwick Green North.  
Passway would be blocked with light weight plasterboard. Existing stair block to be removed.

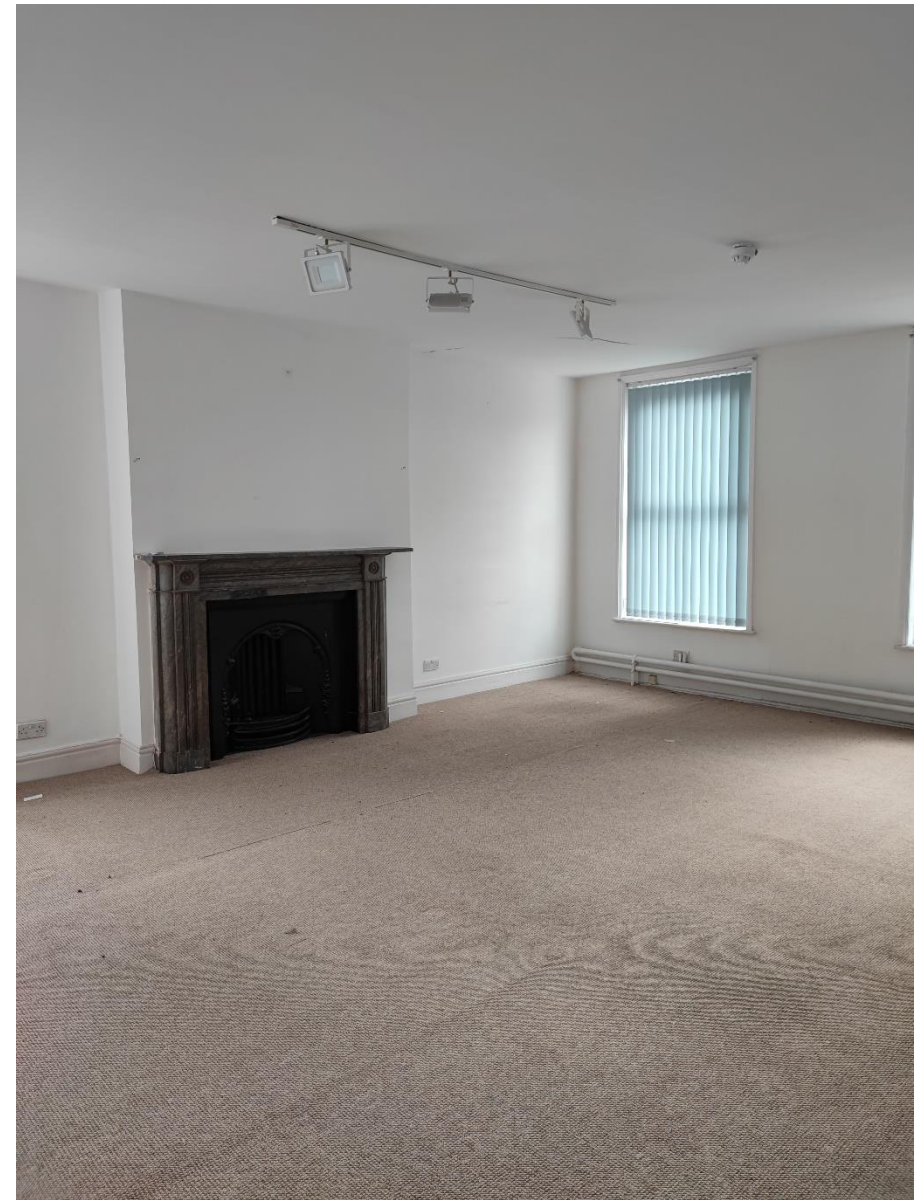
Figure 25 – View South from the front room towards the existing chimney breast fireplace.  
Replace existing light fixture.

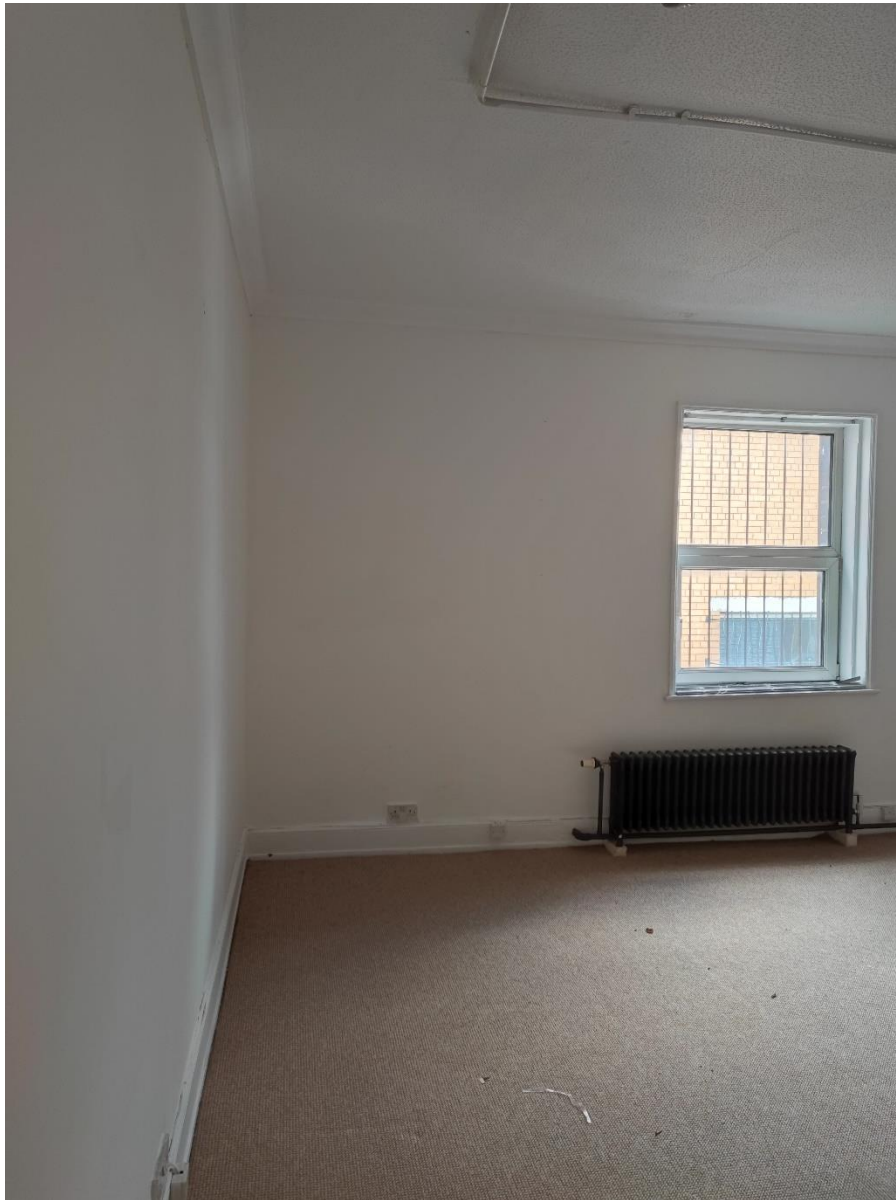
Figure 26 – View North from the middle room towards the rear window.  
Make good where required,

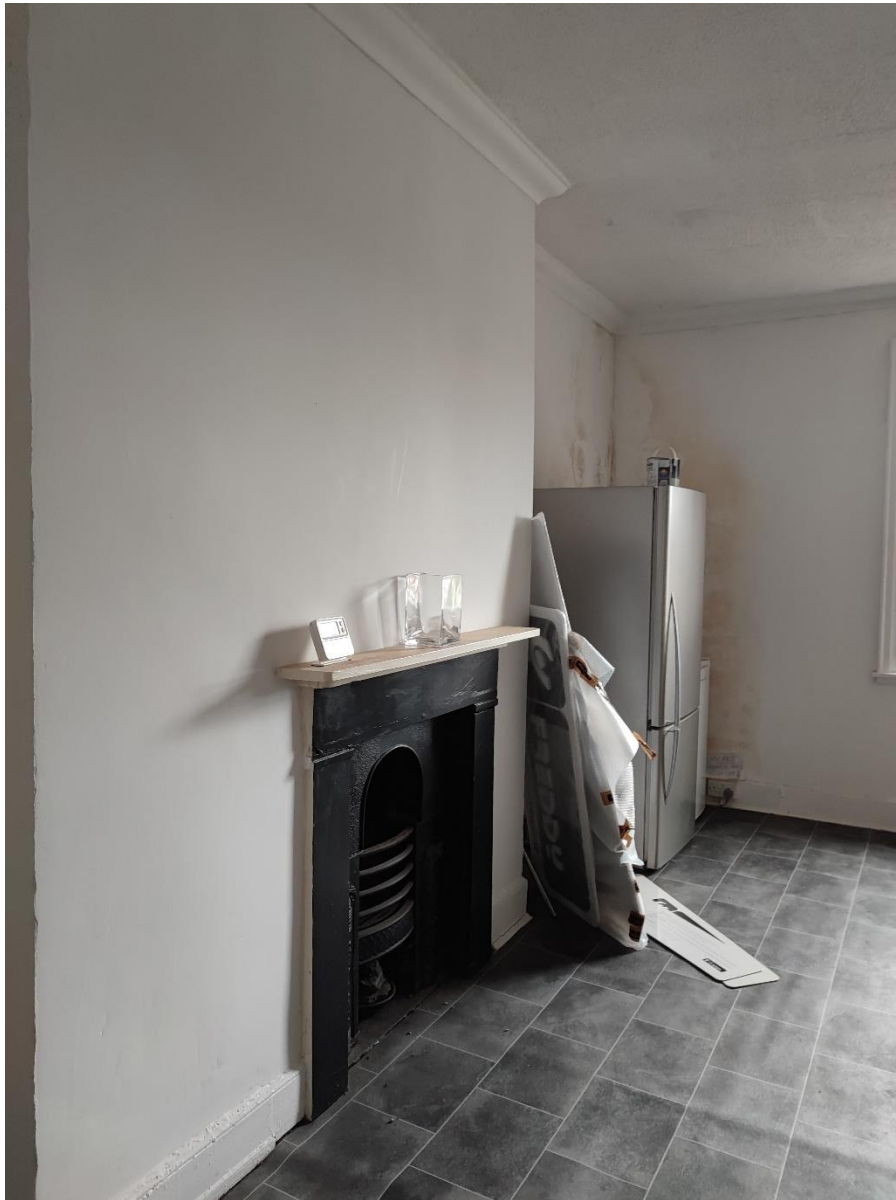
Figure 28 – View North from the rear towards the existing chimney breast fireplace . Make good where required.
