# **Site Tree Appraisal**

## ***27 Adria Road, Didsbury, Manchester M20 6SQ***

Ref: RTS/13042023

The following is a pre-development survey and appraisal of trees on and adjacent to the above site.

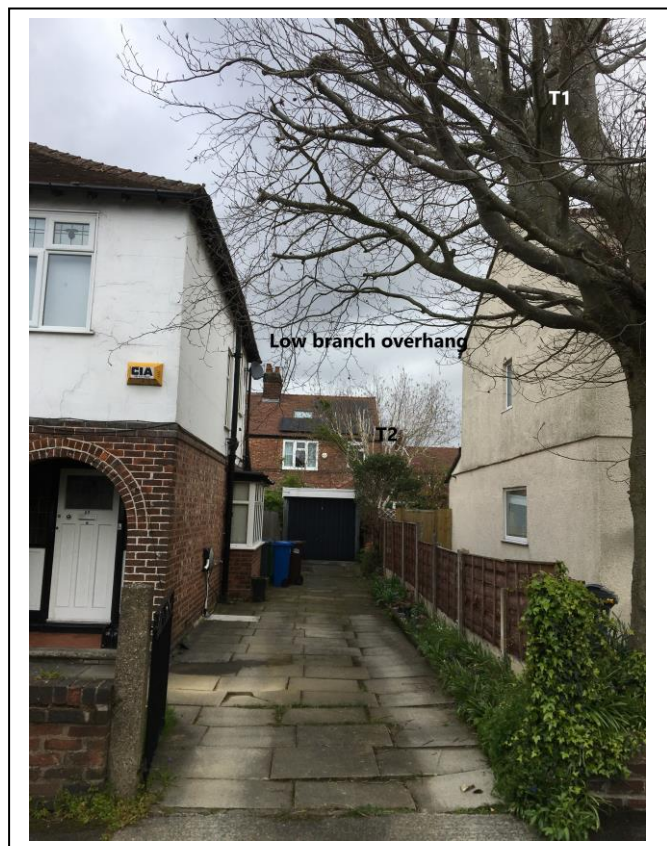
Photo 02:

- 3.5** No tree pruning will be required to facilitate the extension build. However, due to the low branch overhang of the driveway (photo 02), some minor crown lift pruning to T1 is recommended to improve access and material delivery to the site. The pruning specifications are noted in the Recommendations, section 5 of the report.

| Tree | Tree Work | Priority |
|---|---|---|
| T1 | Crown lift the west side of the crown, over the driveway, to obtain a branch height clearance above ground level of approximately 4 metres. | Prior to any other site works |
