# PRELIMINARY ARBORICULTURAL SURVEY (BS 5837:2012)

LAND ADJACENT VIRGIL STREET  
CORNBROOK  
MANCHESTER  
M15 4ED

January 2023

Job Number 5145

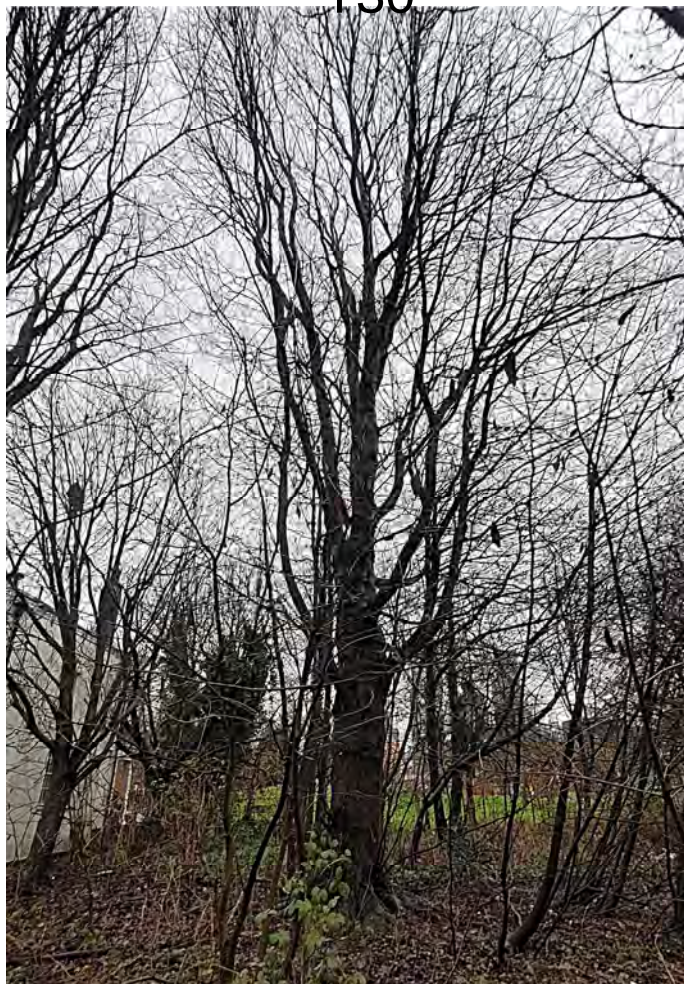
| Tree No. | Species | Dbh (mm) | Height (m) | Age | Crown Spread | | | | Crown C | Cond R | Observations and Comments | Preliminary Recommendations | ERC (Yrs) | TQC R | RPA (m²) | RPA Circle Radius (m) |
|---|---|---|---|---|---|---|---|---|---|---|---|---|---|---|---|---|
| T30 | Silver Maple | 800 | 22 | M | 6 | 8 | 9 | 8 | 3 | A/B | A very large tree on the boundary exhibiting reasonable form and vigour, Forked at 4m. Deadwood present. Evidence of previous minor failures. Basal shoots present. | Remove basal shoots. | 20+ | B2 | 289.53 | 9.60 |

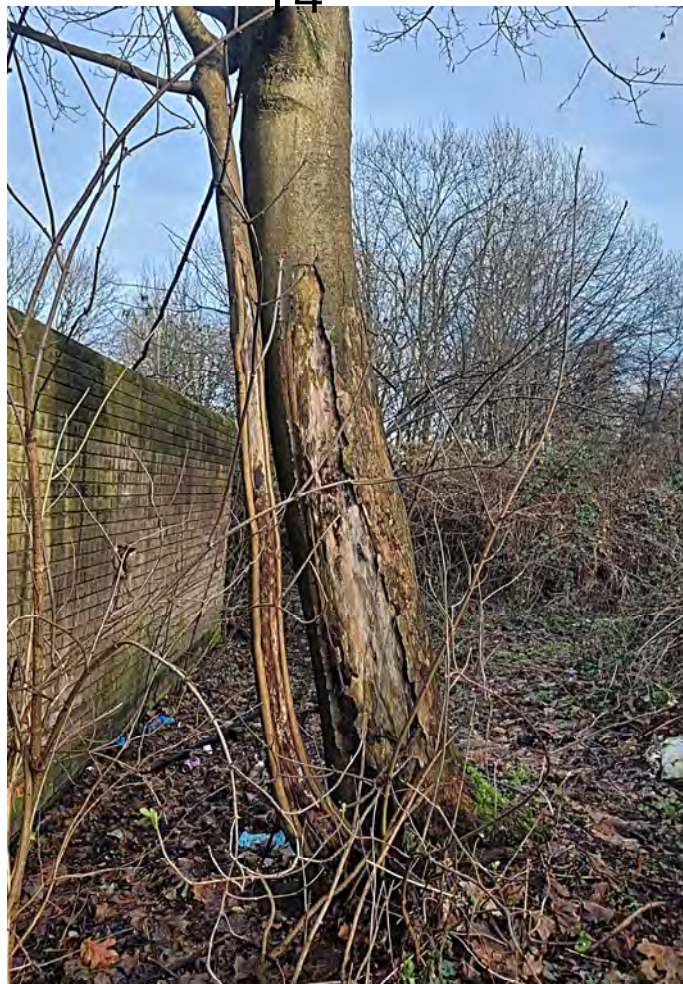
| Arboricultural Data Sheet: Land adjacent Virgil Street, Cornbrook, Manchester, M15 4ED    Date of Survey: 06/01/23    Weather: Overcast    Surveyor: PM | | | | | | | | | | | | | | | | |
|---|---|---|---|---|---|---|---|---|---|---|---|---|---|---|---|---|
| T4 | Norway Maple | 450 | 14 | M | 8 | 7 | 7 | 8 | 2.5 | B/C | Locate close to the building. Significant fire damage on the stem, which will rapidly decay. Reasonable overall form and vigour. Minor deadwood present. Very low potential. | Fell to ground level. | 5-10 | U | 91.61 | 5.40 |

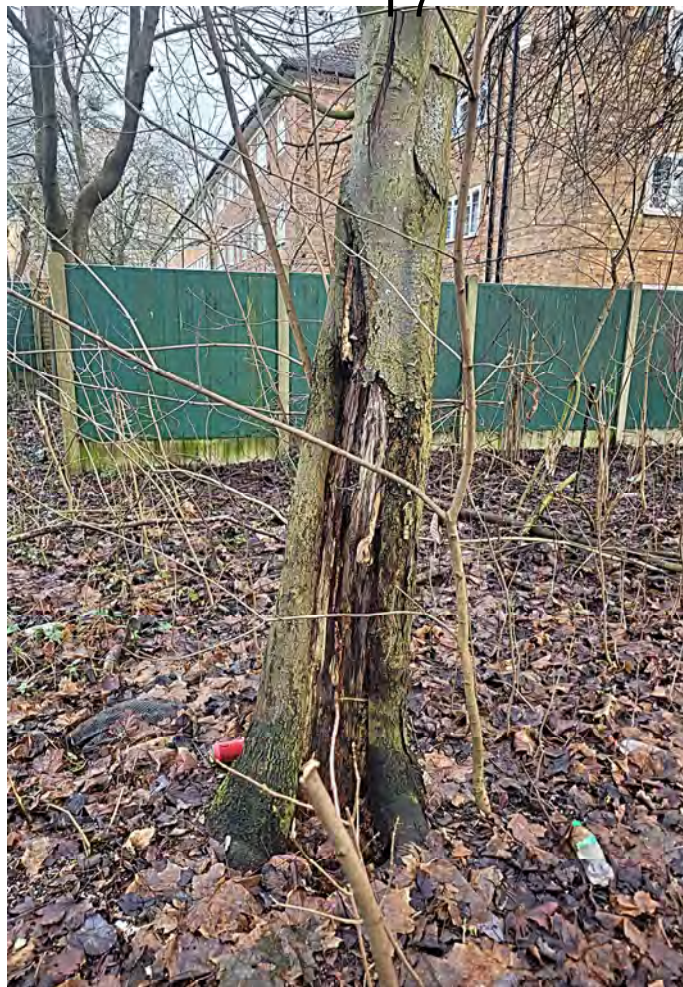
| Tree No. | Species | Dbh (mm) | Height (m) | Age | Crown Spread | | | | Crown C | Cond R | Observations and Comments | Preliminary Recommendations | ERC (Yrs) | TQC R | RPA (m²) | RPA Circle Radius (m) |
|---|---|---|---|---|---|---|---|---|---|---|---|---|---|---|---|---|
| T7 | Whitebeam | 360 | 8 | M | 6 | 4 | 0 | 5 | 2 | C/D | Exhibits major stem decay, imminent risk of complete failure. | Fell to ground level, grind out stump and replace. | 0-5 | U | 58.63 | 4.32 |

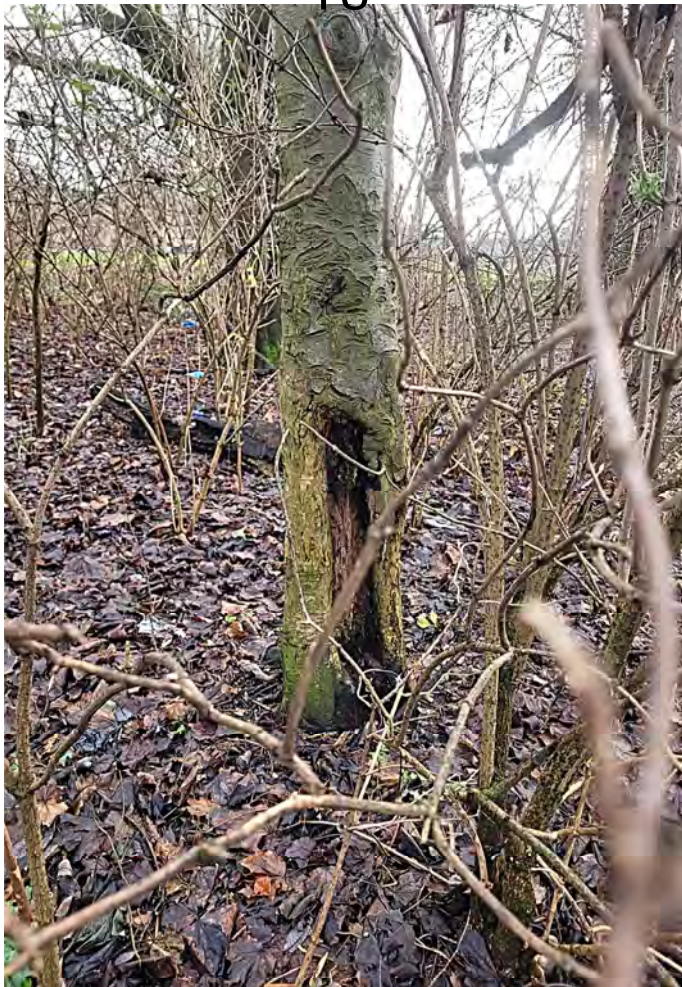
| Tree No. | Species | Dbh (mm) | Height (m) | Age | Crown Spread | | | | Crown C | Cond R | Observations and Comments | Preliminary Recommendations | ERC (Yrs) | TQC R | RPA (m²) | RPA Circle Radius (m) |
|---|---|---|---|---|---|---|---|---|---|---|---|---|---|---|---|---|
| T8 | Whitebeam | 320 | 10 | M | 4 | 4 | 4 | 3 | 3 | C/D | Exhibits major stem and basal decay, imminent risk of complete failure. | Fell to ground level, grind out stump and replace. | 0-5 | U | 46.32 | 3.84 |

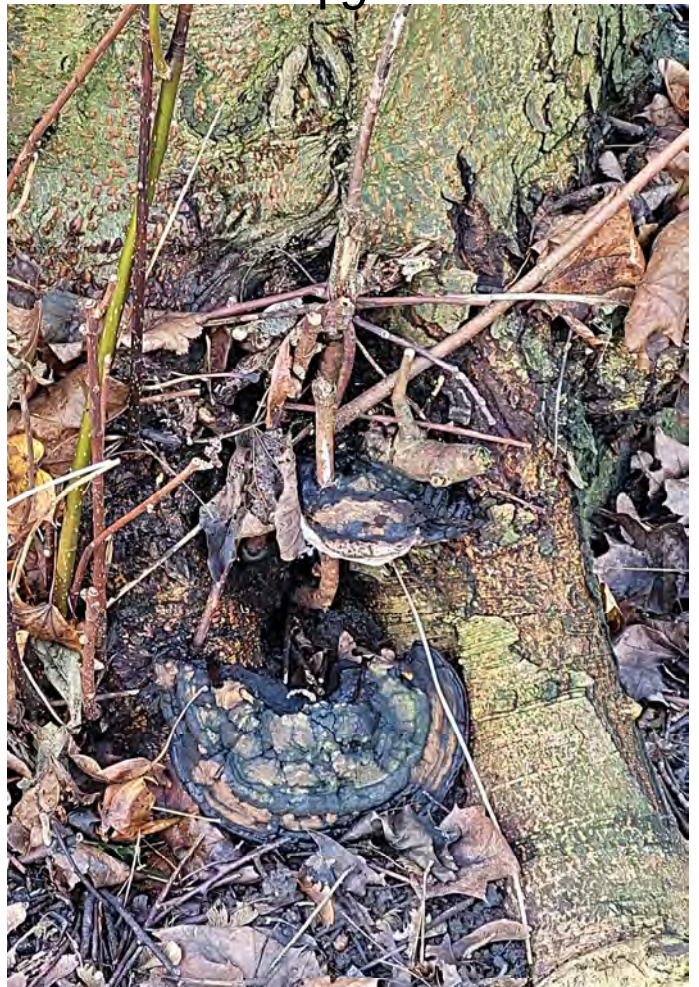
| Tree No. | Species | Dbh (mm) | Height (m) | Age | Crown Spread | | | | Crown C | Cond R | Observations and Comments | Preliminary Recommendations | ERC (Yrs) | TQC R | RPA (m²) | RPA Circle Radius (m) |
|---|---|---|---|---|---|---|---|---|---|---|---|---|---|---|---|---|
| T9 | Bird Cherry | 510 | 11 | FM | 8 | 7 | 3 | 6 | 1.8 | B/C | A large specimen with reasonable vigour but has some decay present in the lower stem and base. There is also the presence of the decay fungus <i>Ganoderma spp</i> on the eastern side at base. Crown asymmetry due to group. Low potential. | Fell to ground level, grind out stump and replace. | 5-10 | U | 117.67 | 6.12 |

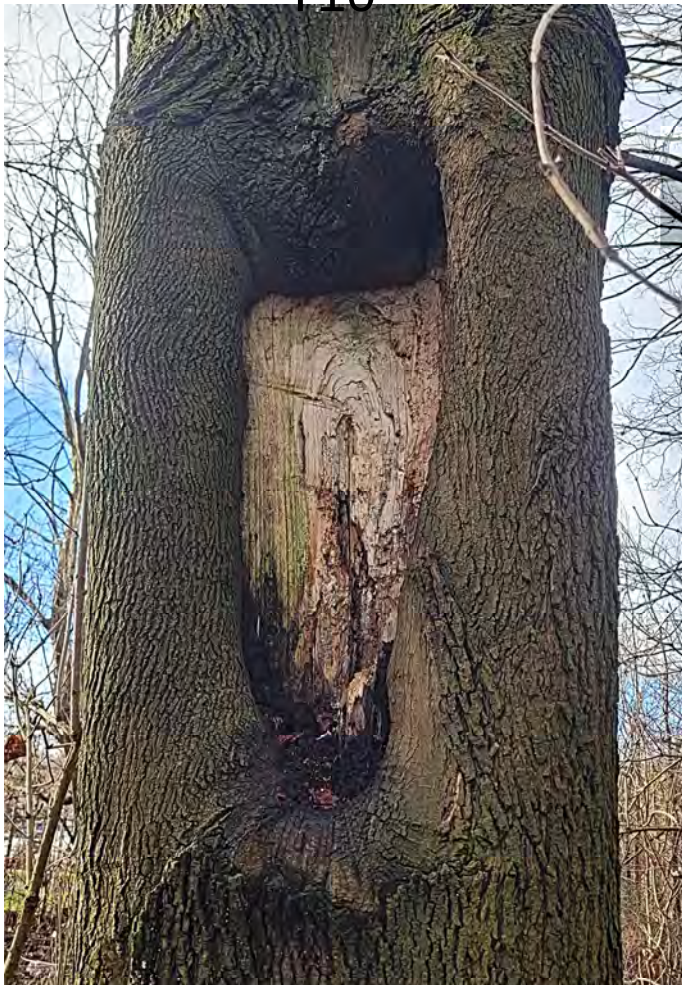
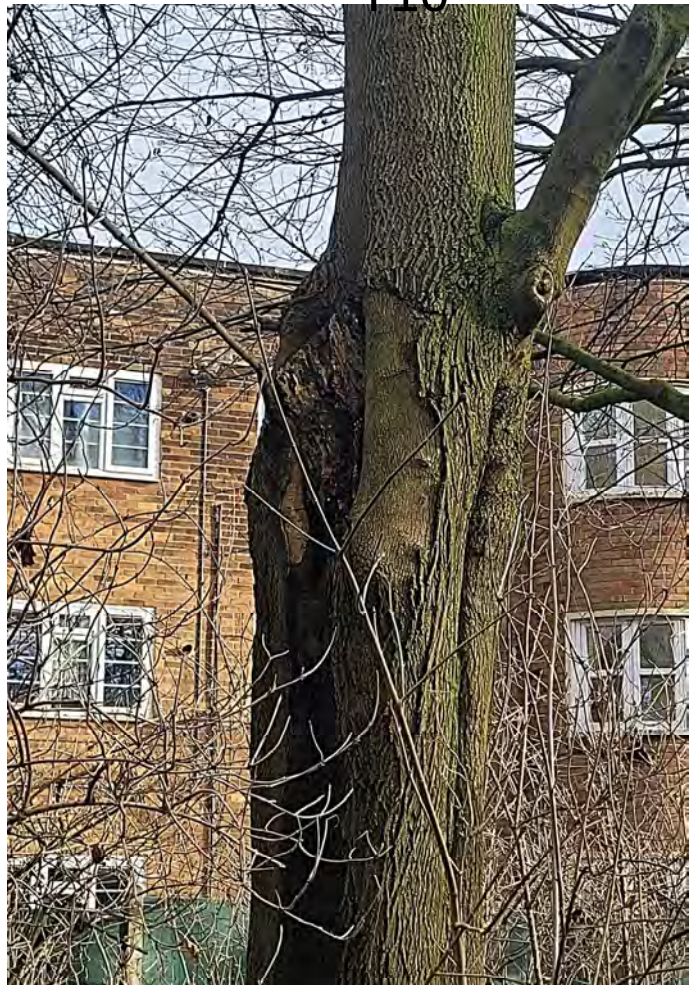
| Tree No. | Species | Dbh (mm) | Height (m) | Age | Crown Spread | | | | Crown C | Cond R | Observations and Comments | Preliminary Recommendations | ERC (Yrs) | TQC R | RPA (m²) | RPA Circle Radius (m) |
|---|---|---|---|---|---|---|---|---|---|---|---|---|---|---|---|---|
| T10 | Norway Maple | 620 | 16 | M | 8 | 6 | 9 | 5 | 4 | C | Has suffered major limb loss at 2m on the northern side and western side resulting in extensive stem decay, which will be rapidly hollowing out. Exhibits major crown asymmetry with very low potential. | Fell to ground level, grind out stump and replace. | 5-10 | U | 173.90 | 7.44 |

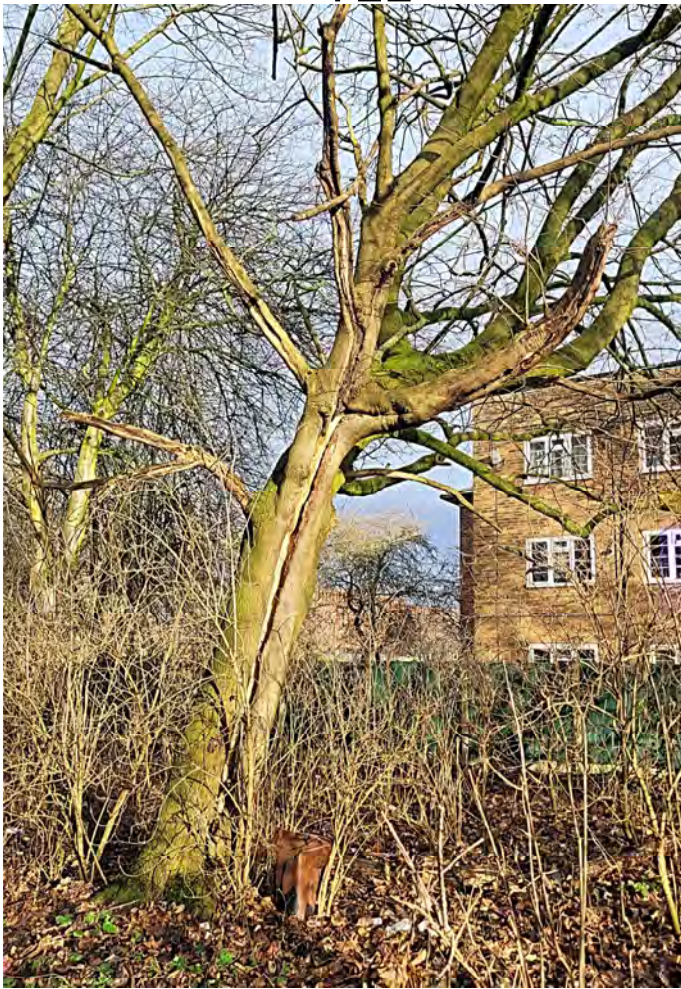
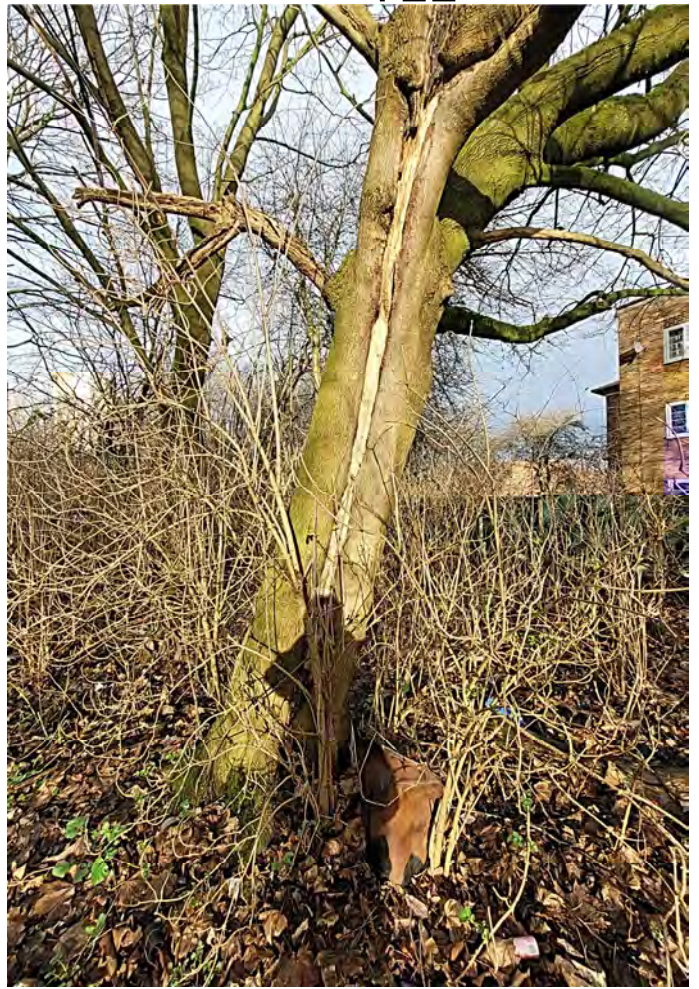
| Tree No. | Species | Dbh (mm) | Height (m) | Age | Crown Spread | | | | Crown C | Cond R | Observations and Comments | Preliminary Recommendations | ERC (Yrs) | TQC R | RPA (m²) | RPA Circle Radius (m) |
|---|---|---|---|---|---|---|---|---|---|---|---|---|---|---|---|---|
| T11 | Norway Maple | 570 | 16 | M | 9 | 9 | 5 | 4 | 3 | C | A poor specimen with an acute northern lean. Exhibits major stem decay on the eastern side, most likely due to fire damage. Hollowing out near base. Very low potential. | Fell to ground level, grind out stump and replace. | 5-10 | U | 146.98 | 6.84 |

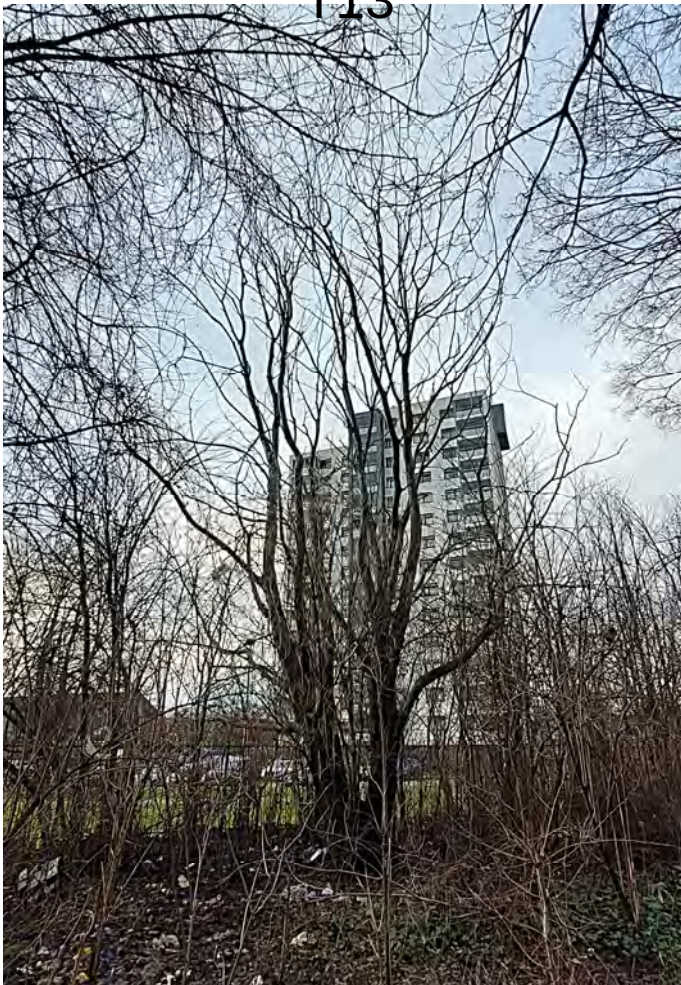
| Tree No. | Species | Dbh (mm) | Height (m) | Age | Crown Spread | | | | Crown C | Cond R | Observations and Comments | Preliminary Recommendations | ERC (Yrs) | TQC R | RPA (m²) | RPA Circle Radius (m) |
|---|---|---|---|---|---|---|---|---|---|---|---|---|---|---|---|---|
| T13 | Elm | 800 | 10 | M | 4 | 5 | 7 | 6 | 3 | D | A dead tree multi-stemmed at base. | Fell to ground level and replace. | n/a | U | 289.53 | 9.60 |

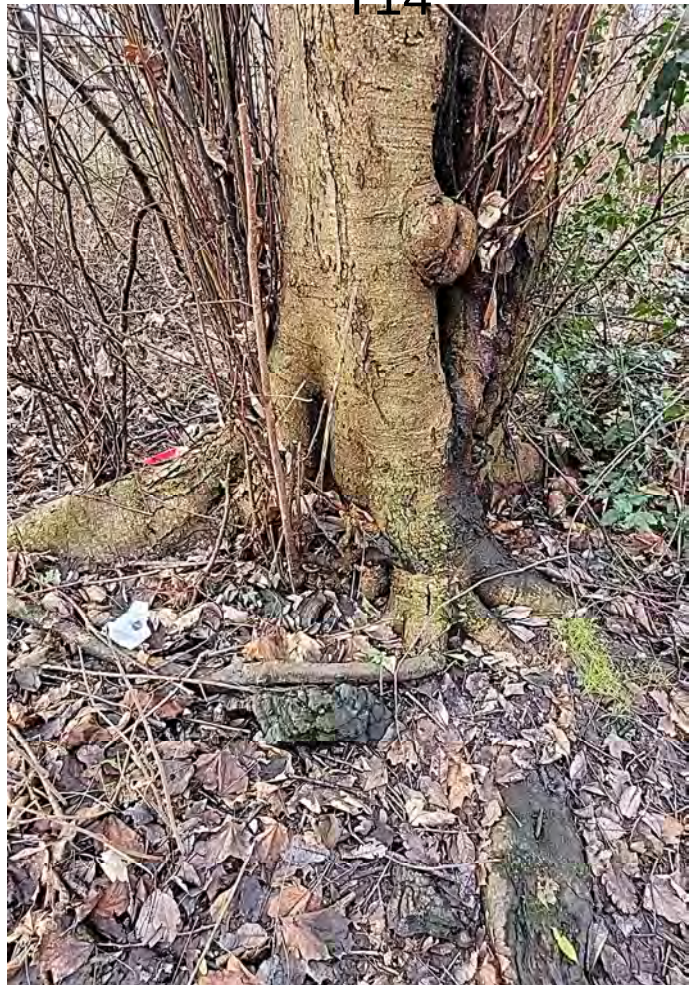
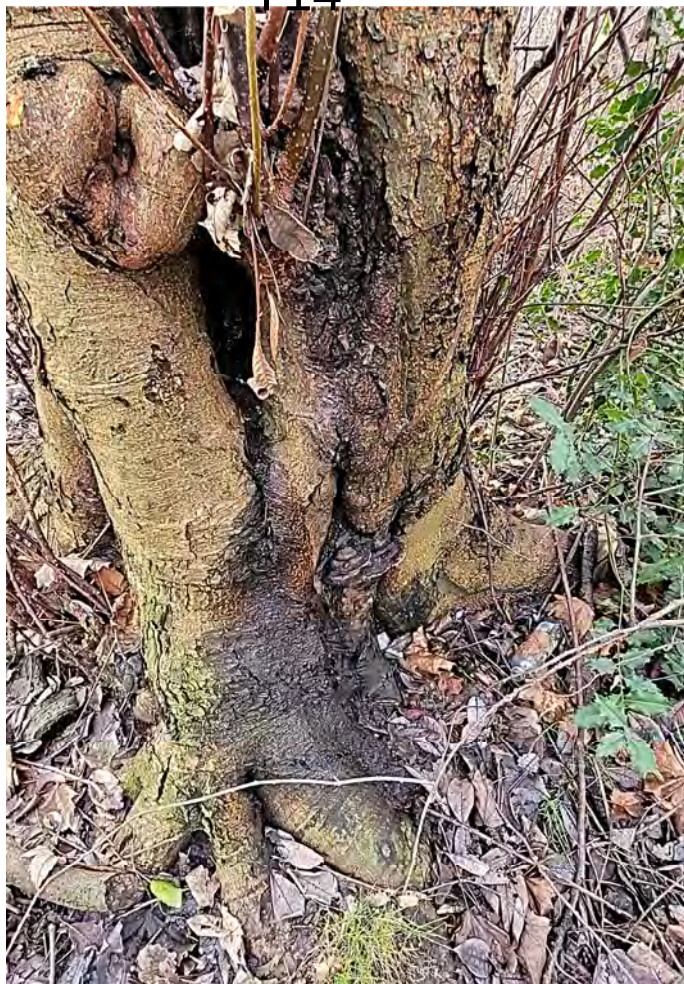
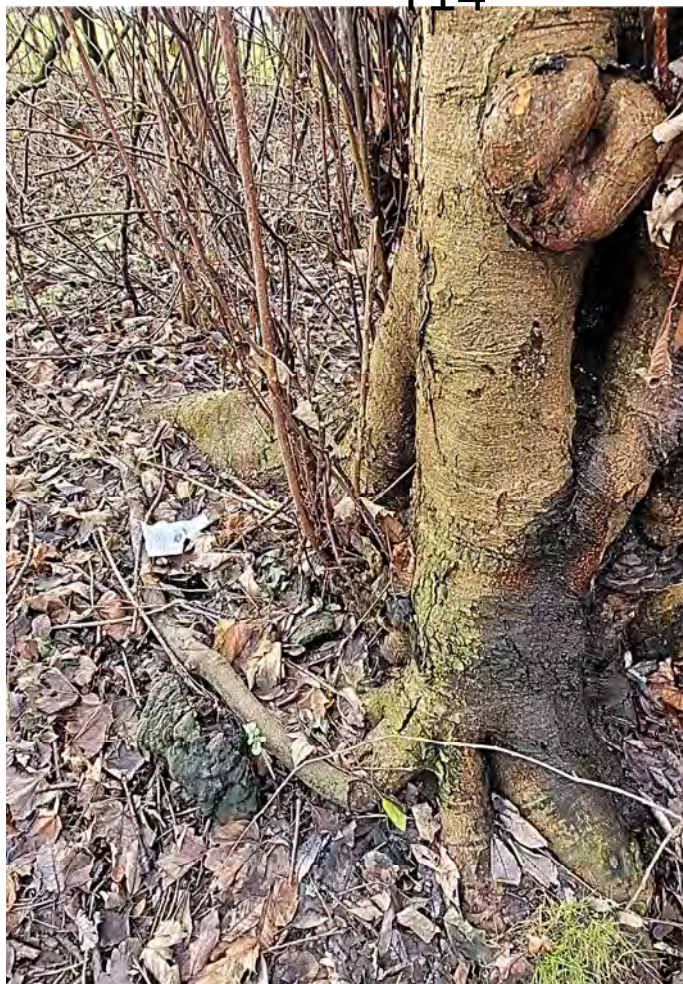
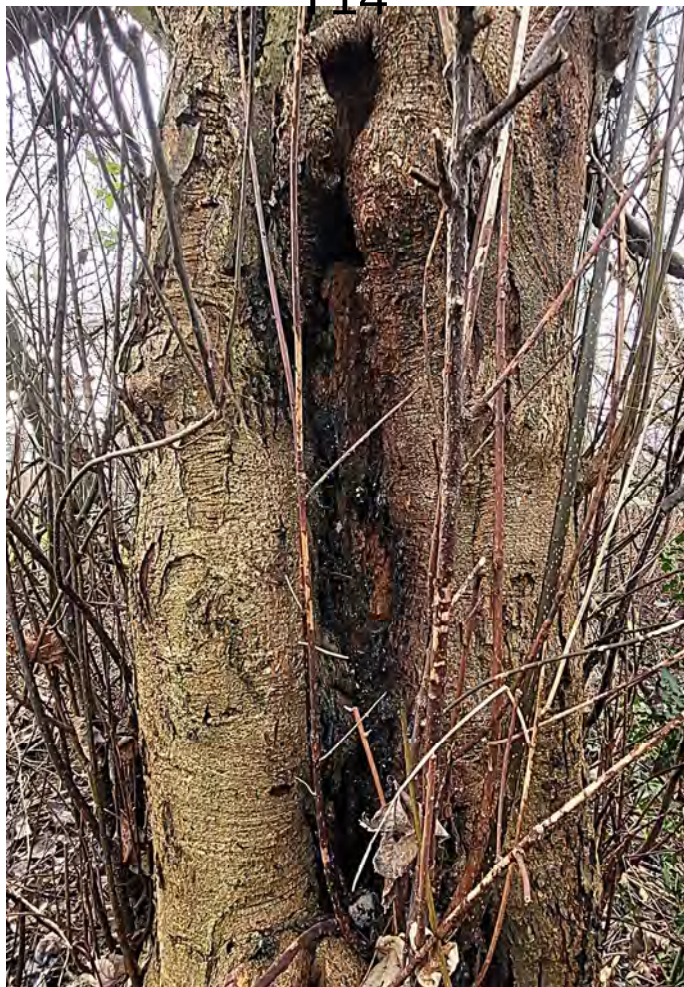
| Tree No. | Species | Dbh (mm) | Height (m) | Age | Crown Spread | | | | Crown C | Cond R | Observations and Comments | Preliminary Recommendations | ERC (Yrs) | TQC R | RPA (m²) | RPA Circle Radius (m) |
|---|---|---|---|---|---|---|---|---|---|---|---|---|---|---|---|---|
| T14 | Bird Cherry | 600 | 10 | FM | 5 | 7 | 8 | 6 | 1.8 | C | A large specimen with reasonable vigour but has stem decay present. Broken lower branch. There is also the presence of the decay fungus <i>Ganoderma spp</i> on the northern side at base. Crown asymmetry due to group. Low potential. | Fell to ground level, grind out stump and replace. | 5-10 | U | 162.86 | 7.20 |

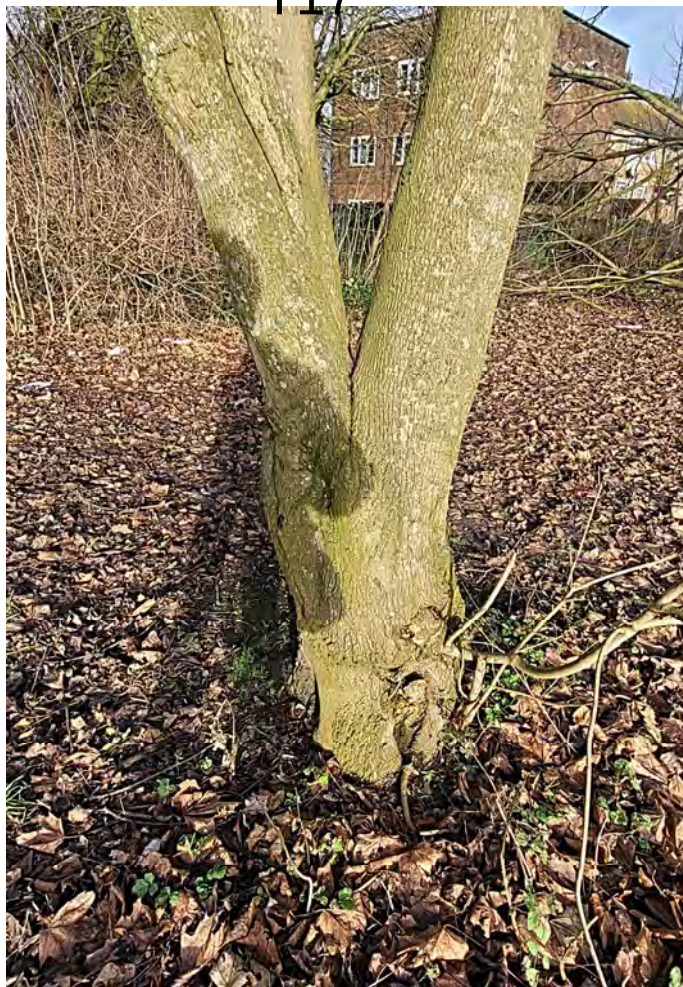
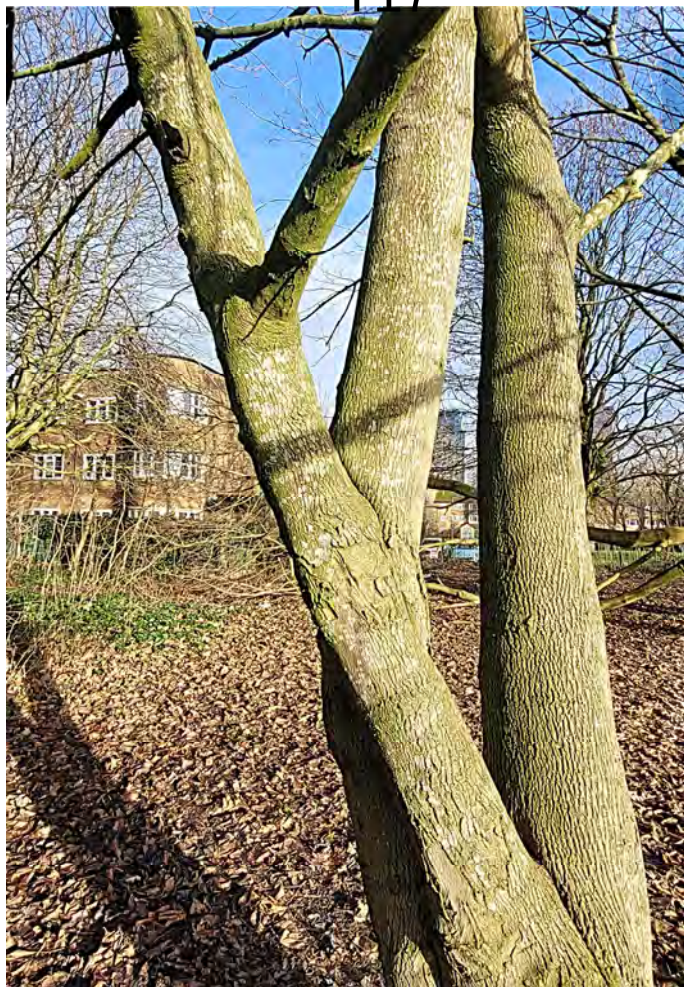
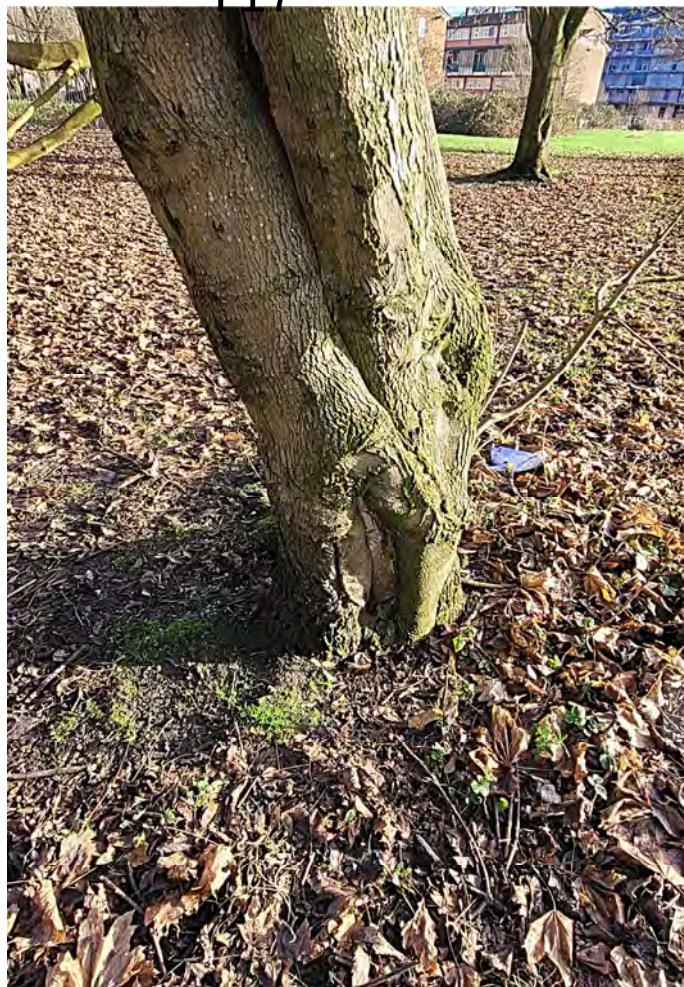
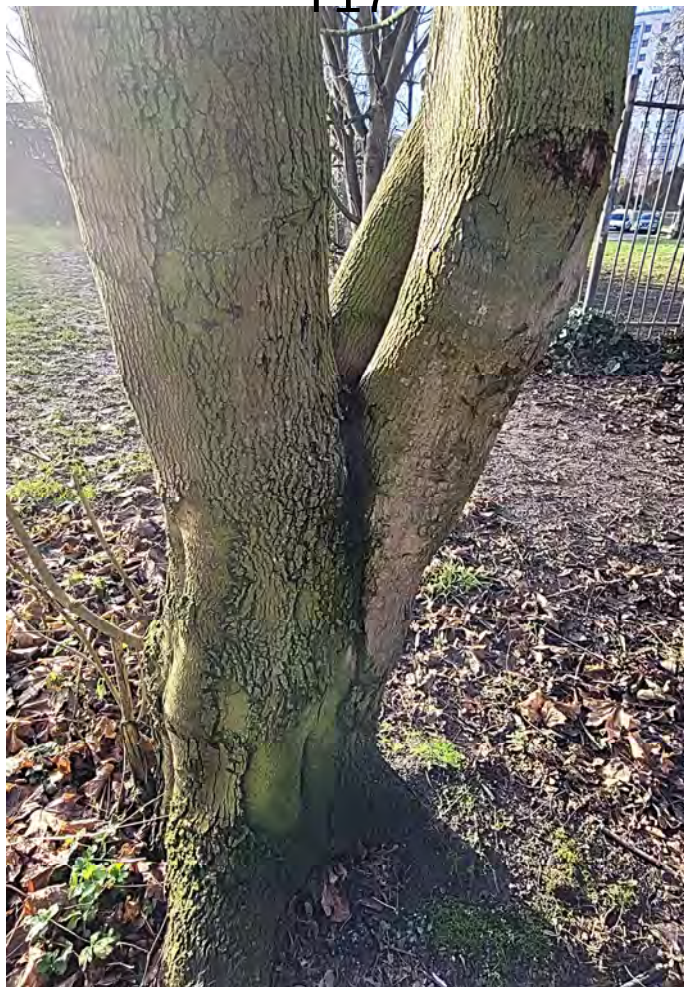
| Tree No. | Species | Dbh (mm) | Height (m) | Age | Crown Spread | | | | Crown C | Cond R | Observations and Comments | Preliminary Recommendations | ERC (Yrs) | TQC R | RPA (m²) | RPA Circle Radius (m) |
|---|---|---|---|---|---|---|---|---|---|---|---|---|---|---|---|---|
| T17 | Norway Maple | 360 | 10 | EM | 5 | 5 | 7 | 8 | 1.8 | B/C | A minor specimen with poor structural form and several weak forks including the main union near base. Several rubbing fused branches. Deadwood present. Decay at base. This tree is right next to an informal footpath. Low potential. | <b>Fell to ground level, grind out stump and replace.</b> | 10+ | C2 | 58.63 | 4.32 |

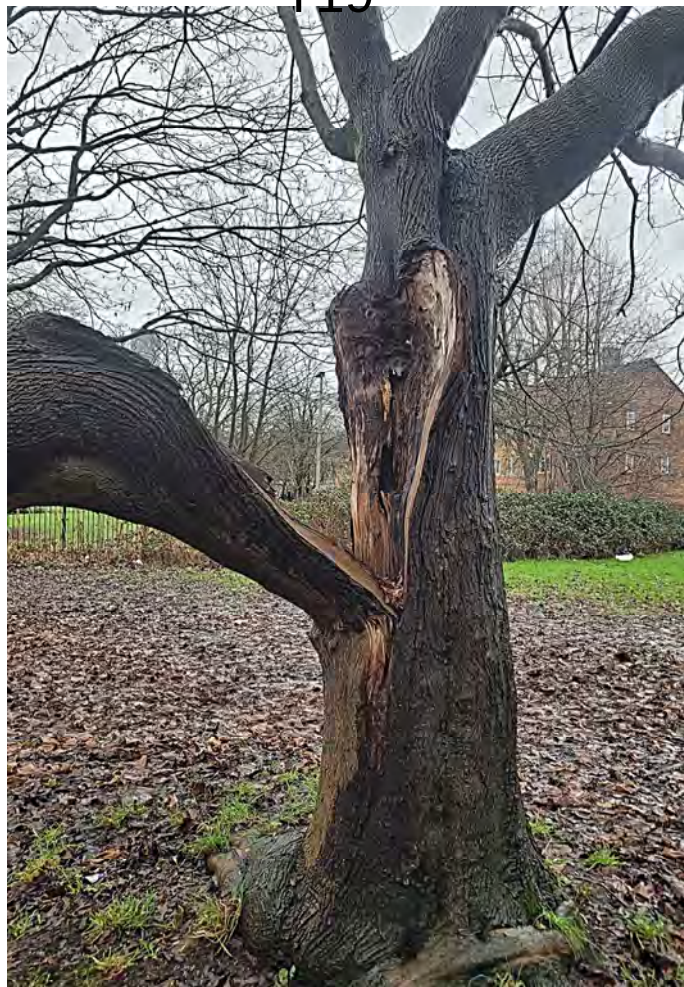
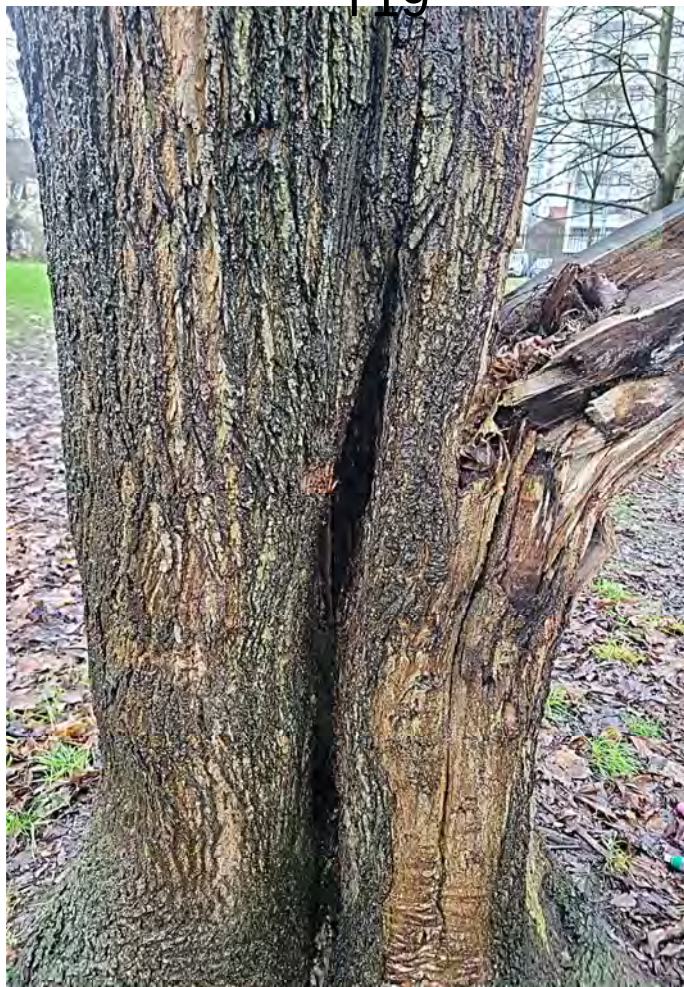
| Tree No. | Species | Dbh (mm) | Height (m) | Age | Crown Spread | | | | Crown C | Cond R | Observations and Comments | Preliminary Recommendations | ERC (Yrs) | TQC R | RPA (m²) | RPA Circle Radius (m) |
|---|---|---|---|---|---|---|---|---|---|---|---|---|---|---|---|---|
| T19 | Norway Maple | 700 | 16 | M | 7 | 8 | 1 | 8 | 1.8 | C/D | This tree has suffered major limb loss due to included union. The remainder of the stem is fragile and there is significant decay present. | <b>Fell to ground level, grind out stump and replace.</b> | 0-5 | U | 221.67 | 8.40 |

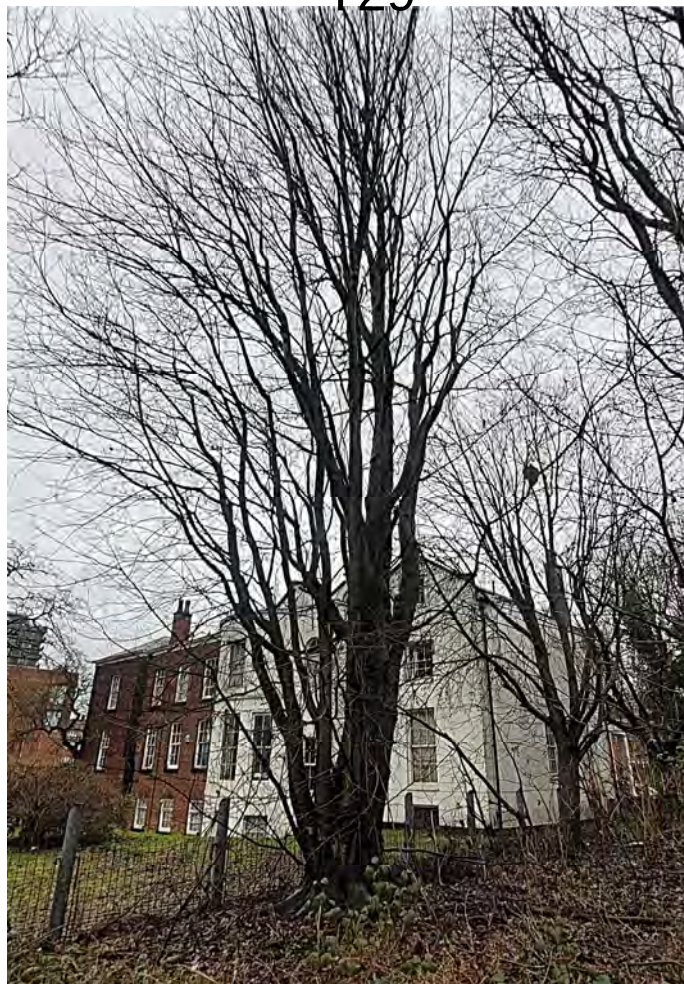
| Tree No. | Species | Dbh (mm) | Height (m) | Age | Crown Spread | | | | Crown C | Cond R | Observations and Comments | Preliminary Recommendations | ERC (Yrs) | TQC R | RPA (m²) | RPA Circle Radius (m) |
|---|---|---|---|---|---|---|---|---|---|---|---|---|---|---|---|---|
| T29 | Silver Maple | 790 | 22 | M | 8 | 7 | 6 | 8 | 2.5 | A/B | A very large tree on the boundary exhibiting reasonable form and vigour, Several included unions and deadwood present. Evidence of previous minor failures. Basal shoots present. | Remove basal shoots. | 20+ | B2 | 282.34 | 9.48 |

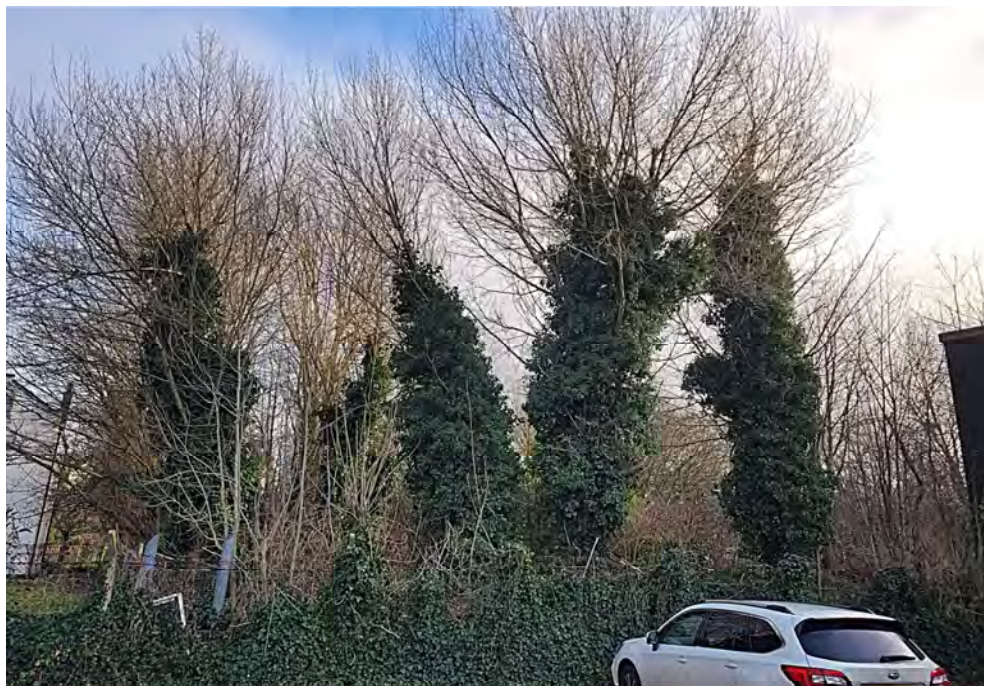
| Arboricultural Data Sheet: Land adjacent Virgil Street, Cornbrook, Manchester, M15 4ED    Date of Survey: 06/01/23    Weather: Overcast    Surveyor: PM | | | | | | | | | | | | | | | | |
|---|---|---|---|---|---|---|---|---|---|---|---|---|---|---|---|---|
| T2 | Poplar x 2 | 400 | 13 | EM | 7 | 7 | 7 | 7 | 4 | B/C | A scrub tree, which is two stems formed from ground level. Swamped in Ivy with a high crown. No view of stem or base. Previous breakouts in the crown and evidence of Squirrel damage. | n/a | 10+ | C2 | 72.38 | 4.80 |
| T3 | Poplar | 380 | 11 | EM | 7 | 5 | 2 | 5 | 2 | B/C | A scrub tree, swamped in Ivy. Low branches over adjacent green area. No view of stem or base. Previous breakouts in the crown and evidence of Squirrel damage. | n/a | 10+ | C2 | 65.33 | 4.56 |
