# Heritage Statement

1830 Warehouse  
essential repairs to  
the roof, Museum of  
Science and Industry  
Manchester

March 2023 | Project Ref 4700I

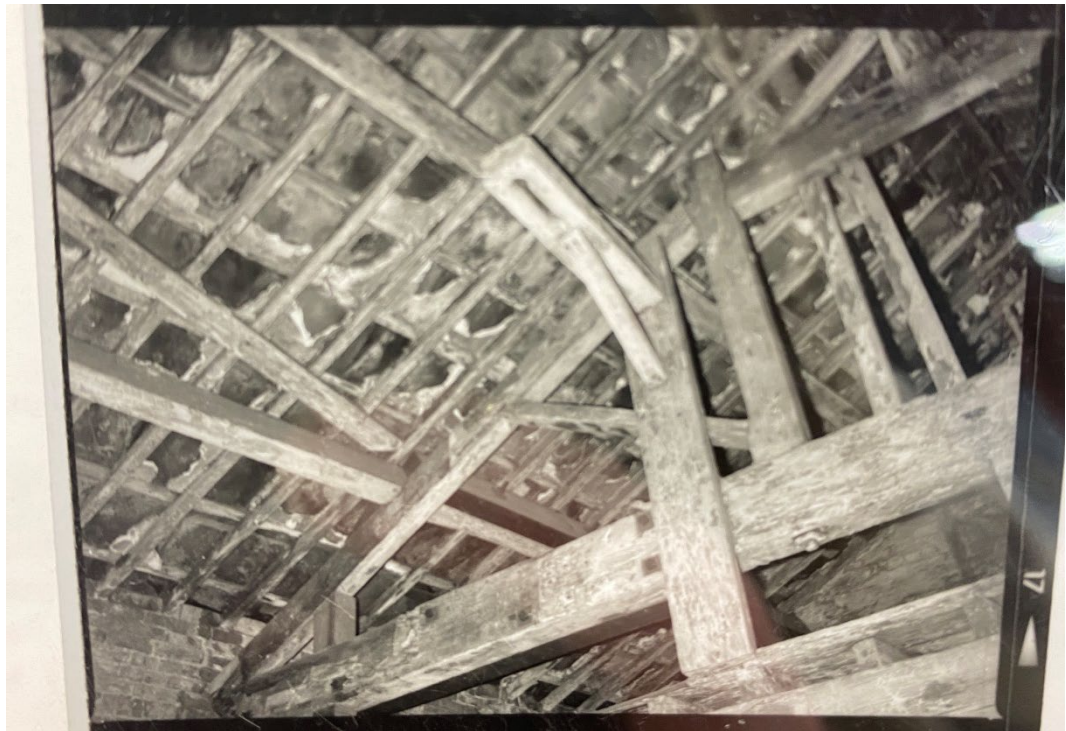
- 2.18** A degraded torched finish was observed and recorded within the GMAU photographic record though not explicitly described within the recorded descriptions in the final report. The photographic contact sheets held in the Museum Archive also reveal that other finishes were observed within the roof, again not explicitly described. The alternate finish recorded in the photographs included continuous use of sarking boards from valley to ridge in at least part of Bay 2. Sarking boards would have a similar weather proofing effect but require less ongoing maintenance.

Figure 8: GMAU photographic archive contact sheet: Film 164, Bay 1 Hoist 3069 showing remnants of torching between rafters and battens to roof slope

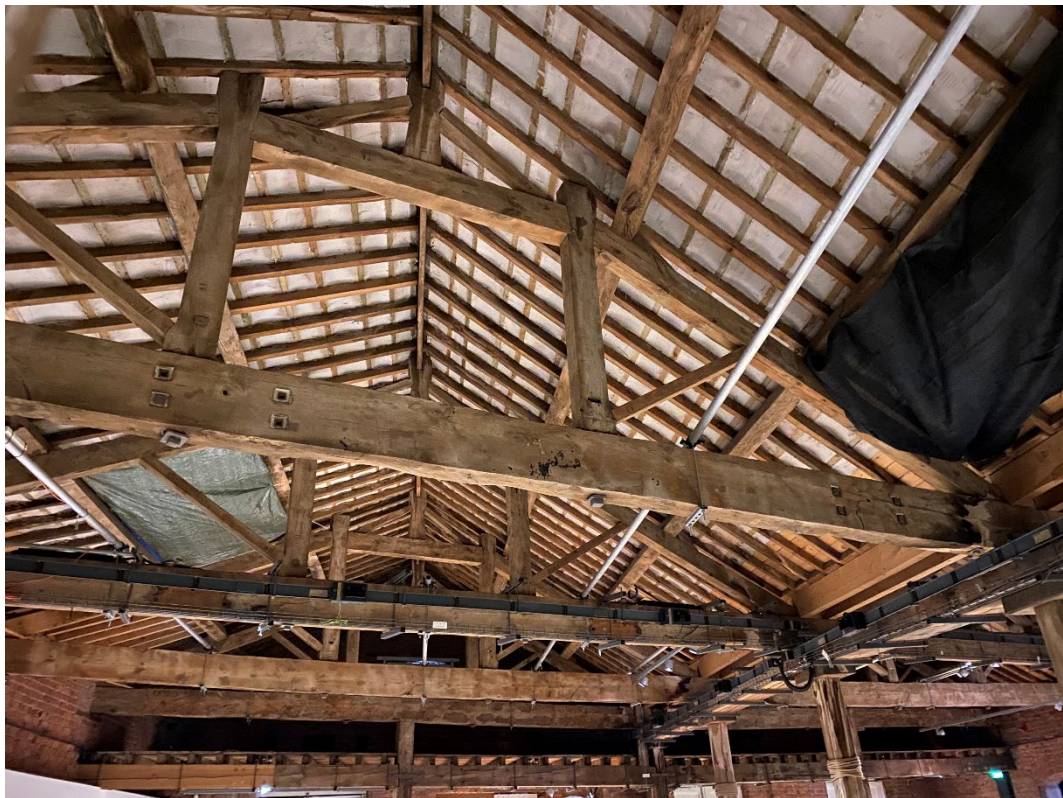
*Figure 10: Bay 4 roof today, note netting in place to catch the falling torching*

- 4.8** The existing condition and need for repairs to Bay 4 are set out on Page 19 of the Design Approach Document. The desire is to maintain active use of the upper floor of Bay 4, to improve the environmental performance of the building overall, and to remove the current ongoing risk to users which is arising through failure of the existing torching leading to falling material on a regular basis.

- 4.24** This option retains the existing roof line but sees the replacement of the torching with an alternate weather proofing system, a permeable membrane and in between the rafters applied insulation finished with an internal lime coat. The insulation falling between the rafters only still leaves potential for cold bridges where slates rest directly over the rafters which extend into the building, the thermal benefits would not be as fully beneficial as in other options.

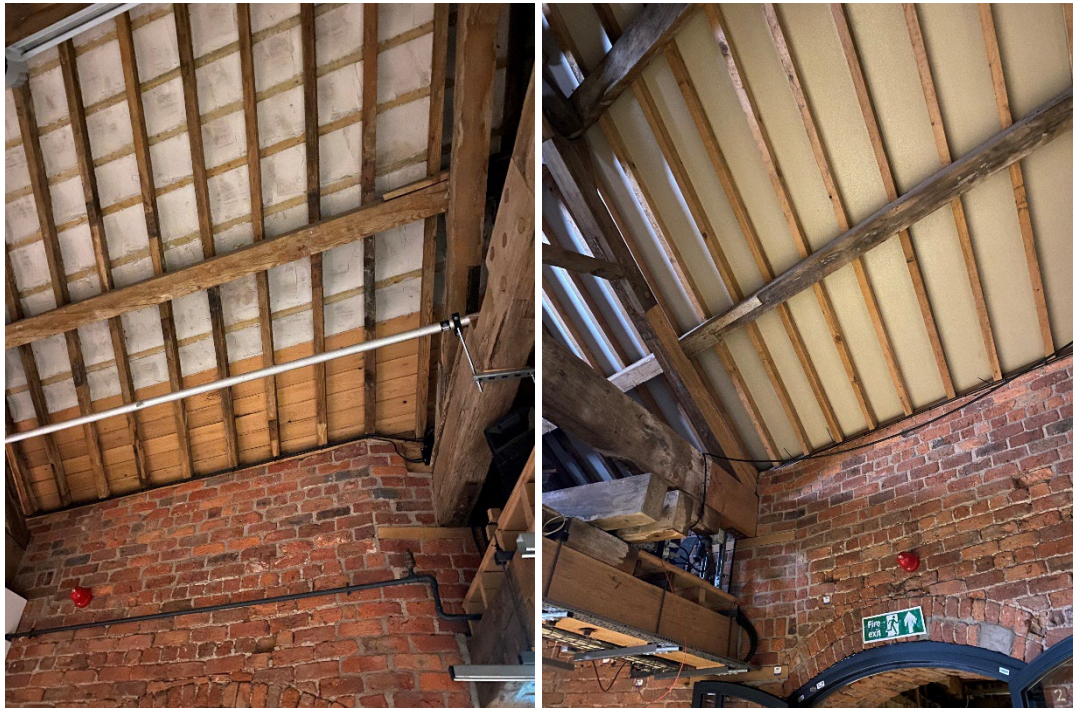
*Figure 11-12: Bay 4 on the left with sarking boards reflecting the position of the valley gutter and the visible battens with torching and (right) Bay 3 with continuous boarded finish above the common rafters.*

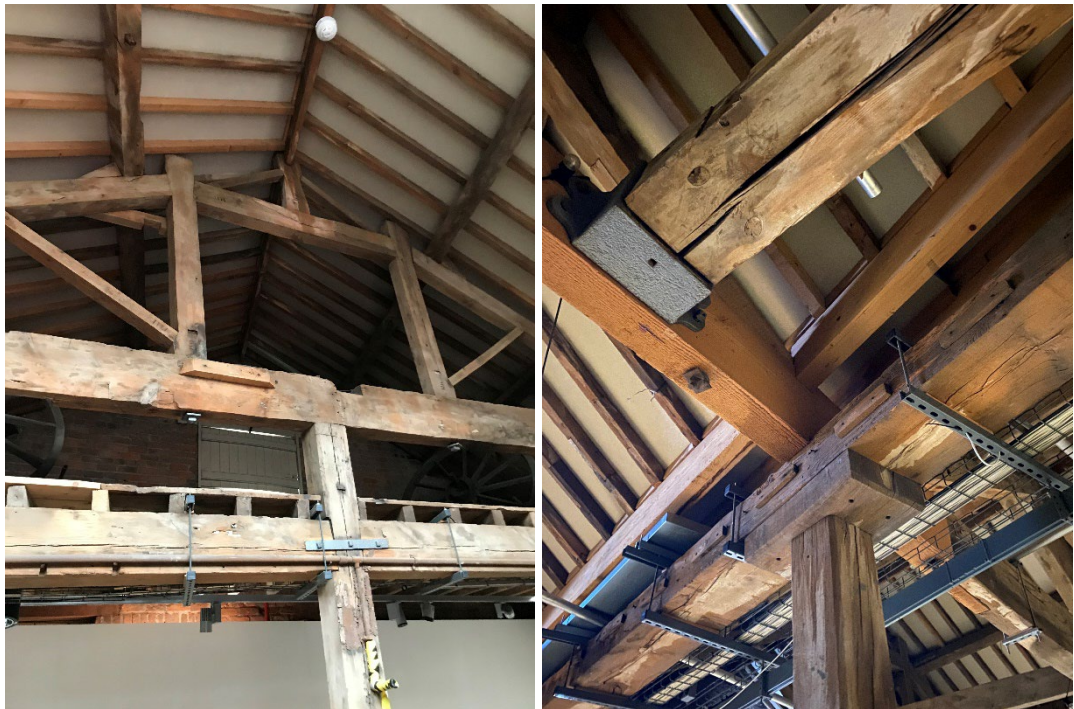
*Figure 13-14: (left) one of the principle roof trusses (Bay 2). (right) valley gutter in Bay 2 showing modern purlins beneath the gutter and above the historic beam, drip tray visible bottom left.*

- 3.8** Internally other materials used in the gutter constructions is a poorer, in particular the use of MDF sheet board rather than traditional sarking boards, this is visible at points from within the upper levels, such modern materials are **neutral** to significance. Remedial works to counteract the failing gutters and unforeseen

overflow comprise a combination of drip trays, plastic piping and buckets. These elements are **detrimental to significance** and are visually negative in relation to the experience possible of the roof structures internally.

- 4.2** The gutters are failing at present due to a combination of structural settling which has lowered the central high point reducing the fall, narrow openings along the length which makes blockages more likely and renders regular maintenance and visual checks difficult, and higher and more intensive rainfall periods.

- 4.6** The proposals will enable the removal of the remedial measures installed to capture uncontrolled water ingress which are detrimental to significance (buckets, drip trays, pipes). This removal, and the addressing of the underlying problem that causes the water ingress, offers a benefit in two ways. Firstly, the unattractive features themselves will be removed, restoring the aesthetic qualities of the original roof structure and opportunities to see and understand the traditional structures without 'clutter'. Secondly, the proposals will minimise and remove risk to the retained roof structures which are of high significance.

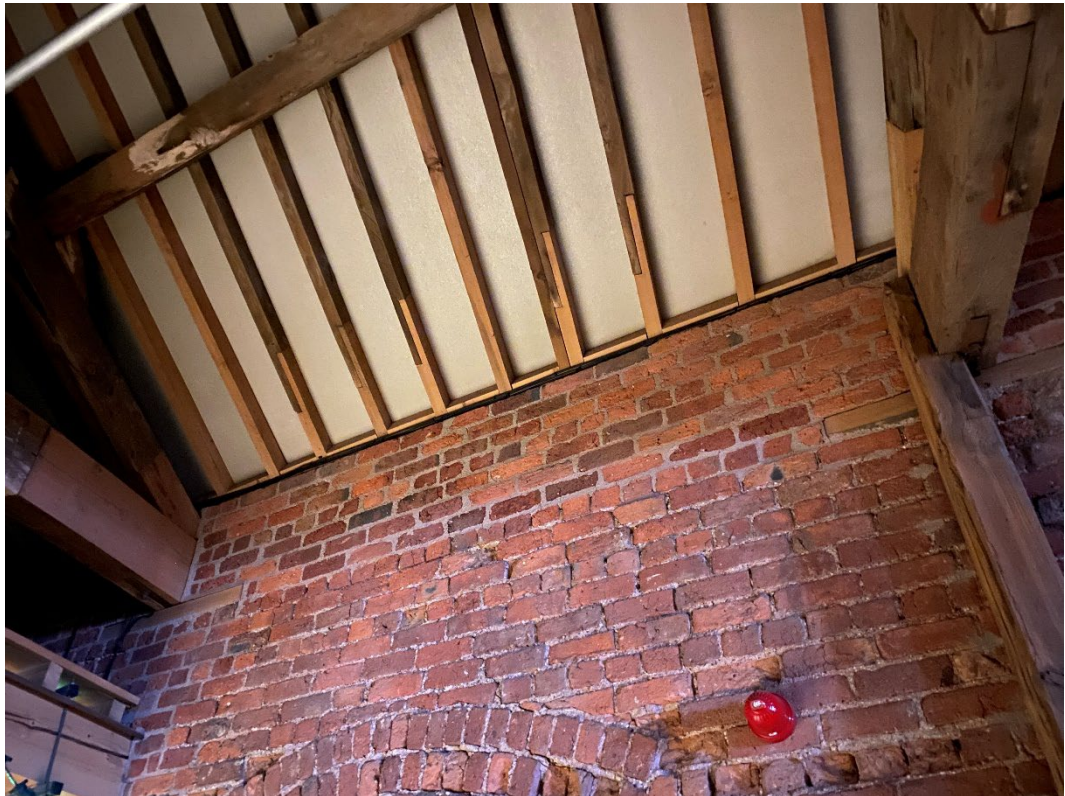
**3.5** Between each bay the valley gutter is concealed within the top of the brick wall dividing the bays. Traces internally suggest that these wall heads were reconstructed in the 1990s period to contain the valley gutter.

*Figure 15: View towards one of the party walls between the bays showing scarfed in timber replacements to the common rafters and a change in the brickwork between the trusses suggestive of rebuilding to enclose the valley gutters.*

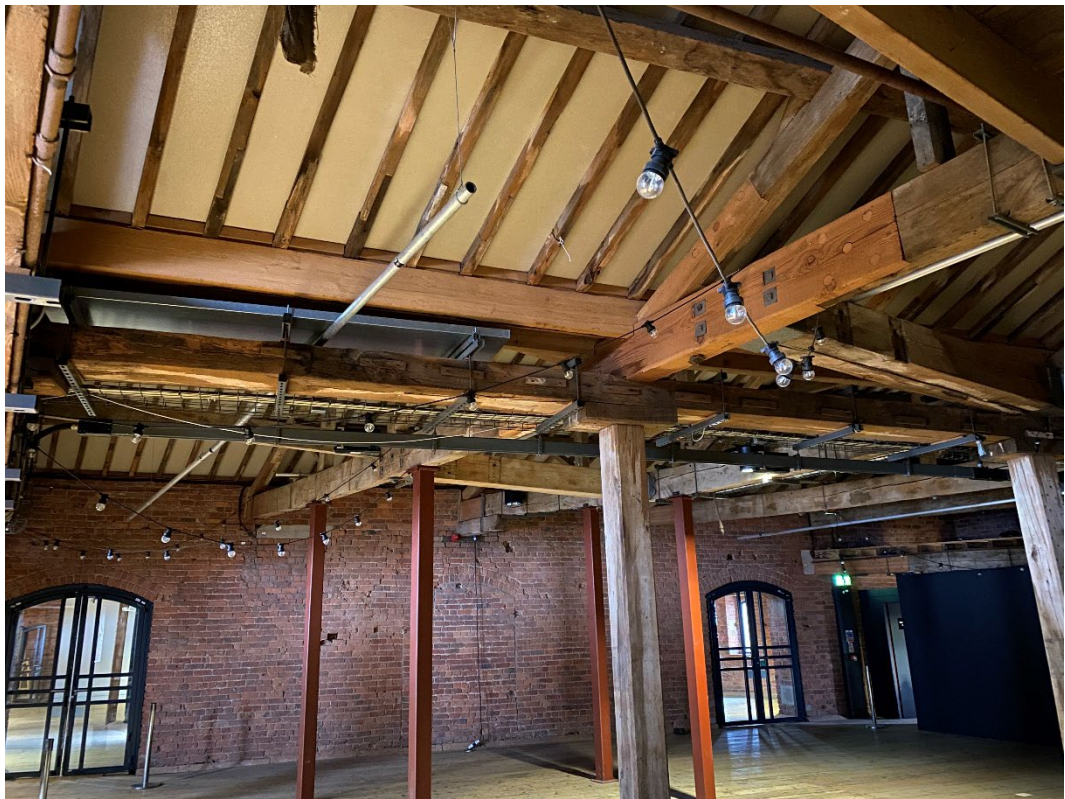
**3.14** Later structural supports such as the hollow steel posts are considered to **detract from architectural and historic interest** to some degree. Though they are easily identifiable as later added support they intrude into the space beneath the trusses in a way that interrupts the historic sense of structure and bay rhythm as well as its openness. The structural survey identifies that this form of reinforcement places the rest of the building, particularly the floor structures beneath the supports under undue stress and risk of cumulative damage.

*Figure 16: Later steel columns inserted beneath major truss within Bay 2 and intruding into the otherwise open space. Also note carefully spliced in timber repairs to the truss which are more sympathetic to heritage character while still being legibly as a repair.*

- 4.35** A variety of failures, splits and damaged truss chord timbers were observed in Bays 1 and 2 of the 180 Warehouse. They are detailed from page 26 onwards in the Design Approach Document and in structural reporting from Conisbee. Several of these failures have been addressed in the past with semi-permanent props installed but these are not satisfactory in the long term and transfer load in a way that places the rest of the building, specifically floor structures, under risk.

- 4.36** Proposed repairs are a combination of spliced in timber repairs with reinforcing bolts and in one instance resin and a system of overplating the damaged areas leaving as much historic fabric in situ as possible.

- 4.38** The repairs will secure the removal of later remedial works – the props – which will enhance these areas restoring the historic character of the space.

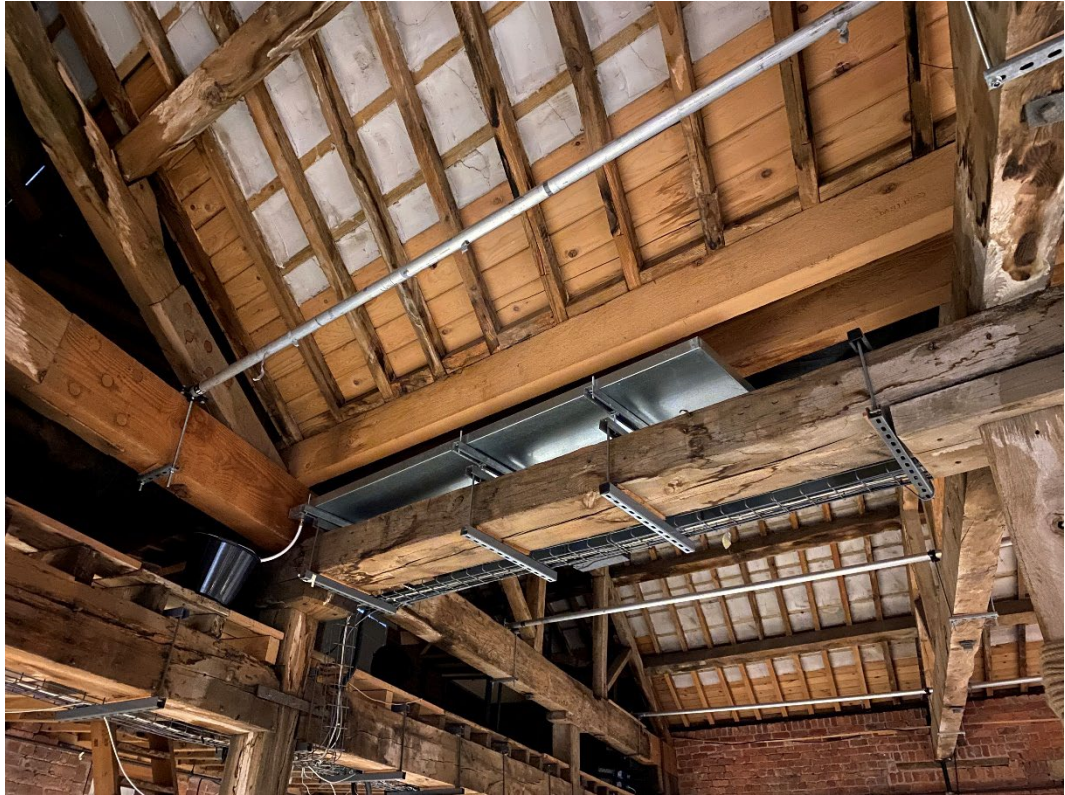
- 3.11** The innate material qualities of the Bay 4 finish are considered of **low to moderate significance**. The torching uses broadly traditional lime plaster but it has been incorrectly mixed and blended with an inappropriate aggregate so that it is a poor quality and not reflective of the value of the building. This inadequacy has led directly to the failure in the material being experienced now. It is not the original fabric and with the poor mix is considered not to contribute to special interest despite the traditional approach.

*Figure 17: torching in Bay 4 with sarking boards indicating the different finish to accommodate and support the lead of the valley gutter. None of the actual roof surfaces or finishes are visible internally.*
