DESIGN AND ACCESS STATEMENT  
incorporating a  
HERITAGE STATEMENT

**The Wentwood,  
72-76 Newton Street  
M1 1EE**

**12/11/2022**

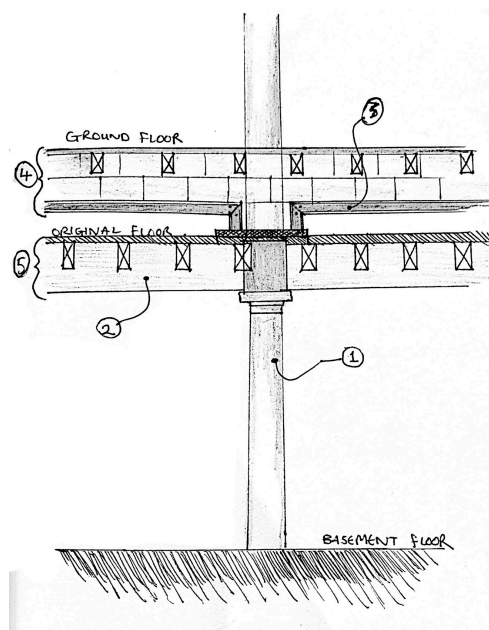
*Indicative Section through ground floor:*

2.6. This timber floor area does not contribute to the structural stability of the building or the floor level above, having been covered by a new concrete floor, to support that above. This is illustrated below.

*(1) Cast Iron Columns, (2) Primary Timber Beams, supported by Cast Iron columns, (3) Stub columns/beams, built off concrete plinth/Cast Iron Columns, (4) New 'Floating' floor constructed off Stub Columns/beams, (5) Original Floor construction; primary beams built off Cast Iron columns, joists off primary columns, Floorboard + screed off joists. The basement appears to be acting as a collection point for the building's rainwater. This collects in a large brick-built chamber below basement floor level.*

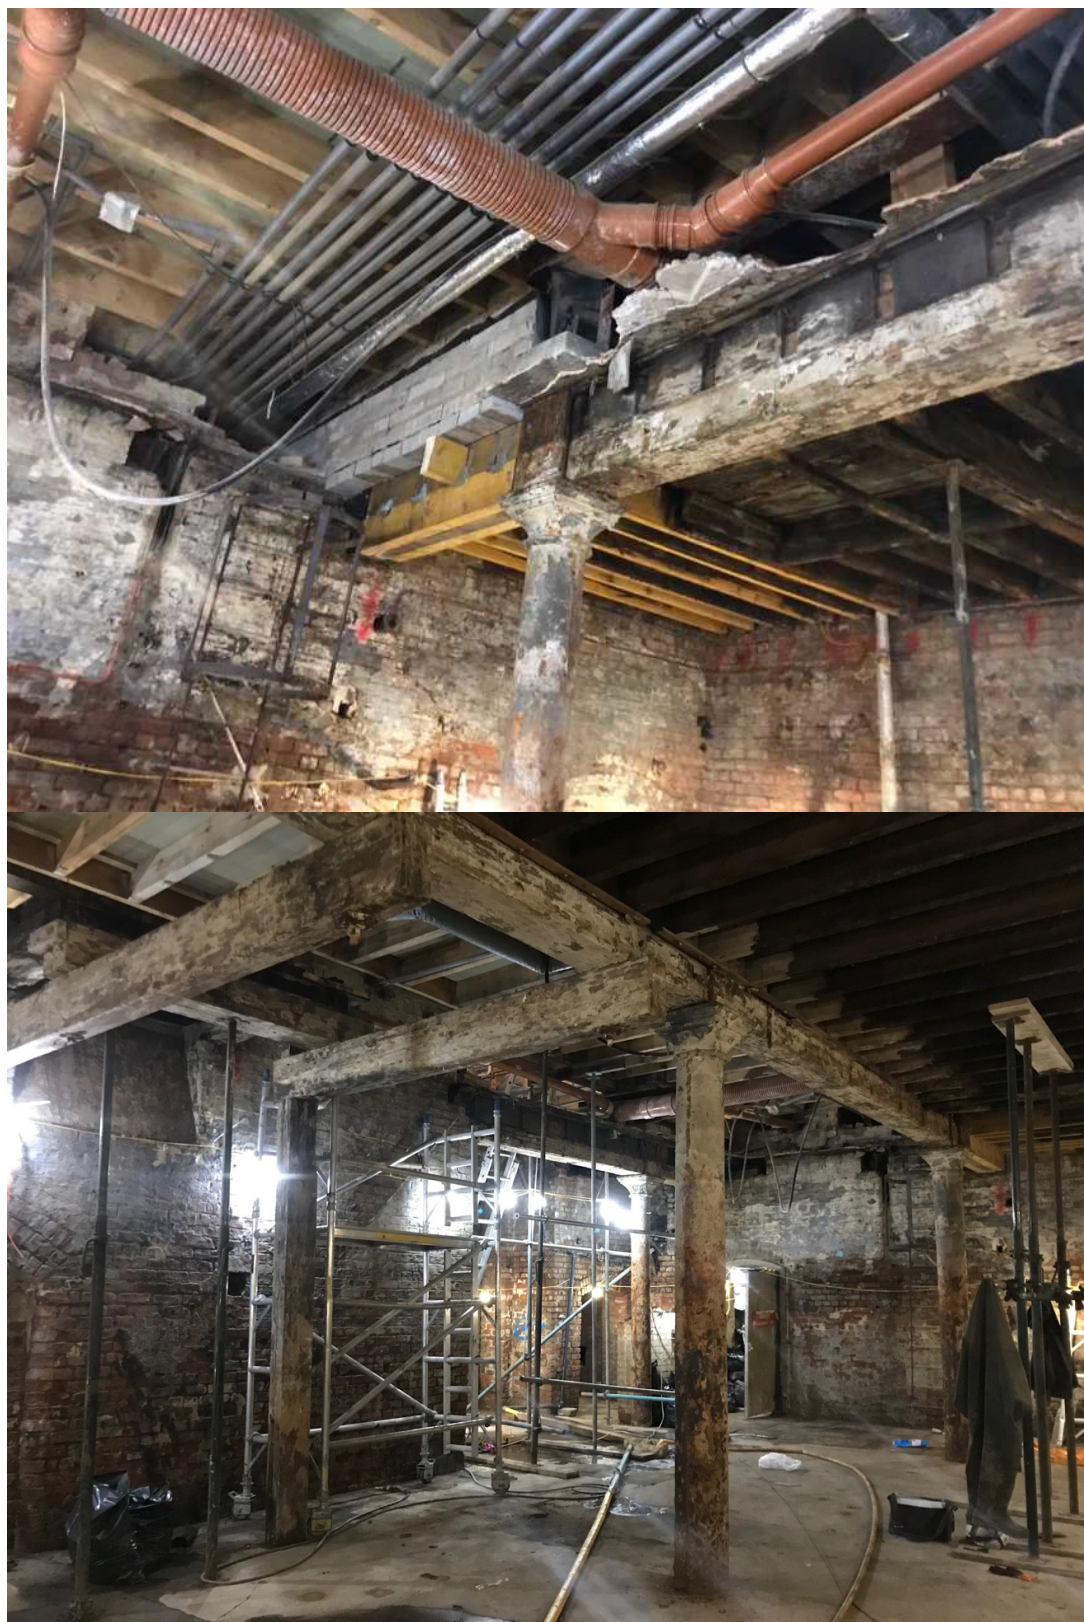
2.4. Having pumped the water out it was evident that the water level had been raised for a long period of time and has caused damage to much of the original timber.

2.8. These works were halted owing to a lack of funds and the various working constraints presented by the COVID-19 pandemic. In the time that has elapsed the structure, as well as timbers that were removed prior to their repair, have deteriorated further. Wet and dry rot have spread and many of the timbers removed for repair having become unuseable.

Photograph showing the area where the timber has been removed

- 3.2. A series of timber treatments and repairs have been identified by PRS Manchester – a specialist timber preservation company. These are outlined in the attached quotation and include repairs to the insitu primary structure using a combination of splice repairs – utilising salvageable timber from the site i.e. like for like – and resin repairs to strengthen the decayed timber.( See Appendix 2).
