# Anwyl Homes

Alexandra Park  
Feasibility Study

Report date: 27/09/2022

Report Title: Sports Pitch Feasibility Report  
Sports Facility Name: Alexandra report  
Date of Visit: 30<sup>th</sup> August 2022  
Visit Objective: Initial Site Appraisal

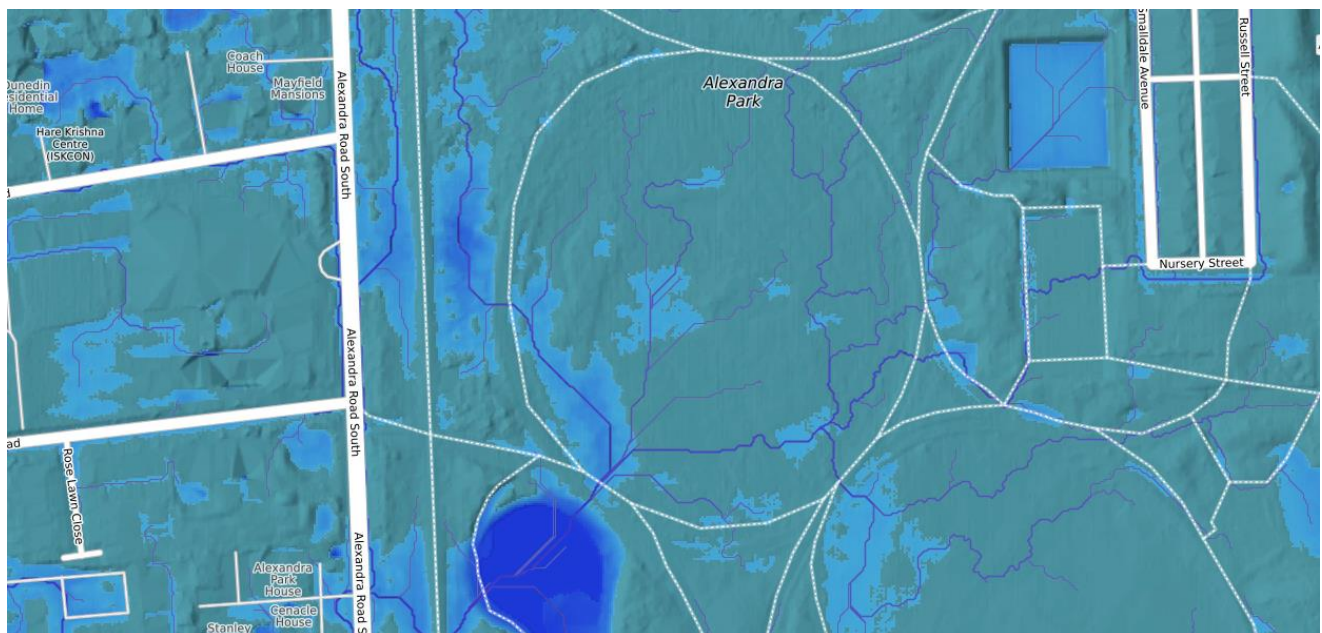
Figure 4 - Scalgo Image

Overall, there were slight variations in firmness across the site at the time of visit. The west of the site (near Trial Pit 4) was softer under foot compared to other areas. This correlates with the evidence of seasonal waterlogging observed.

As part of the drainage review, Scalgo was utilised to assess areas of surface water. Scalgo uses sensors and mapping technology to create high-resolution 3-dimensional maps of the surface of the earth. The Scalgo image below illustrates the areas within the site where seasonal water ponding is likely.

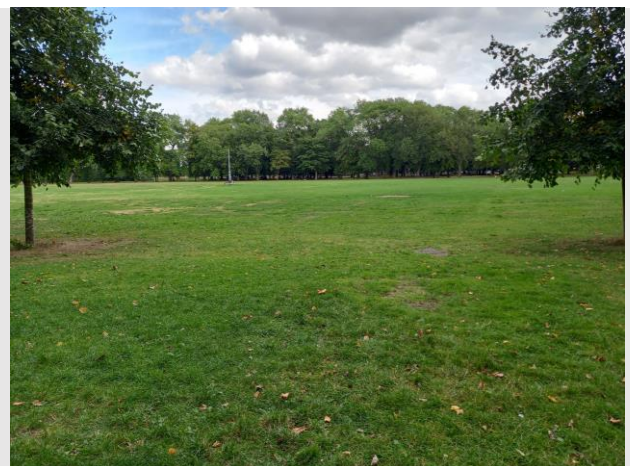
The site is generally flat with a minor gradient towards the south-west side. The highest ground levels were observed in the north-eastern side of the site (30.73 m). The lowest ground levels were observed in the south-western side of the site (29.52 m). Gradients observed across the site were inconsistent.

Photo 6: Lowest part of the site beside the pond (south-west)

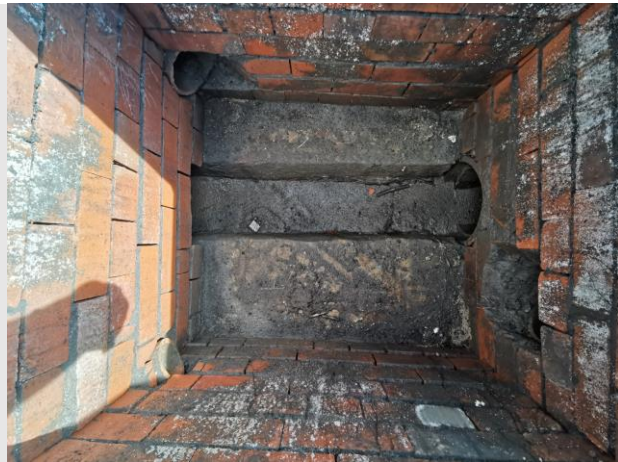
There was a manhole chamber located in the centre of the northern half of the site. In total there were three clay pipes entering this chamber, and two exiting the chamber. One pipe entered the chamber from the north, consisting of a 300 mm diameter clay pipe with an approximate invert level of 1100 mm below cover level. This pipe exited the chamber in a southern direction. A second inlet pipe was observed, consisting of a 150 mm diameter clay pipe, entering the chamber from a north-east direction. The pipe had an invert level of 750 mm below cover level. A 150 mm diameter clay pipe exited the chamber in a south-east direction with an invert level of 800 mm below cover level. A third pipe, 100 mm in diameter entered the chamber from a north-west direction with an invert level of 700 mm below cover level. It was noted that there was no water flowing through any of the pipes during the visit

Photo 7: Manhole chamber in the north centre of the site

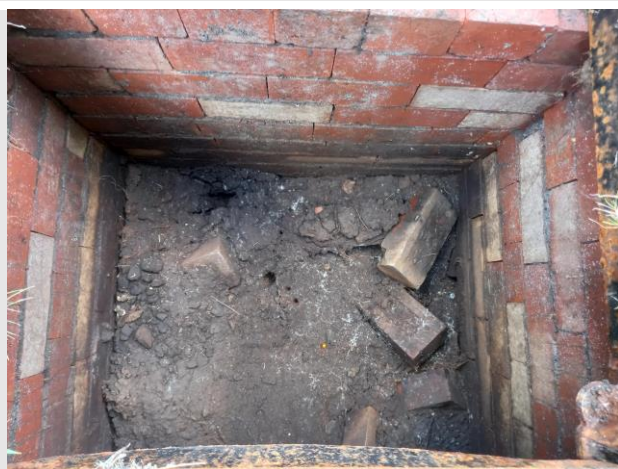
The second manhole chamber was observed in the south-east corner of the site and appeared to be the final downstream chamber associated with the existing site drainage system. When opened, the chamber was blocked with a silty material and brick fragments. It is assumed that the pipework exiting this chamber heads in a south-west direction to the existing pond within the park grounds. A 200 mm diameter unperforated plastic pipe was observed entering the pond from this direction. This is the only known outlet location associated with the existing drainage system.

Photo 9: Outlet manhole chamber in the south-western corner

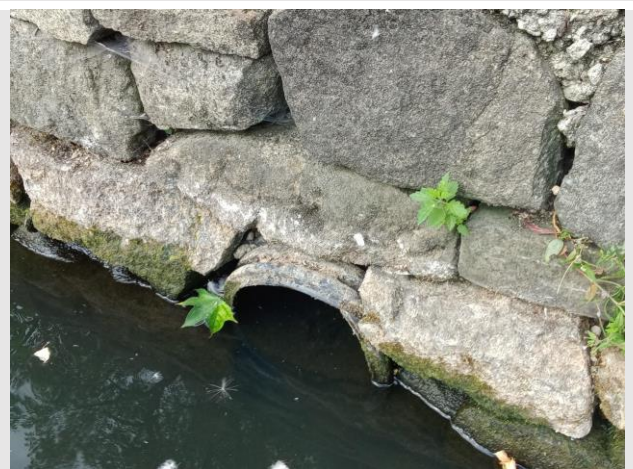
Photo 10: Existing outlet into pond, 200 mm plastic unperforated pipe

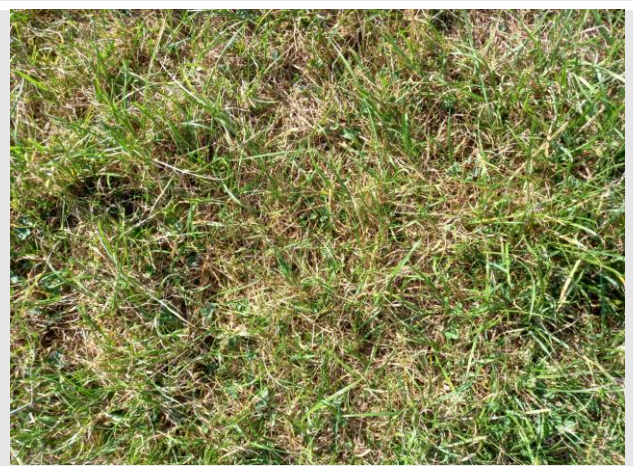
The site was grassed with *Lolium perenne* (Perennial ryegrass), with a high percentage of weed grass species such as *Poa annua* (Annual meadow-grass), and tufted grasses such as *Holcus lanatus* (Yorkshire fog). Grass cover was reduced in areas where water had been ponding during the winter months. Grass cover was reduced in the southern half of the site within the existing football pitch area, most notably in the goal mouths. Significant works are required to improve the agronomic condition of the turf to ensure wear tolerant surfaces fit for increased usage.

Photo 12: Close-up of vegetation

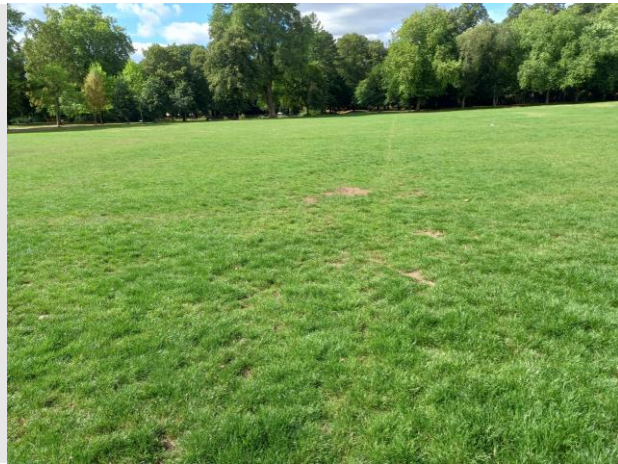
At the time of the visit, the agronomic condition of the turf was poor across the entire site.

Photo 13: Existing pitch grass cover

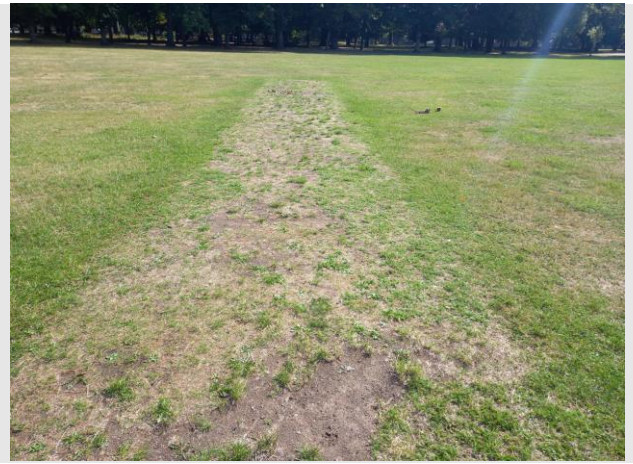
The existing natural grass cricket wicket in the northern half of the site was in a state of disrepair and was not in a condition suitable for use. The northern half of the site is not currently utilised as a playing field and presents an opportunity to develop a replacement playing field area.

Photo 14: Unused cricket wicket

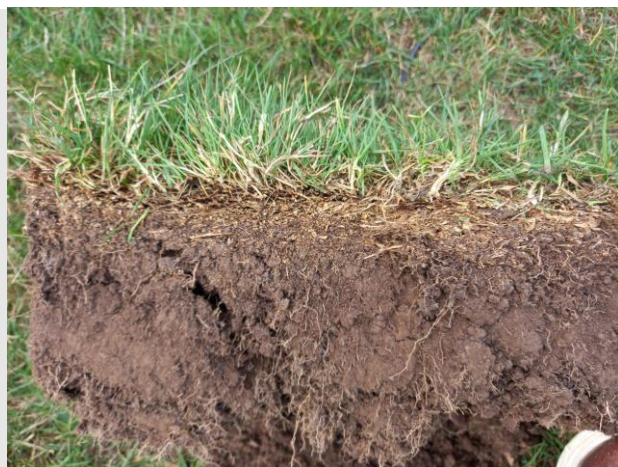
Photo 15: Excessive thatch build-up

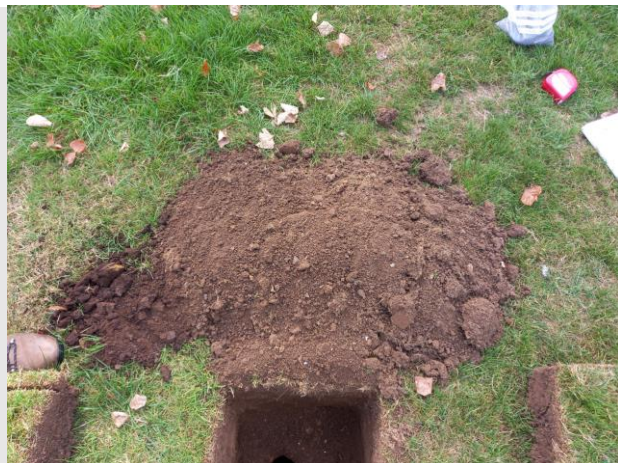
Photo 17: TP2 showing gradual transition from topsoil to darker subsoil

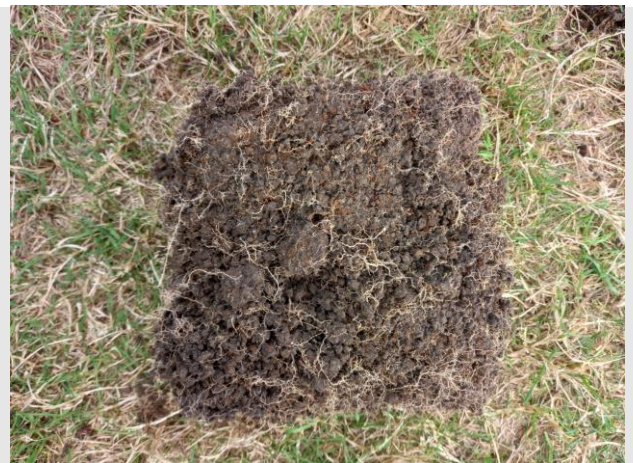
There was evidence of season waterlogging across the site based on the agronomic condition of the turf.

Photo 18: evidence of seasonal waterlogging (root lines)

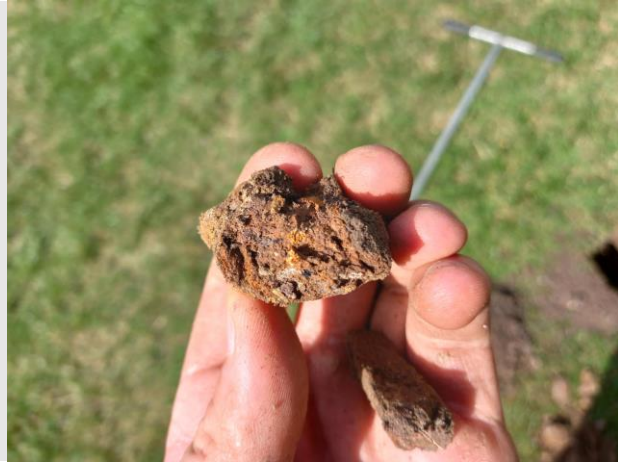
Photo 19: Evidence of seasonal waterlogging (mottling)

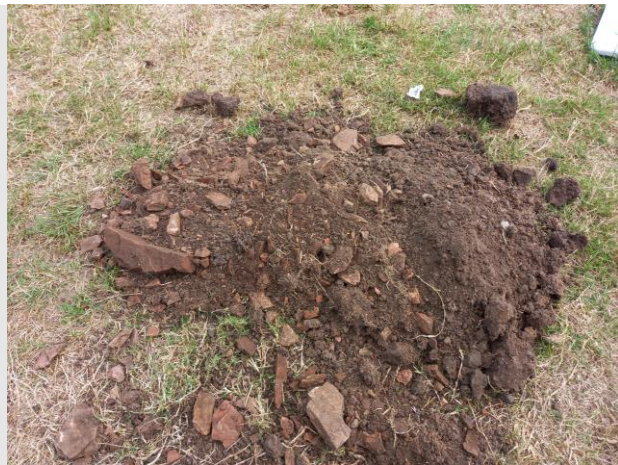
STRI carried out an excavation over an existing drain to confirm the materials present. During excavations, topsoil ingress was noted within the drainage backfill materials. This will significantly limit the efficiency at which surface water can percolate into the underlying clay pipes. The backfill material generally consisted of large stones (approx. 100 mm diameter) contaminated with soil. The lateral drains within the northern half of the site appeared to be located at approx. 5 – 6 m centres. In the southern half of the site, lateral drains appeared to be located at approx. 7 m centres.

Photo 21: Backfill material containing soil

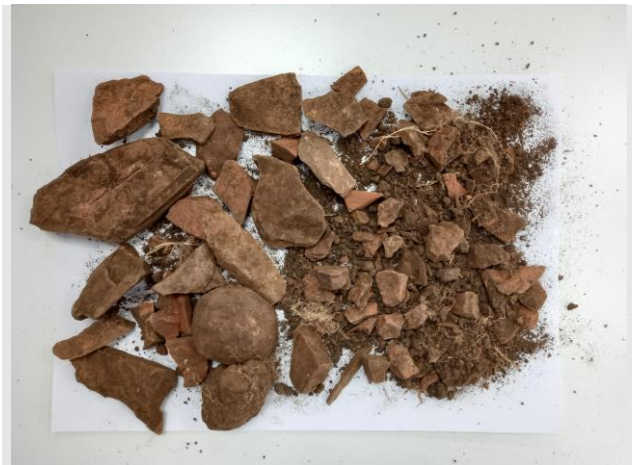
Photo 22: Backfill material sample containing soil

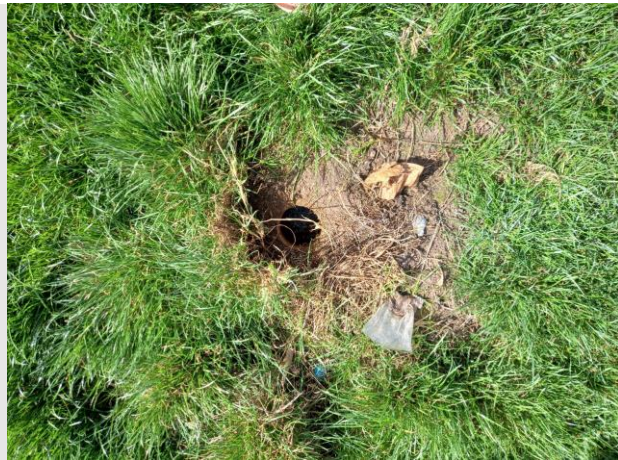
The existing pitch had faint line markings at the time of the visit, however there were no goal posts in place. Goal sockets were observed. It was noted that there were no protective caps over the sockets.

Photo 25: Sockets for football goals
