# BS 5837 Trees in Relation to Design, Demolition and Construction – Recommendations Report

SUEZ

Reliance Street HWRC Extension

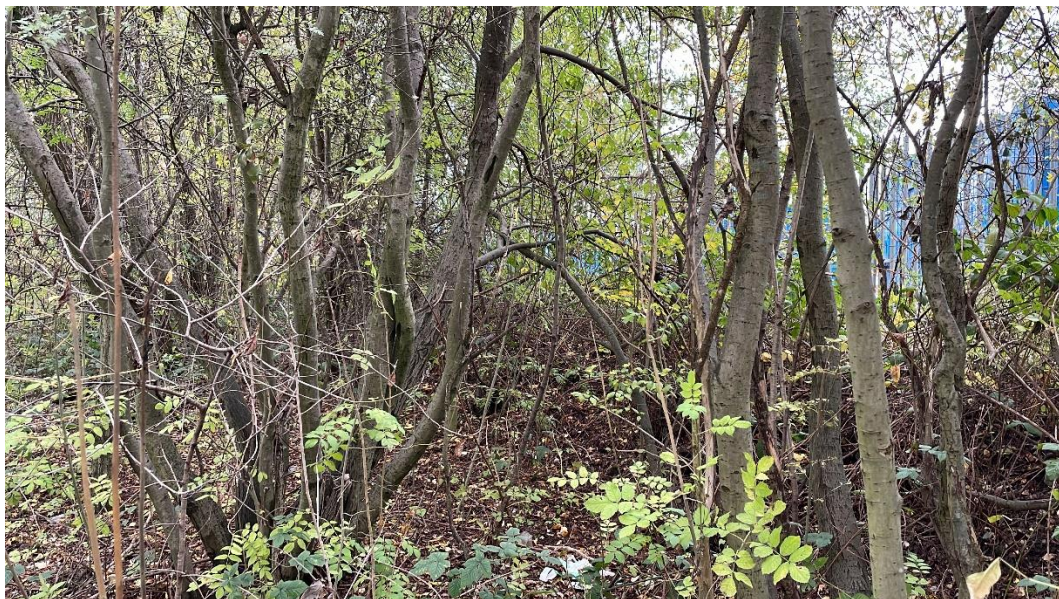
*Fig 1: Much of the site is as above in this image: a smaller number of trees with many hundreds of self-set small diameter stems throughout the area*

- 4.3 The trees' overall physiological condition is fair.
- 4.4 The trees' overall structural condition is poor, with many self-set, poor form trees that have not received any management since planting and therefore have limited remaining contributions.
- 4.5 The development will involve felling and removal of many of the surveyed trees; however given the overall structural and physiological condition of the trees, once the development has been completed there is an opportunity to plant replacement trees.
- 4.6 Those trees which are not being felled, excavations within and the construction of foundations within the Root Protection Area (RPA) may be necessary.

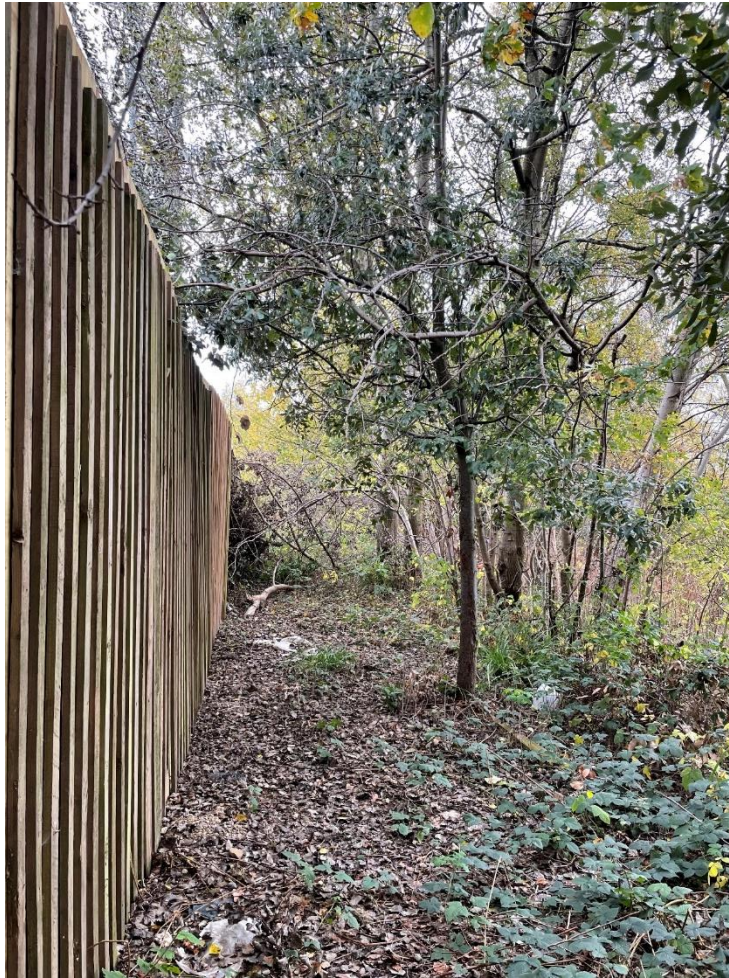
*Fig 2: this image was taken from the eastern end of the proposed development site, looking west along the current fenceline*

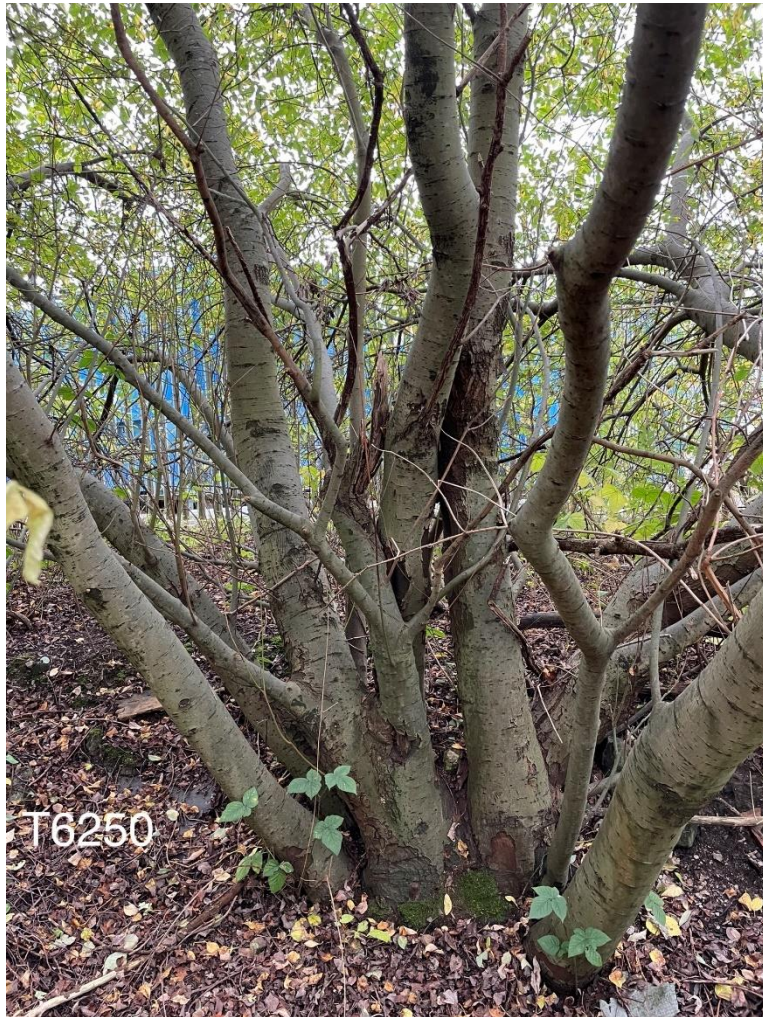
T6250 (above): many of the trees within the proposed development area are multi-stemmed forms such as this

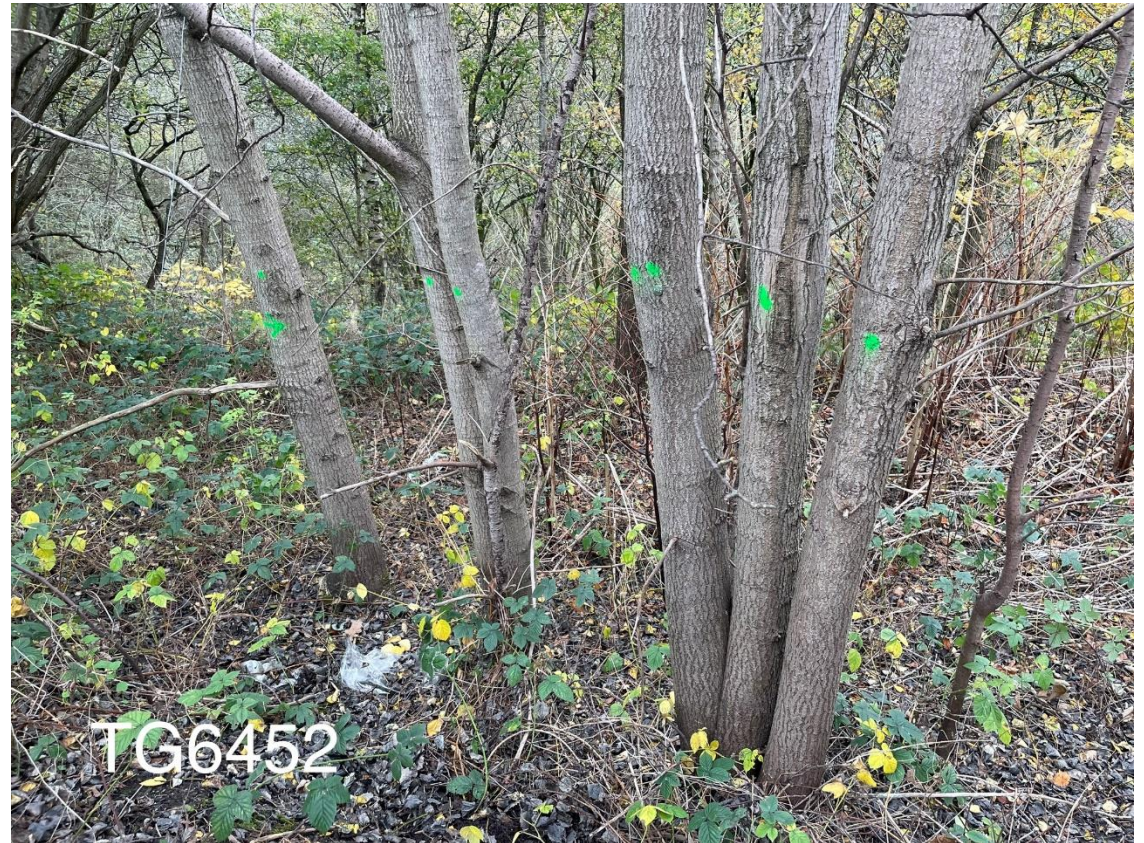
| Tree Number | Species | Tree Height (m) | Stem diameter (mm) | Life Stage | | | | General observations and comments | | | | Est'd remaining contribution (yrs) | | | | BS 5837 category | RPA radius (m) | RPA (sq. m) |
|---|---|---|---|---|---|---|---|---|---|---|---|---|---|---|---|---|---|---|
| TG6452 | Aspen | <i>Populus tremula</i> | 8.0 | 200 | | Y | | Fair | Fair | 3 trees, 6 stems | | | | Y | | B | 2.4 | 4.3 |

TG6452 (above): image to illustrate this group – 3 trees and 6 stems planted in a line
