# **Site Tree Report and Appraisal**

***Vasa Club 283 White Moss Road, Manchester, M9 6NZ***

Ref: RTS/13102020

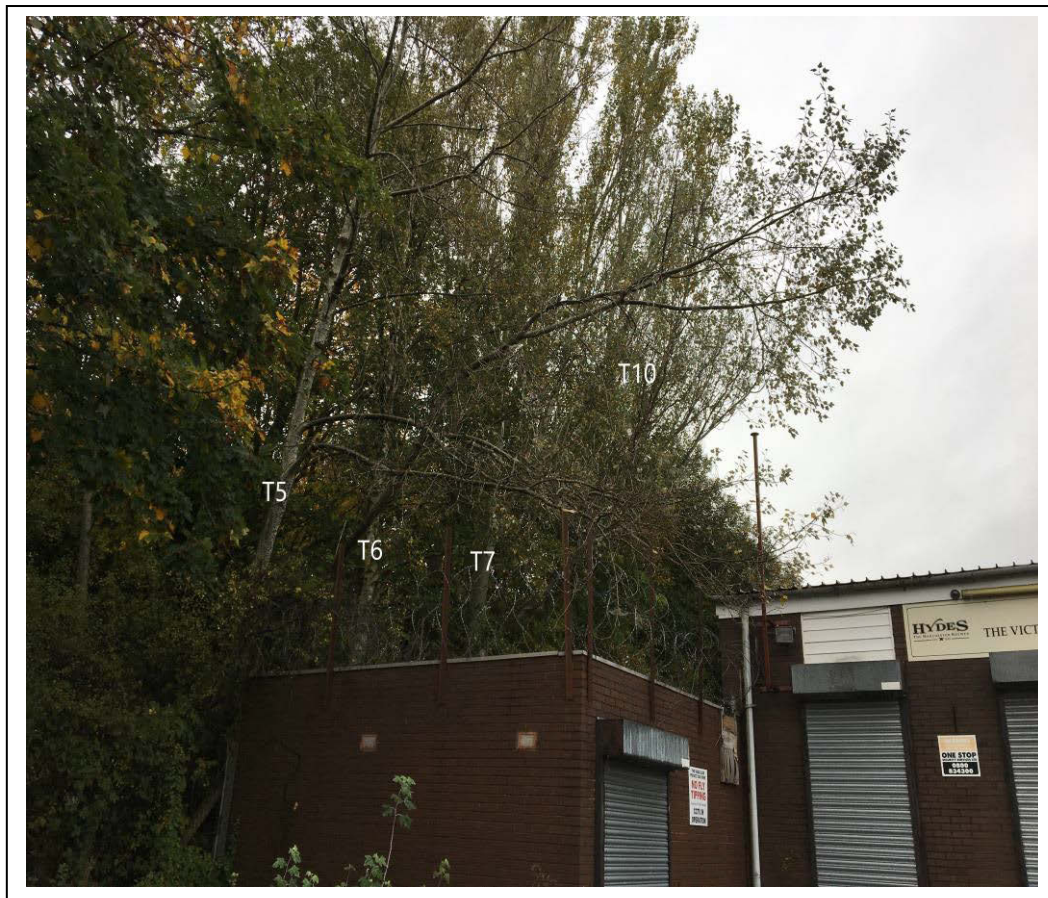
**Photo 002:**

- 3.4** Removal of the copse edge trees (T5 to G12) would also be recommended irrespective of the development proposal due to their practical nuisance to the existing building (photo 002). Removal of these edge trees would also encourage better structural form of the remaining copse trees, thus improving the visual amenity of the area.

| Tree | Tree Work | Priority |
|---|---|---|
| G12 | Fell to ground level trees in the group that are within the development land boundary and grind out the remaining stumps. | Prior to any other site works |
