SITE AT CARMOOR ROAD,  
MANCHESTER, M13 0FB

**P451205-D0C-S-002**

**Demolition Statement**

18<sup>th</sup> November 2022

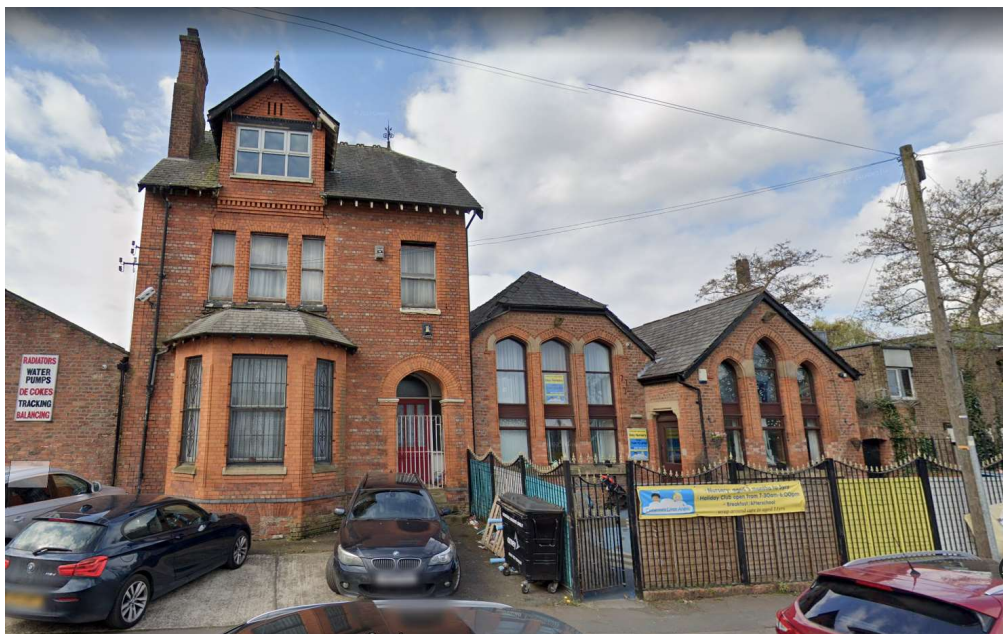
Figure 04: Residential Building & Ciara's Tots (Google Maps)

The large three-storey brick-built residential building on the left on Figure 04 is abandoned and appears to be in a state of severe disrepair. The services to the property had been disconnected but the property is full of rubbish, old furniture, and abandoned household items. The fixtures and fittings are in a bad state and rot, damp and partial collapse of the plasterboard and wall fixtures was noted during the site walkover by our subconsultants.

The demolition methodology should first consider stripping out by hand and the re-use of materials wherever possible – e.g. reclaimed timber, bricks and slates. A top-down demolitions approach would enable this.

The contractor should consider any public and personnel safety precautions as part of these works – including the use of scaffolding, hoarding, closing of footpaths etc.

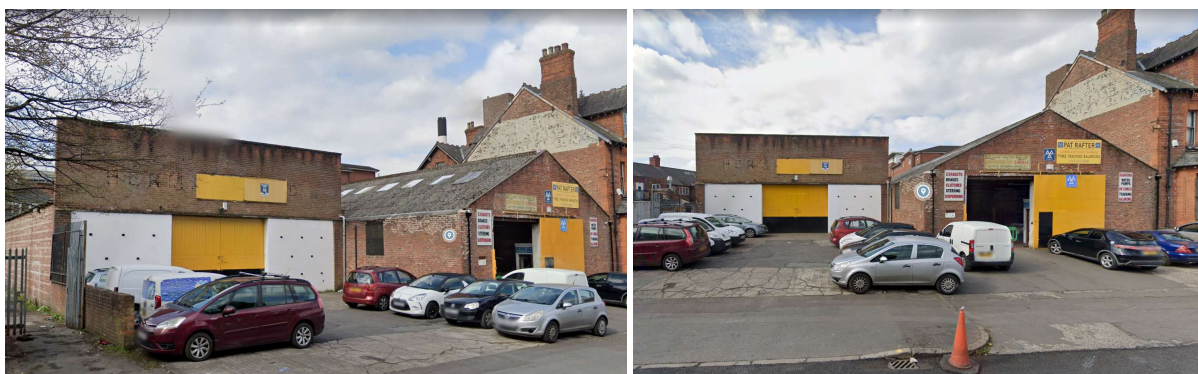
*Figure 06: Warehouse/Garage (Google Maps)*

There are three warehouse/garage buildings on site, two of which are adjacent buildings along the eastern and southern sides of the site and are shown in Figure 06. These buildings are brick-built and have been in-situ for at least 50 to 60 years based on their design and condition. They are noted to be in very poor condition and include sheeted corrugated asbestos roofs, with poor quality wooden timber beams, doors, and windows. The building in the middle of the site is operating as the main garage, whilst the one along the southern edge is used for car storage.

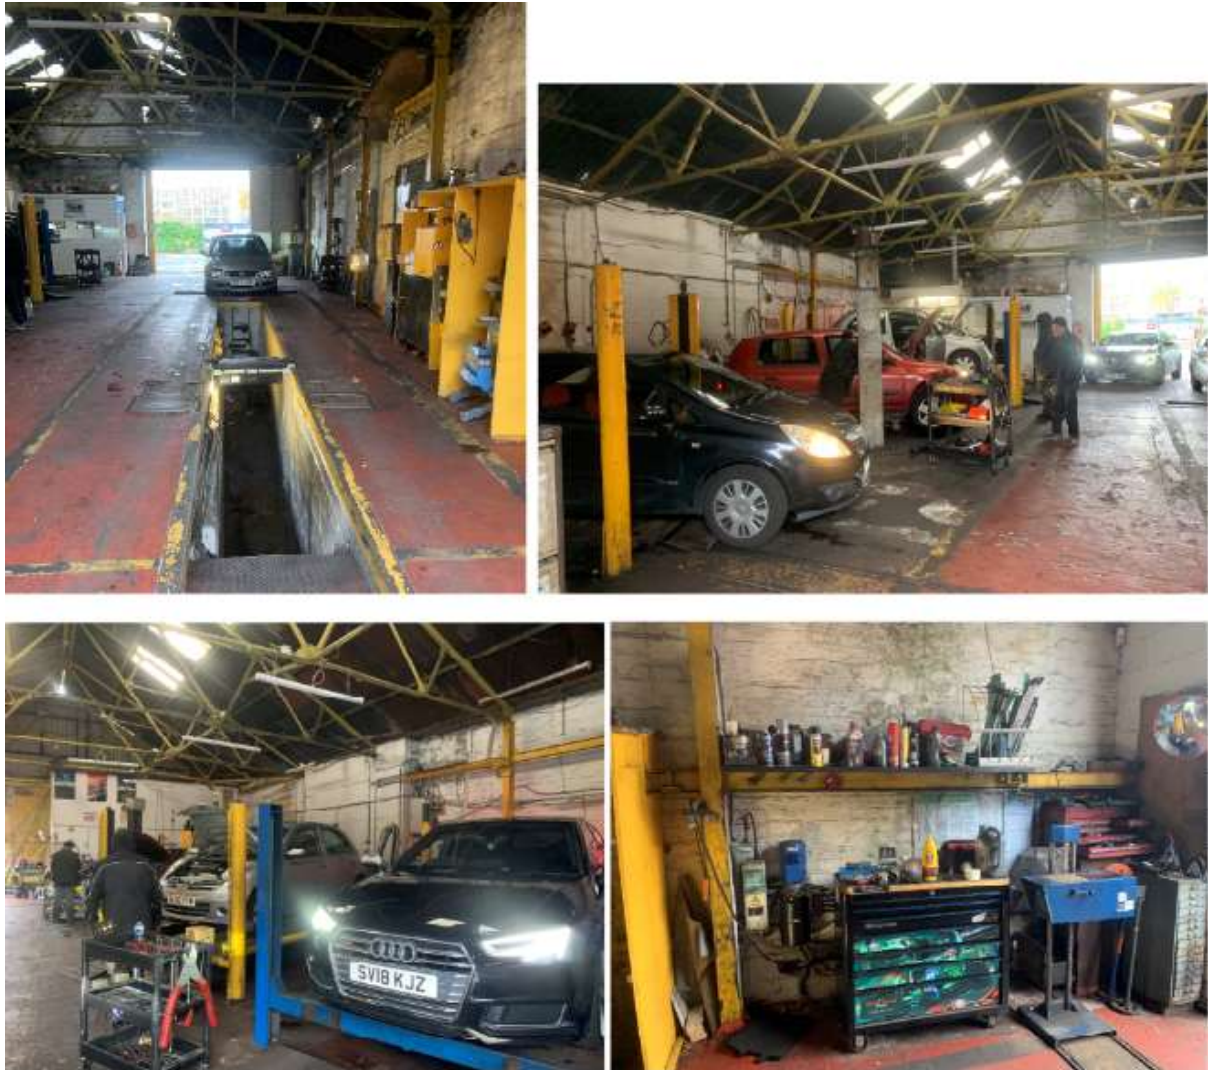
*Figure 07: Main Garage Internal Structure (Phase 1 Desk Study)*

The buildings include masonry perimeter walls supporting a steel pitched roof with a profiled cladding covering, see Figure 07. This building could be demolished by removing the roofing sheets followed by the roof trusses. Appropriate temporary works should be adopted by the contractor to maintain

the stability of the perimeter walls. The walls can then be demolished top-down and bricks reclaimed where possible.

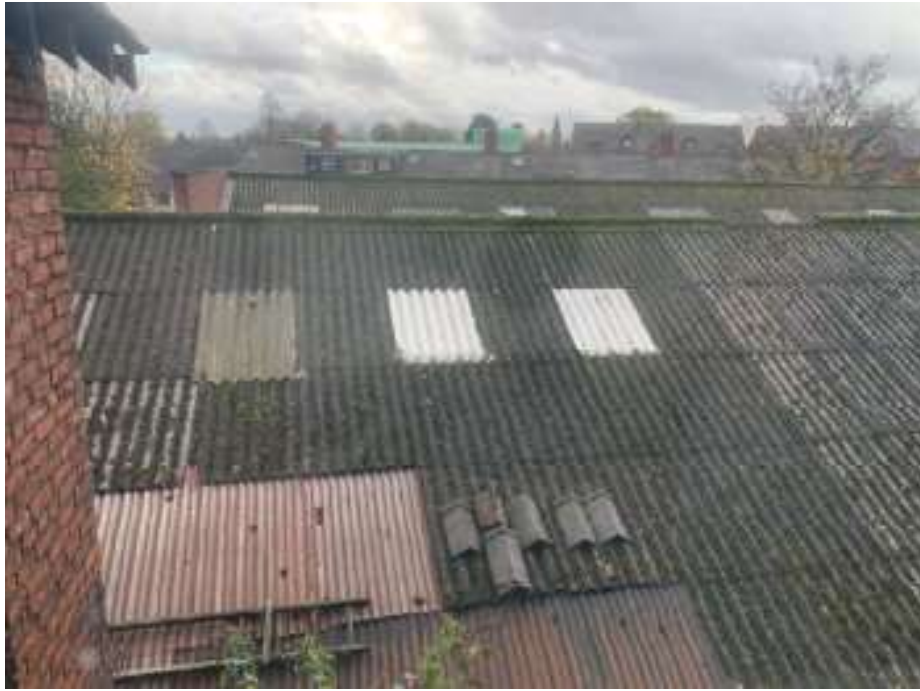
*Figure 08: Existing Garage Asbestos Roofing (Phase 1 Desk Study)*

Safety measures must be placed, and extreme caution taken when dismantling the roof construction, especially with the confirmed presence of asbestos there. Please see Figure 08.

The gable wall on the southern site boundary will need to be demolished by hand and a full scaffold will be necessary along this elevation to reduce risk to adjacent retail terraces.
