## **Arboricultural Impact Assessment**

**Ev0 Building, Didsbury  
Bruntwood Works**

Report reference: AR-5143-01  
July 2022

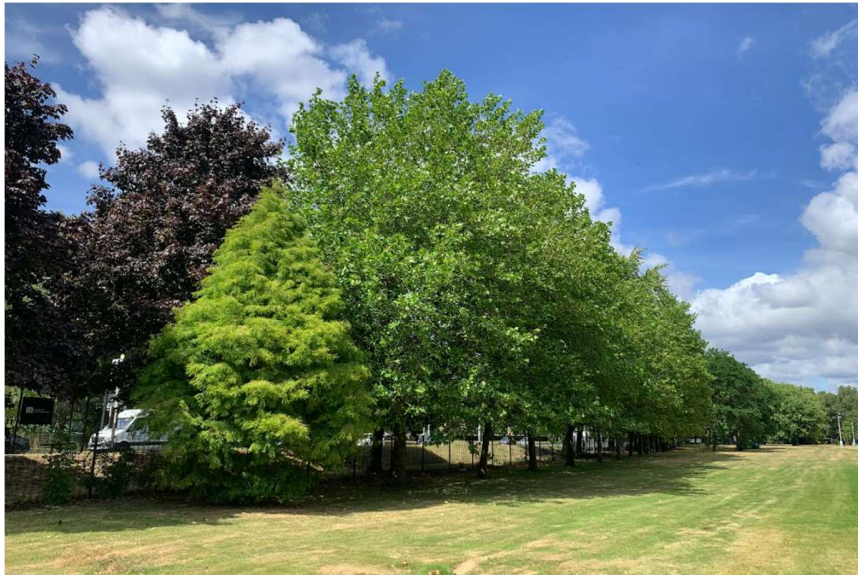
**Figure 2: G87, an attractive group of mature trees located to the W of the site along Princess Road.**

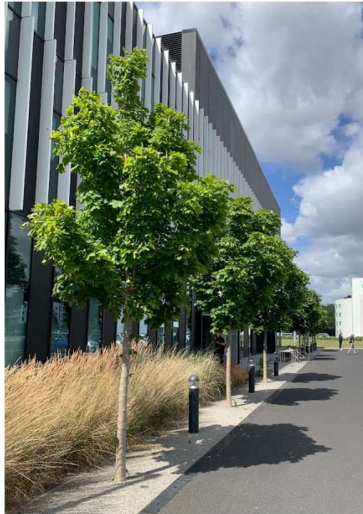
**Figure 3: G88, young London Plane trees located in the SW of the site.**

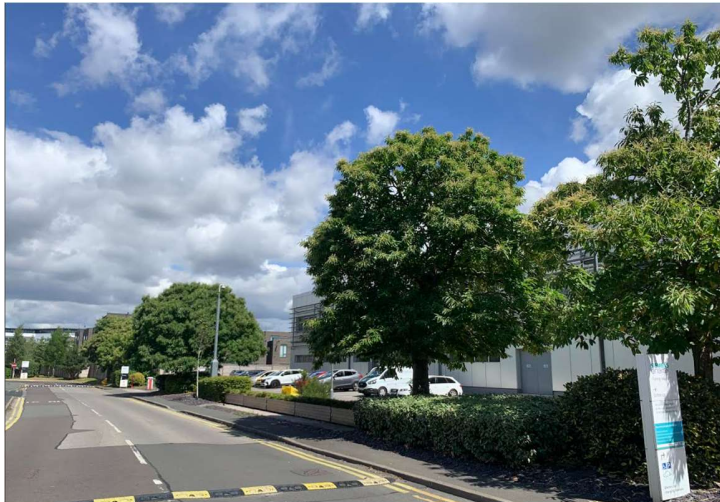
| Ref | Species | Life stage | Ht (m) | Can Ht (m) | Stem diam (mm) | Canopy spread (m) | Physio logical | Structural condition | Recommendations | Life exp. (yrs) | Ret cat |
|---|---|---|---|---|---|---|---|---|---|---|---|
| <b>T35</b> | Sweet Chestnut | M | 12 | 2 | 460 | N 4.3<br>E 4.3<br>S 4.3<br>W 4.3 | G | Single vertical stem with a balanced canopy. Minor deadwood. Minor basal epicormic growth. Overhanging road. No major visible defects. | No action required. | 40+ | B1 |
| <b>T36</b> | Sweet Chestnut | M | 7 | 2 | 265 | N 3.2<br>E 3.2<br>S 3.2<br>W 3.2 | G | Single vertical stem with a balanced canopy. Minor deadwood. Minor basal epicormic growth. Overhanging road. No major visible defects. | No action required. | 40+ | B1 |
| <b>T37</b> | Sweet Chestnut | M | 7 | 2.5 | 210 | N 2.6<br>E 2.6<br>S 2.6<br>W 2.6 | G | Single vertical stem with a balanced canopy. Minor deadwood. Minor basal epicormic growth. Overhanging road. No major visible defects. | No action required. | 40+ | B1 |
| <b>T39</b> | Sweet Chestnut | M | 12 | 2.5 | 445 | N 5.5<br>E 5.5<br>S 5.5<br>W 5.5 | G | Single vertical stem with a balanced canopy. Overhanging road. Overhanging car park. No major visible defects. | No action required. | 40+ | B1 |
| <b>T40</b> | Sweet Chestnut | M | 10 | 2.5 | 270 | N 2.9<br>E 2.9<br>S 2.9<br>W 2.9 | G | Single vertical stem with a balanced canopy. Overhanging road. Overhanging car park. No major visible defects. | No action required. | 40+ | B1 |

**Figure 4: T35-T40 located along an access road in the SE of the site.**

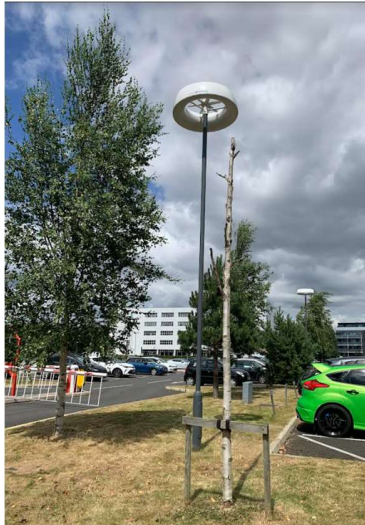
**Figure 5: T43, a deceased Birch in the foreground.**
