Heritage Statement

**FULL PLANNING APPLICATION  
AND LISTED BUILDING CONSENT  
77 WHITWORTH STREET WEST  
MANCHESTER  
M1 5WQ**

**October 2022**

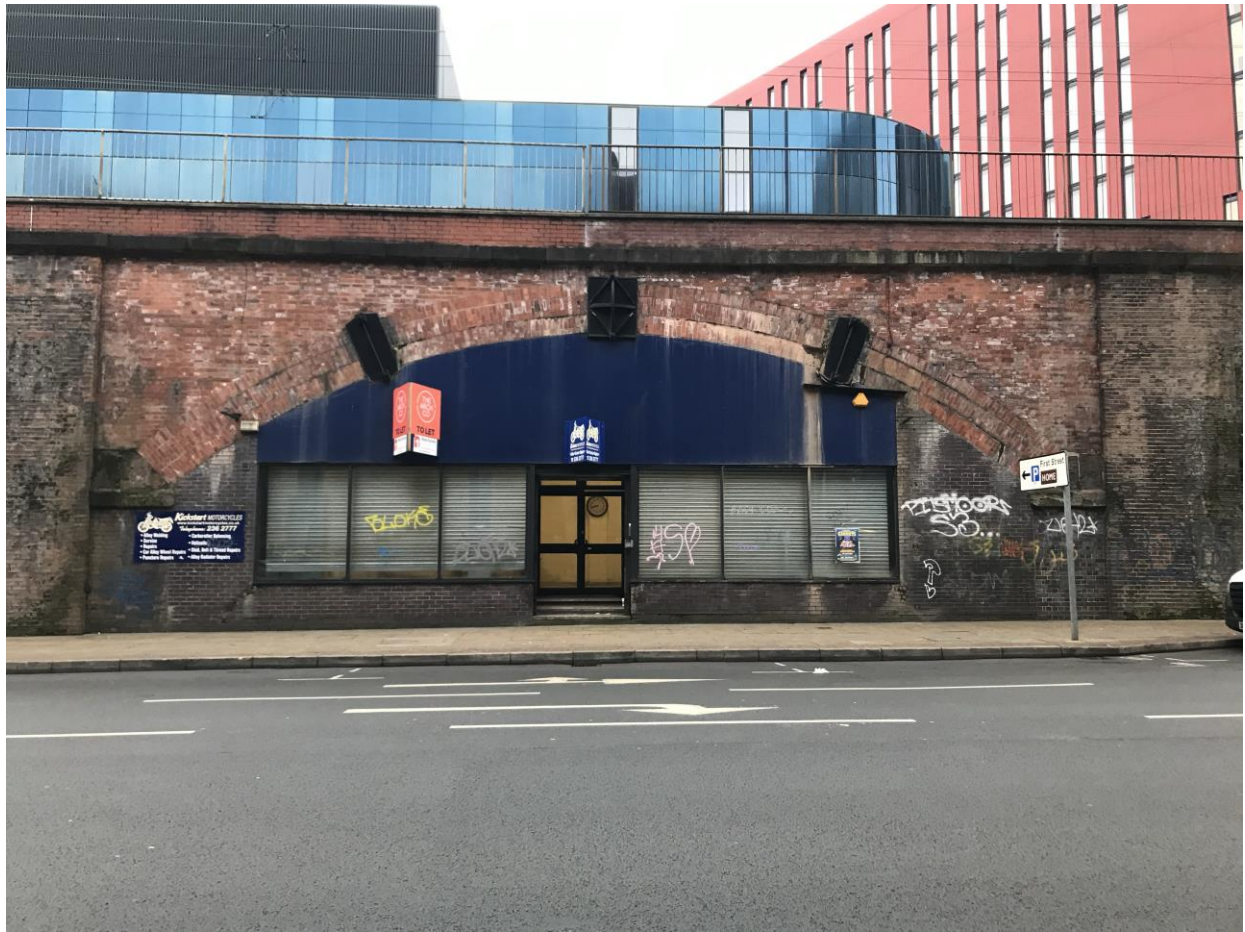
**Figure 1 - Front elevation of the building**

- 2.1 77 Whitworth Street West comprises a commercial unit situated under a railway viaduct, with the frontage comprising a brickwork infill, powder coated aluminium shopfront with glazed window units and a painted timber fascia.

- 2.4 Internally the property is in a poor condition and due to the lack of emergency and disabled access the unit offers, the property is currently in an un-lettable state. The previous use of the property was for retail purposes.

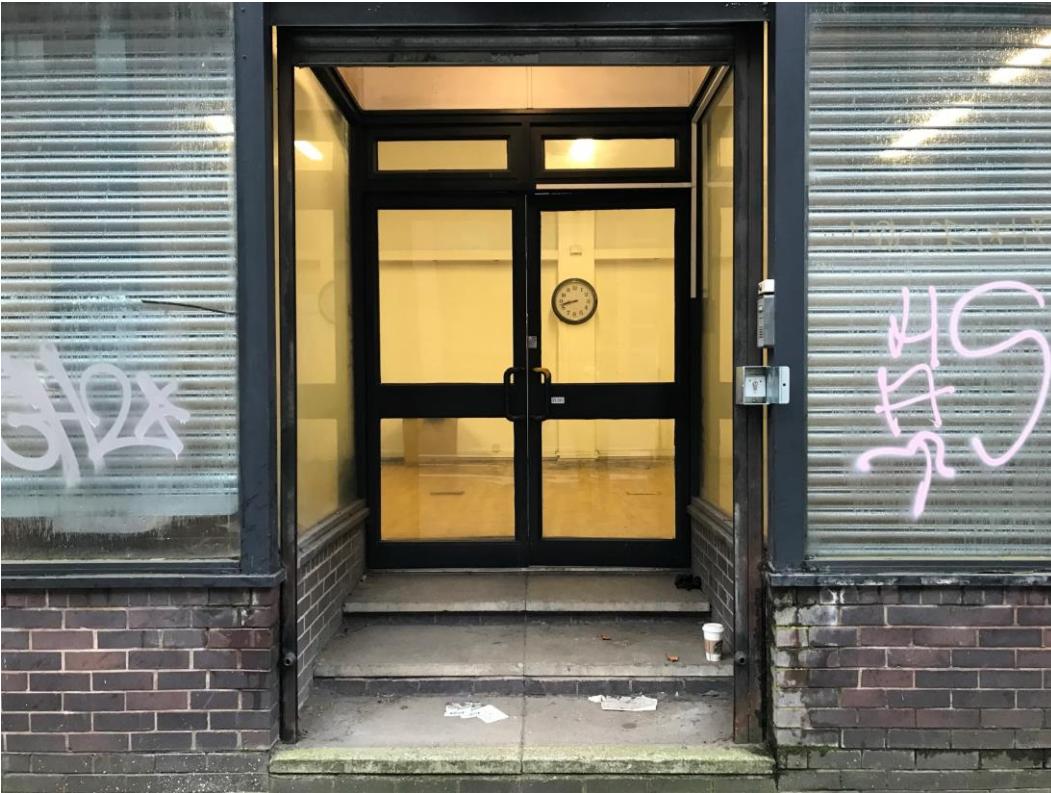
5) The paved stepped entrance and double entrance doors which would be altered to create a fully accessible entrance into the unit.

- 6.4 The works to the shopfront involve altering the aluminium shopfront, with the entrance doors being re-situated. Once the concrete access steps has been broken up and removed safely from the entrance, the double entrance doors will be brought forward and sit flush with the infill to provide an even and safe point of access for those who require assistance to manoeuvre. The works undertaken in altering the shopfront are to be compliant with Part M of the Building Regulations.

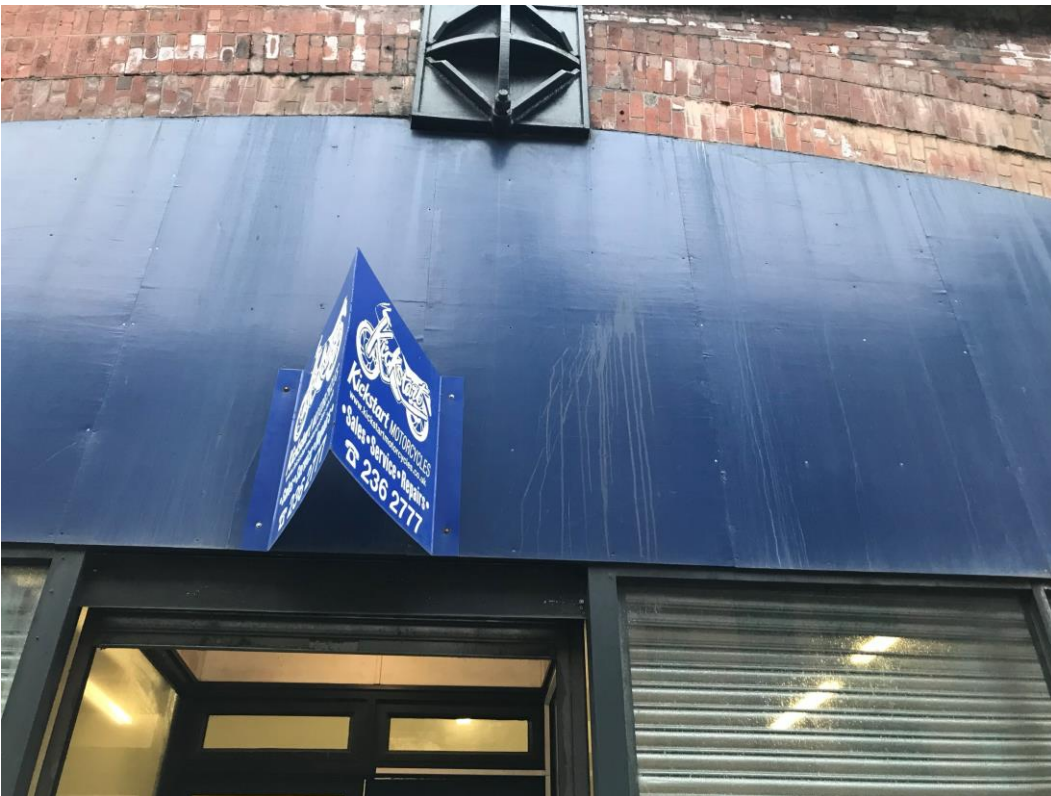
6) Painted signage fascia which would receive redecoration works as part of the project. The colour of paint would match the existing.

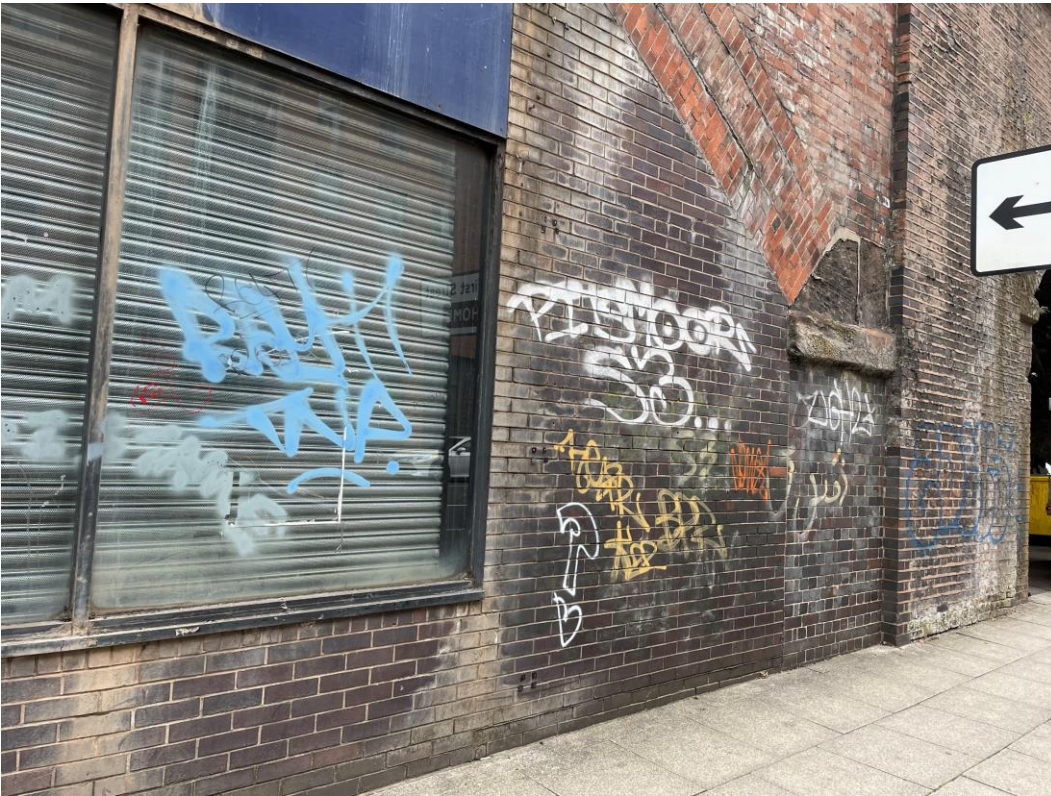
7) Right hand side of the brickwork infill where the proposed emergency exit would be situated.

- 6.5 As part of the works in further altering the front infill, an emergency exit would be created within the brickwork to the right hand side. The reasoning for this is that the unit did provide a rear means of escape. A neighbouring property has made the rear means of escape redundant. A new secondary means of escape is therefore required to the right hand side of the front infill to comply with Part B of the Building Regulations.

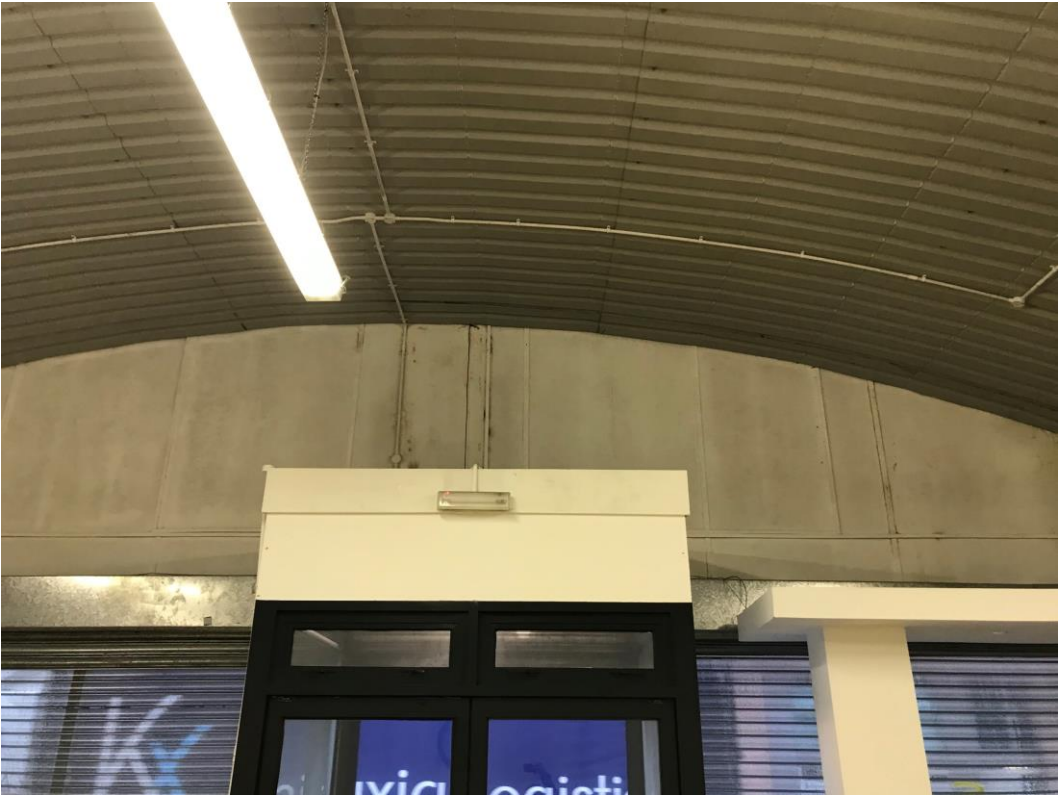
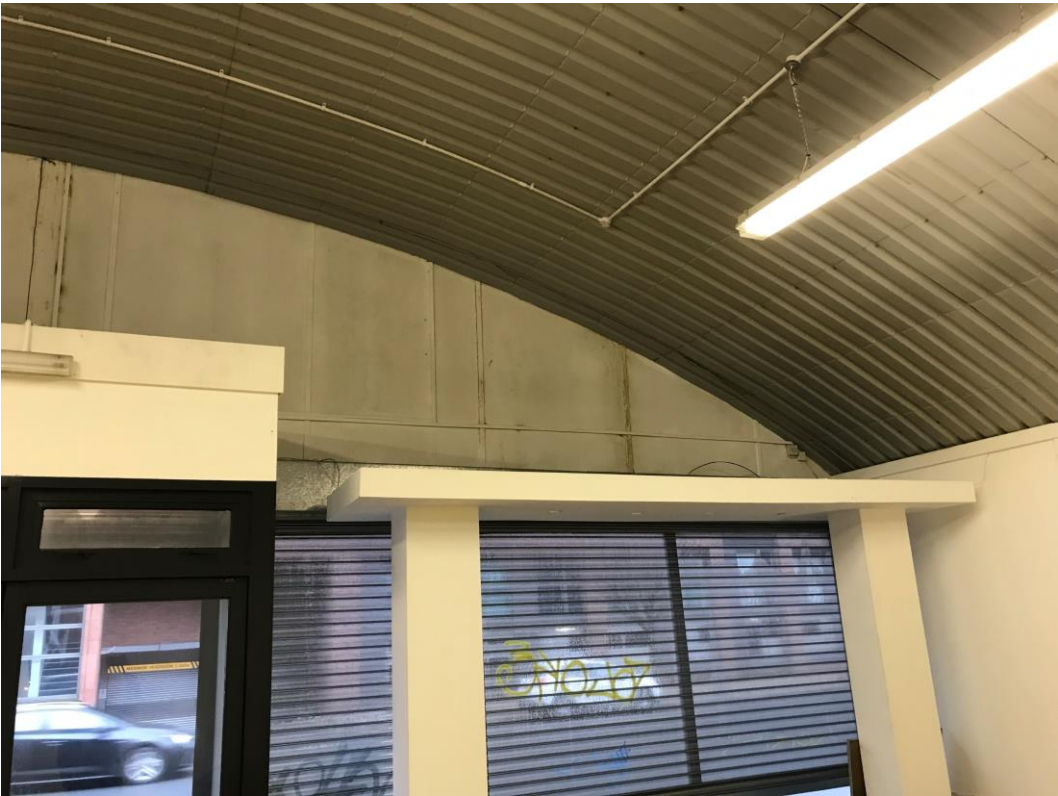
10) Stained wall lining.

11) Stained wall lining.

12) Stained wall lining.

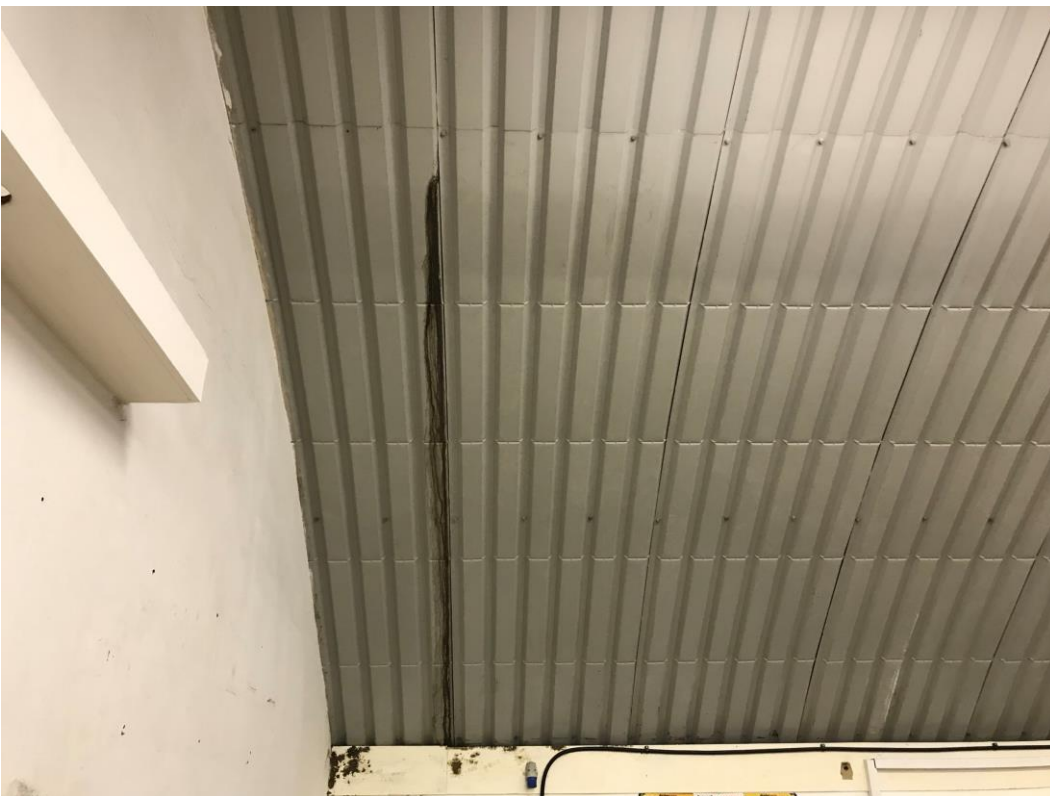
16) Isolated location of leak coming through the lining system.

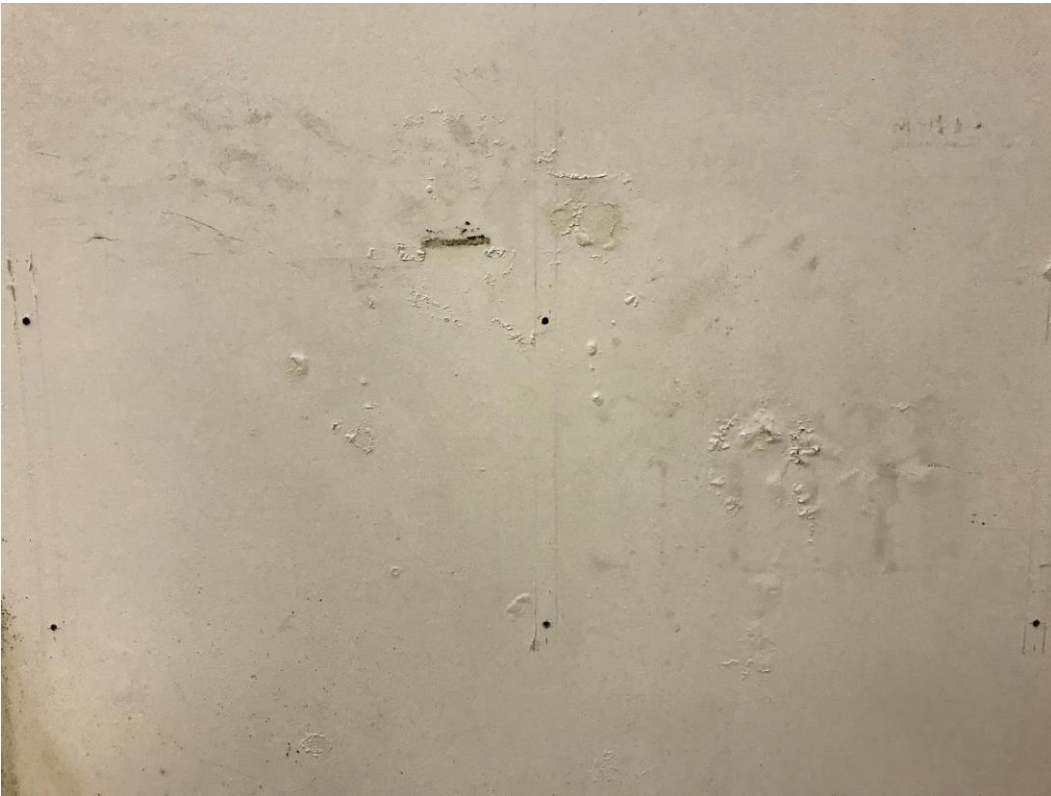
17) Damp affected paint finish.

20) Damp affected paint finish.

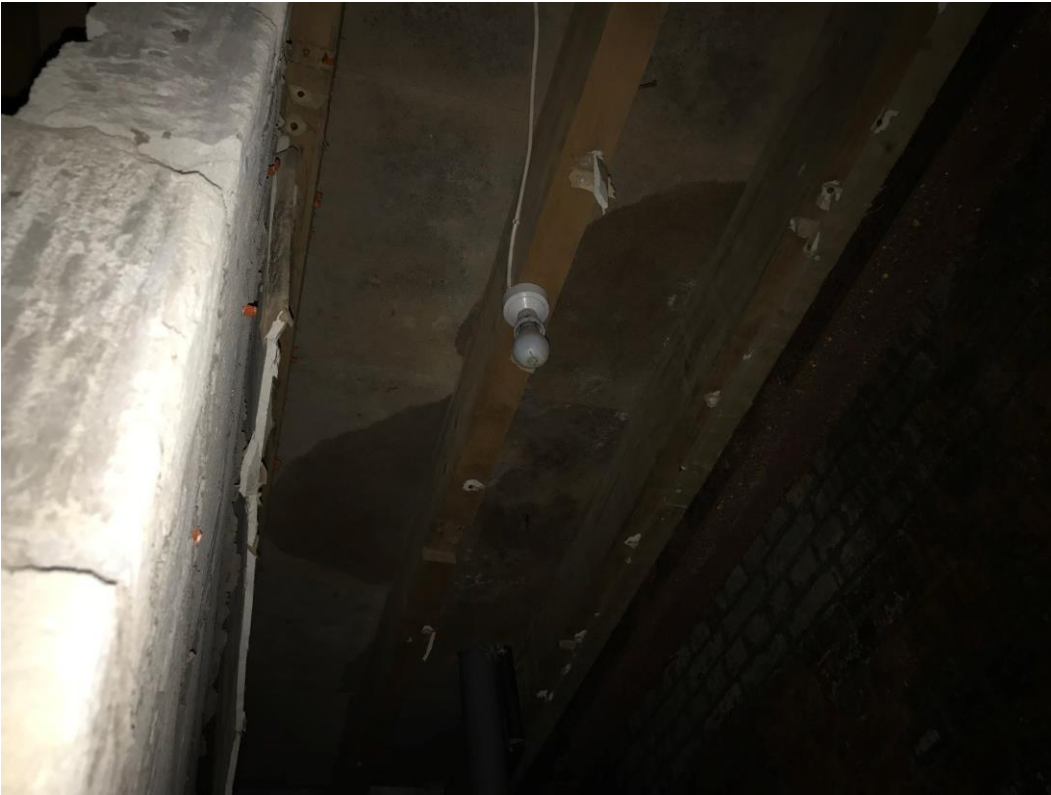
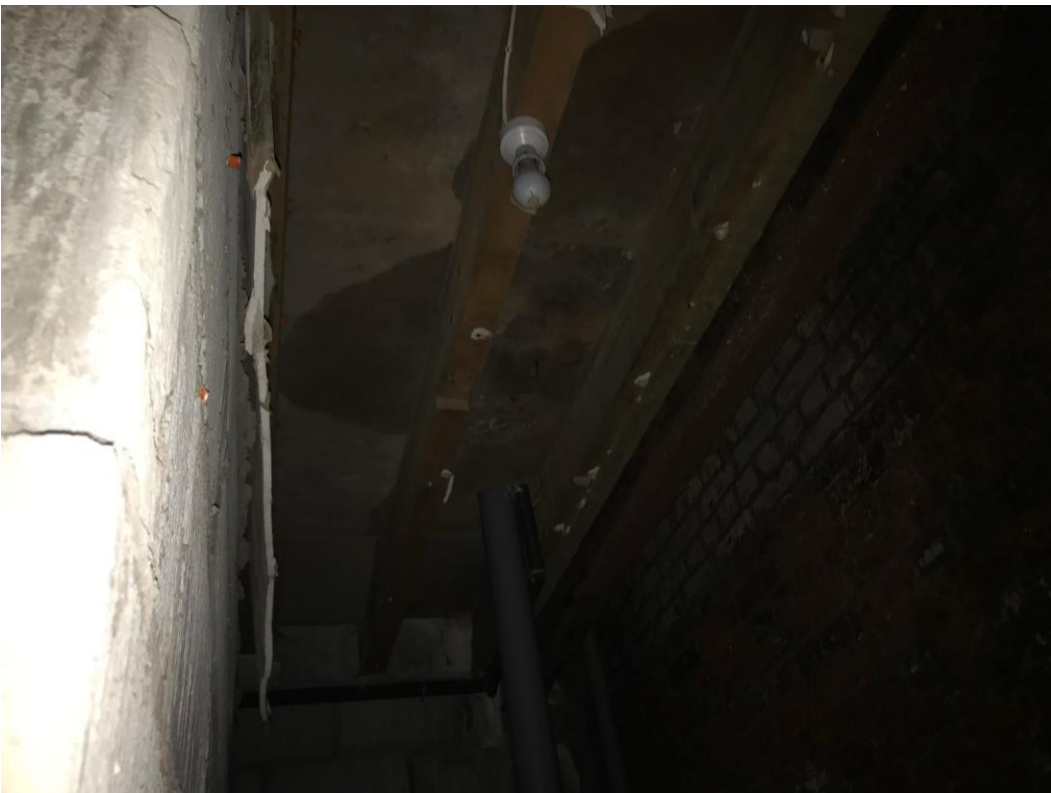
23) Underside of the mezzanine structure, which is damp affected and not fit for purpose.

24) Underside of the mezzanine structure, which is damp affected and not fit for purpose.

26) Underside of the mezzanine structure, which is damp affected and not fit for purpose.

- 6.6 The existing mezzanine structure is found to not be fit for purpose for the use class that the unit currently operates under. As such, the existing mezzanine will be demolished and taken away from site and a safer mezzanine structure will be constructed in its place. Along with the mezzanine structure, a fire corridor and enclosed stairwell will be constructed, which will allow occupants at basement level safe egress to the secondary means of escape.
- 6.7 The mezzanine will not only be safer and more practical for the unit's use class, but it will help the unit become a fully accessible space.

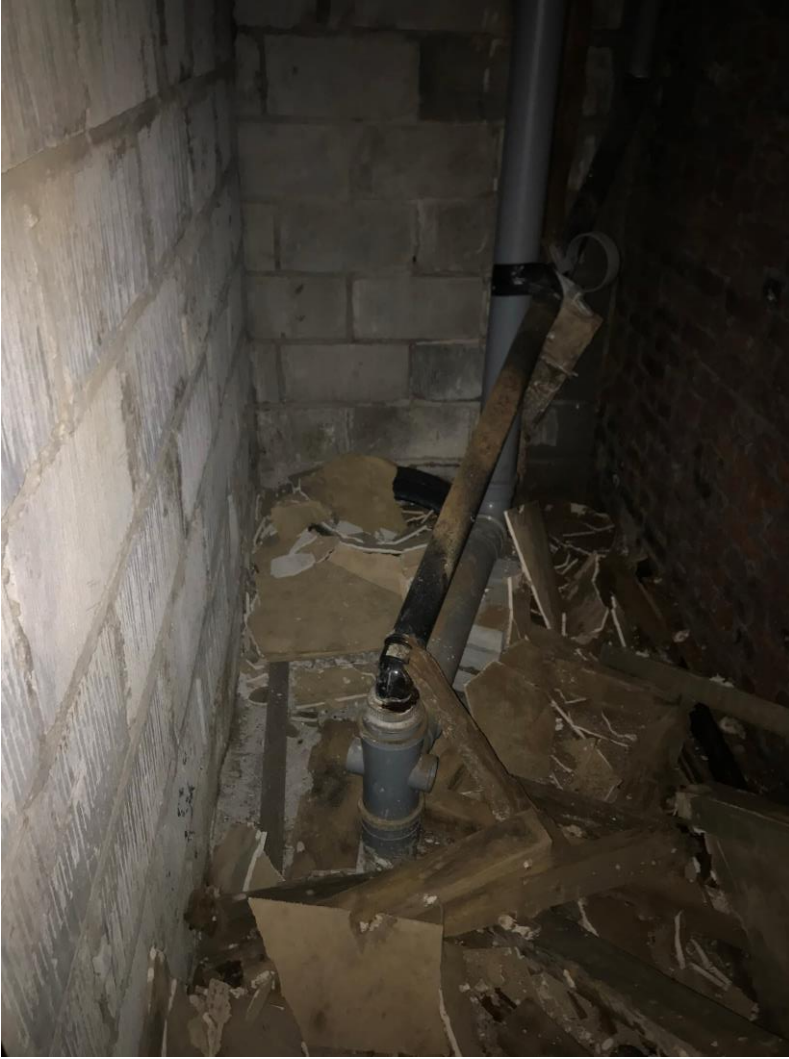
21) Debris to basement level. Location of existing foul waste which will be connected into as part of the WC construction works.

22) Debris to basement level. Location of existing foul waste which will be connected into as part of the WC construction works.

25) Debris to basement level. Location of existing foul waste which will be connected into as part of the WC construction works.

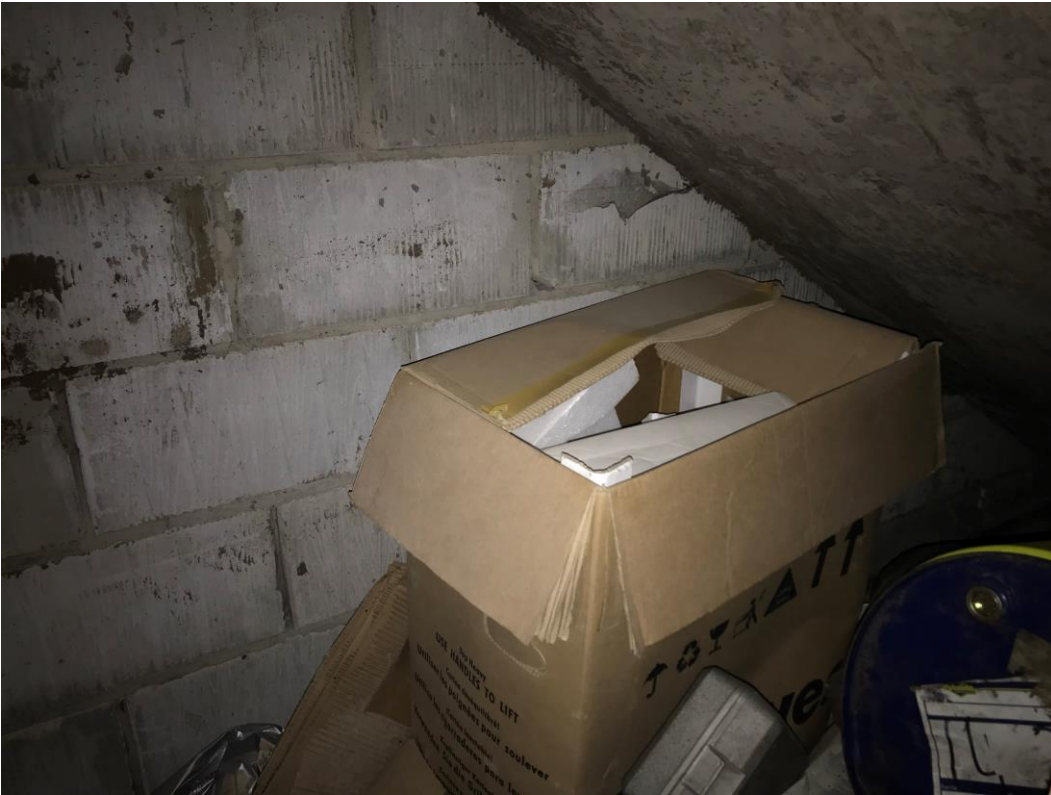
27) Debris to basement level.

28) Debris to basement level.

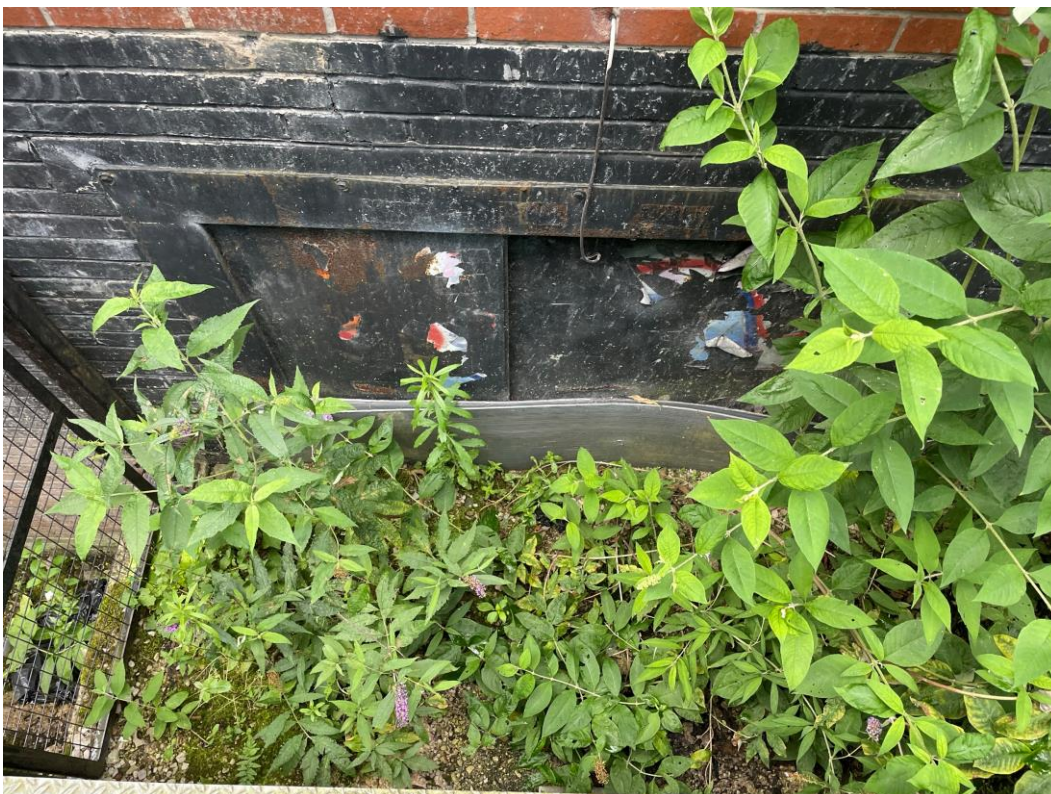
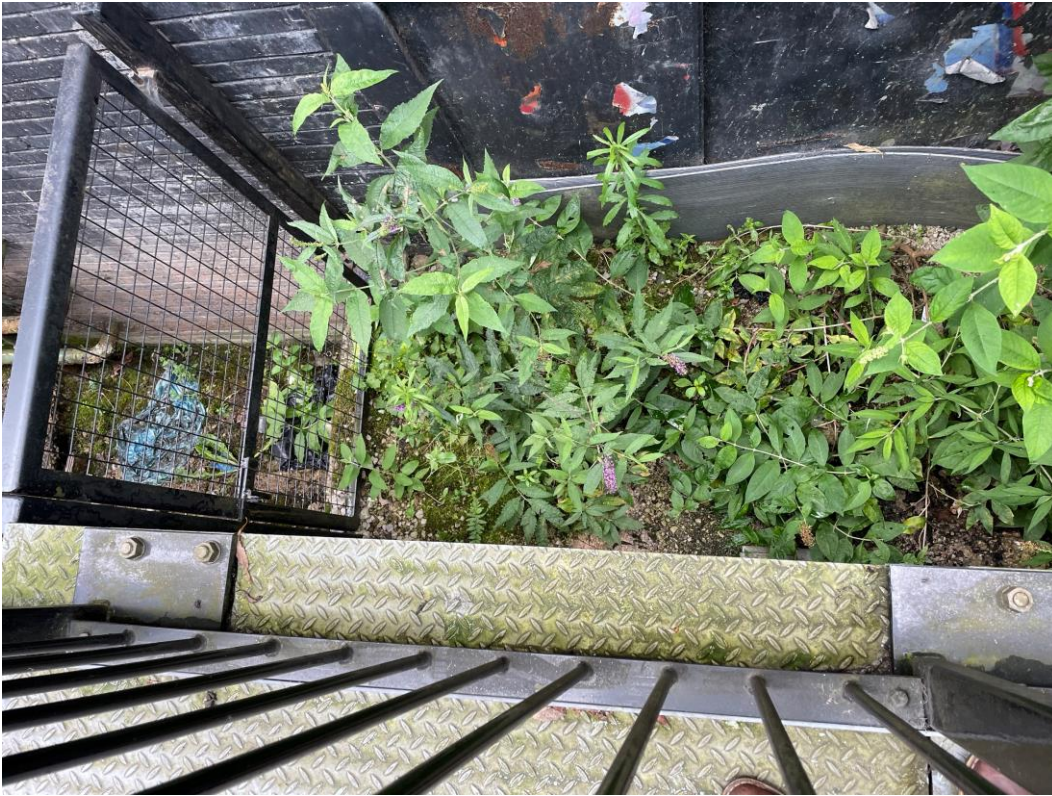
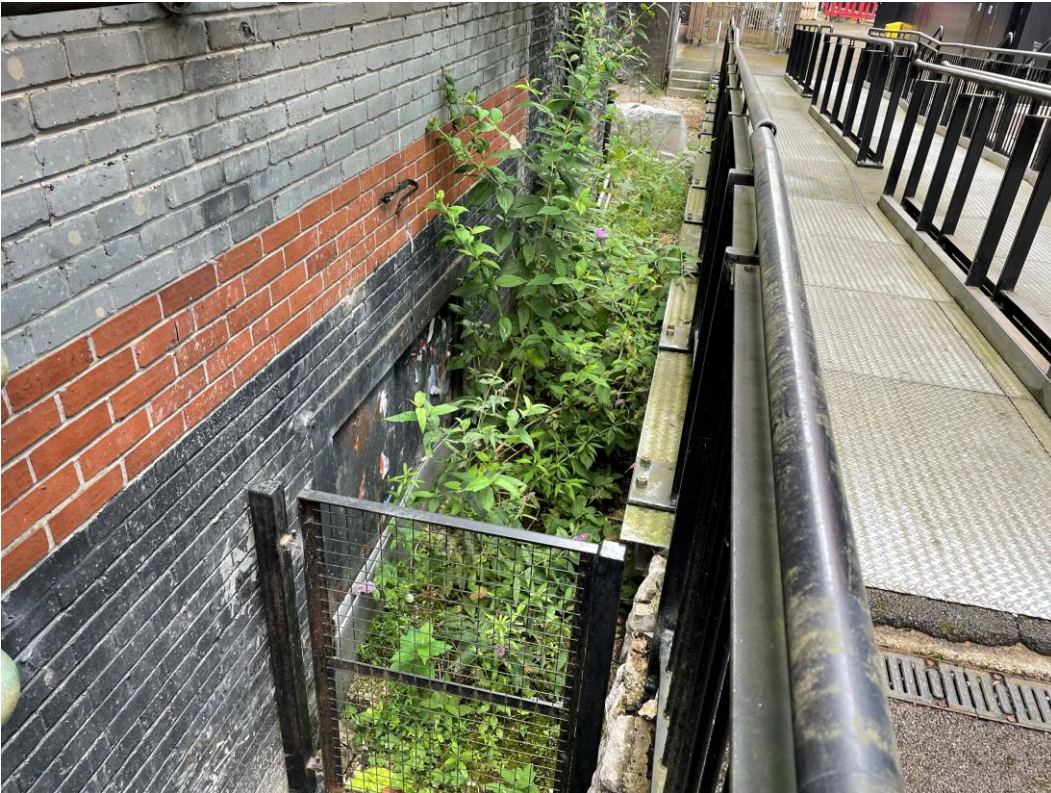
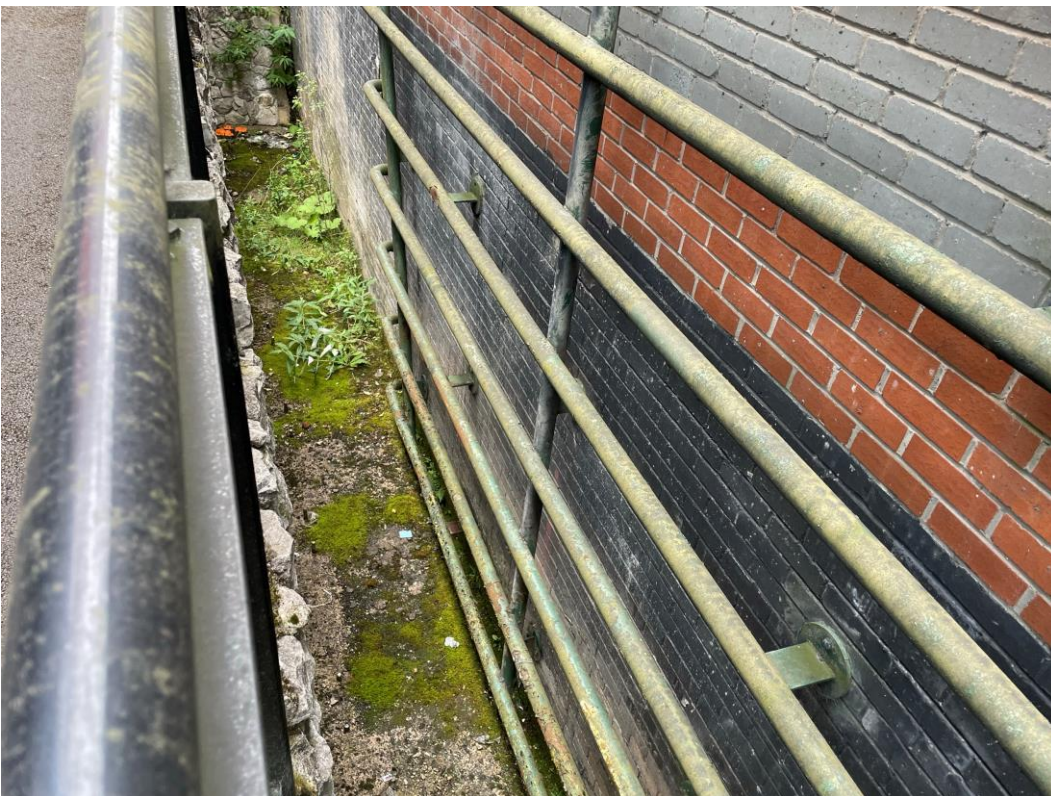
31) The rear emergency exit to 77 Whitworth Street West with the neighbouring retaining structure being built in close proximity, meaning that it is unsafe and impractical to use this exit.

32) The rear emergency exit to 77 Whitworth Street West with the neighbouring retaining structure being built in close proximity, meaning that it is unsafe and impractical to use this exit.

33) The rear emergency exit to 77 Whitworth Street West with the neighbouring retaining structure being built in close proximity, meaning that it is unsafe and impractical to use this exit.

34) The rear emergency exit to 77 Whitworth Street West with the neighbouring retaining structure being built in close proximity, meaning that it is unsafe and impractical to use this exit.

35) The rear emergency exit to 77 Whitworth Street West with the neighbouring retaining structure being built in close proximity, meaning that it is unsafe and impractical to use this exit.
