# EXTENDED PHASE 1 HABITAT SURVEY & DAYTIME BAT SURVEY

ST GABRIEL'S, OXFORD PLACE,  
GREATER MANCHESTER

FEBRUARY 2022

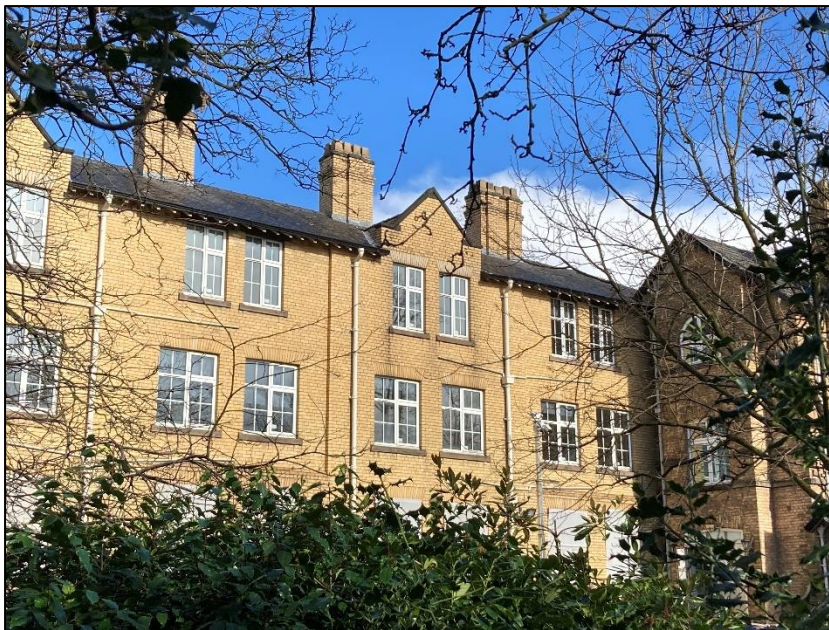
- 3.13 St Gabriel's Hall comprises interconnected buildings constructed from brick with multiple hipped roofs. The external brick walls are in good condition, with no missing bricks or mortar, and do not support suitable cavities for roosting bats (see Photographs 12 and 13). The brick chimney stacks are complete. The windows and door frames are uPVC and are well-sealed. A small number of windows on the third storey have been left open which could provide potential access into the internal space of the building (see Photograph 15). Some of the lower-floor windows are covered with sheet metal and are well-sealed.

*Photograph 12 showing the exterior St Gabriel's Hall*

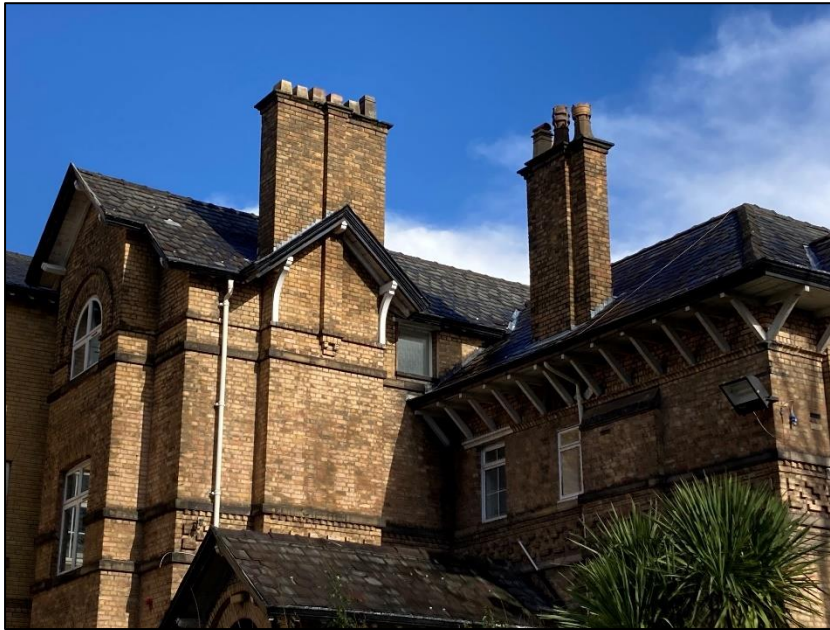
*Photograph 13 showing the brickwork*

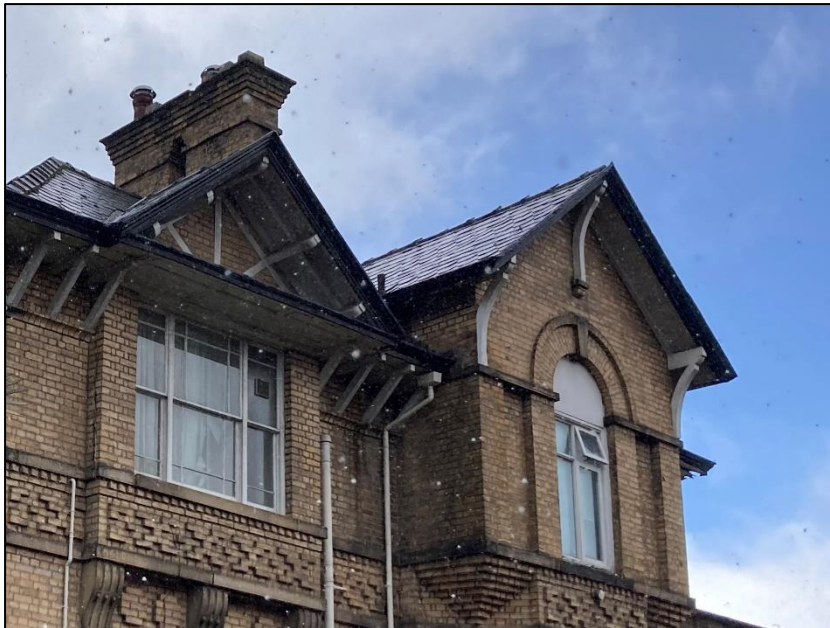
*Photograph 14 showing an open window*

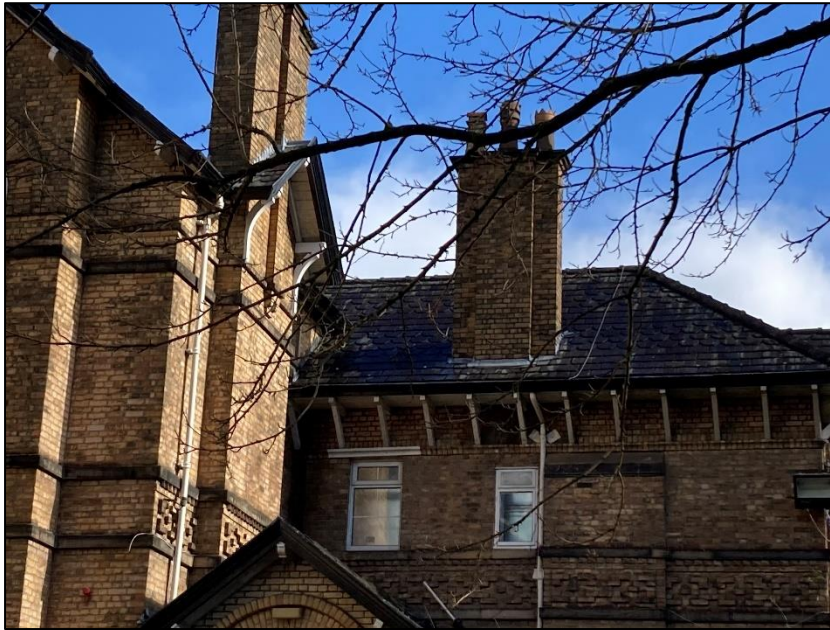
- 3.14 The building has multiple hipped and gabled roofs constructed with slate tiles (see Photograph 15). Multiple tiles have slipped or are damaged offering potential access to the internal spaces for bats (see Photograph 16). The remaining tiles lie flush to one another. The ridge tiles are in-situ, however missing mortar has created gaps beneath some of the ridge tiles offering potential entry points into the roof void. Lead flashing exists around the chimney, and in the valleys between pitches. This is flush to the tiles and brickwork.

*Photograph 15 showing part of the roof of St Gabriel's Hall*

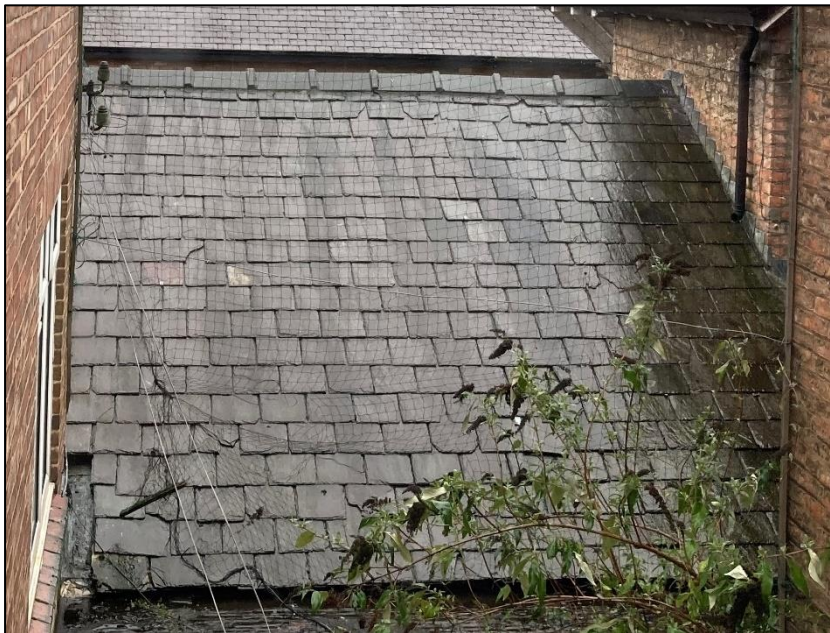
*Photograph 16 showing some of the slipped and damaged roof slates*

- 4.6 St Gabriel's Hall is a large three-storey brick-built building with multiple pitched slate covered roofs. It supports potential access points to the roof voids through slipped and missing roof voids, gaps in the wooden soffit boards and via a small number of open windows on the upper floor. The slipped tiles also offer external roosting opportunities. The roof voids in the east of the building were not accessible at the time of the survey, one large roof void in the west of the building was accessed and found to support multiple potential access points, no evidence of bat activity was found within this roof void during the survey. St Gabriel's Hall is considered to offer **Moderate Potential** to support a bat roost. A minimum of two dusk emergence surveys should be conducted to determine if bats are using the roof void in the east of the building and the external features of the building.

- **Bats** - A minimum of two dusk bat emergence surveys is recommended on St Gabriel's Hall. A minimum of one dusk bat emergence survey is recommended on St David's Hall. The surveys should be carried out between May-September, in suitable weather conditions. Should an active bat roost be found on the site, bat mitigation will be required, as well as a Natural England bat mitigation licence in order to carry out works on the bat roost. Mitigation could include a number of bat boxes, for example.

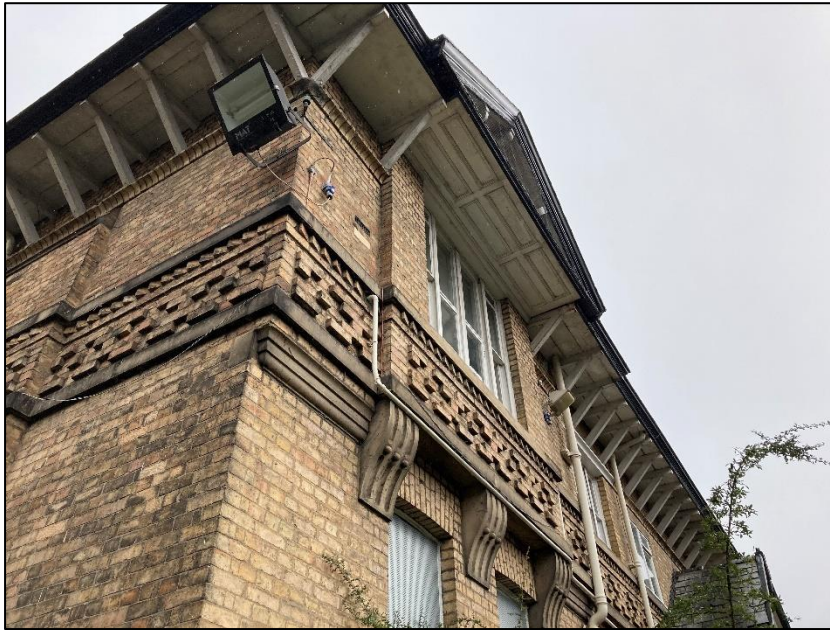
- 3.15 Painted wooden soffit boards are featured throughout the building and bargeboards are present on the gable ends (see Photograph 17). The soffit boards do support some damage and rot in places. Gaps are present beneath the eaves of the roof at the front of the property, creating potential access points for bats (see Photograph 18).

*Photograph 17 showing the wooden soffits*

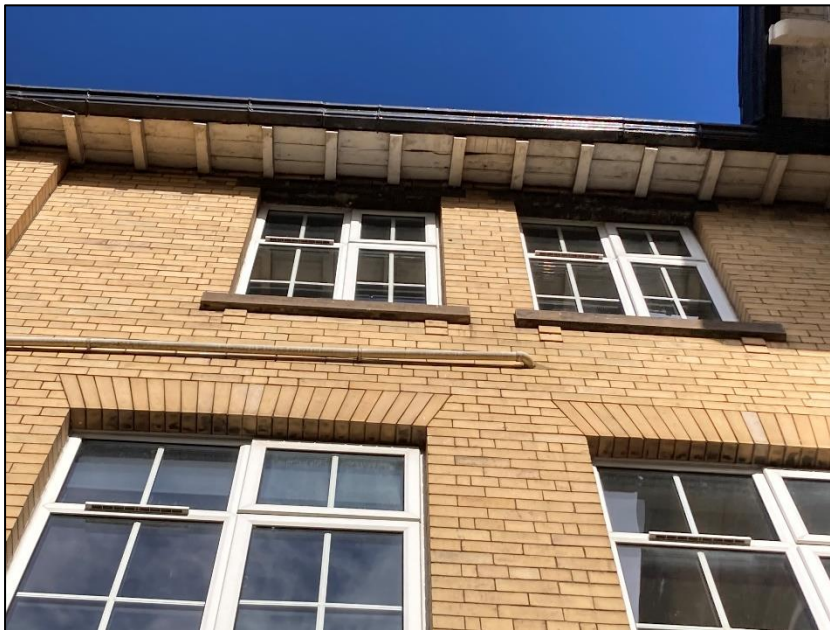
*Photograph 18 showing the gaps at the eaves of the roof and damaged soffits*

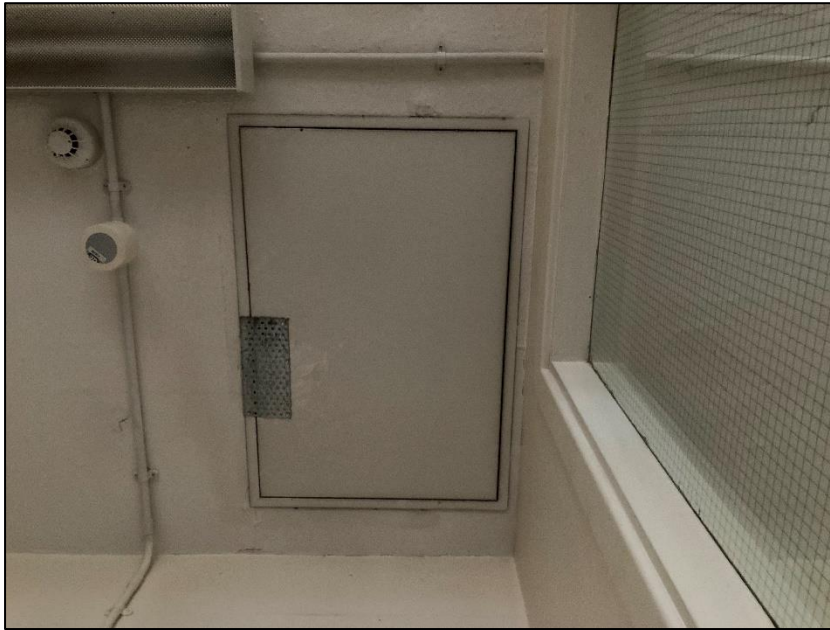
- 3.16 The ground floor-, first floor and second-floor rooms are finished spaces and do not present suitable bat roosting habitat. The roof voids in the eastern section of the buildings were not accessible (see Photograph 19). The western section of the building has one large and accessible roof void, which covers the expanse of the roof space (see Photograph 20).

*Photograph 19 showing the inaccessible loft hatch in the eastern section of the building*

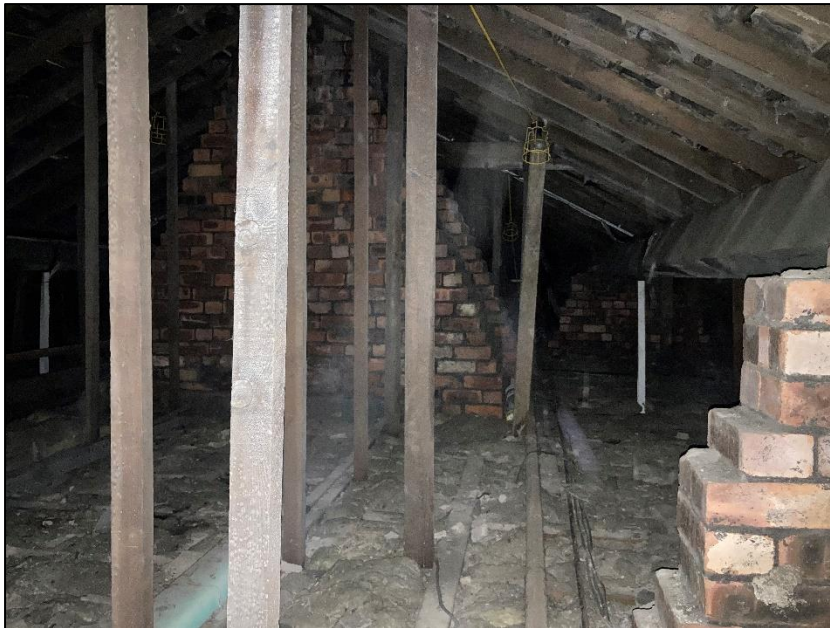
*Photograph 20 showing the roof void in the western section of the building*

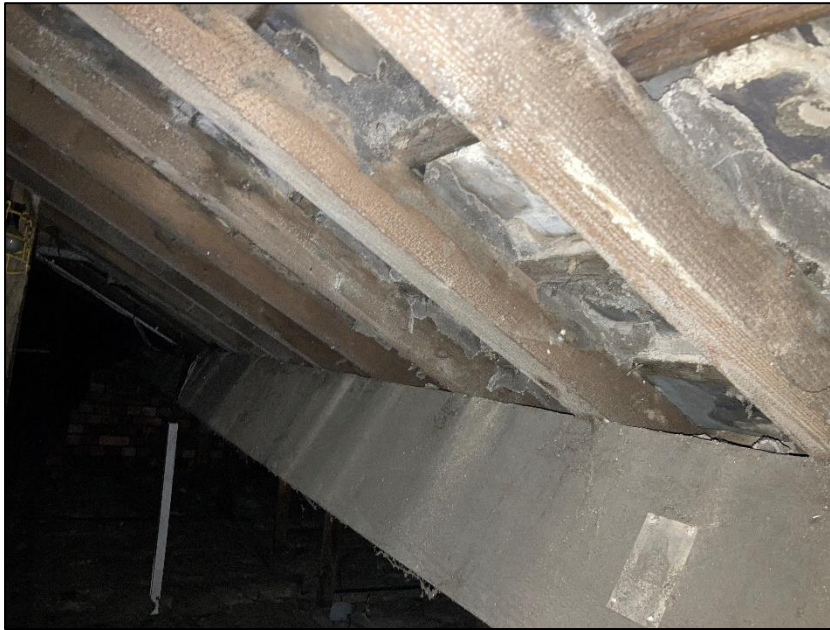
- 3.17 The roof void has wooden roof joists, which are without cracks for bats to use (see Photograph 21). Small gaps do occur where roof timbers meet, these were found to be cobwebbed suggesting they have not been used by bats to roost in (see Photograph 22). The mortar lining the roof tiles is crumbling and daylight can be seen in places (see Photograph 23).

*Photograph 21 showing the roof timbers*

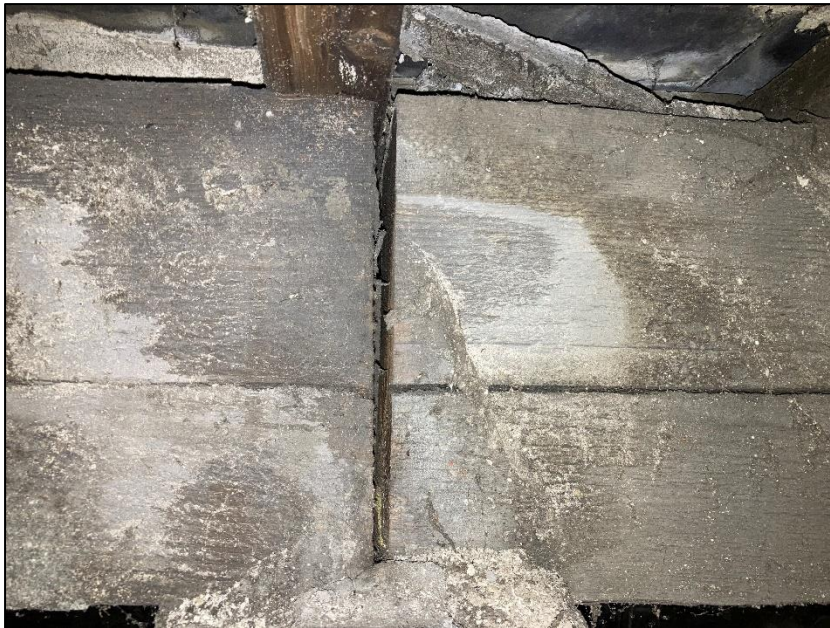
*Photograph 22 showing the gap between roof timbers*

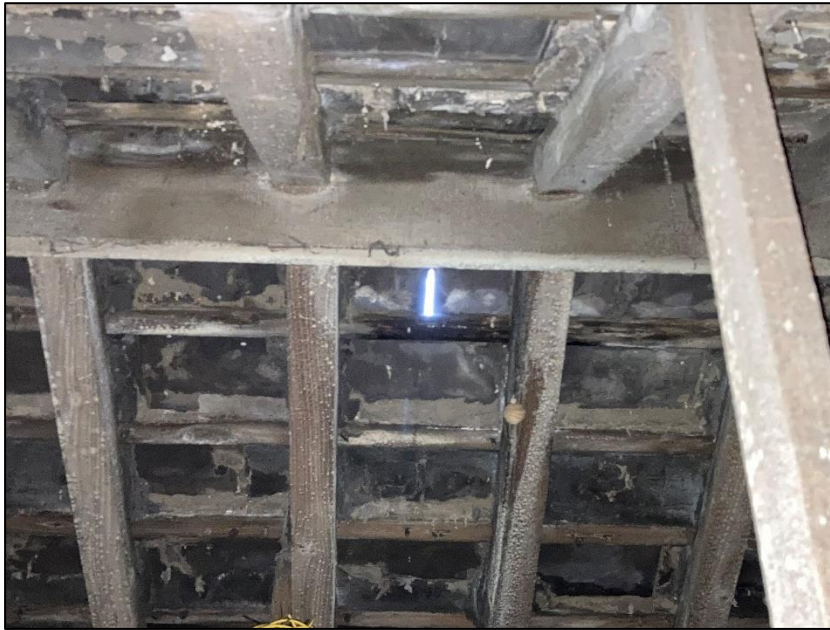
*Photograph 23 showing the daylight seen where mortar has crumbled*

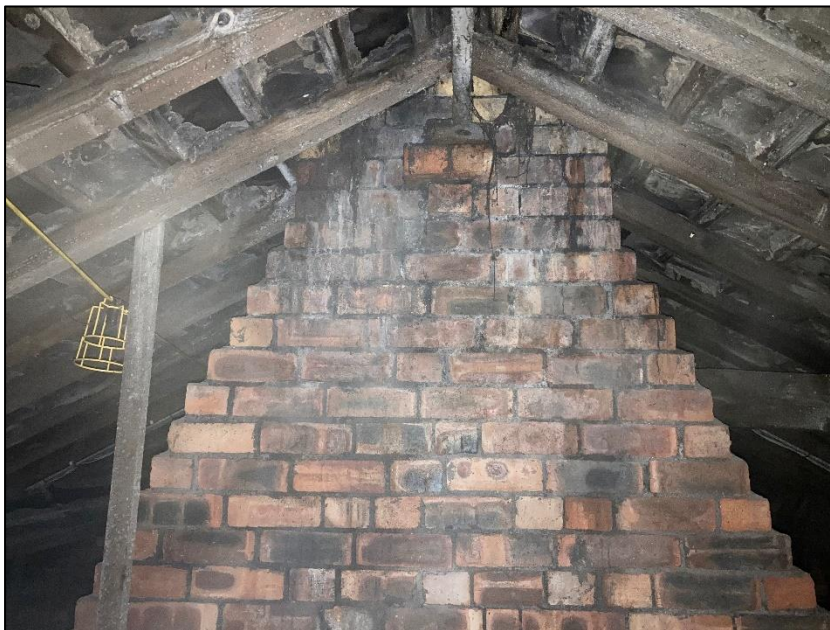
- 3.18 The roof void is insulated to the floor throughout. The internal brickwork is complete and sealed at the apex (see Photograph 24). Daylight is present at the roof edges throughout (see Photograph 25). No evidence of bat activity, such as bat droppings, were found within the western roof void.

*Photograph 24 showing some of the internal brickwork*

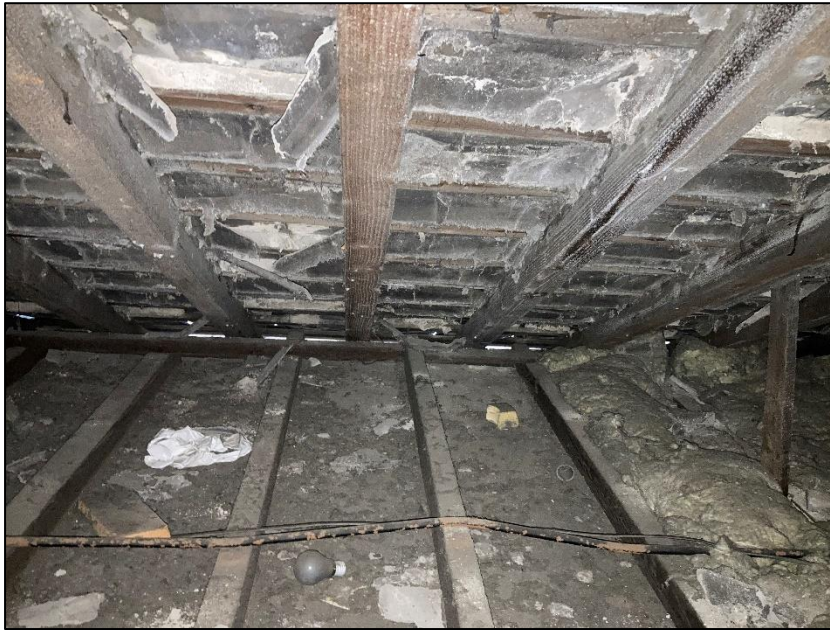
*Photograph 25 showing daylight at the roof edges*

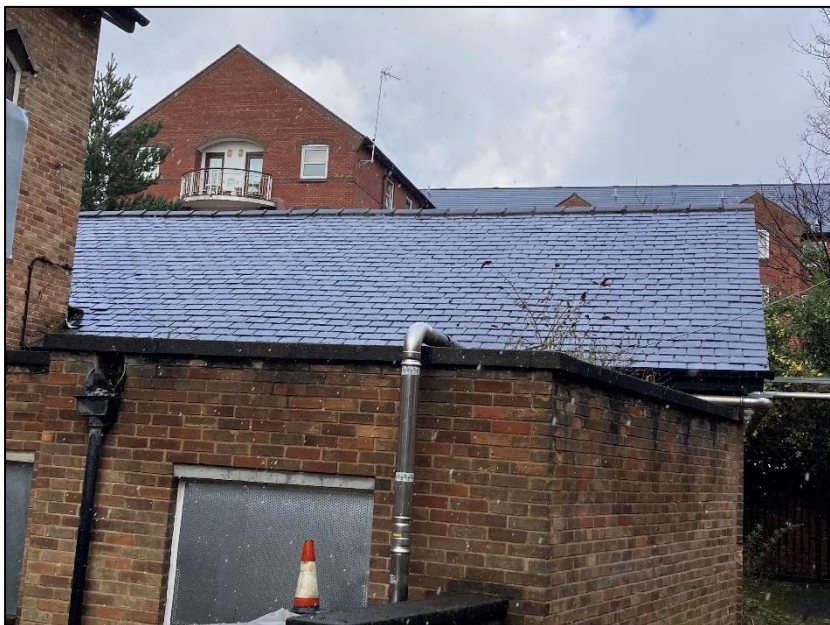
- 3.20 The building has multiple gabled and flat roofs constructed with slate tiles (see Photograph 28). A small number of tiles have slipped or are minorly damaged, but no potential cavities or access opportunities are created as a result that could be used by bats. The remaining tiles lie flush to one another. The ridge tiles are all in position and well-sealed with mortar. The flat roofs are firmly sealed. Bargeboards are featured on the gable ends. These are complete and in position (see Photograph 29).

*Photograph 28 showing a section of the Chapel roof looking north*

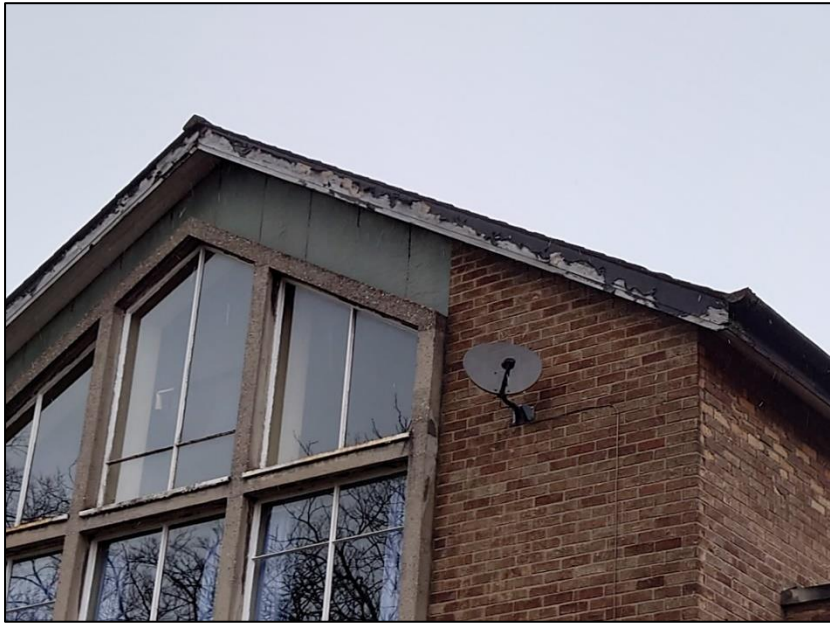
*Photograph 29 showing the bargeboards on the Chapel*

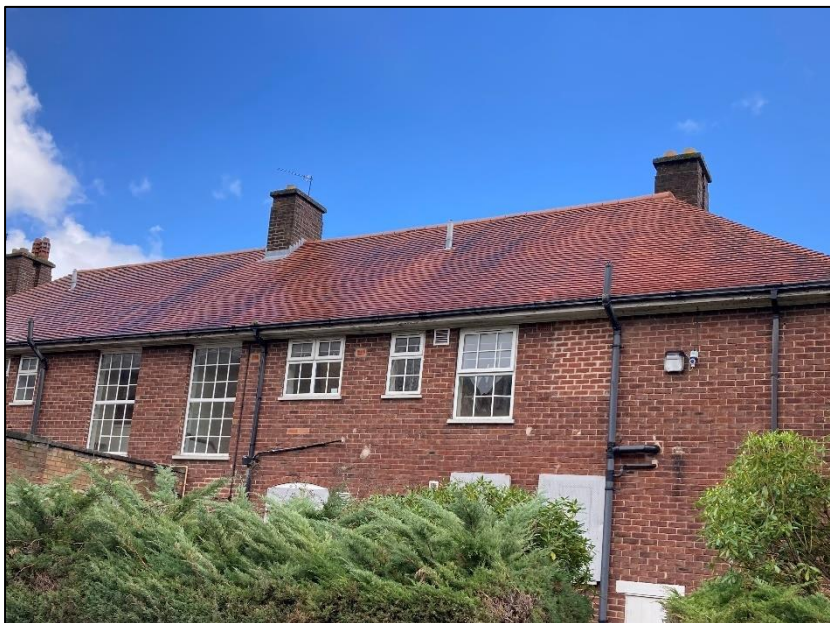
- 3.23 The roof of the building is hipped and constructed from clay tiles (see Photograph 34). A small number of tiles are minorly damaged or slipped and one tile is missing (see Photograph 35) but no suitable cavities for bat roosting are created or access to the internal space. The ridge tiles are all in position and well-sealed with mortar. Lead flashing exists around the chimney, and in the valleys between pitches. This is flush to the tiles and brickwork.

*Photograph 34 showing the roof of Woodthorpe Hall*

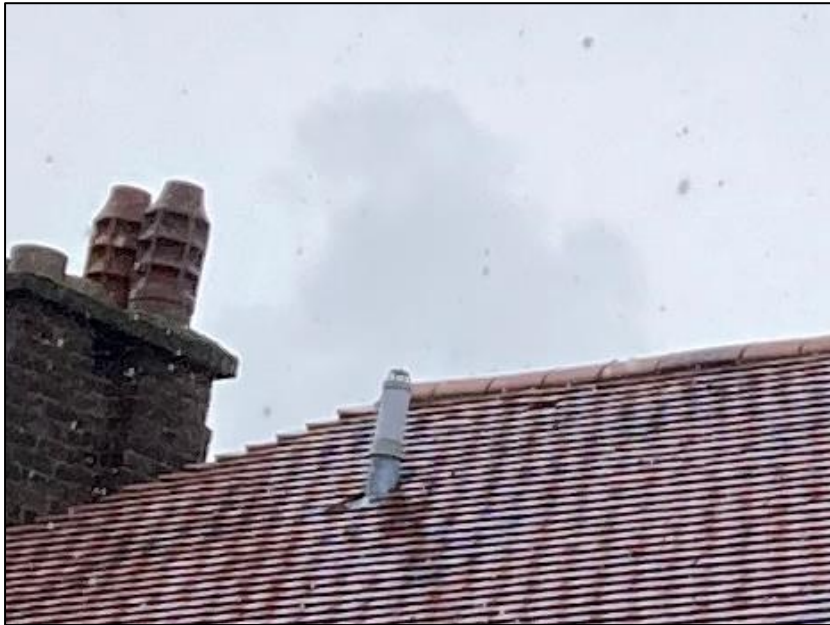
*Photograph 35 showing the missing tile*

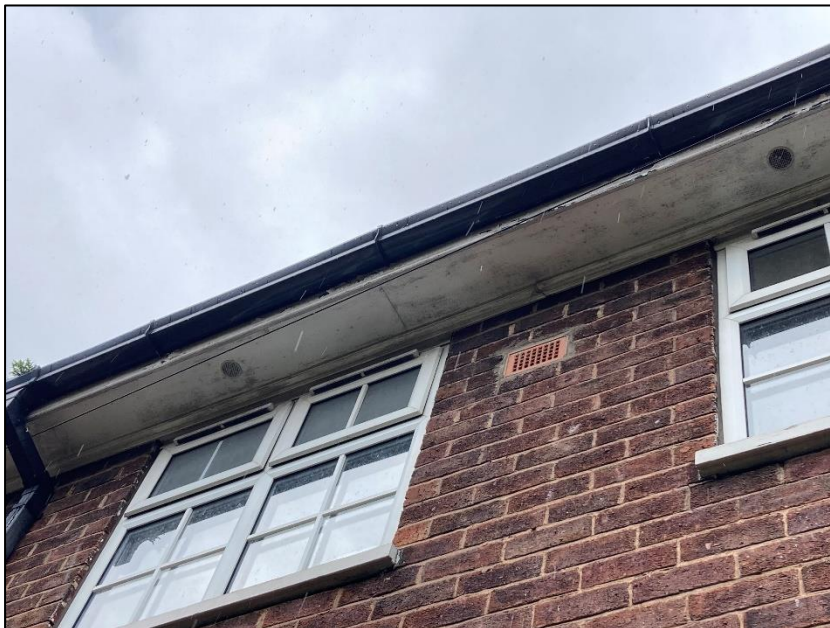
- 3.24 Wooden soffit boards are present on the roof edges throughout the building, these have vents throughout. These are complete and generally in a good condition. In places they do not lie flush to the brickwork, creating a small gap. This was inspected and was found to be cobwebbed suggesting no bat access has taken place (see Photograph 36).

*Photograph 36 showing the soffits*

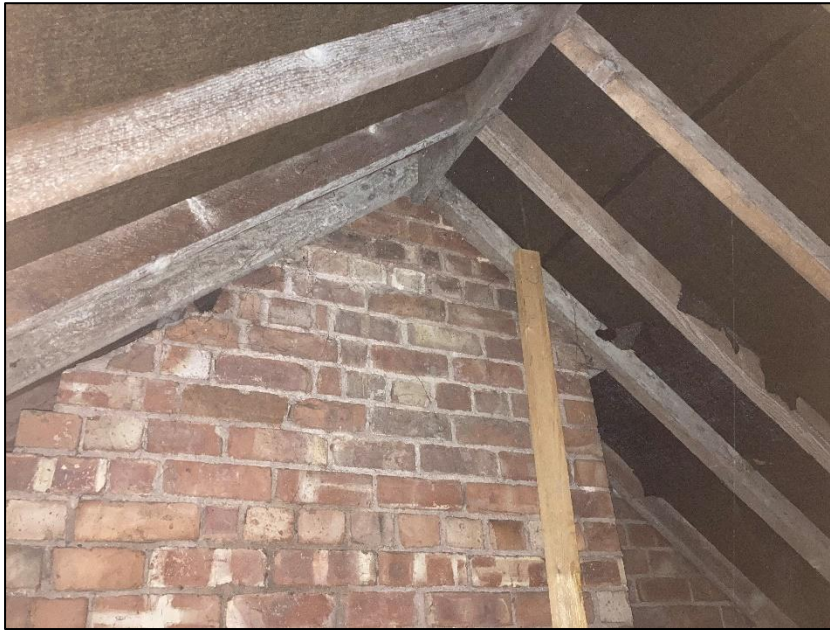
- 3.26 The roof voids are fully insulated to the floor. The internal brickwork within both buildings is complete but are not fully sealed at the apex (see Photograph 39). These cavities are heavily cobwebbed (see Photograph 40). Daylight is present at the roof edges in several places where the vented soffit boards exits (see Photograph 41). No evidence of bat activity, such as bat droppings, could be found inside the property

*Photograph 39 showing the internal brickwork*

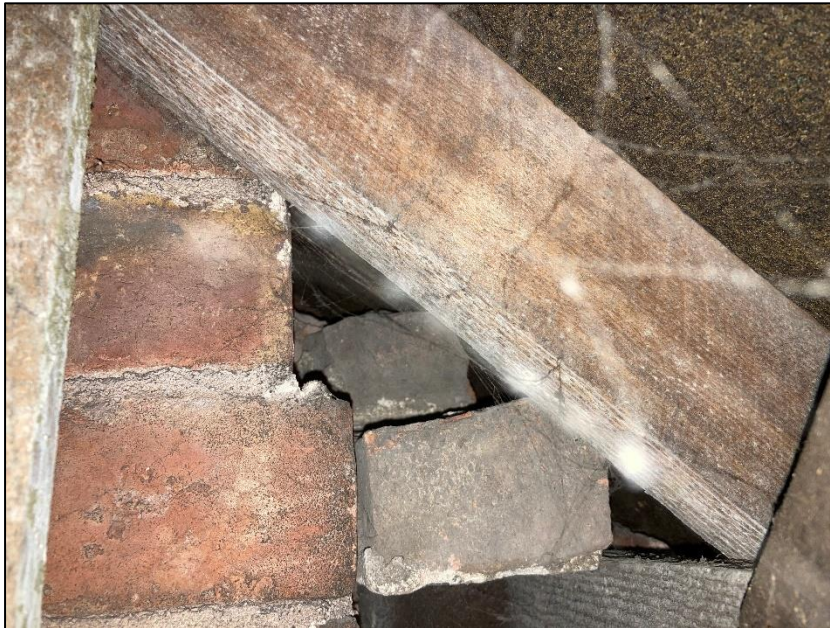
*Photograph 40 showing a cavity at the roof apex*

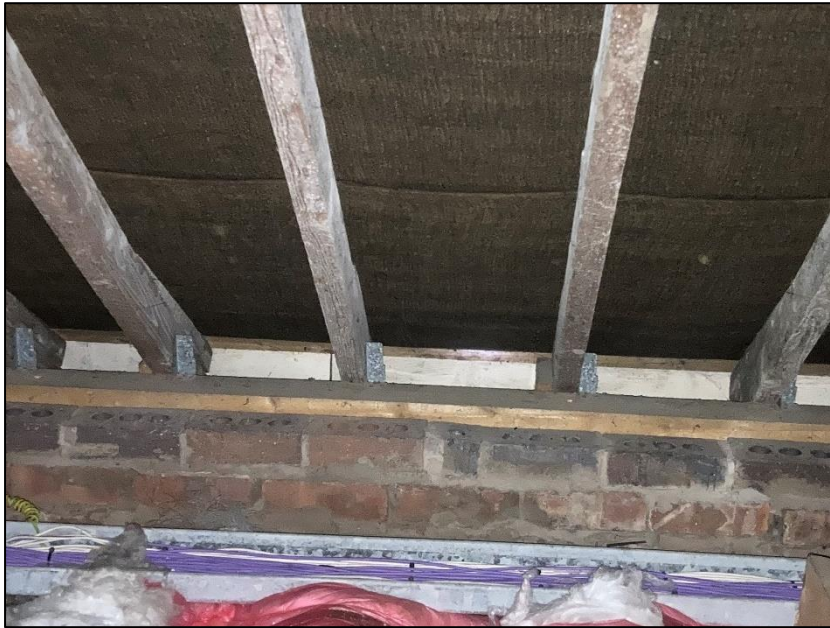
*Photograph 41 showing daylight at the roof edges*

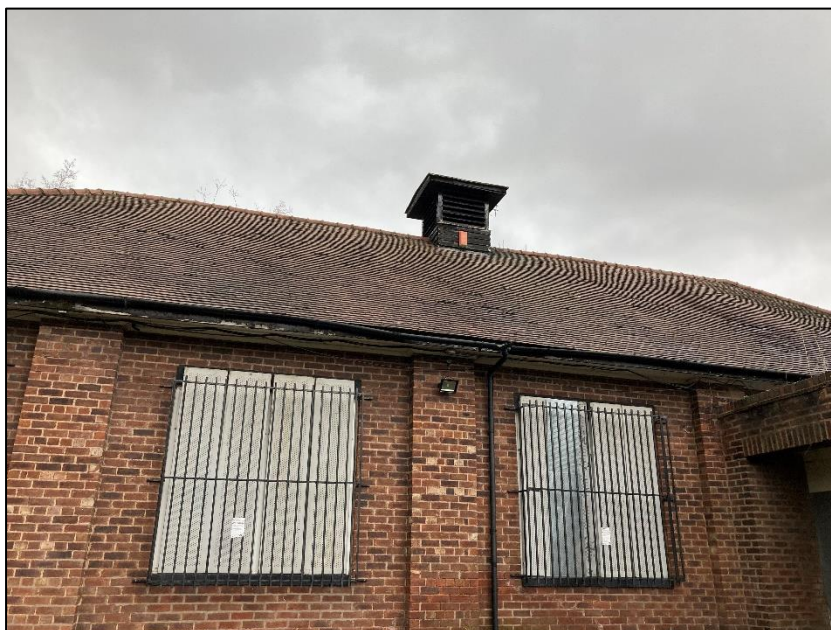
roof supports a decorative cupola with louvre windows (see Photograph 43). This offers potential entry points for bats into the roof void of the building. Lead flashing exists around the chimney, and in the valleys between pitches, this lies flush to the tiles. The building features soffits which are complete and lie flush to the brickwork.

*Photograph 43 showing the roof of St David's Hall*

- 4.9 St David's Hall is a double height single-storey brick. The building is generally in a good material condition with the only potential access point the decorative cupola on the roof. There is a concealed roof void above the main theatre below the cupola. St David's Hall is considered to offer **Low Potential** to support a bat roost. A minimum of one dusk emergence surveys should be conducted to determine if bats are gaining access to the roof void.
- 4.10 The trees on site were subject of a ground level assessment to search for features that could support roosting bats. No such features were found during the survey, the trees on site are considered to offer **negligible potential** to support a bat roost.

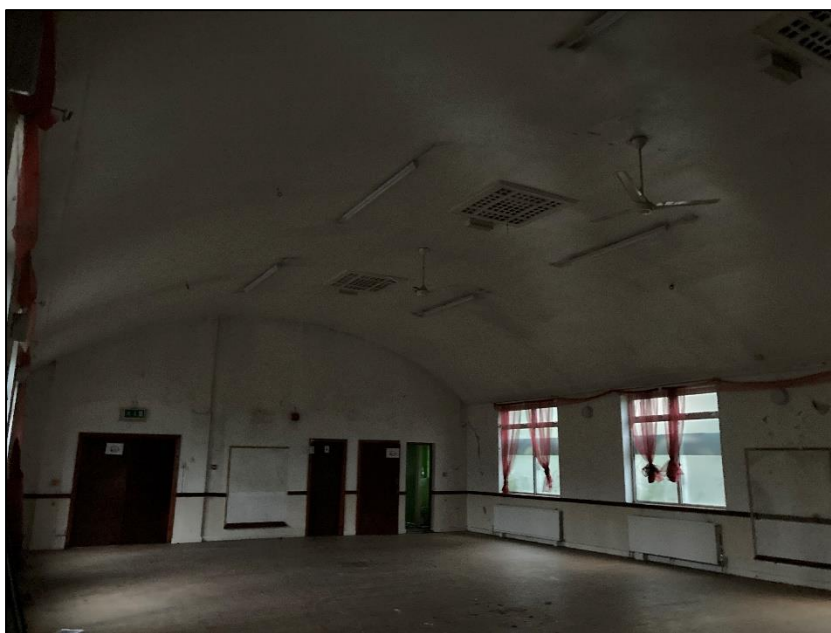
- 3.29 The building is not currently in use, the ground floor rooms are finished spaces that do not present suitable bat roosting habitat. The building has a concealed roof void above a plastered ceiling (see Photograph 44). It was not possible to access the roof void. No evidence of bat activity was found within the internal space of St David's Hall.

*Photograph 44 showing the internal space of St David's Hall*

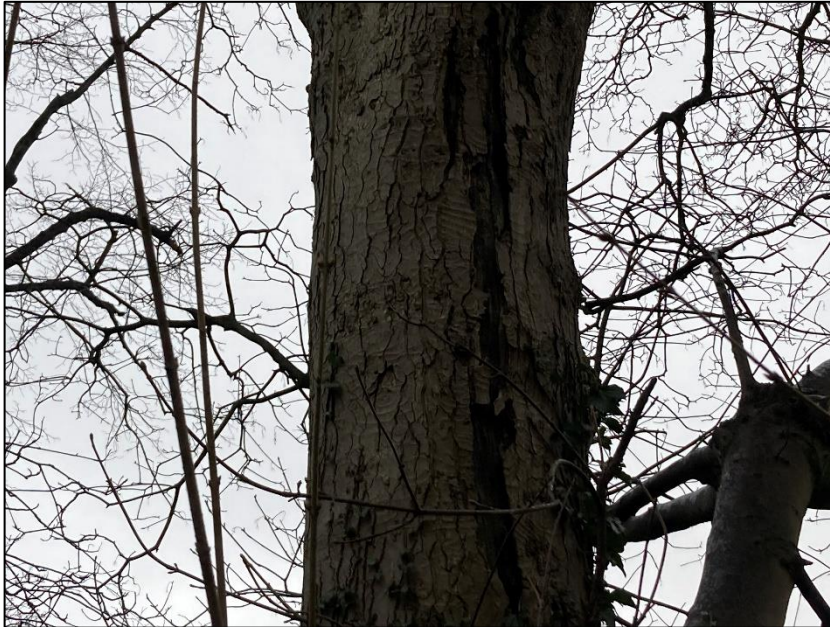
- 3.31 The trees on site were the subject of a ground level assessment to search for potential roosting features (PRFs) such as damaged limbs, cavities, or woodpecker holes. None of the trees on site are considered to offer any such features. Some of the trees support minor damage but none of it is significant enough to support a roost, being too shallow and exposed (see Photograph 47). Bats use linear landscape features for foraging and commuting and it is possible that bats forage and commute over the site, particularly the tree belts and hedgerow.

*Photograph 47 showing a tree with minor trunk damage*
